# **Cisco TelePresence SX, MX and DX Series**

**Collaboration Endpoint Software 8**

D15314.14

February 2017

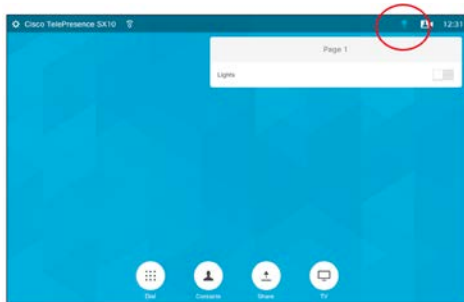
- Global

Global	Homescreen	In-Call
<p>Recommended features:</p> <ul style="list-style-type: none"> <li>▪ Lights</li> <li>▪ Blinds</li> <li>▪ Ventilation</li> </ul> <p>Available in and out of call</p>	<p>Recommended features:</p> <ul style="list-style-type: none"> <li>▪ TV</li> <li>▪ Services</li> <li>▪ Media</li> </ul> <p>Available outside of call only</p>	<p>Recommended features:</p> <ul style="list-style-type: none"> <li>▪ Microphones</li> <li>▪ Recording</li> <li>▪ Help</li> </ul> <p>Available inside of call only</p>

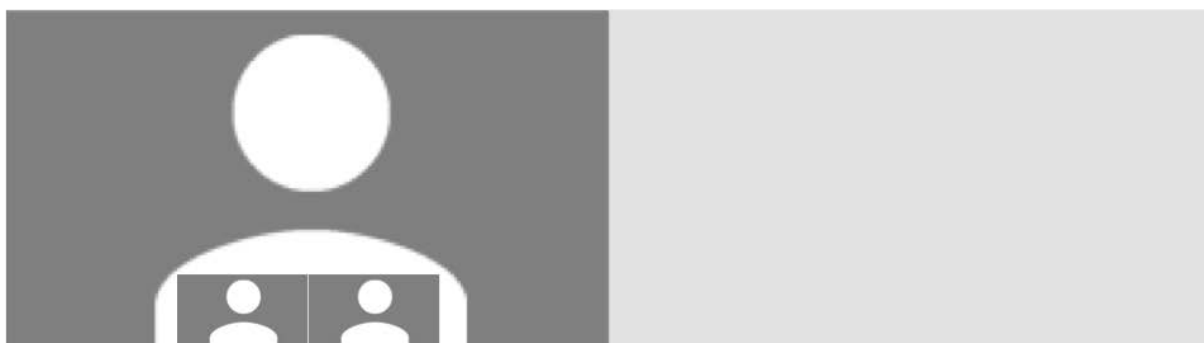
The above example shows a two-screen system in a conference where Multistream is not enabled. The endpoint is receiving only one transcoded stream from the Cisco TelePresence Server.

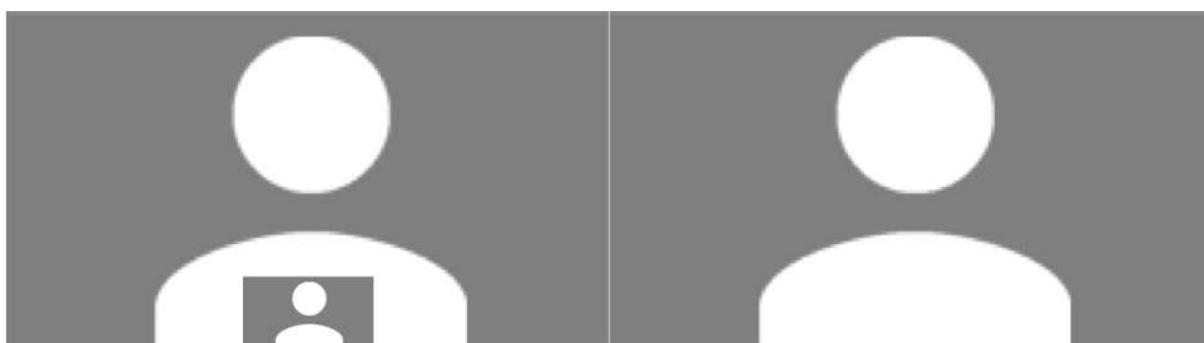
The above example shows the same conference with Multistream enabled.
