Clock Path ECO with PrimeTime DMSA fix_eco_timing

Anne Yue Rajeev Srivastava

Synapse Design San Jose CA, USA

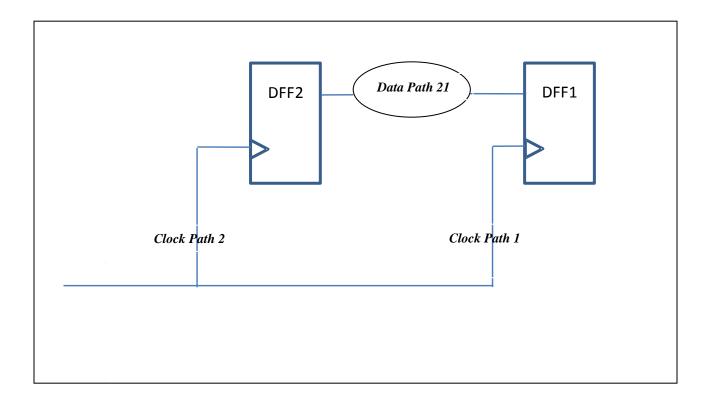
Figure 1 – DFF with Clock Path & Data Path

The DMSA ECO log files show us very complicated iteration and process for a fix_eco run. The algorithm is complicated, but exactly what tool can do is very simple. If we use the following violation path as example, what *fix_eco_timing* and *fix_eco_drc* can do is:

- . Sizing the cells in Data Path 21(DFF2->DFF1)
- . Add buffers in Data Path 21.

But, by studying Figure 1, we will ask the question: Does everyone forget the Clock Path 1 & Clock Path 2?

- . Change the Clock Path 1 & Clock Path 2.
- . Remove cells. PrimeTime ECO cannot remove any cell along Clock Path 1, Clock Path 2 & Data Path 12.

PrimeTime ECO cannot change the Clock Path 1 & Clock Path 2 in Figure 1. In general, Clock Path components include the clock buffer/inverter cells. The bad news is, beside the general clock tree cells, PrimeTime considers the clock path endpoint cell (DFF) as part of the clock tree system, hence the PrimeTime ECO will not touch the DFF cells.

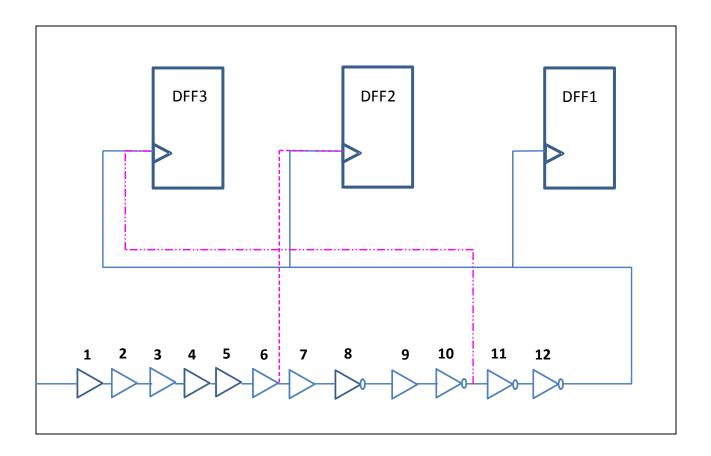
Figure 2 – Clock tree re-stitching with 1^{st} level & 2^{nd} level borrowing

With Figure 2, what we start with is the violation of DFF2->DFF1 path. For some reason the violation is not fixed even after the PT DMSA *fix_eco_timing*. The sizing of DFF2->DFF1 Data Path is not sufficient to fix the setup negative slack. We will perform the following steps to do the Clock Path ECO:

- DFF1 is the endpoint of the violation path. There may be multiple violation paths with one single end point. Report all the violating start points (DFF2s) with this endpoint. The violation slack from different start points should have different numbers.

We want to do as little as possible clock tree stitching. To avoid 2nd level borrowing, rerun DMSA ECO after 1st level clock re-stitching. Utilize the PT_ECO data path sizing features for potential 2nd level setup fix. In Figure 2, since the path DFF3->DFF2 is exposed to PrimeTime ECO as first time during the (1st level borrowing + PT_ECO), the PT_ECO can definitely do something on the DFF3->DFF2 data path. The potential 2nd level setup violation has good chance to be fixed, or at least be reduced after the (1st level borrowing + PT_ECO).

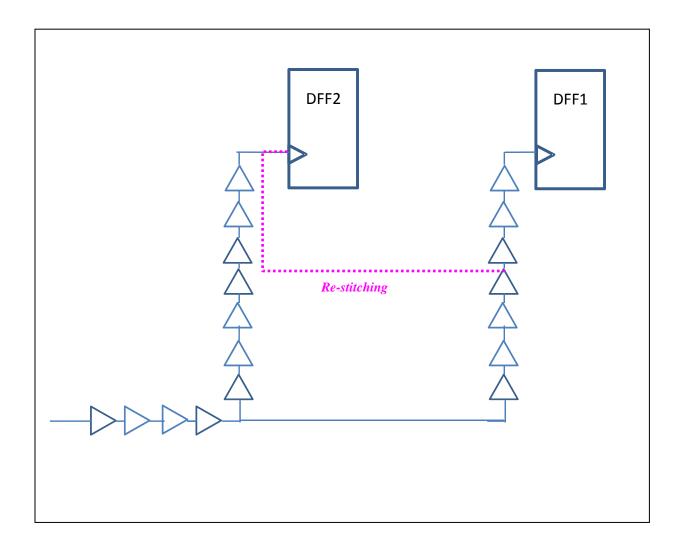
Figure 3 – Extra CRPR timing bonus with re-stitching

- *Tips:* We can get the extra CRPR timing bonus for re-stitching. In Figure 3, by rearranging the launch & capture clock (DFF2/CK & DFF1/CK) to the same CTS branch (DFF1/CK branch), we can easily bypass the CRPR penalty, and get less tool calculation pessimism. In some cases, we can get ~120ps extra bonus on this in-depth study restitching.
- Point of interest for Synopsys tool development team:
 - . Is it a bug (or feature) for "WLM used for disconnected nets"? Could that be fixed?
 - . Current 1st level setup borrowing and 2nd level setup borrowing analysis utilize some scripts, but they have room for more automation. Synopsys should be able to implement this "check margin + check stitch point" in a more efficient way.
 - . "CRPR extra bonus" could be an option for high weight critical path.
