CONTRIBUTION OF CROSS LAMINATED TIMBER PANELS TO ROOM FIRES

A thesis submitted to
the Faculty of Graduate and Postdoctoral Affairs
in Partial Fulfillment of the requirements for the degree

Masters of Applied Science in Civil Engineering

Department of Civil and Environmental Engineering
Carleton University

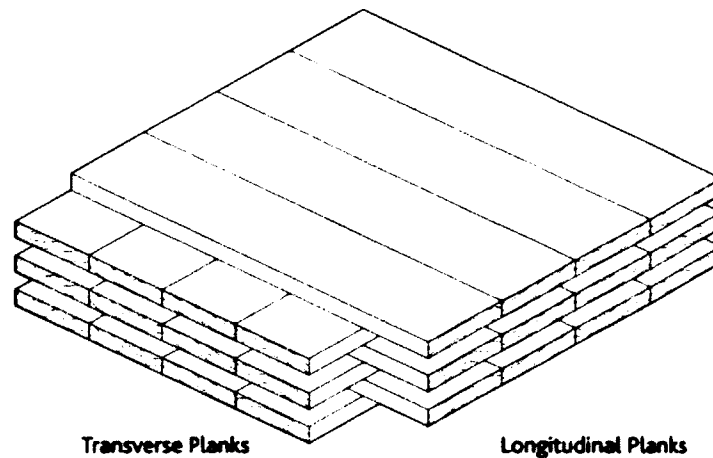
Figure 1 – CLT panel configuration [2]

CLT is manufactured in layers using solid sawn wood members, 38 x 89 mm members are commonly used however dimensions can vary depending on manufacturer and application. The individual members in each of the layers are finger joined, where necessary, to provide the required lengths for uninterrupted construction and layers are stacked perpendicular to each other at a 90 degree offset which can be seen in Figure 1.

In construction, the members in each layer are pressed together and the faces of the layers are then bonded, most commonly using an adhesive although it is possible to use dowels or nails. Multiple layers are used to create thick panels of typically 3-9 layers. Generally the structural characteristics of these layers are determined by one of the two planes, for example calculations may use properties of the longitudinal direction and the transverse layers are assumed to have no structural input. The transverse layers also tend to use a lower grade of wood. Kiln dried wood which has a moisture content of less than

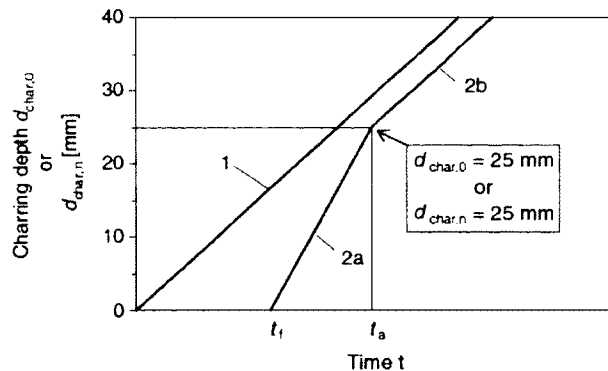
This scenario assumes that no charring of the protected member occurs until a time when the protection falls off entirely. The surface is protected by a cladding that delays the start of charring until the protection falls off at time t_f . Charring is assumed to occur at twice the rate of the unprotected surface from t_f , the increased rate of charring is assumed until the timber develops a level of char which would be expected in initially unprotected timber, for which the depth of 25 mm is adopted.

Key:

- 1 Relationship for members unprotected throughout the time of fire exposure for charring rate β_n (or β_0).
- 2 Relationship for initially protected members after failure of the fire protection:
 - 2a After the fire protection has fallen off at time t_f , charring starts at increased rate.
 - 2b After char depth exceeds 25 mm at time t_a , the charring rate reduces to the rate shown by curve 1.

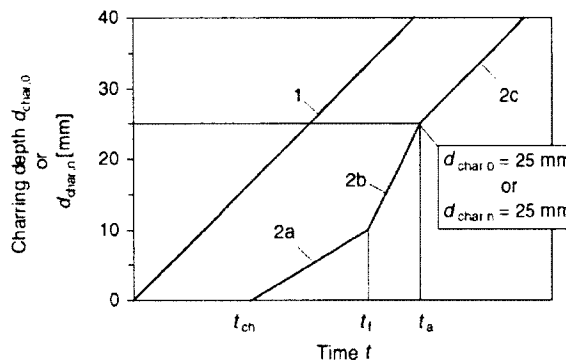
Figure 5 - 1 dimensional charring rates for unprotected and protected timber (charring begins before protection falls off) [13]

The timber surface is protected by a layer that delays the start of charring until time t_{ch} , shown in Figure 5, and provides some protection for a period before falling off. This results in a charring rate of 50% of that for unprotected wood until the protection falls off completely at time t_f . After this the charring occurs at twice the normal rate until reaching a depth of 25mm when the charring rate reverts back to that for initially unprotected timber.

Key:

- 1 Relationship for members unprotected throughout the time of fire exposure for charring rate β_n (or β_0).
- 2 Relationship for initially protected members where charring starts before failure of protection:
 - 2a Charring starts at t_{ch} at a reduced rate when protection is still in place.
 - 2b After protection has fallen off at time t_f , charring starts at increased rate.
 - 2c After char depth exceeds 25mm at time t_a , the charring rate reduces to the rate shown by curve 1.

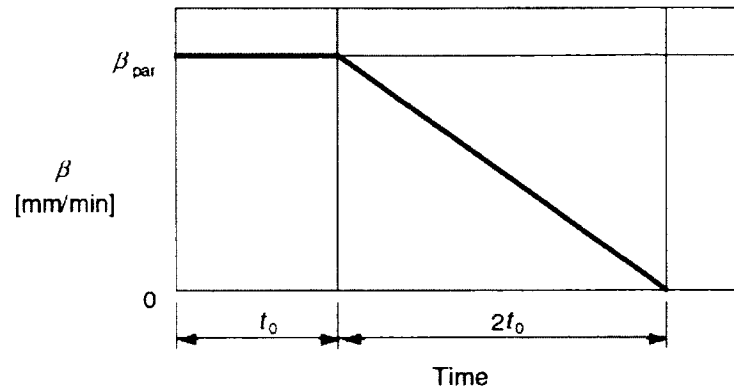
Figure 6 – Eurocode 5 [13] charring rate for parametric fires.

Parametric design fires, which attempt to provide a realistic prediction of temperature based on observations from previous tests, go through a period of continuous heating before entering a decay period. In parametric fires, the charring rate is considered constant until the start of the decay period at t_0 shown in Figure 6. After this, the charring rate is assumed to decay linearly reaching zero at $3 t_0$.

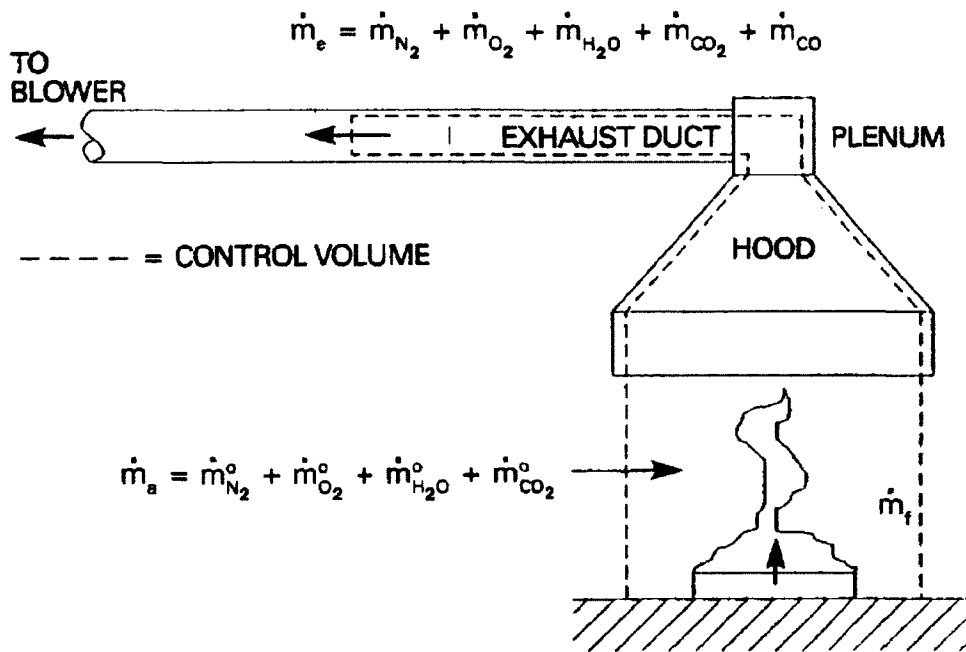
Figure 7 – Schematic of a full scale fire test combustion system [19]

In 1991 Janssens [19] proposed a series of equations, developed specifically for full-scale fire tests where it is assumed that it is not possible to measure the air flow rate into the system. The basic requirement for the test is that all of the combustion products are collected and measured downstream at a sufficient distance for adequate mixing. At a minimum the oxygen can be measured, however the accuracy is increased by measuring the concentrations of CO, CO₂ and H₂O in the gas stream which account for incomplete combustion. The schematic of the full scale fire test combustion system is presented in Figure 7.

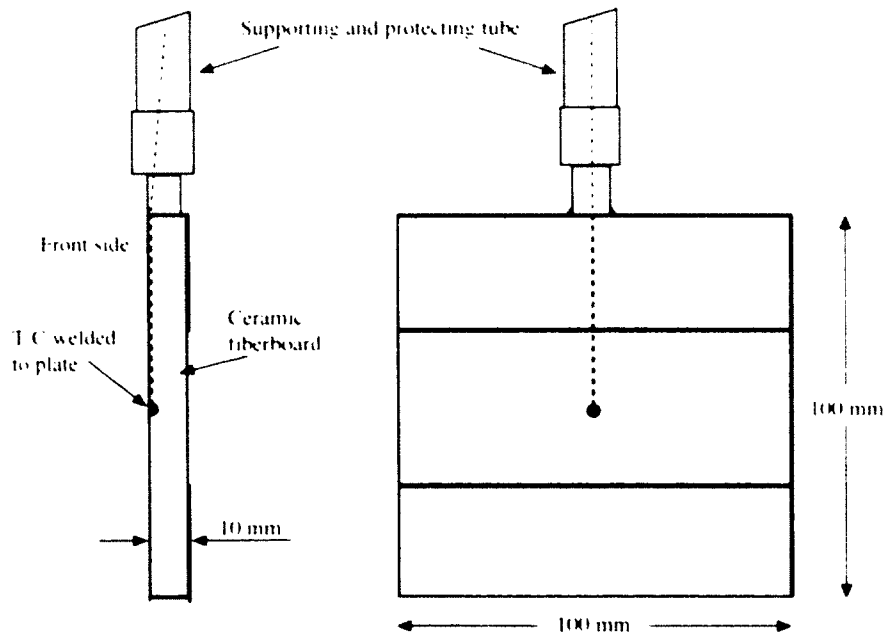
Figure 12 – Plate thermometer schematic [24]

The plate thermometer, shown in Figure 12, has a large surface area which is more sensitive to radiative heating than a standard thermocouple which has a small surface area and is more sensitive to local convective heat transfer. It is generally used in furnace testing where heat transfer depends primarily on radiant flux to a specimen rather than convection. It is installed in front of the specimen so that it receives the same amount of radiant exposure and is insulated behind so that it is not affected by the specimen [24]. As a result, the plate thermometer represents a reading of the adiabatic surface temperature of the plate which may differ from the surrounding gases significantly.

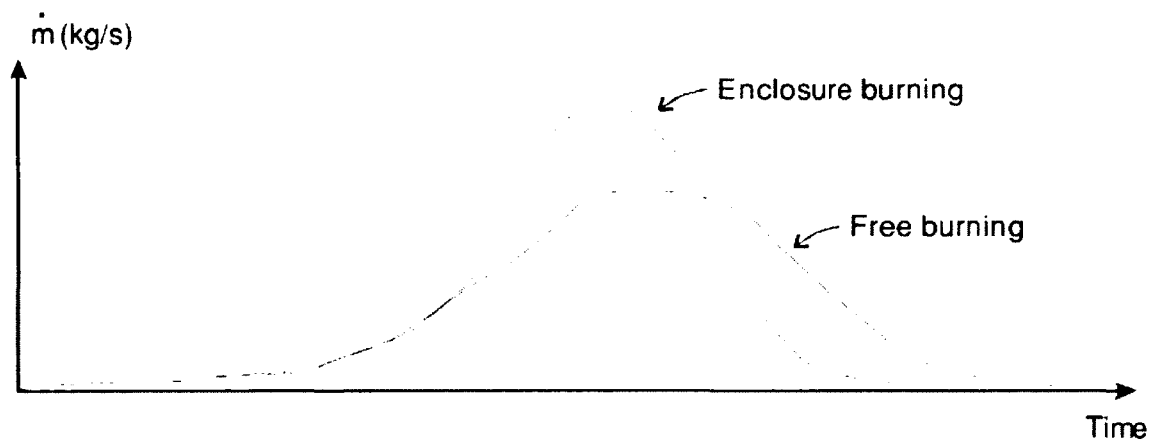
Figure 13 – Enclosure effect on mass loss rate [16]

In a room fire the hot gases from combustion collect at the ceiling, developing a hot layer and heating the internal surfaces of the room. Together, these radiate heat back to the fuel enhancing the combustion process and increasing the burning rate which is demonstrated in Figure 13. The openings in the room however can limit the oxygen supply which can cause a decrease in the amount of fuel burnt and energy released which can ultimately decrease the burning rate. An expression which has been shown to be proportional to the burning rate in a room is termed the ventilation factor and is provided in Eq 9 [16].

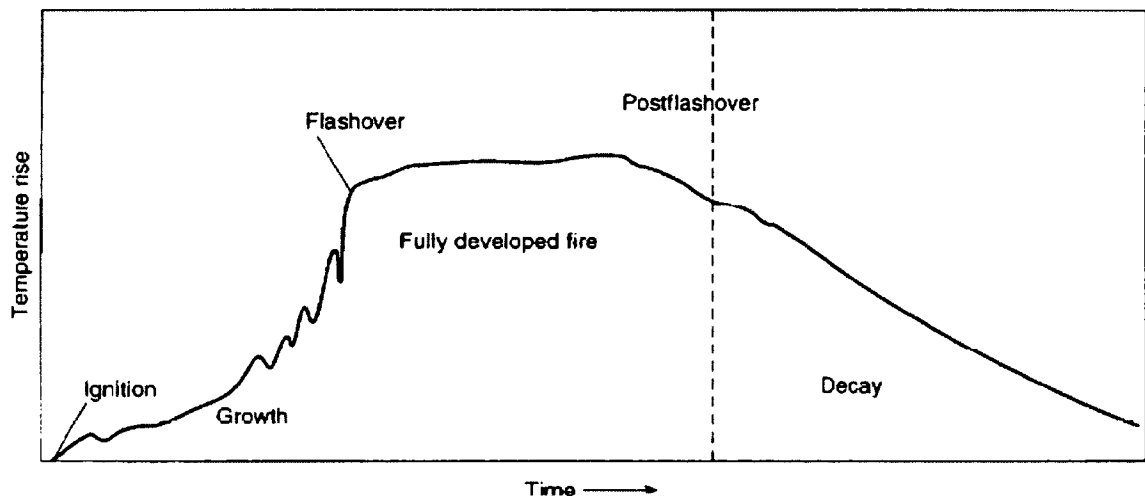
Figure 14 - Stages of fire development in room without suppression [26] - Temperature

Room fires generally consist of two main periods, the pre flashover fire and the post flashover fire [16]. The pre flashover period involves the growth stage of the fire, and is the period where fire safety design focuses on safety of humans [16]. The post flashover period is where the fire safety design focuses on structural stability, safety of fire fighters and measures to save property [16]. A more detailed description is provided by Walton and Thomas [26] which describes the fire in five stages relating to temperature, shown in Figure 14. A similar schematic for the five stages, relating to HRR, is presented in Figure 15. These stages are:

1. Ignition
2. Growth
3. Flashover
4. Fully Developed, and
5. Decay

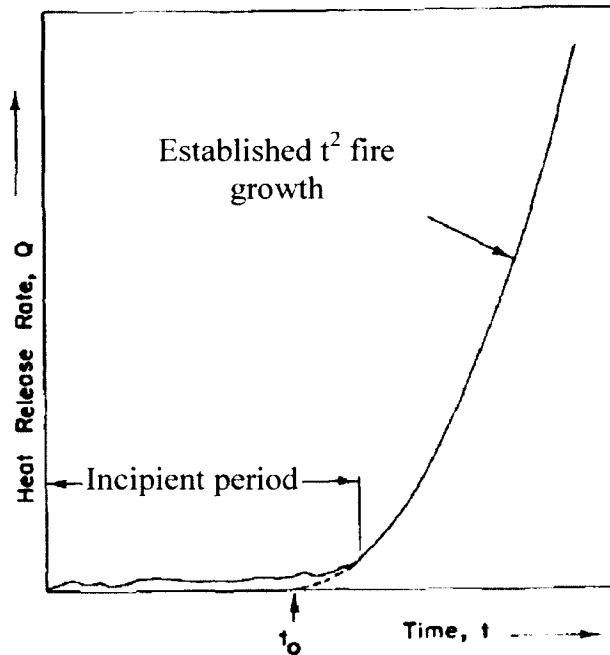
Figure 16 – t squared fire growth following incipient phase (modified from [28])

Following ignition a fire undergoes an incipient period, shown in Figure 16, during which the fire grows very slowly until the confinement begins to influence the fire development. This period is difficult to quantify and can be influenced by various factors

such as strength of ignition source, location of the burning items and the properties of the first item ignited [9].

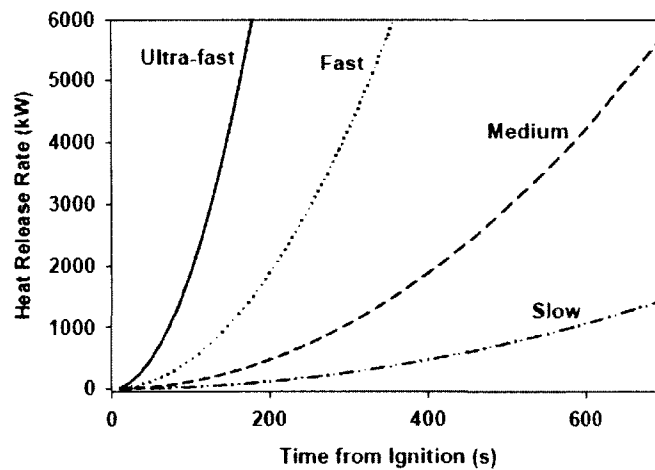
Figure 17 – Energy release rates for different growth rates [30]

The NFPA [16, 29] recommended categories of fire growth in design fires, corresponding to the time it takes to reach 1055 kW, are presented in Table 1 and graphically in Figure 17,

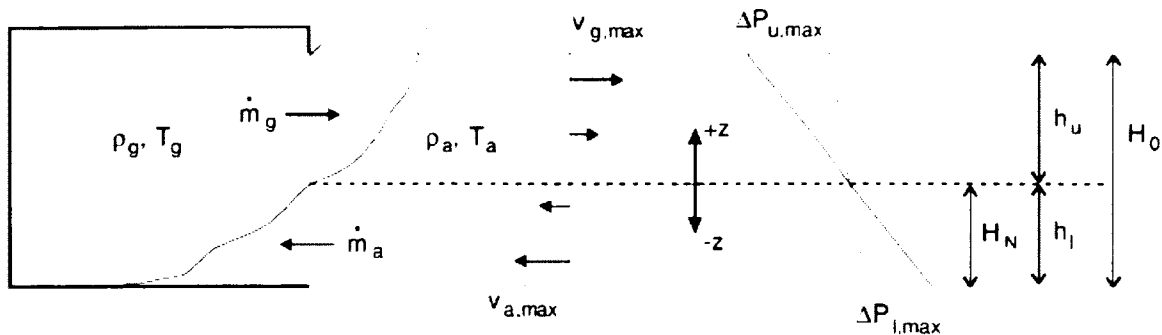
Figure 18 – Vent flows for well mixed room with uniform temperature where $T_g > T_a$ [16]

To determine the mass flows in and out of the compartment, vent flow analysis can be used. Assuming the well mixed case, shown in Figure 18, and taking into account the burning rate in the room, Eq 13 and Eq 14 are generated [16].

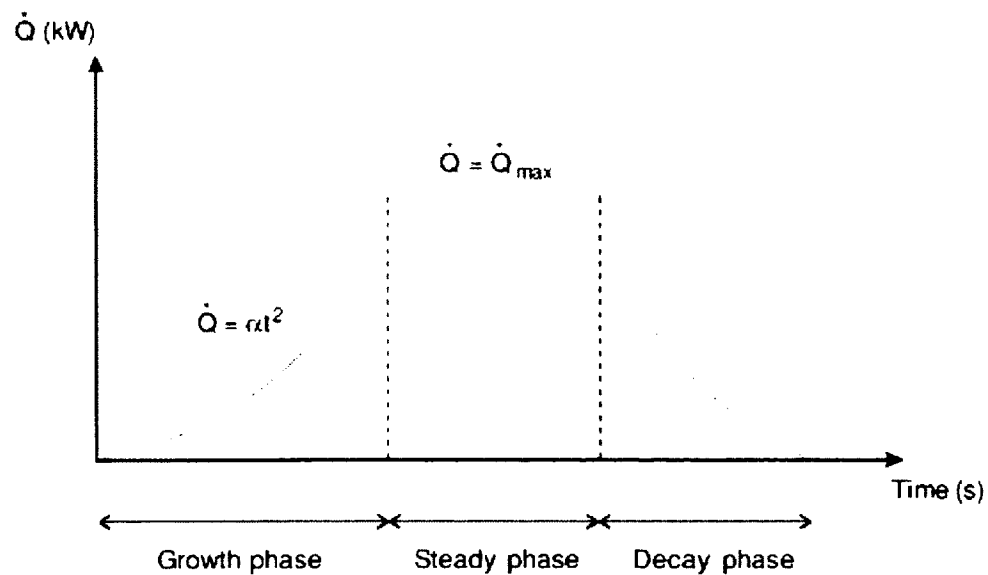
Figure 20 – Example of a simple fire curve [16]

As there is no exact methodology or procedure available to determine the design fire to be used in room fires, the engineer must use all available information on the building and fuels, and engineering judgement to determine an appropriate fire [16]. The design fire is expressed in terms of HRR vs time and, in the simple case, incorporates three phases: Growth, Steady burning and Decay. The t^2 fires, discussed in Section 2.6, are commonly used to model the growth phase of the fire and can also be adjusted to represent the decay. An example of a simple design fire is presented in Figure 20.

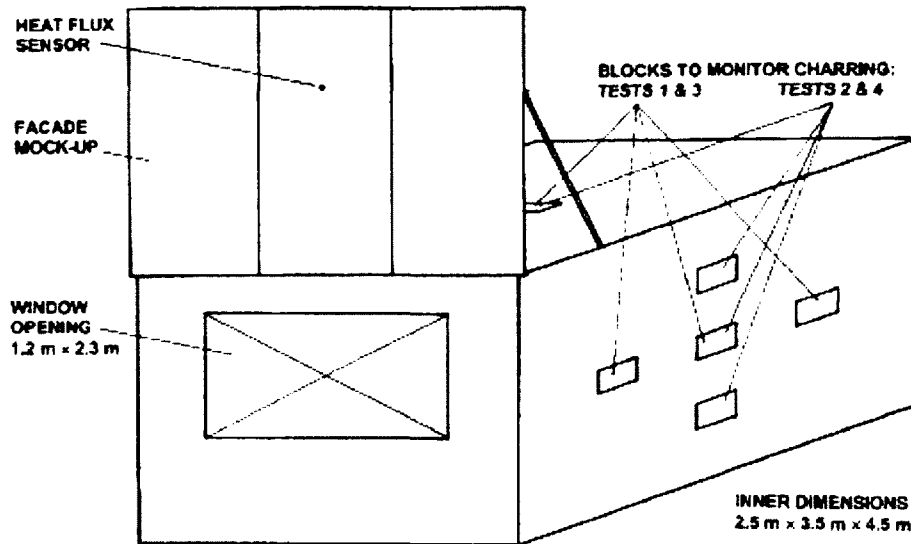
Figure 22 – Schematic of test room – Hakkarainen [38]

A brief review of temperature development in compartment fires and charring of timber structures was included. The dimensions of the room used in the tests, shown in Figure 22, were 4.5 x 3.5 x 2.5 m height. Opening dimensions were width 2.3 x 1.2 m height.

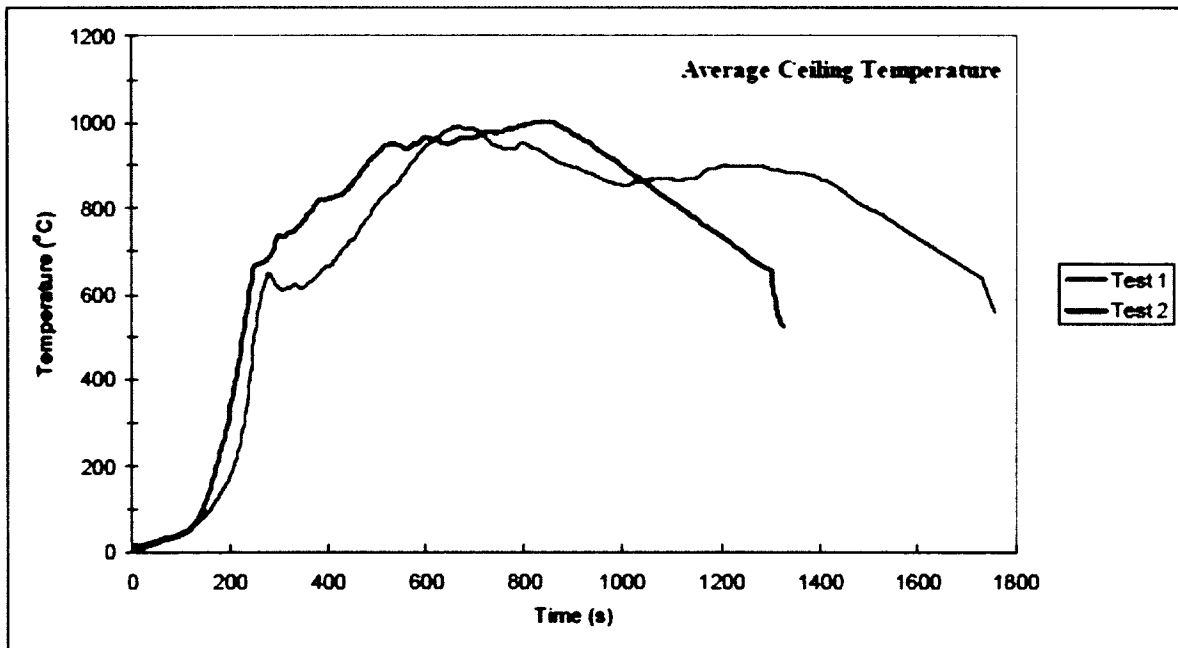
Figure 29 - Average temperatures measured at the ceiling – Chen [40] tests

The average ceiling temperatures for Tests 1 and 2 are presented in Figure 29, which show peaks of approximately 990°C. Localised peak temperatures of approximately 1200°C and 1100°C were observed for Tests 1 and 2 respectively. Peak heat flux measurements of 286 kW/m² and 234 kW/m² were recorded at the northeast corners (opposite the opening) for Tests 1 and 2 respectively.

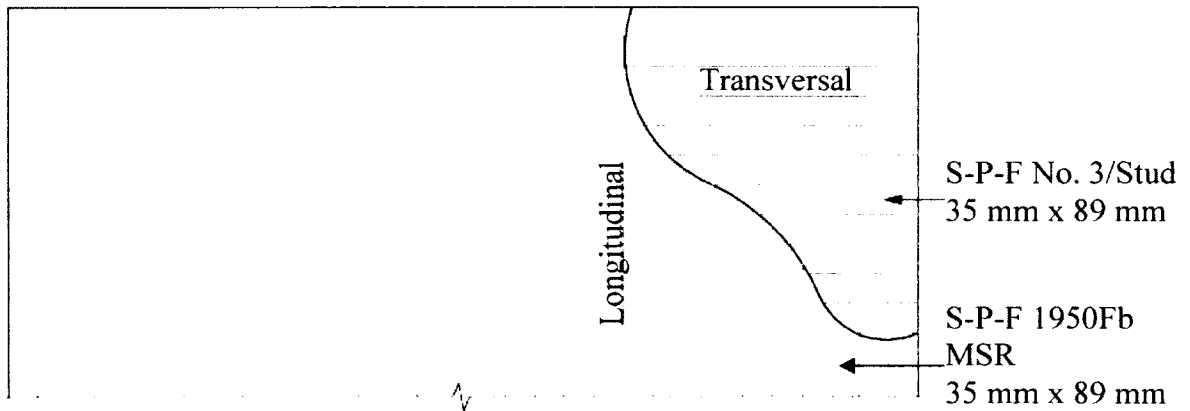
Figure 31 – X-Lam (105-s3) panel layup (modified from [42])

All rooms were constructed from X-Lam (105-s3), 105mm thick 3 ply CLT panels provided by Nordic Engineered Wood. The outer (longitudinal) laminations were made from SPF 1950Fb MSR 35 x 89 mm members with the centre (transversal) lamination made from S-P-F No 3/Stud 35 x 89 mm at a 90 deg offset orientation as shown in Figure 31 and Figure 32.

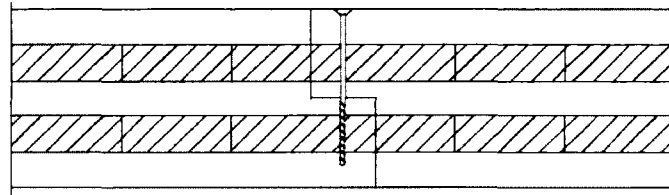
Figure 36 – Longitudinal joints in walls, ceilings and floors (5-Ply drawing shown) [44]

Three types of joints were used between the panels in the construction of the rooms. Lap joints connect panels longitudinally at the walls, ceiling and floor and were secured at 300 mm intervals with $\varnothing 6$ mm x 100 mm self-tapping screws as shown in Figure 36.

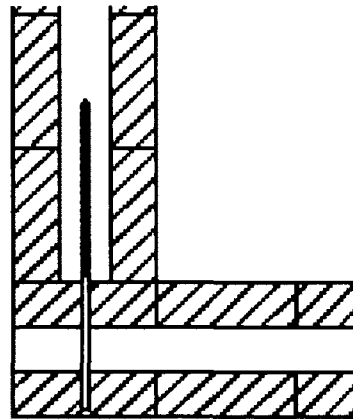
Figure 37 - Corner wall joint [44]

Wall to wall corner joints were secured at 300 mm intervals with $\varnothing 8$ mm x 180 mm self-tapping screws as shown in Figure 37.

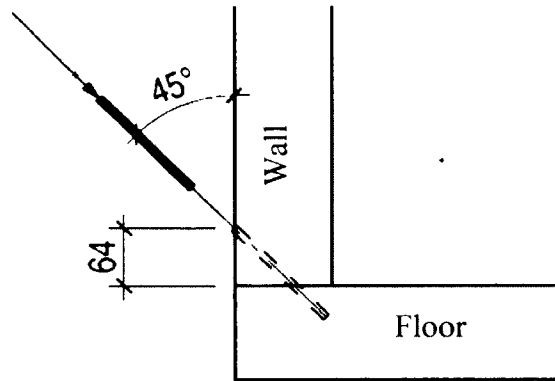
Figure 38 - Wall to floor joints (modified from [43])

Wall to floor joints were secured at 300 mm intervals with $\varnothing 8$ mm x 180 mm self-tapping screws driven in at 45 deg as shown in Figure 38.

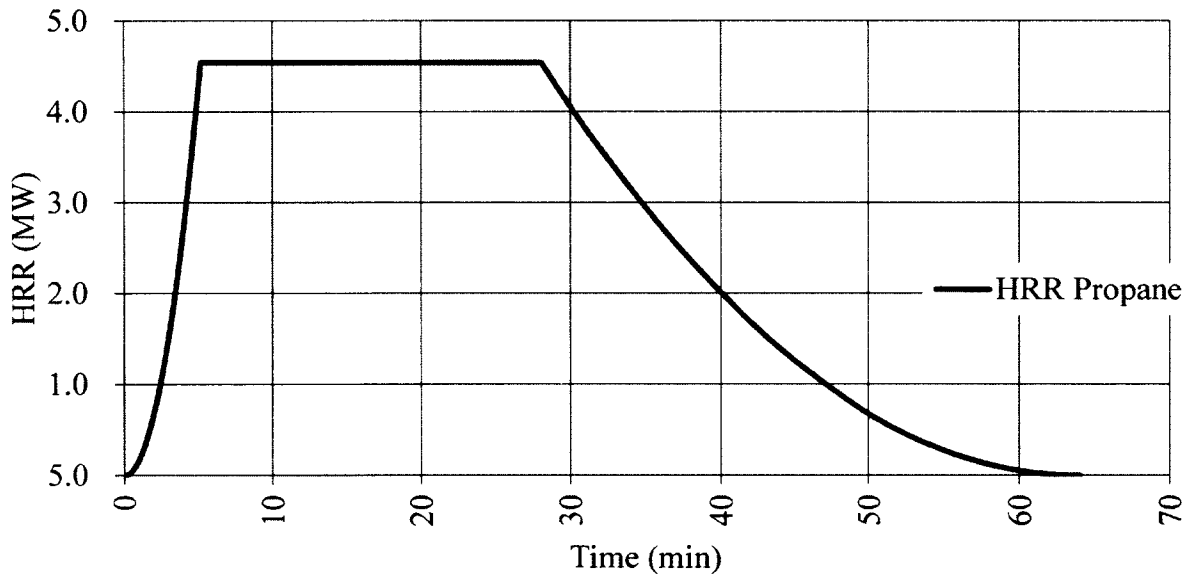
Figure 44 - Design fire profile - Test 1

A simple design fire profile, presented in Figure 44, was adopted for propane HRR based on results of Chen [40] for a hotel room with a queen bed. The design fire comprised three phases:

This section was proportional to the decay phase recommended by Chen [40]. A t-square decay was used with a decay rate of $\alpha=9.72 \times 10^{-4}$ MJ/s² giving an expected test duration of approximately 60 minutes.

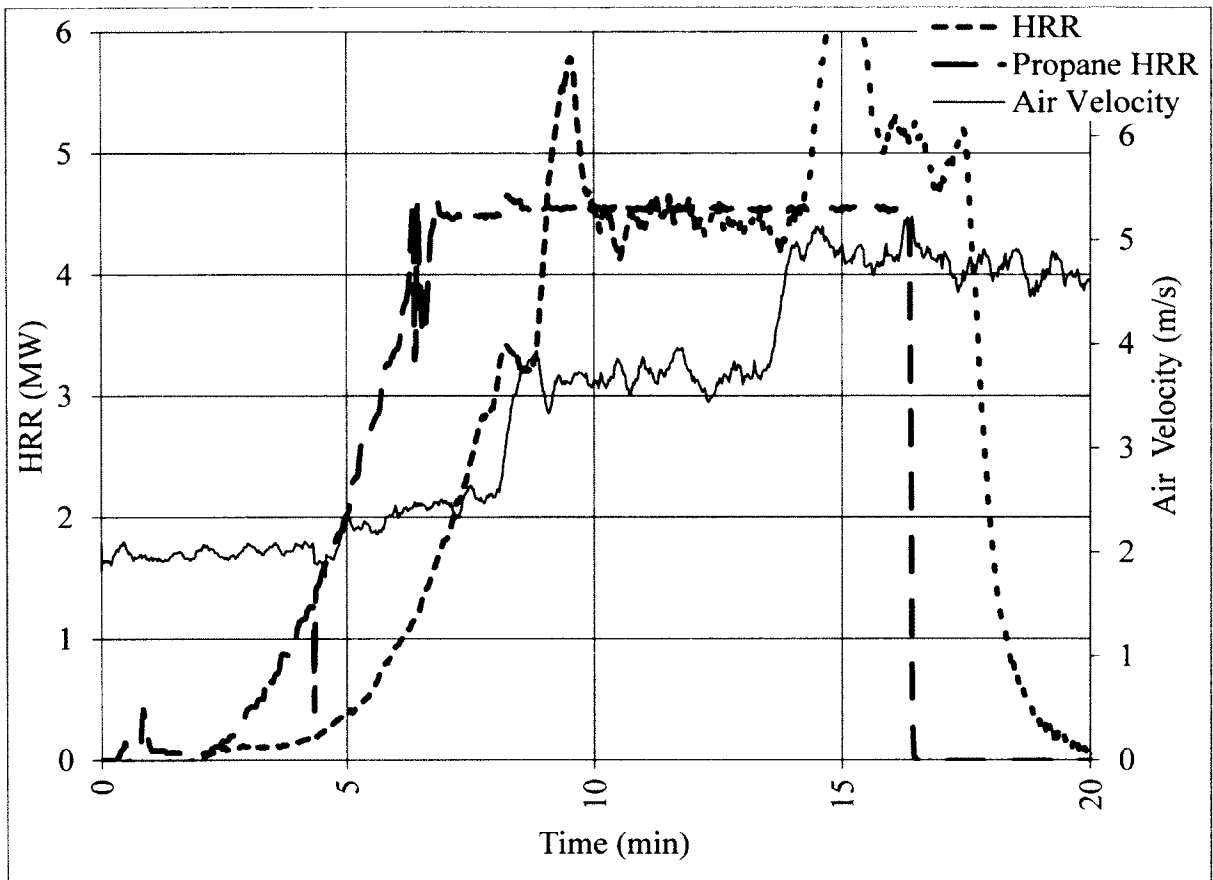
Figure 49 – Heat release rates from calibration tests – April 4 2012

The results from the calibration check, presented in Figure 49, show a close correlation between the measured HRR and the calculated propane HRR. The test was considered successful and the adjustment factor of 0.83 was used throughout the testing.

The spikes in HRR correlate to increases in air flow as the fan speeds were increased to clear smoke buildup in the tunnel and should be disregarded. The delay between propane HRR and measured HRR is due to transport time of the gases from the fire to the measurement point and through the measurement system.

Corrections applied to data in this section address a delay between the readings of propane and measured HRR that occurred due to the travel time of the products of combustion from the room to reach the measurement area of the chamber. Ko [21] measured these delays at 35 and 10 seconds for fan speeds between 25% and 100% respectively and also specified an additional 45 second delay time due to the gas analysis system. The observed delays in the calibration test for this setup were approximately 150 and 60 seconds at fan speeds of 25% and 75% respectively as seen in Figure 49. To account for this, graphs have been adjusted to accurately predict the contribution of CLT panels in each of the tests. Graphs in this section have been overlaid to enable comparison of the growth rates once the fire took hold and may not represent the actual start times.

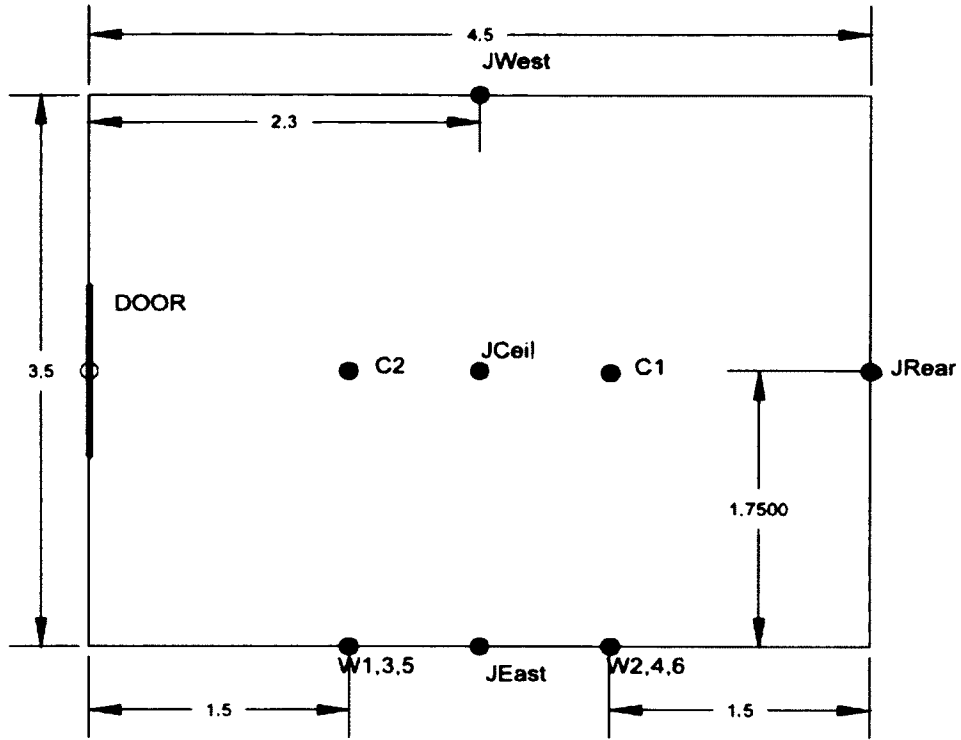
Figure 55 – Embedded thermocouple locations – Plan view

Groups of six thermocouples were installed at 8 locations (C1, C2, W1, W2, W3, W4, W5 and W6) shown in Figure 55, Figure 56 and Figure 57 to measure the charring rates. Table 8 provides details of the depths at which thermocouples were installed for each of the tests.

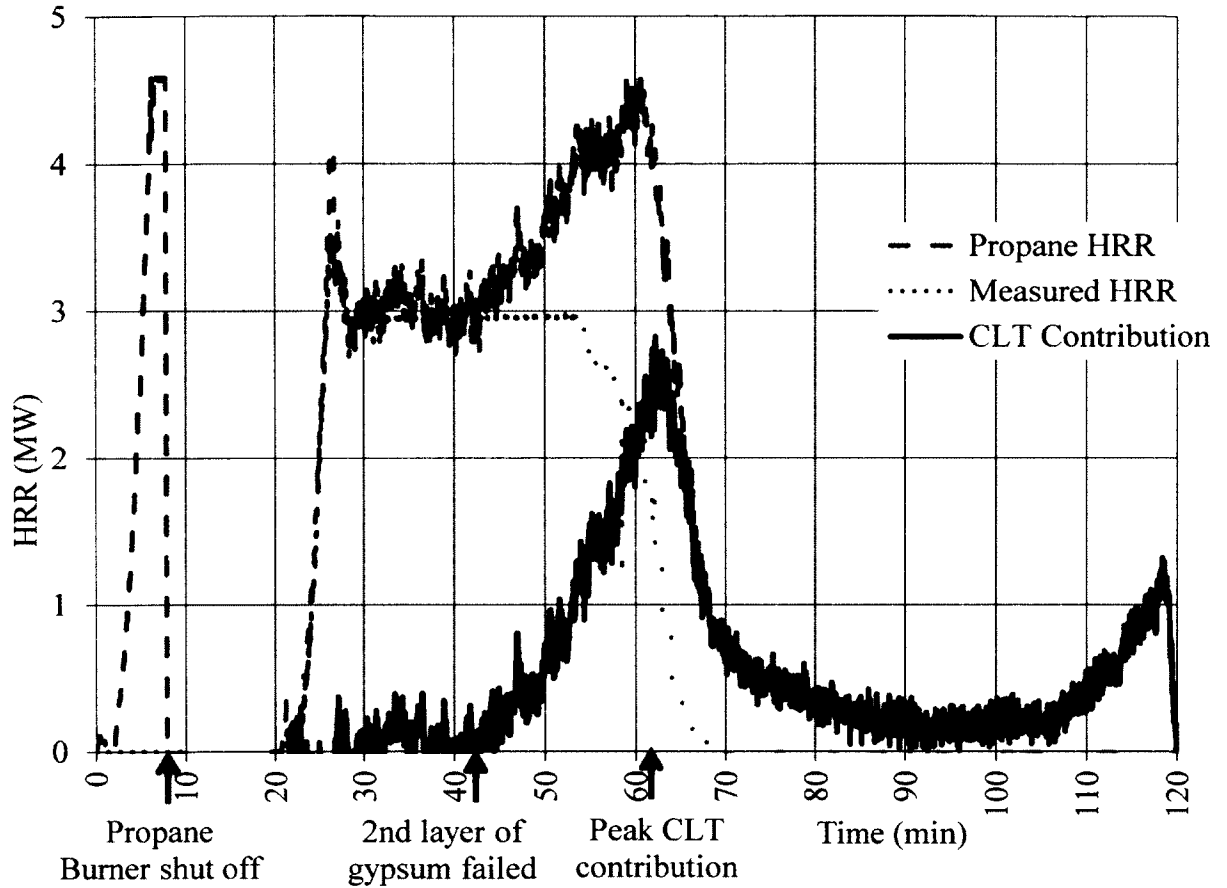
Figure 59 - Heat release rate – Test 1

The propane burners were ignited at 11:50 AM with an ambient temperature of 5.5°C. At 1 minute after the burners were ignited, the propane flow, presented in Figure 59, was increased at a ‘fast’ fire growth rate to the calculated peak HRR of 4.54 MW (Eq 27). The propane flow rate reached 1.055 MW after 3:40 minutes and flames were seen emerging from the room at 4:57 minutes, at which time the propane flow rate was 2.33 MW. The propane flow reached 4.54 MW at 6:17 minutes and much flaming and black smoke were observed outside the compartment indicating that there was insufficient oxygen within the compartment to combust all of the propane. A failure in the HRR measurement was discovered and the burners were shut off after 8 minutes.

The HRR continued to increase, and flaming and flow of black smoke increased outside the room. The reduction of the propane flow was initiated at 54:23 minutes after the HRR exceeded 4MW, however the HRR continued to increase reaching a peak of 4.59 MW at 61:21 minutes before a sharp period of decay occurred. After the propane flow was shut off completely at 68:30 minutes, when the HRR at this point was approximately 0.75MW, the rate of decay of the HRR slowed which can be seen in

Figure 59. The HRR continued to drop slowly settling at approximately 200 kW at 70 minutes and glowing combustion could be seen on the exposed CLT panels.

The CLT contribution to HRR presented in Figure 59 commences at 43 minutes and grows steadily reaching a peak of 2.8MW at 64 minutes, after which the CLT contribution to HRR begins to decay rapidly similar to the overall HRR in the room. Smouldering and glowing combustion continued to occur in the room until the first layer of the CLT panels began to delaminate which caused a second growth to flashover.

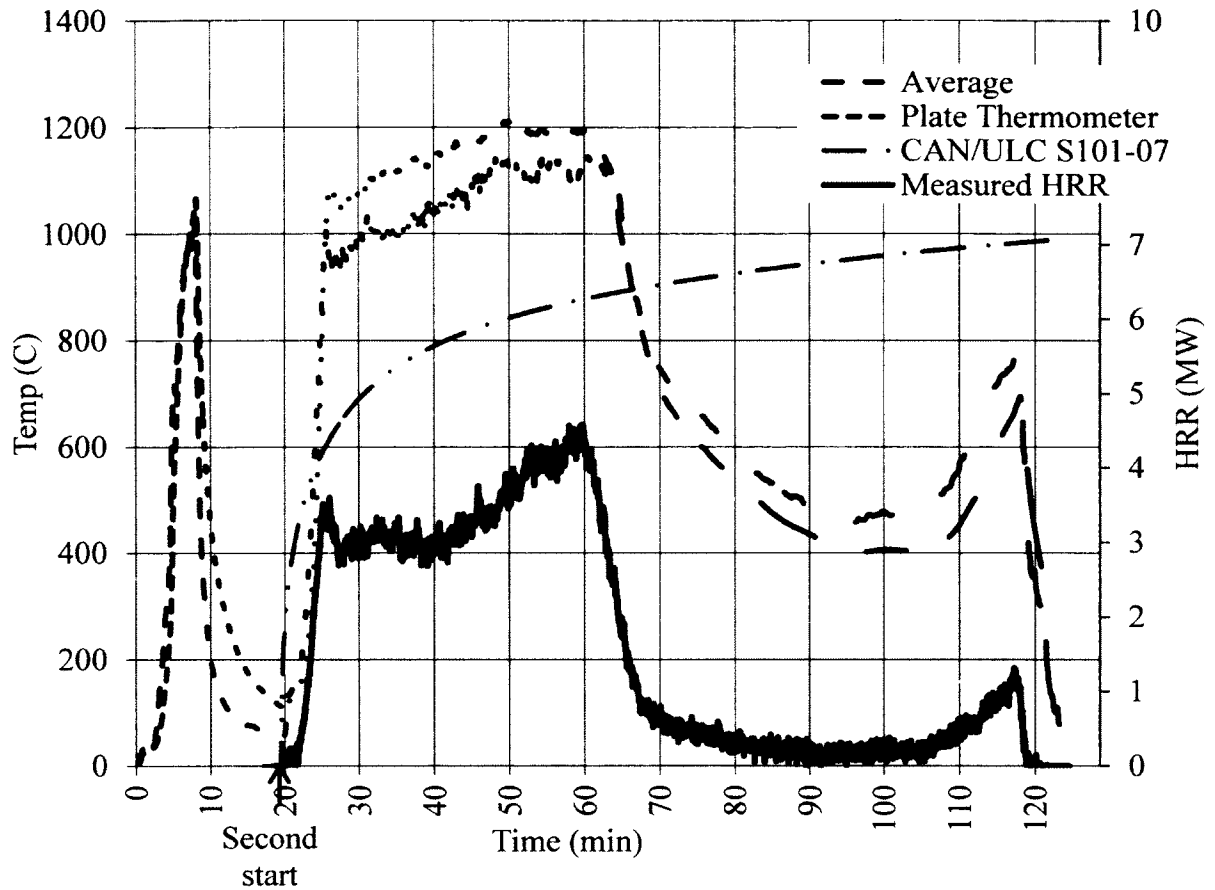
Figure 65 – Comparison of room temperatures and HRR – Test 1

In Figure 65 the average temperature of the thermocouple trees is compared to the plate thermometer readings, with the standard fire test and the HRR overlaid for reference. The temperatures quickly rise at flashover exceeding 1000°C before entering a much slower growth phase. The average room temperature stabilises near 1130°C (1200°C for the plate thermometer). There is a sharp decay whilst the HRR continues to drop and then a slower decay once the HRR stabilises. The temperature stabilises near 480°C (400°C for the plate thermometer) whilst smouldering combustion continues in the compartment and again increases with the HRR as the room enters the second phase of flashover.

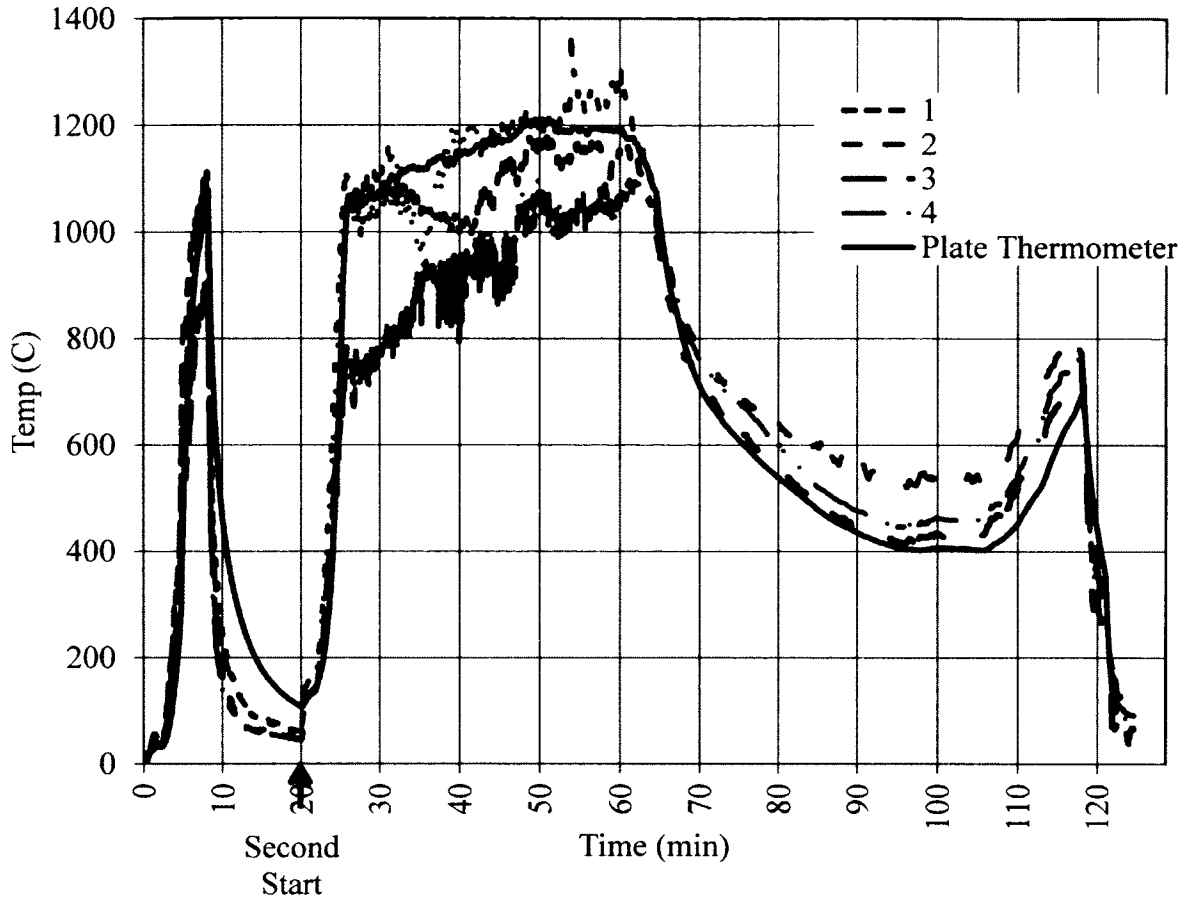
Figure 66 – Thermocouple tree average temperatures – Test 1

The average temperature at each of the thermocouple trees is presented in Figure 66. The temperatures initially rise together rapidly at flashover for both starts, however higher peaks are experienced at positions 1 and 2 whilst the temperatures at positions 3 and 4 were very similar. After the rapid rise in temperature at flashover (second start) temperatures continued to rise slowly and appeared to stabilize after 50 minutes.

The highest temperatures are observed at position 2 closest to the seat of the fire, which indicates that the thermocouple tree is exposed to the intense combustion occurring as the propane mixes with the incoming fresh air. The consistent difference in temperatures in this case indicates a uniform counterclockwise circular flow of gases in the room in the following order:

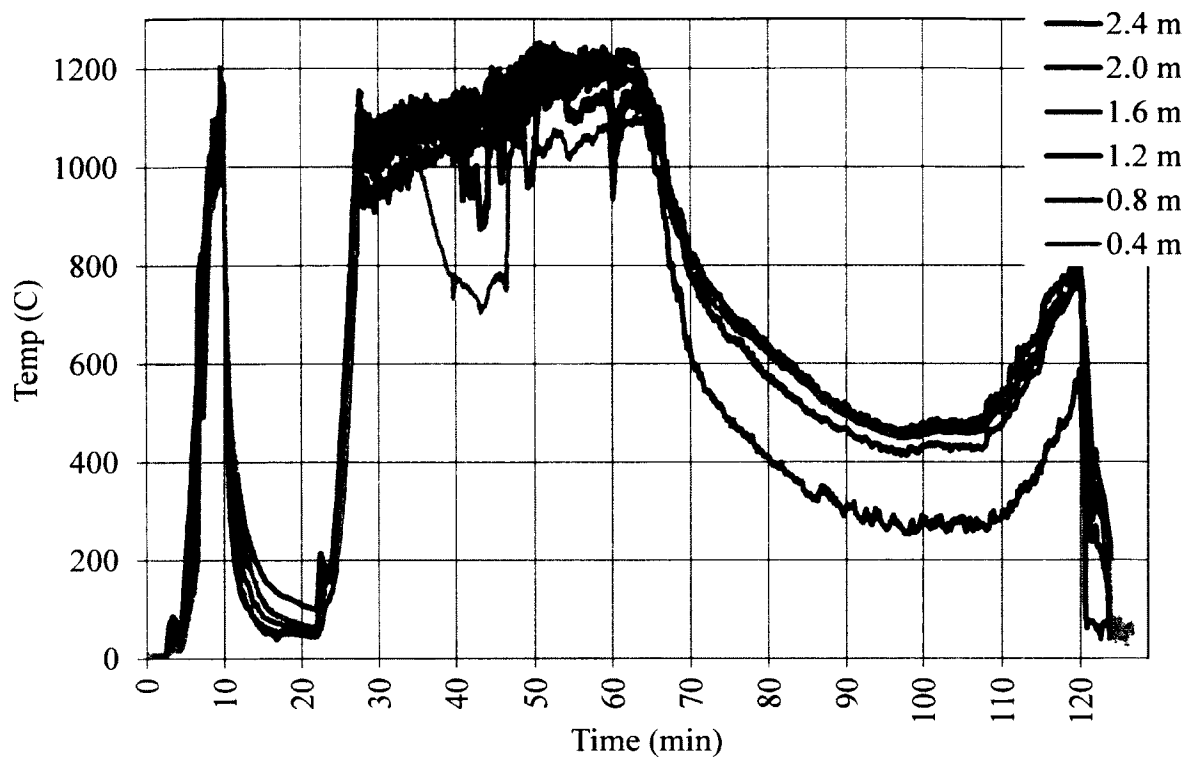
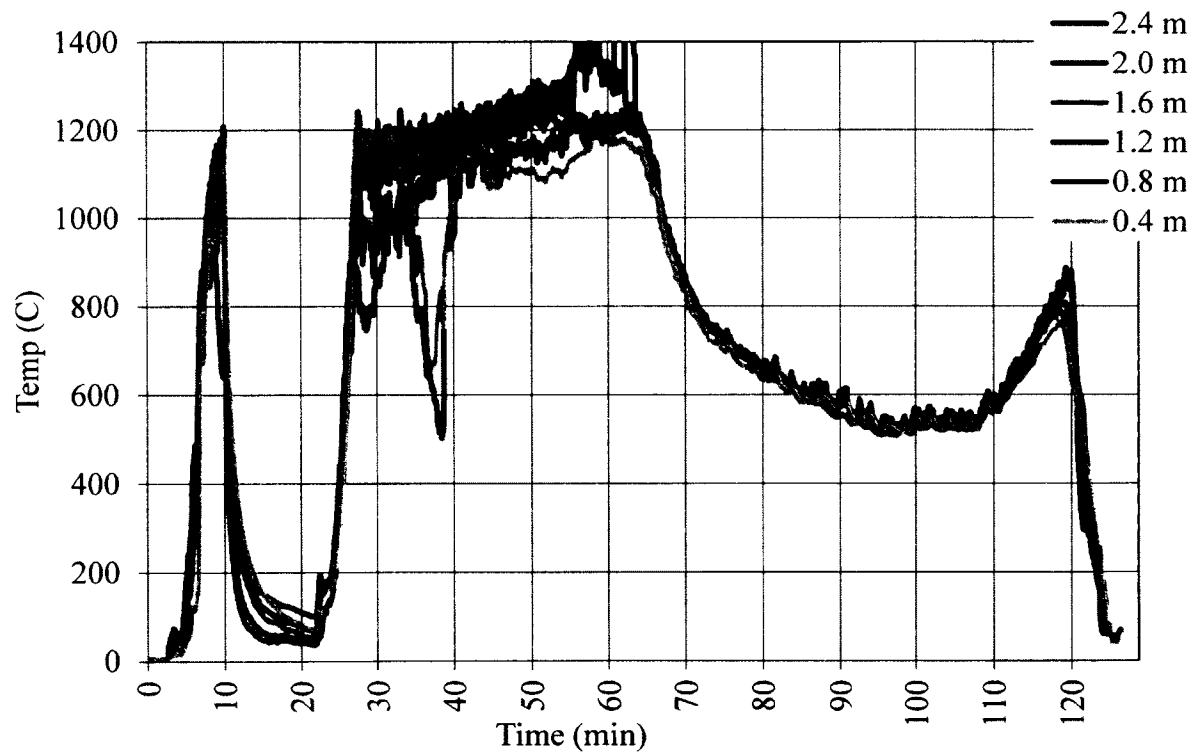
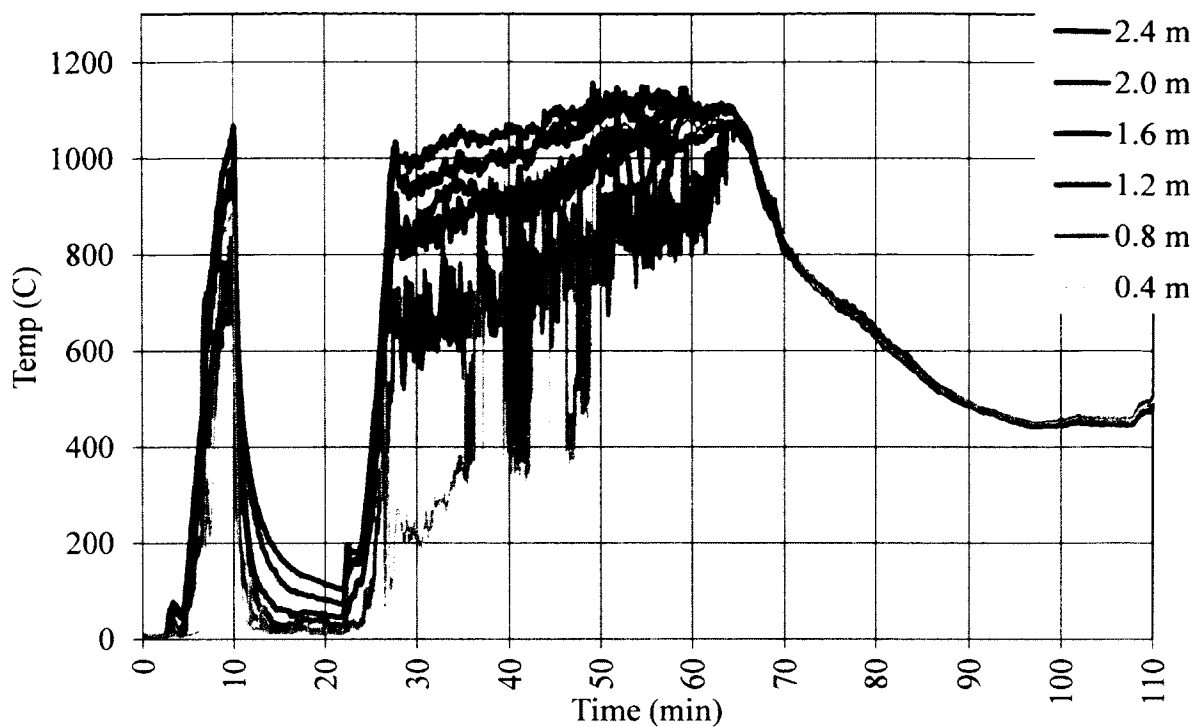
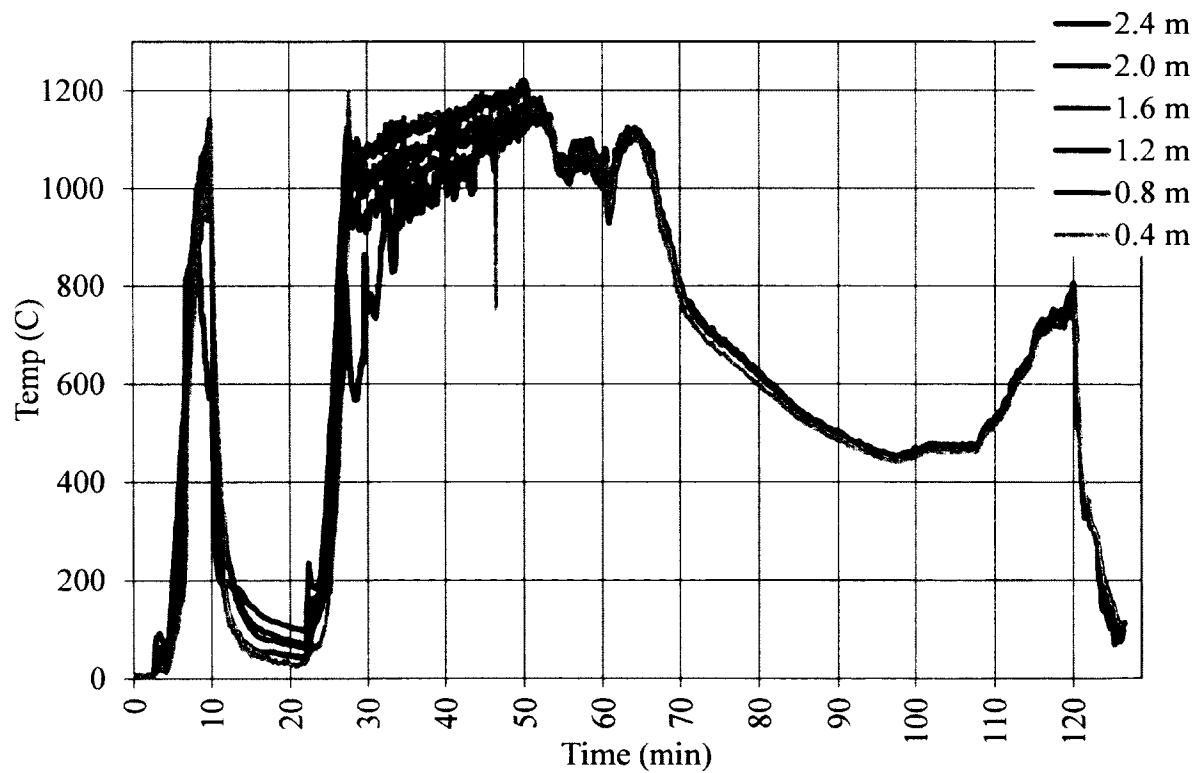
The highest temperatures were observed at TCT2 position at the rear of the room ($T_{\max}=1304^{\circ}\text{C}$ @ TCT2-16). Thermocouples 2-12 and 2-24 showed higher readings (2-24>1500 and 2-12>2000) however have been disregarded as spikes appear to indicate some interference. The temperatures measured at the TCT's are presented in Figure 67, Figure 68, Figure 69 and Figure 70. It is clear that the temperatures experienced at TCT2, which was nearest the fire, were higher than the other positions.

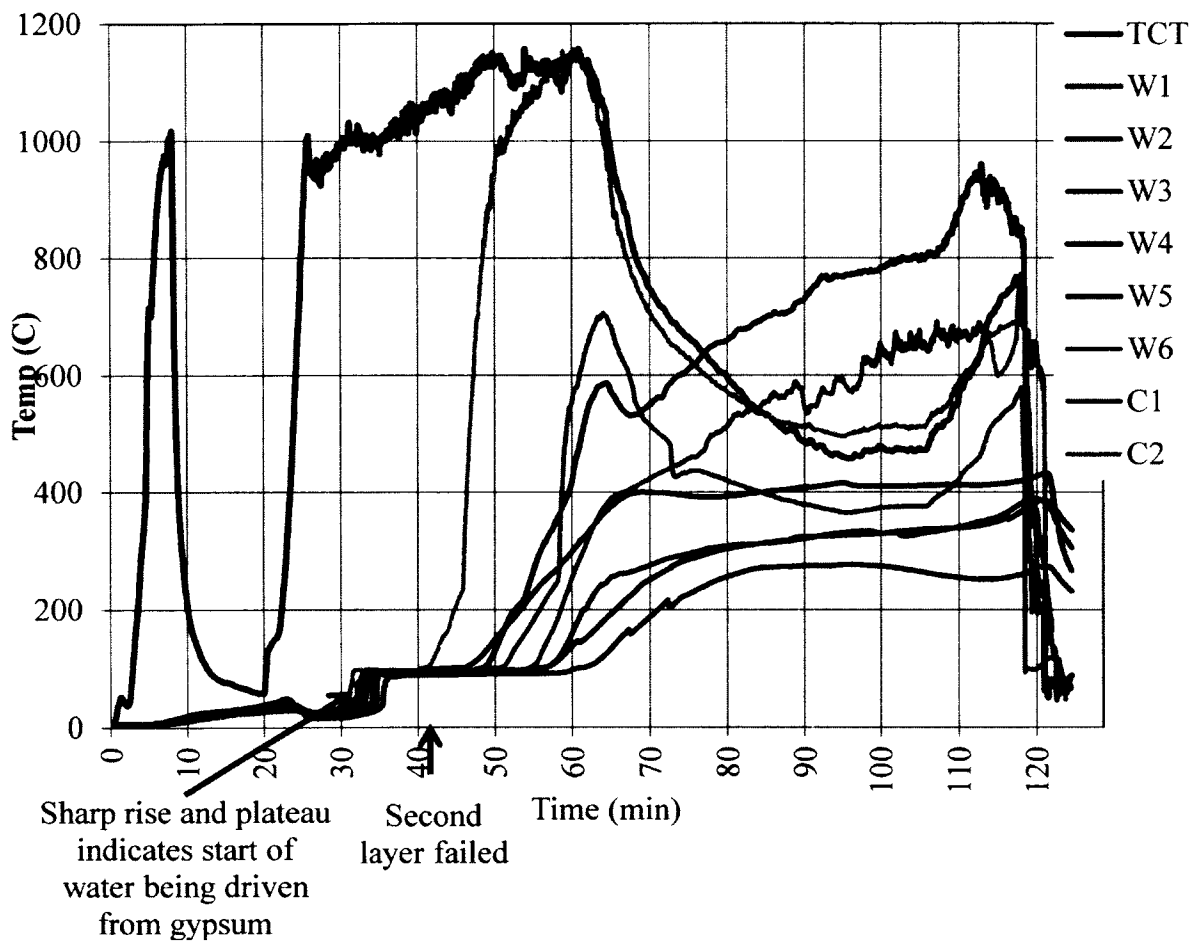
Figure 71– Temperatures at interface of gypsum board protection and CLT panels
– Test 1

The temperatures measured at the interface of the gypsum board protection and the CLT panels are presented in Figure 71 along with the average room temperature. Sharp rises in temperature are observed between 31 and 36 minutes which plateau at approximately 100°C as chemically bound water is driven from the gypsum [48]. This occurs in the second layer after the first layer has already failed, first indicated at position C2, directly above the fire, at approximately 31 minutes. The temperature behind the gypsum begins to increase above 100°C once all of the water has been released. The first indication of this is at 41mins at position C2.

After the decay period begins, the room temperature drops, most temperatures within the structure begin to stabilise, however some temperatures continue to increase as observed at positions W4 and W6. This is a result of pyrolysis and smouldering combustion occurring behind the gypsum board protection which remained in place despite having lost its chemically bound water. The effects of this can be seen in Figure 62 where the flames are emerging from the joints between the gypsum board panels and Figure 72 where smouldering combustion was exposed when the protection was removed more than 1 hour after the test was ended and the fire extinguished. This demonstrates that the fire can spread, and continue, behind the insulation which must be considered during the post fire period.
