CONTRIBUTION OF CROSS LAMINATED TIMBER PANELS TO ROOM FIRES

A thesis submitted to
the Faculty of Graduate and Postdoctoral Affairs
in Partial Fulfillment of the requirements for the degree

Masters of Applied Science in Civil Engineering

Department of Civil and Environmental Engineering
Carleton University

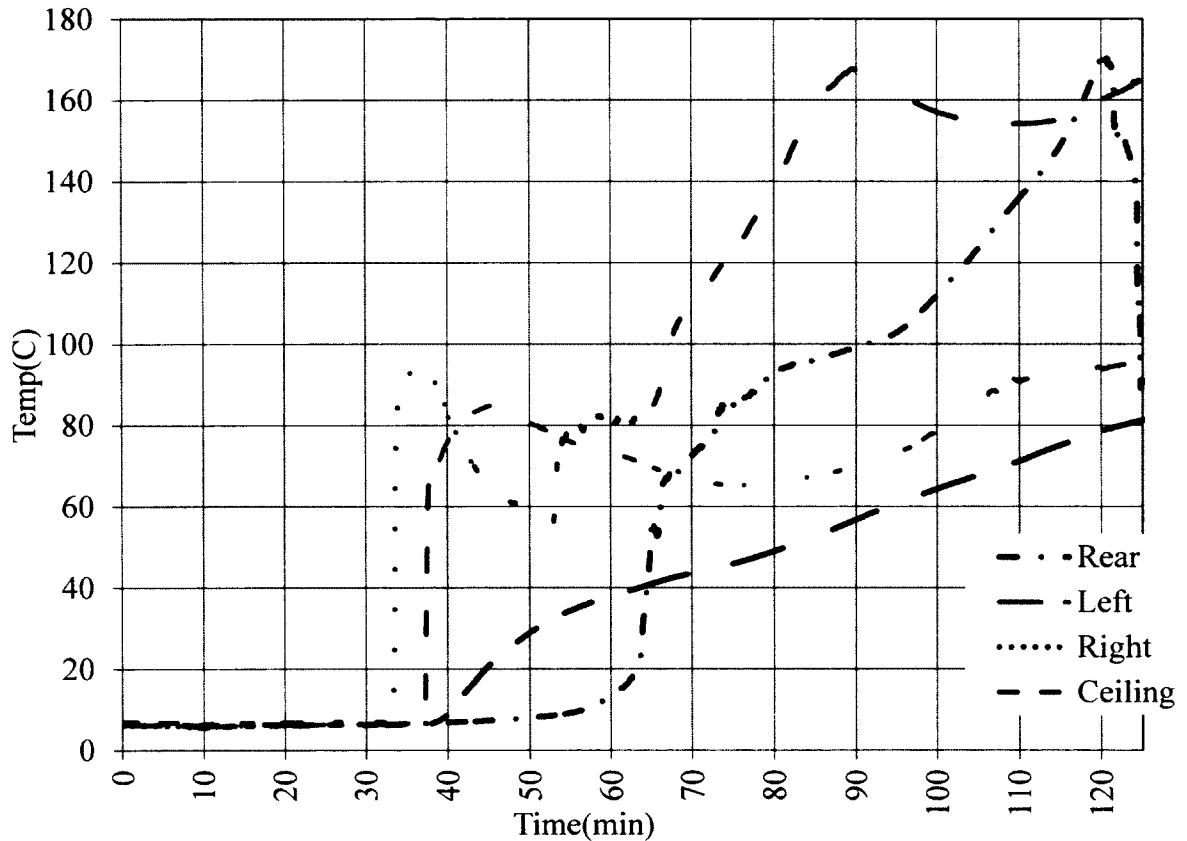
Figure 73 - Joint temperatures - Test 1

Despite there being no sealant used in the test the joints temperatures presented in Figure 73 did not reach the level at which pyrolysis (200°C) or charring begins (300°C). The maximum temperatures were experienced at the rear and ceiling joints, the nearest to the fire, and were observed after the most intense period of the fire.

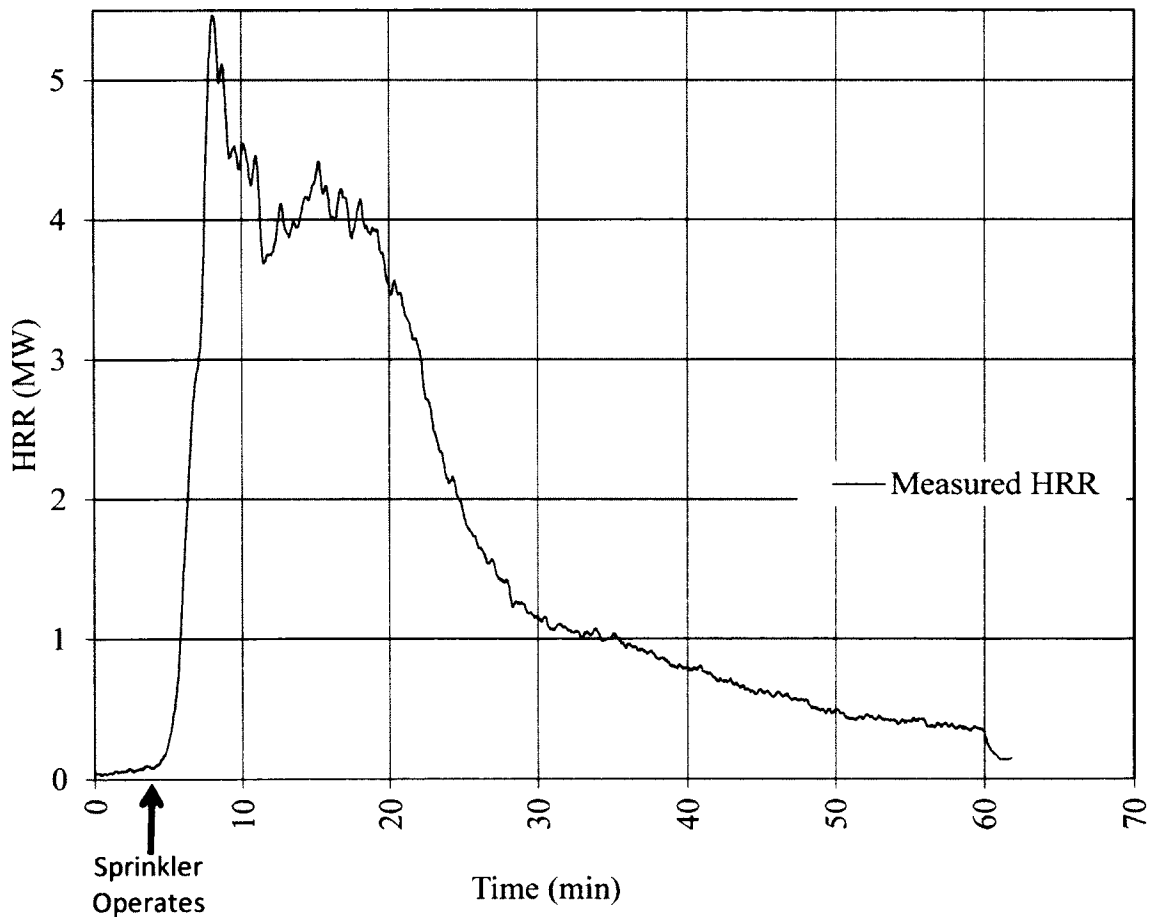
Figure 75 – Heat release rate - Test 2

The HRR graph presented in Figure 75 shows a fire growth rate comparable to that of the ultra-fast t^2 discussed in Chapter 2.6 which reaches 1.055 MW at 5:48 minutes and continues to increase to a peak of 5.49 MW at 8:06 minutes. At this point all items in

the room appeared involved in the fire and intense flaming was observed outside the room. The fire burned intensely for a short period before reducing in intensity and then noticeably increased again when the bed collapsed. The fire entered the decay period after approximately 18 minutes. Early in the test and before flashover, thick black smoke was observed exiting the room. Once flashover occurred, the amount of smoke decreased, however a large amount of smoke was still observed, more so than in the propane fire in Test 1 which indicates a larger amount of incomplete combustion occurring.

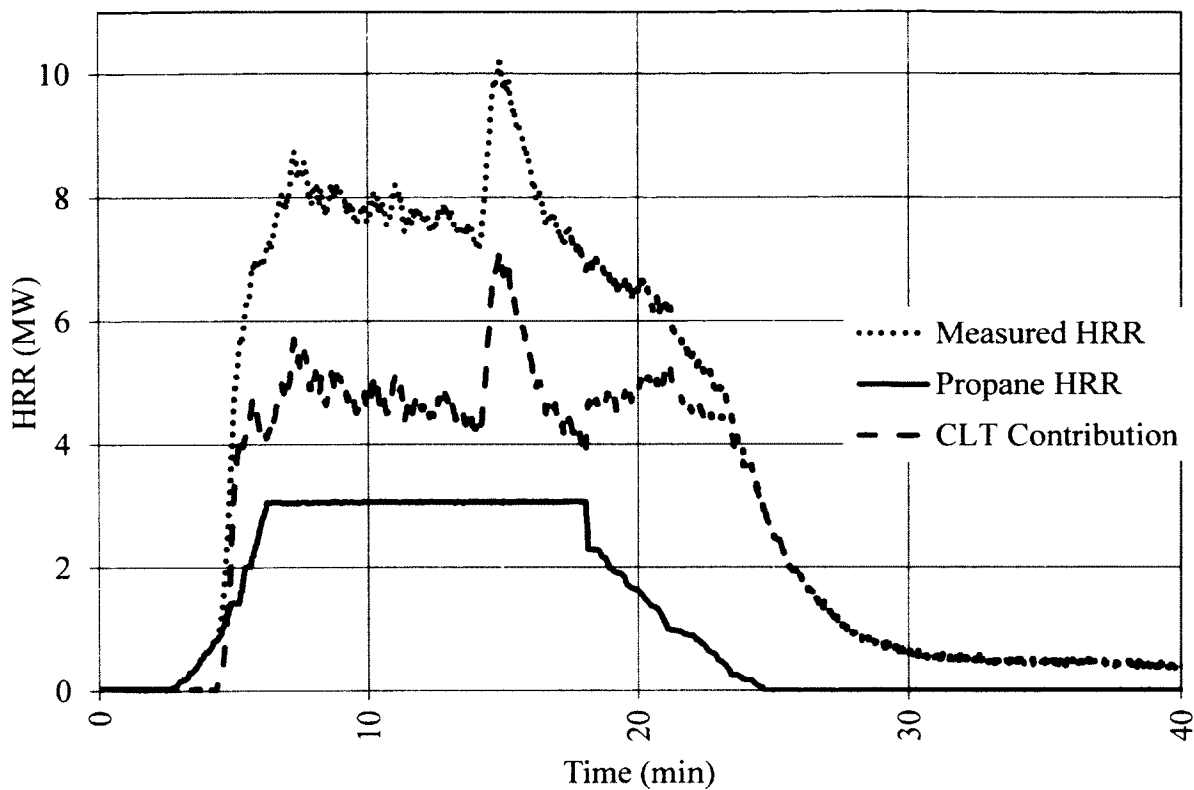
Figure 77 – Heat release rate - Test 3

The propane burners were ignited at 10:50 AM with an ambient temperature of 16°C. At 1:05 minutes after the burners were ignited the propane flow, presented in Figure 77, was increase at a fast fire growth rate to a peak of 3MW, as used in Test 1. The measured HRR followed the fast fire growth rate until it reached 0.811 MW at 4:25 after which the growth rate increased sharply above that of the propane flow, indicating that the CLT panels were becoming involved in the fire.

The HRR, as seen in Figure 77, exceeded the ventilation limit reached a peak of 8.75 MW, indicating that a large amount of combustion had occurred outside the room, and began a slow decay.

A large spike in HRR at approximately 15 minutes, shown in Figure 77 is the result of an increase in the speed of the extraction fans to remove a buildup of smoke in the tunnel upstream of the test. The higher flow rate and concentration of smoke passing the sensors whilst the buildup cleared resulted in a spike in the calculated HRR. The magnitude of the spike is disregarded for this test, however the total area under the graph is relevant for analysis as it represents the energy released (oxygen consumed) during the test.

The CLT contribution to HRR shown in Figure 77 rises rapidly from 0 at 4:24 minutes to 4 MW at 5:15 minutes after which the growth rate decreases and reaches a peak of 5.71 MW at 7:20 minutes. The HRR then drops away settling at approximately 4.5 MW, indicating uniform charring and pyrolysis of all the surfaces, until entering a decay period at 23:00 minutes at which point the decreasing propane HRR is at 0.48 MW.

the ultra-fast classification (0.1896 MJ/s^2) as a result of the involvement of the CLT panels in the fire. The peak HRR of 8.75 MW in Test 3 indicates a peak CLT contribution of approximately 5.75 MW after 7 minutes as seen in Figure 77, almost twice the 3 MW observed before combustion occurred outside the room.

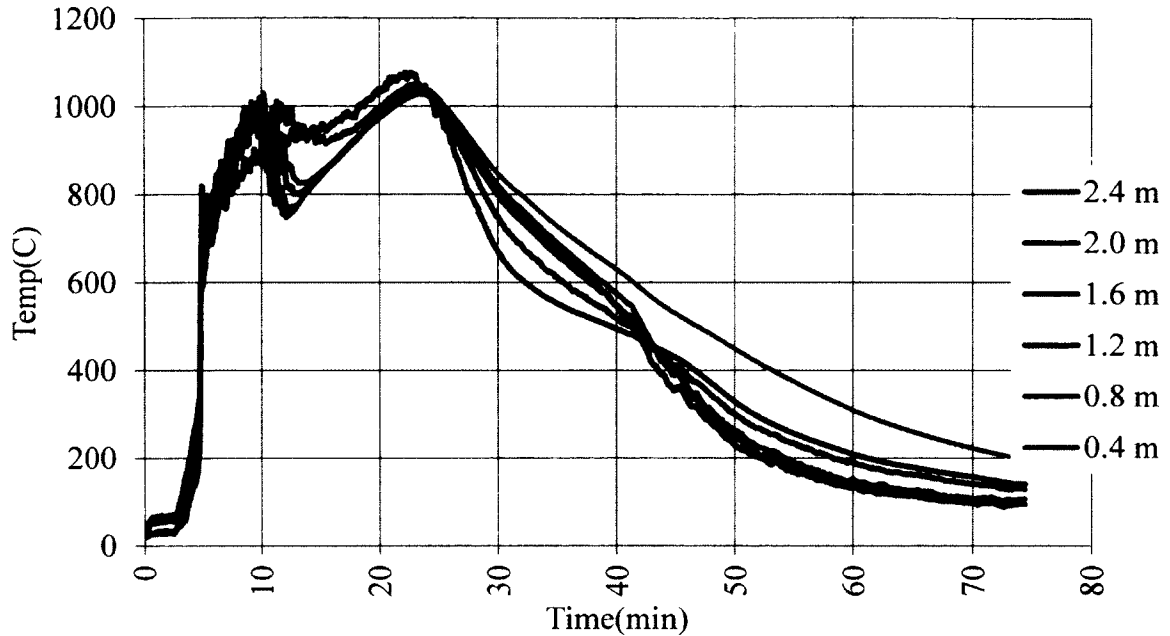
Figure 80 - Thermocouple Tree 1 temperatures - Test 3

The temperatures for each of the thermocouple tree measuring points are presented in Figure 80, Figure 82, Figure 83 and Figure 84. After flashover, the temperatures continue to rise, however they drop soon after most noticeably at points closest to the floor. These drops are not observed at the highest measuring points (2.4 metres) which, similar to the plate thermometer, may be related to the close proximity to the structure, which will be further discussed later in this section.

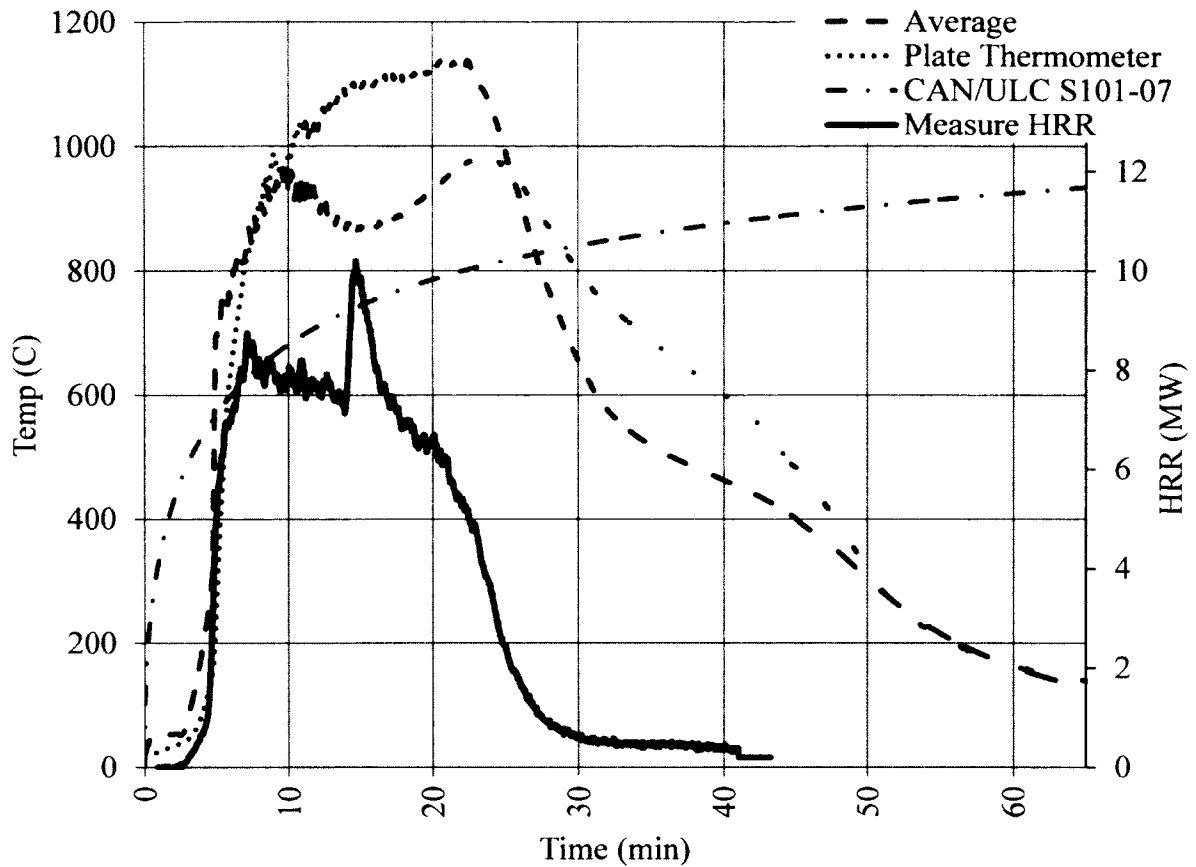
Figure 81 – Plate Thermometer and Average room temperatures showing HRR – Test 3

Similar to the Test 1, the average room temperature shown in Figure 81 rises quickly at flashover, however the growth rate slows noticeably at 700°C, 300°C below that in Test 1, before rising to a peak of 963°C at 09:56 minutes. This is followed by a drop in temperature, possibly due to poor ventilation, before increasing again to a peak of 982°C at 24:06 minutes. The plate thermometer peaks at 1140°C at 21:00 minutes and does not experience a drop in temperature, this may be due to the proximity of the measuring point to the room walls.

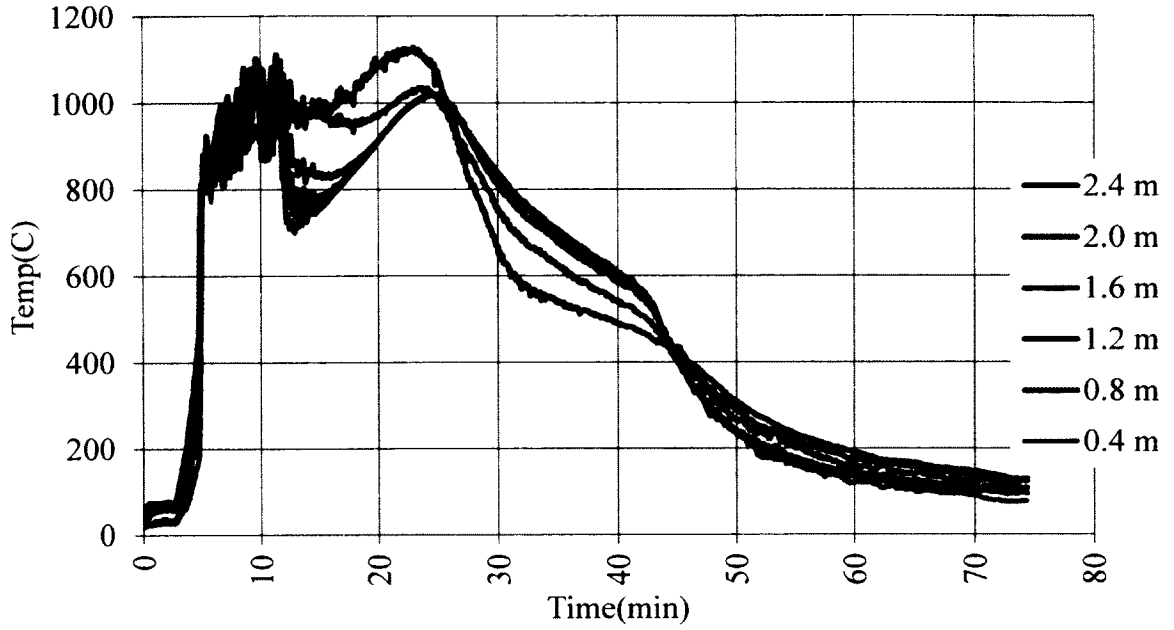
Figure 82 - Thermocouple Tree 2 temperatures - Test 3

After the drops are observed, the temperatures at each location begin to group together at approximately the same time that HRR begins to decay.

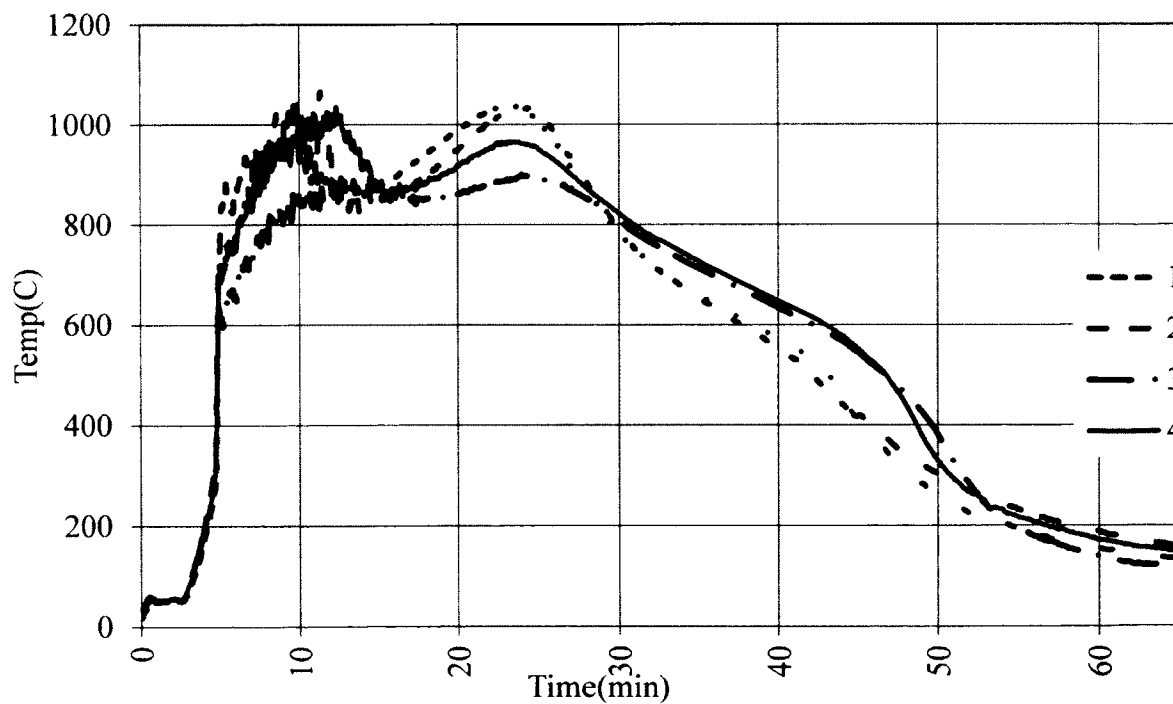
Figure 86 – Thermocouple tree average temperatures – Test 3

The average temperatures at each thermocouple tree, presented in Figure 86, show drops in temperature occurring after 10 minutes. The temperatures begin to increase again peaking between 23-25 minutes before beginning to decay.

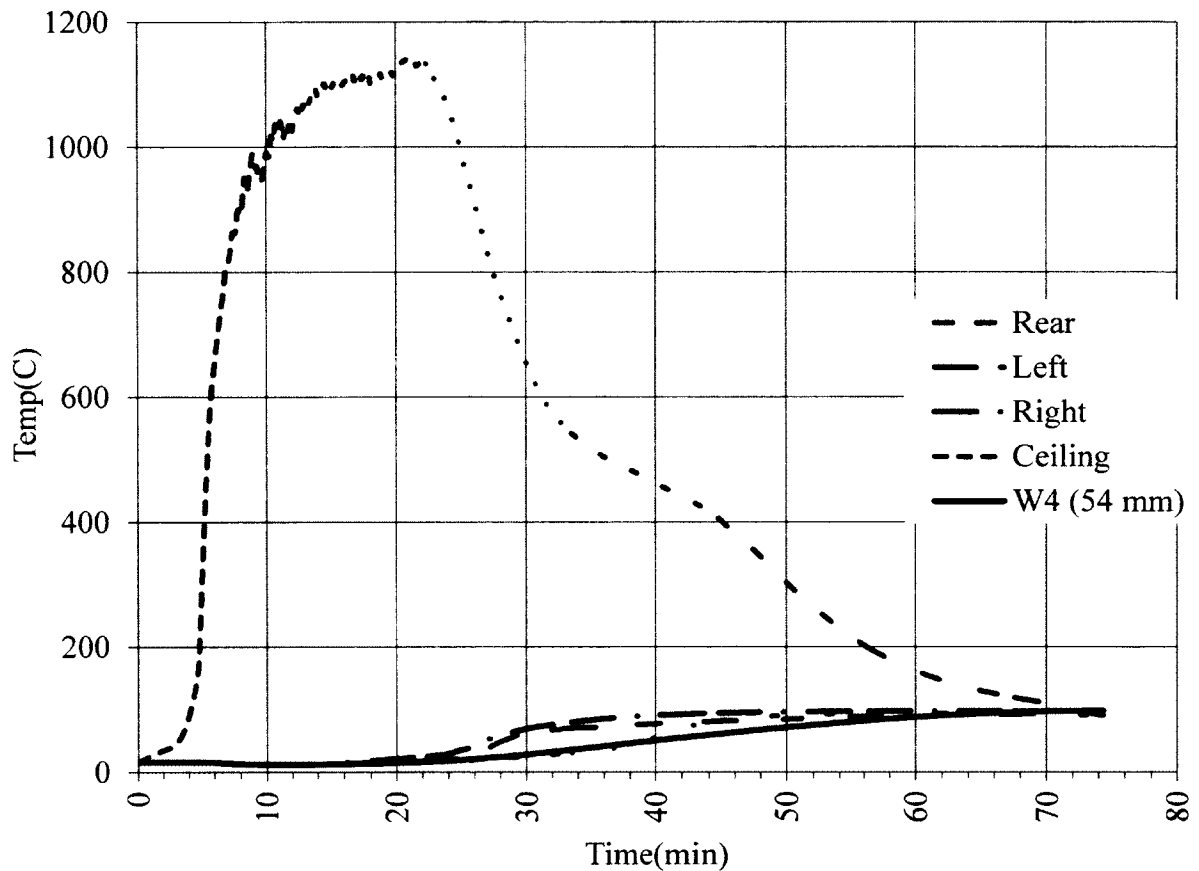
Figure 87 - Temperatures at joints and W4 measuring position - Test 3

The joint temperatures presented in Figure 87 show increases which plateau above 90°C. This likely indicates the transport of steam through the joints as it is driven from the wood as the char front advances. The temperature of the structure rises slower at a comparable depth of 54 mm at position W4, driven by conductive heat transfer within the structure.

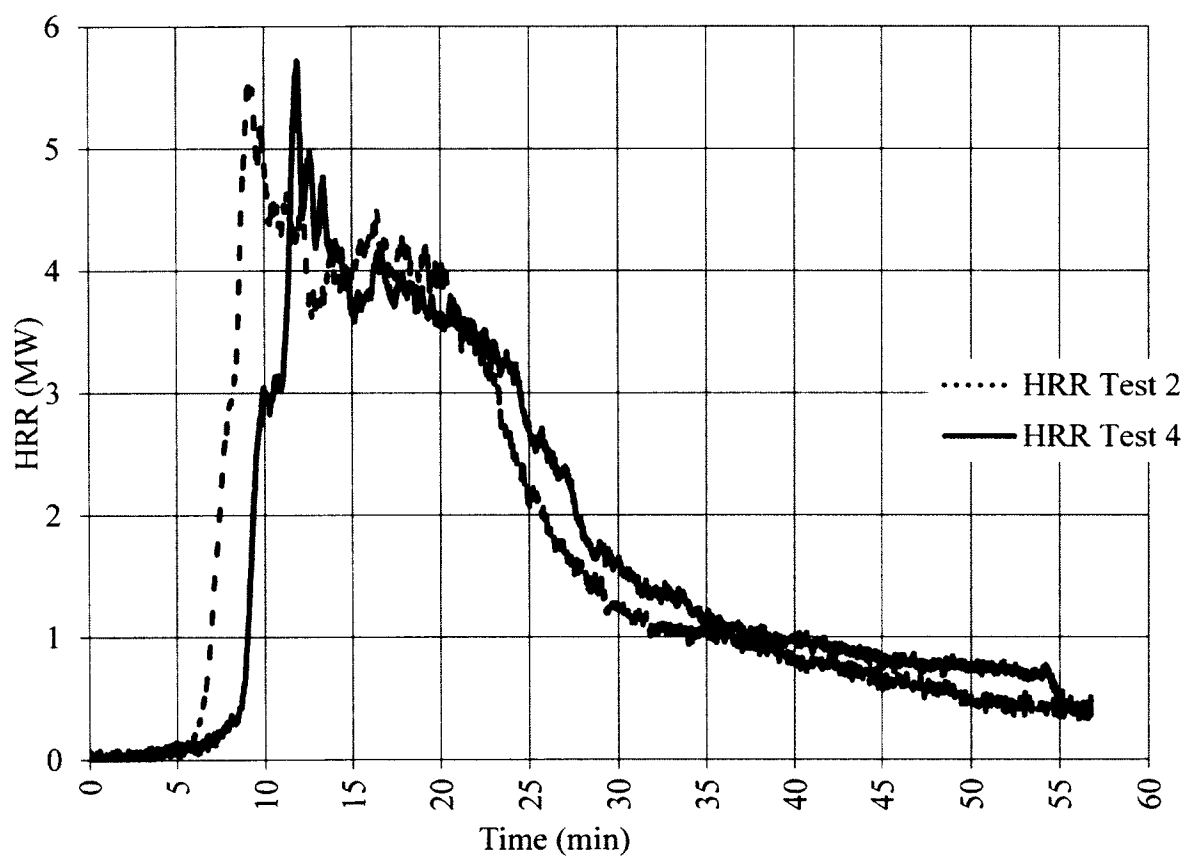
Figure 89 - Heat release rate - Test 2 and 4

The HRR curve presented in Figure 89 shows a longer incipient phase than Test 2 before entering a rapid fire growth period which exceeds that for an ultra-fast classification. For comparison the two graphs have been matched at the point where sustained fire growth at flashover occurs. A plateau is observed at 3 MW which lasts for

approximately 1 minute before the growth continues reaching a peak of 5.7 MW at 11:58 minutes. At this time consistent bright orange flaming was observed extending from the door. The plateau is likely related to a longer time to involvement of the hardwood flooring which can be explained by its position at the bottom of the room and being largely sheltered from the hot upper layer and flames by the bed. Flaming on the hardwood flooring in the doorway was not observed until 10:08 minutes. Fire growth at the doorway is shown in Figure 90.

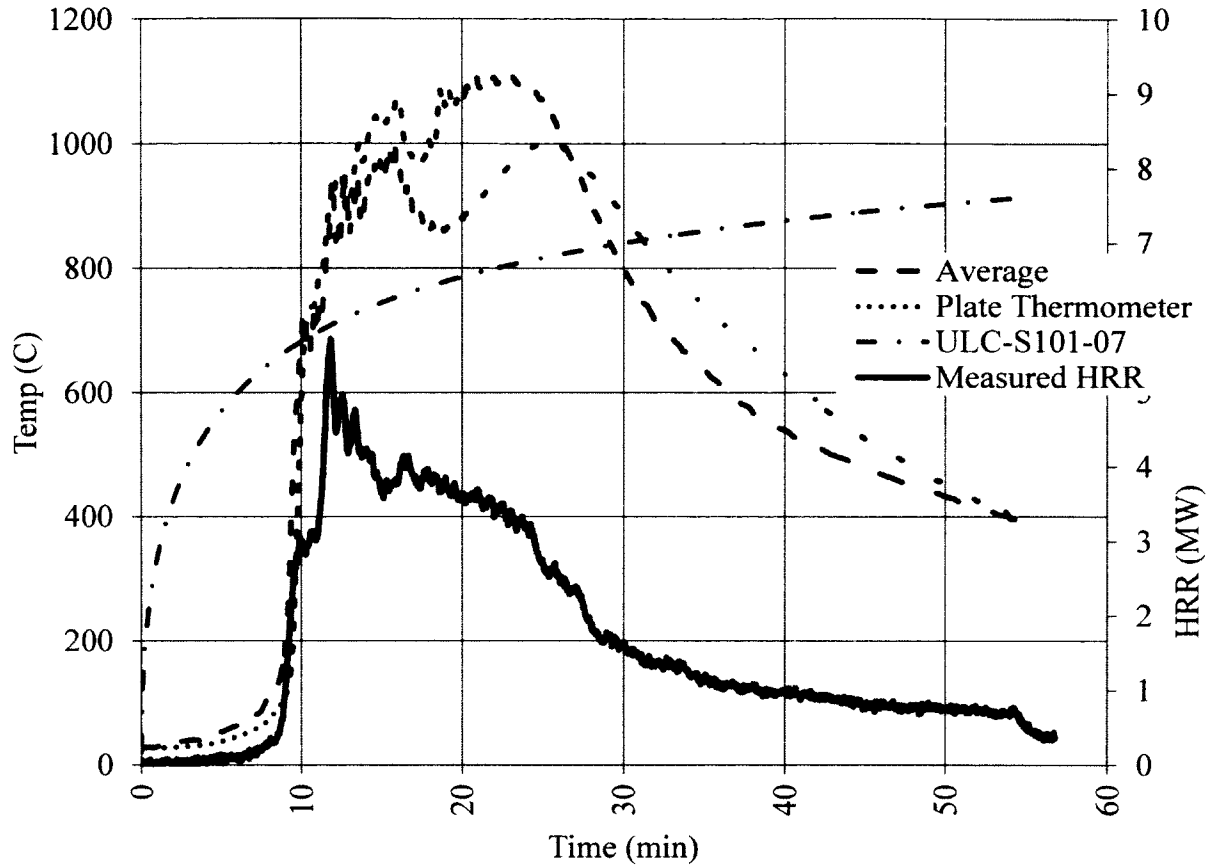
Figure 92– Plate thermometer and Average room temperatures showing HRR – Test 4

The room temperature, presented in Figure 92 rises rapidly at flashover, as seen in previous tests, with a noticeable decrease in growth rate observed at approximately 700°C, similar to Test 3, before rising to a peak of 998°C at 16:01 minutes. Similar to Test 3, a significant drop in temperature is observed before increasing again to a peak of 1002°C at 25:20 minutes. The plate thermometer shows a smaller drop in temperature, not observed in Test 3, which then recovers and continues to increase reaching a peak of 1109°C at 23:15. Following the peaks, the temperatures begin to decay along with the HRR.

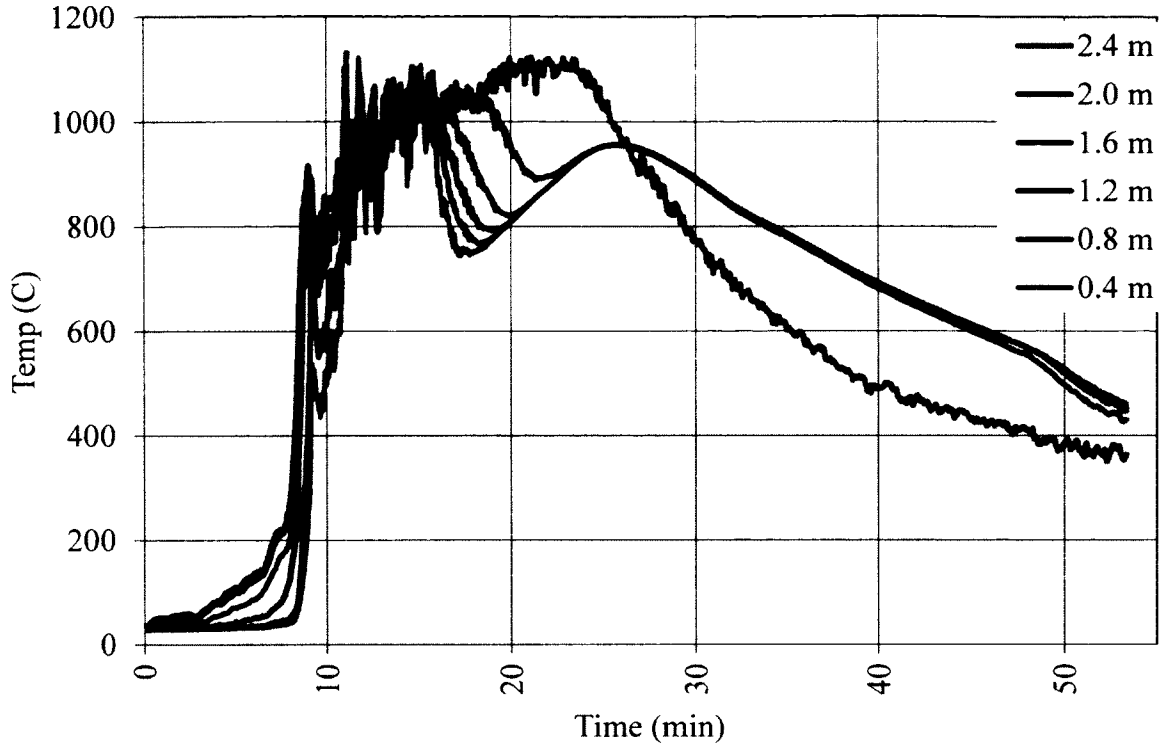
Figure 93 - Thermocouple Tree 1 temperatures - Test 4

Similar to Test 3, drops are observed in Figure 93, Figure 94, Figure 95 and Figure 96 at locations nearest to the floor following the initial peak after which the temperatures group together as the HRR begins to decay. Like Test 3, the temperatures at the highest points in the room are noticeably different, which is likely an effect of the proximity to the structure. The maximum temperature of 1154°C was measured at thermocouple tree two at 2.4 metres.

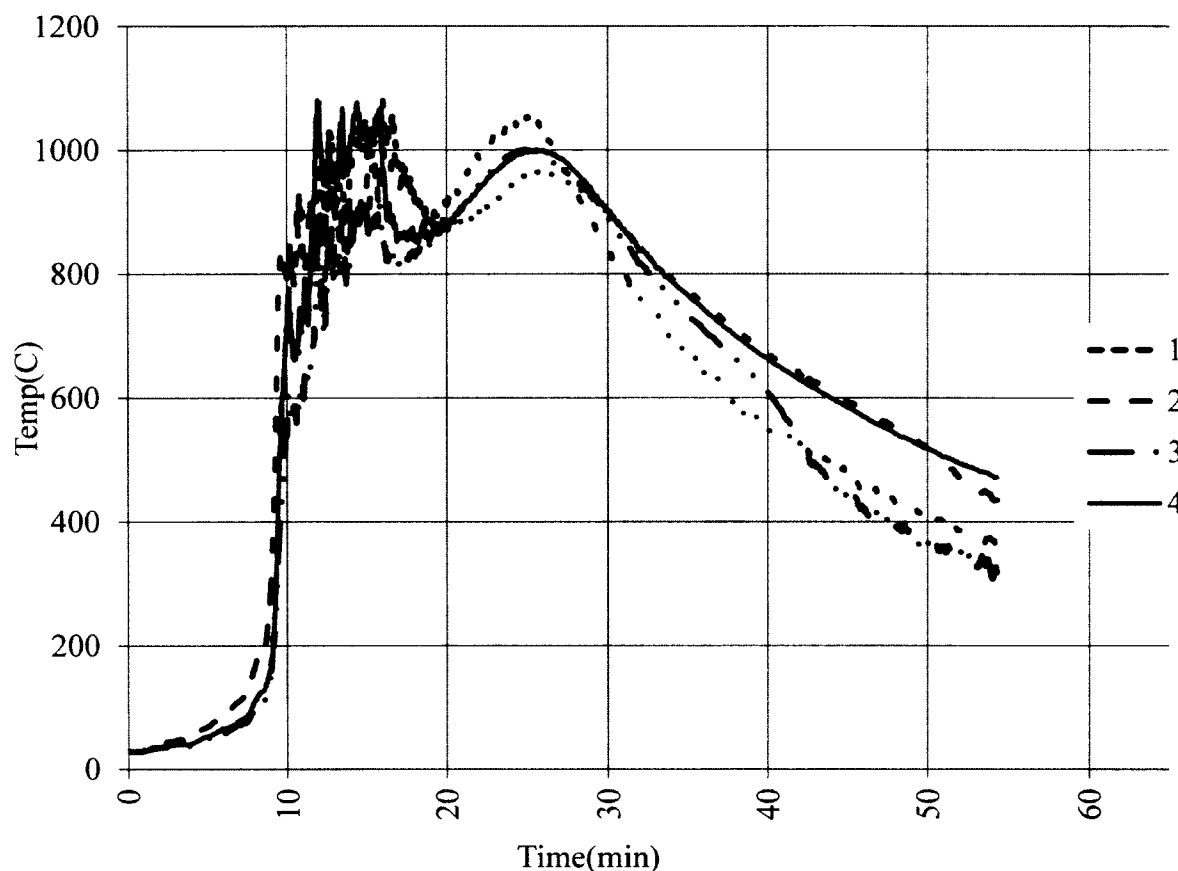
Figure 97 - Average thermocouple tree temperatures - Test 4

The average temperatures at each location are presented in Figure 97. The highest temperatures are experienced at the rear of the room during the initial fire growth phase. Immediately following this the rear of the room experiences lower temperatures, likely an effect of limited ventilation.

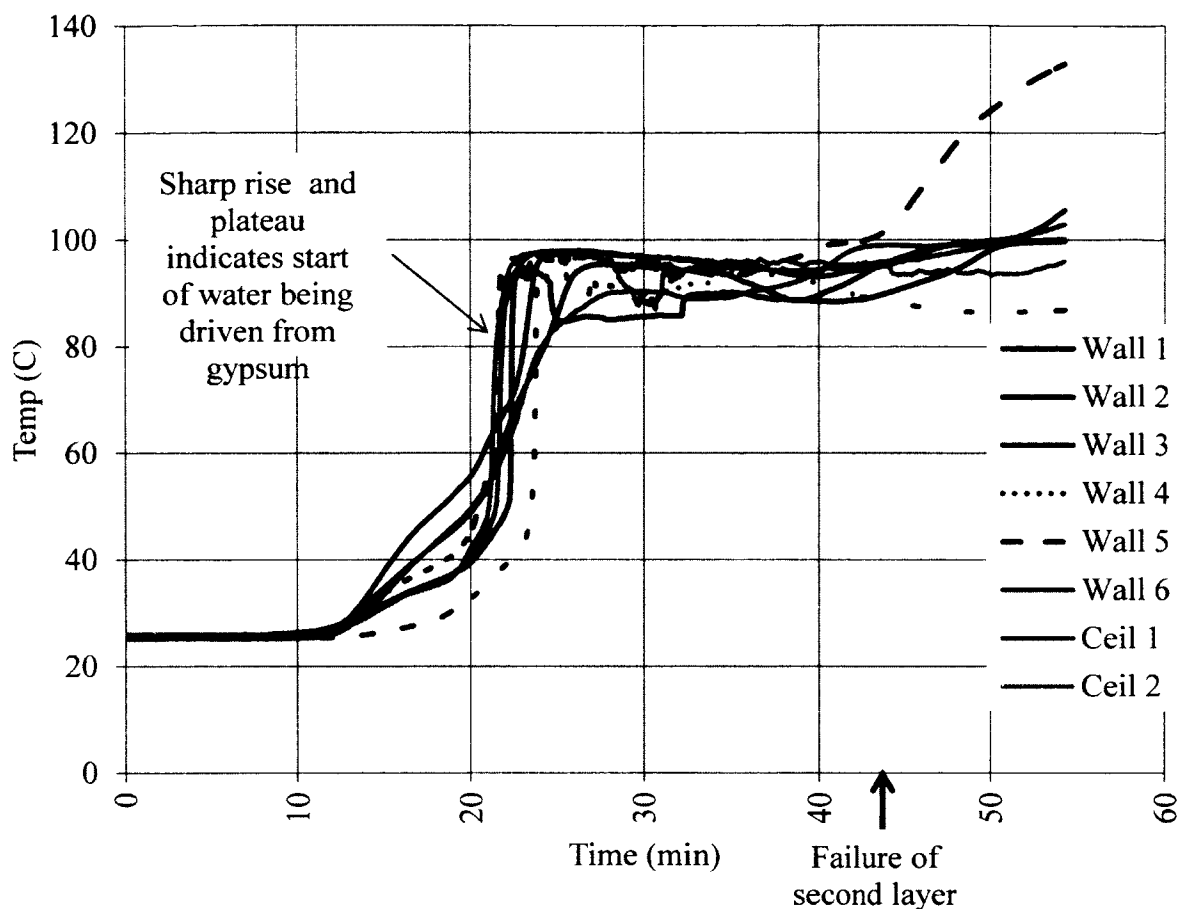
Figure 98 - Temperatures at interface of CLT panels and Gypsum Board insulation - Test 4

Like Test 2, the lining remained in place for the duration of the test, consequently the CLT panels did not become involved in the fire and did not experience any charring. The temperatures at the CLT/Gypsum board interface are presented in Figure 98 which show the failure of the first layer of gypsum board after approximately 21 minutes and the first indication of failure of the second layer after 43 minutes. The maximum temperature measured at the CLT/gypsum board interface was 133°C.

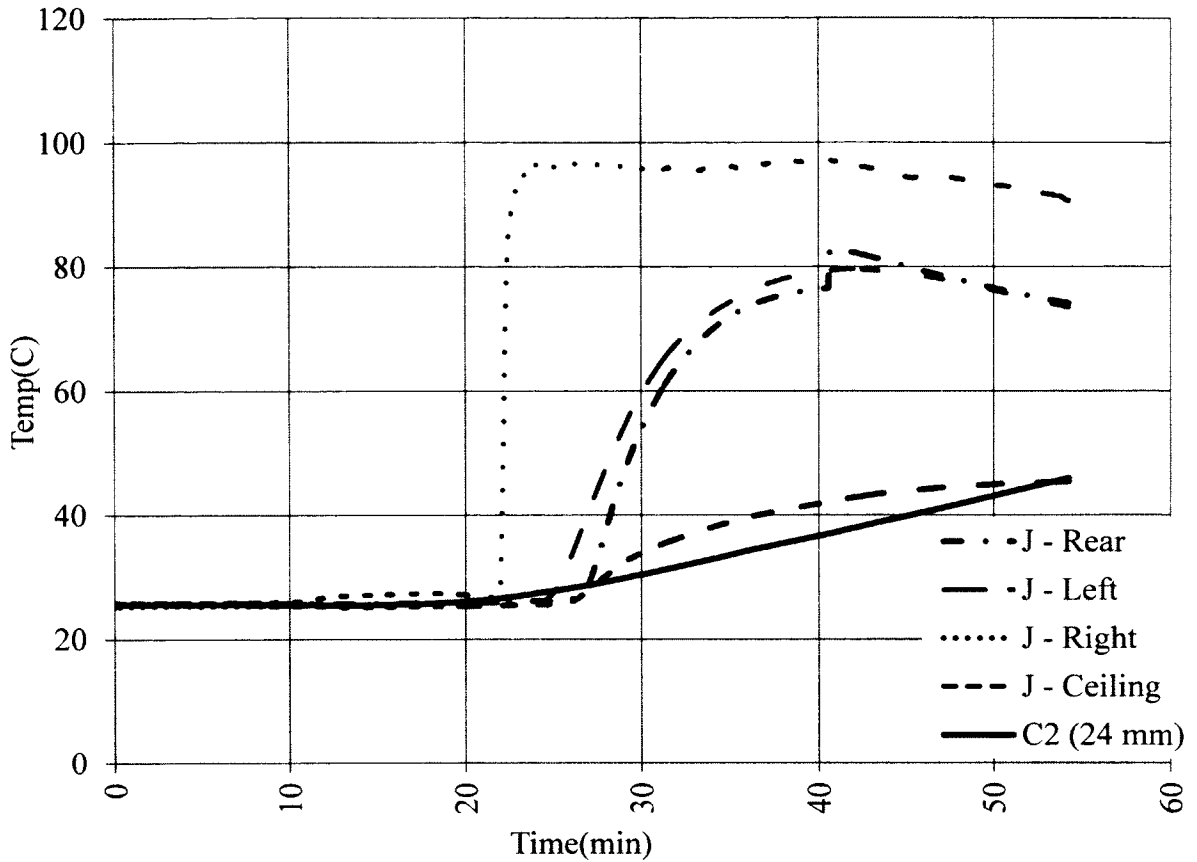
Figure 99 - Temperatures at the joints and embedded 24 mm from surface at position C2 – Test 4

The temperatures of the joints are presented in Figure 99. The temperature at the ceiling joint rises towards 100°C after 22 minutes indicating the transport of the chemically bound water being released from the gypsum board after the first layer of gypsum board fails. The temperatures then show a decrease after 40 mins, as the room cools (but still remain above 40°C) and at that time most of the chemically bound water in the second layer of gypsum board would have been released. A thermocouple embedded in the structure at position C2, 24 mm from the surface, shows a much slower temperature increase than that of the joints.

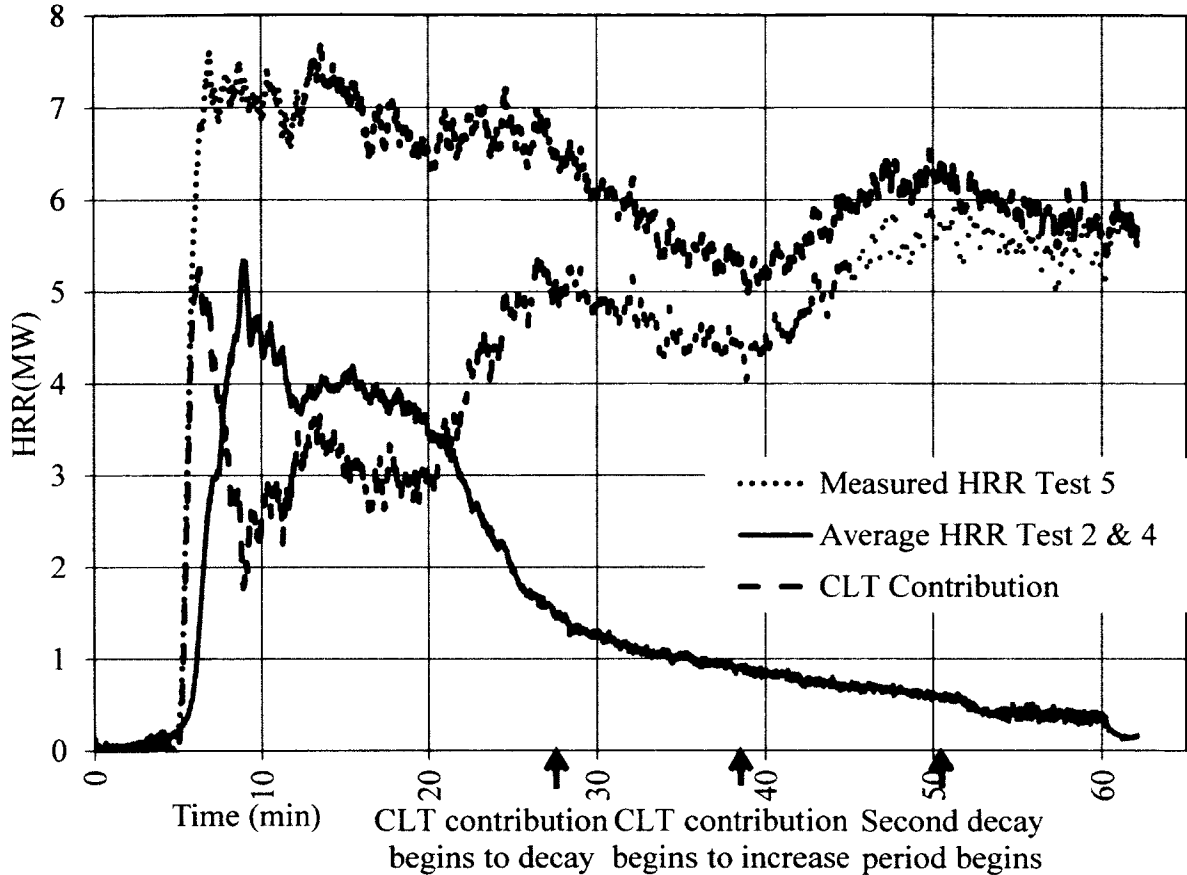
Figure 102- Heat release rate showing estimated contributions from CLT panels and furniture - Test 5

At 5:19 minutes the HRR, presented in Figure 102, exceeds 1.055 MW. The HRR continues to rise reaching a peak of 7.64 MW at 7:00 minutes with the fire burning at approximately 7 MW for 20 minutes before entering a decay period at 27 minutes. The decay occurs as the estimated contribution from the furniture and hardwood floor drops below approximately 1.5 MW.

Similar to Test 3, Figure 102 shows a rapid rise in the CLT contribution to HRR at flashover as the structure becomes involved in the fire. This increases the growth rate of the HRR putting the room into flashover earlier than observed in the protected rooms of Tests 2 and 4. The contribution from CLT is 5 MW during the early stage of the fire increasing to up to 6 MW when the first layer starts to delaminate. The period between 6 and 27 minutes suggests a decrease in contribution to HRR from the CLT, however this is unlikely as a constant rate of charring is expected. It is likely that the overall HRR is limited by the environment and a large proportion of volatiles released are transported away and not combusted.

In Test 5 the HRR began to rise rapidly at 0.4 MW with a fire growth rate of 1.3 MJ/s² similar to that observed in Test 3 and much faster than Tests 2 and 4. The lower value of 0.4 MW in comparison to 1 MW in Test 3, was likely due to the effects of the furniture in the room vs a largely empty room for Test 3 and the elevated seat of the fire on top of the bed exposing the ceiling to direct flames earlier. The fire reaches 1.055 MW approximately 30 seconds earlier than Test 2 and continues to rise to a peak of 7.69 MW. The calculations of contribution of CLT panels to the fire indicate approximately 5 MW, as seen in Figure 102, similar to that from Test 3.

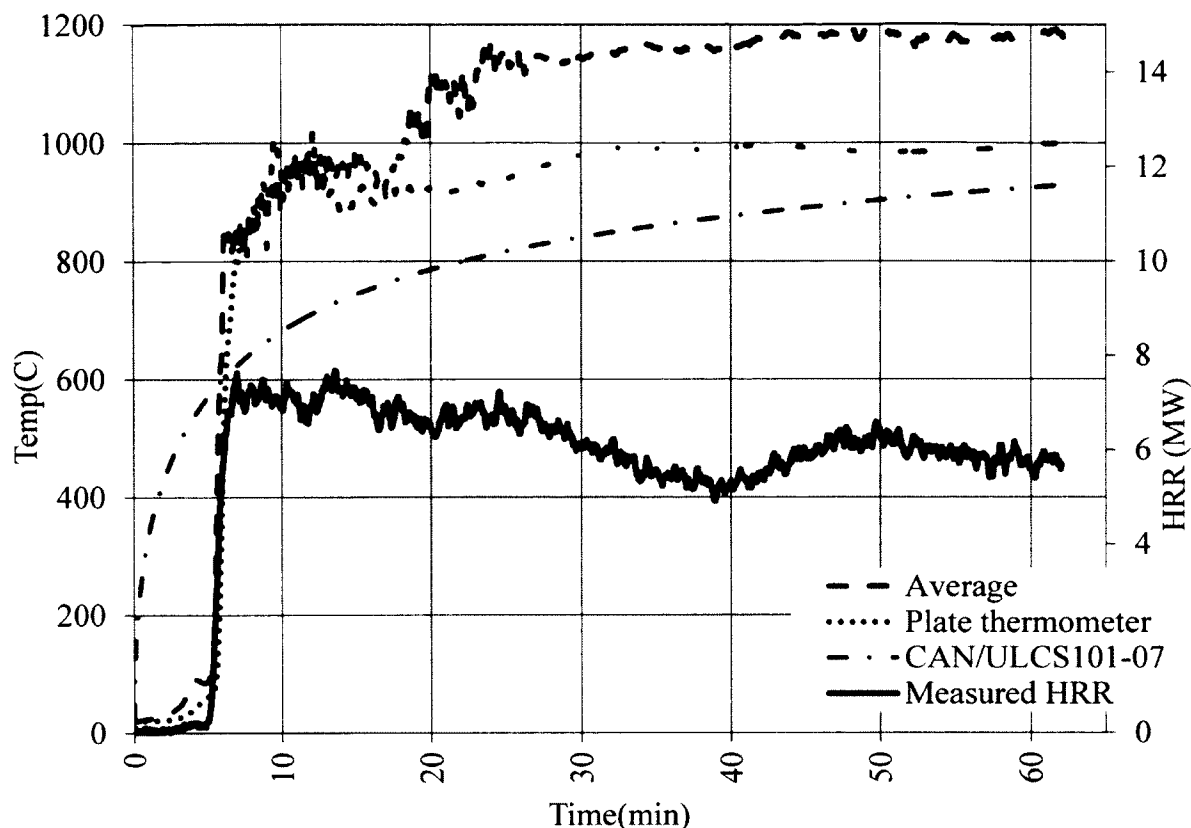
Figure 104 – Plate thermometer and Average room temperatures showing HRR – Test 5

The average room temperature, presented in Figure 104, rises rapidly at flashover, as seen in previous tests, with a decrease in growth rate occurring at 825°C before rising to 980°C and stabilising. A drop is observed after 16 minutes, similar to that observed in Tests 3 and 4, with the temperature stabilising at approximately 1000°C after 30 minutes. The plate thermometer rises to approximately 1000°C, experiencing a dip after 13 minutes, before rising to approximately 1170°C at 24 minutes where it stabilises.

The lower early temperatures at position 2 can be seen in Figure 106, Figure 107, Figure 108 and Figure 109 as well as the grouping at all positions as the temperatures stabilise after approximately 25 minutes. After 50 minutes the thermocouple tree collapsed at position 2 exposing the thermocouple wires to the flame and allowing flame and gases to exit through the penetration. An increase in temperature is noted in all points on the thermocouple tree indicating that all the readings have been affected. The temperatures approach that of the plate thermometer which showed consistently higher temperatures. For calculation of the average room temperature, presented in Figure 104 above, these increases have been disregarded.

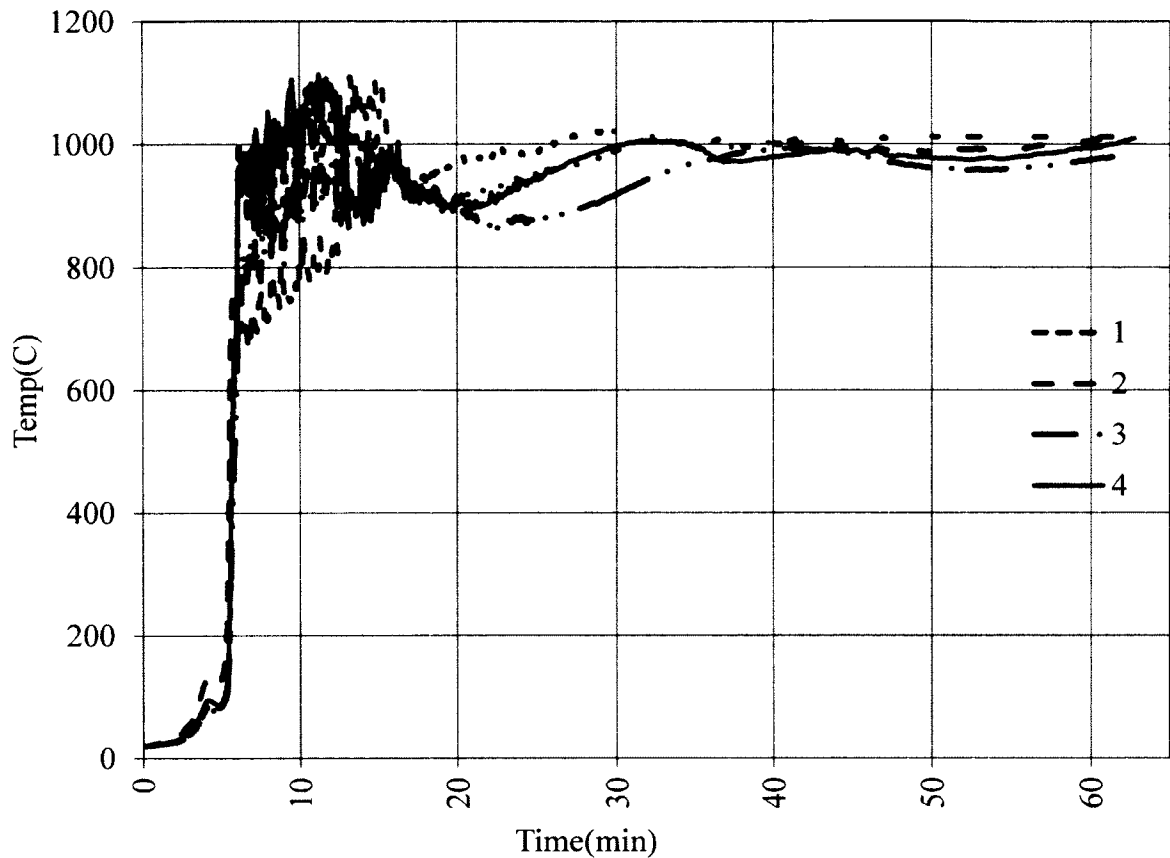
Figure 105 - Average temperatures at thermocouple tree positions - Test 5

The temperature at the rear of the room reaches a lower peak than the centre and doorway which is likely an effect of limited ventilation as a large amount of volatiles are released in the room. This spikes to approximately 1100°C after 13 minutes nearing the peak temperatures reached at positions 1 and 4 in the centre of the room. The spike is likely due to an improvement in ventilation resulting from a decrease in volatiles production in the room, which can be expected as the initial peak for the furniture would have passed at this time. Drops in temperatures are observed in Figure 105 at all positions, similar to previous tests, before the temperatures throughout the room stabilise at approximately 1000°C.

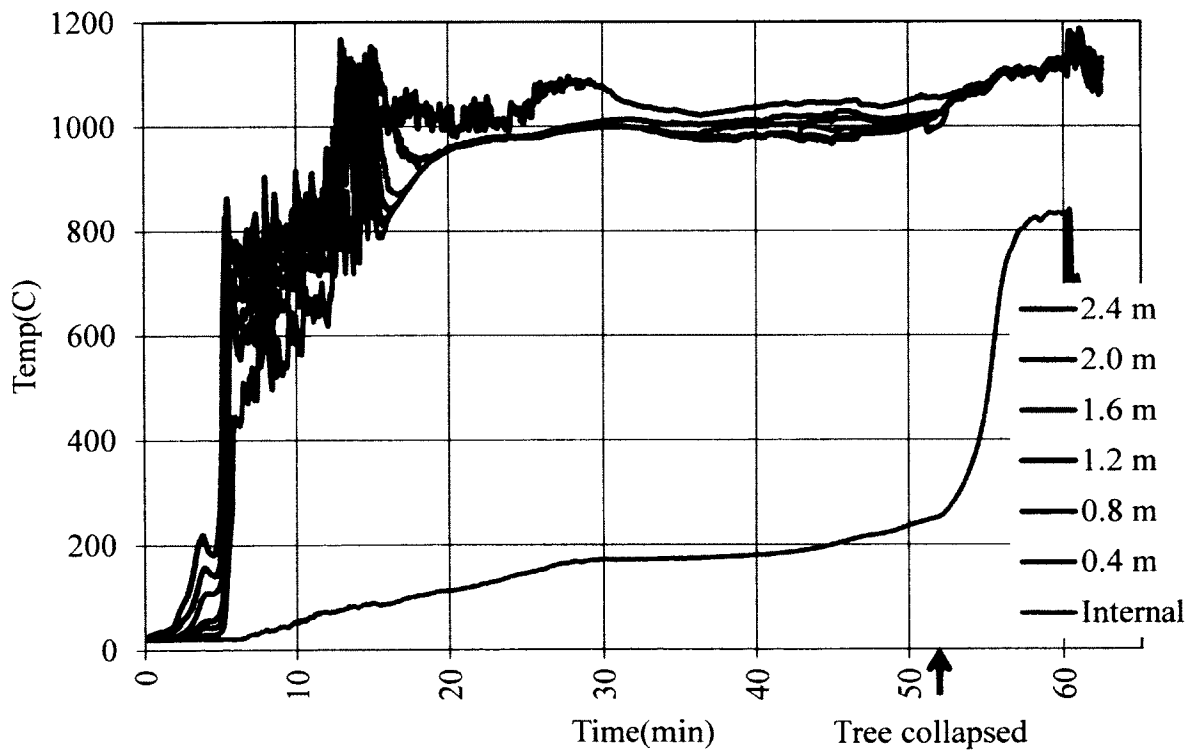
Figure 107 - Thermocouple Tree 2 temperatures – Test 5

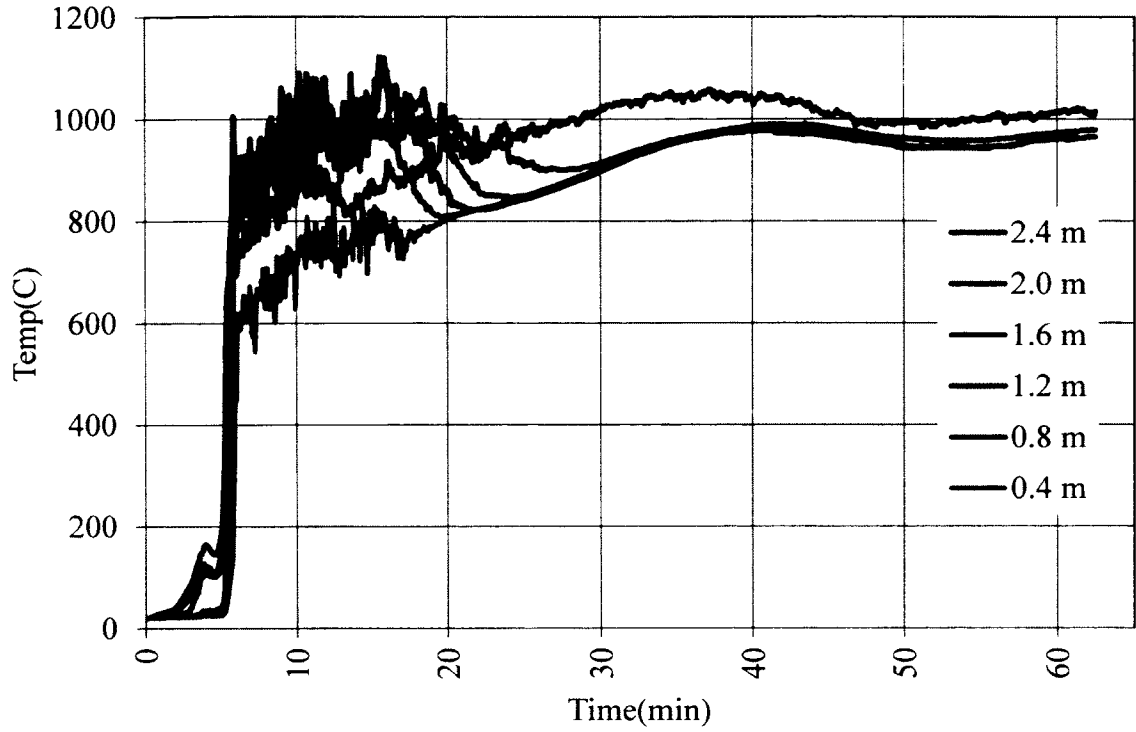
Figure 108- Thermocouple Tree 3 temperatures – Test 5

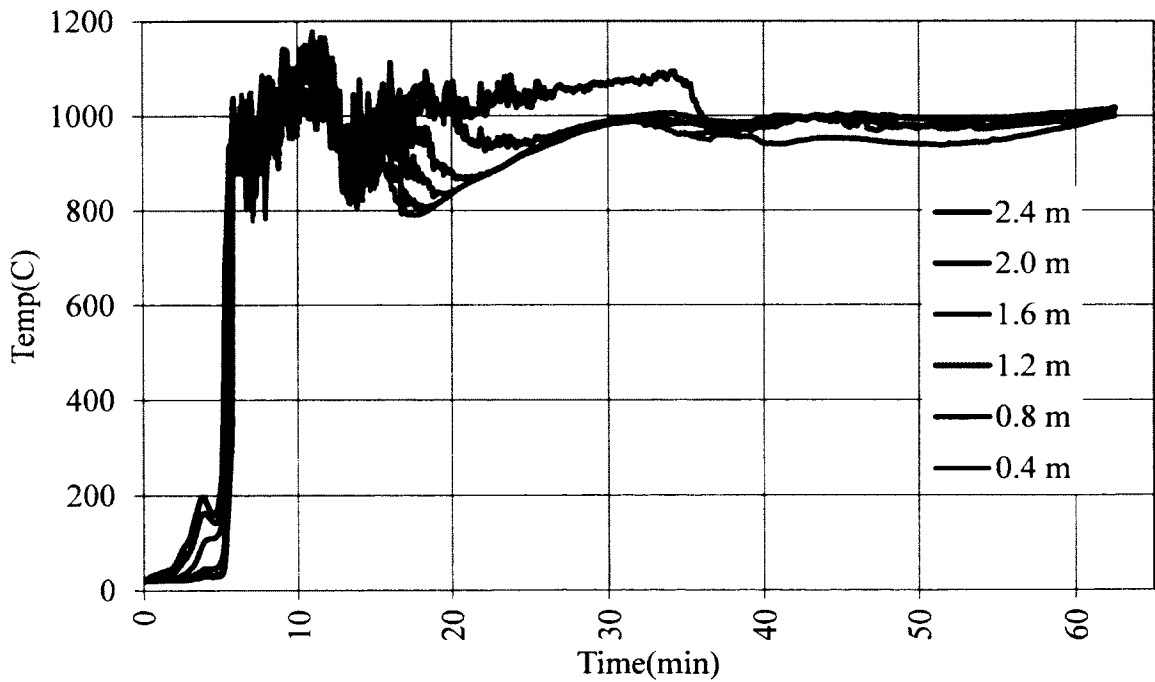
Figure 109- Thermocouple Tree 4 temperatures – Test 5
