CONTRIBUTION OF CROSS LAMINATED TIMBER PANELS TO ROOM FIRES

A thesis submitted to
the Faculty of Graduate and Postdoctoral Affairs
in Partial Fulfillment of the requirements for the degree

Masters of Applied Science in Civil Engineering

Department of Civil and Environmental Engineering
Carleton University

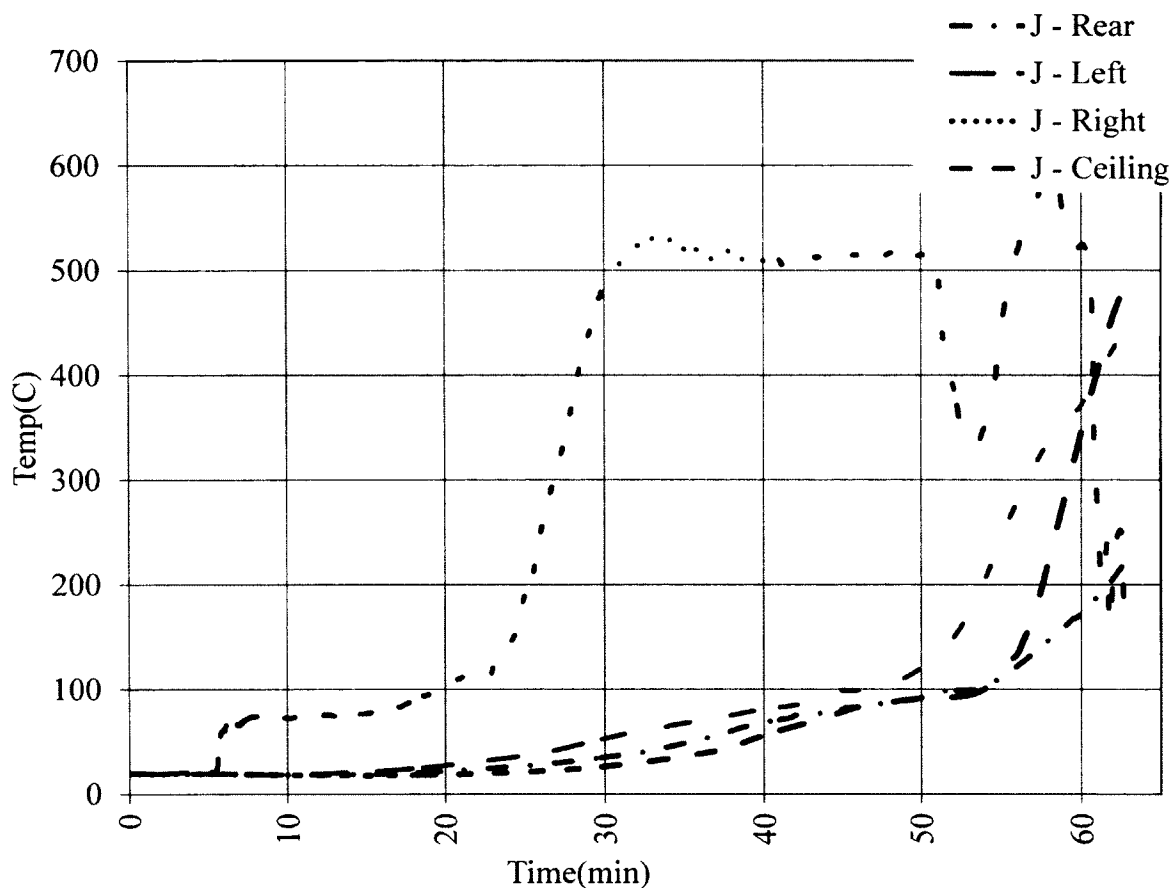
The joint temperatures presented in Figure 111 show failure of the ceiling joint early on in the test, this was also observed by gases escaping as seen in Figure 112. The drop in temperature at 50 minutes occurred when water was sprayed on the roof which provided cooling for a short time. The temperatures of the other joints exhibit rises much

later as a result of the pyrolysis and char fronts progressing through the structure. Despite the rear joint failing at 50 minutes near the floor, as seen in Figure 110, the measuring point does not indicate that the char rate at the two locations differ. This is likely due to a misalignment in the panel resulting in some separation at the base of the joint.

Figure 111 - Joint temperatures - Test 5

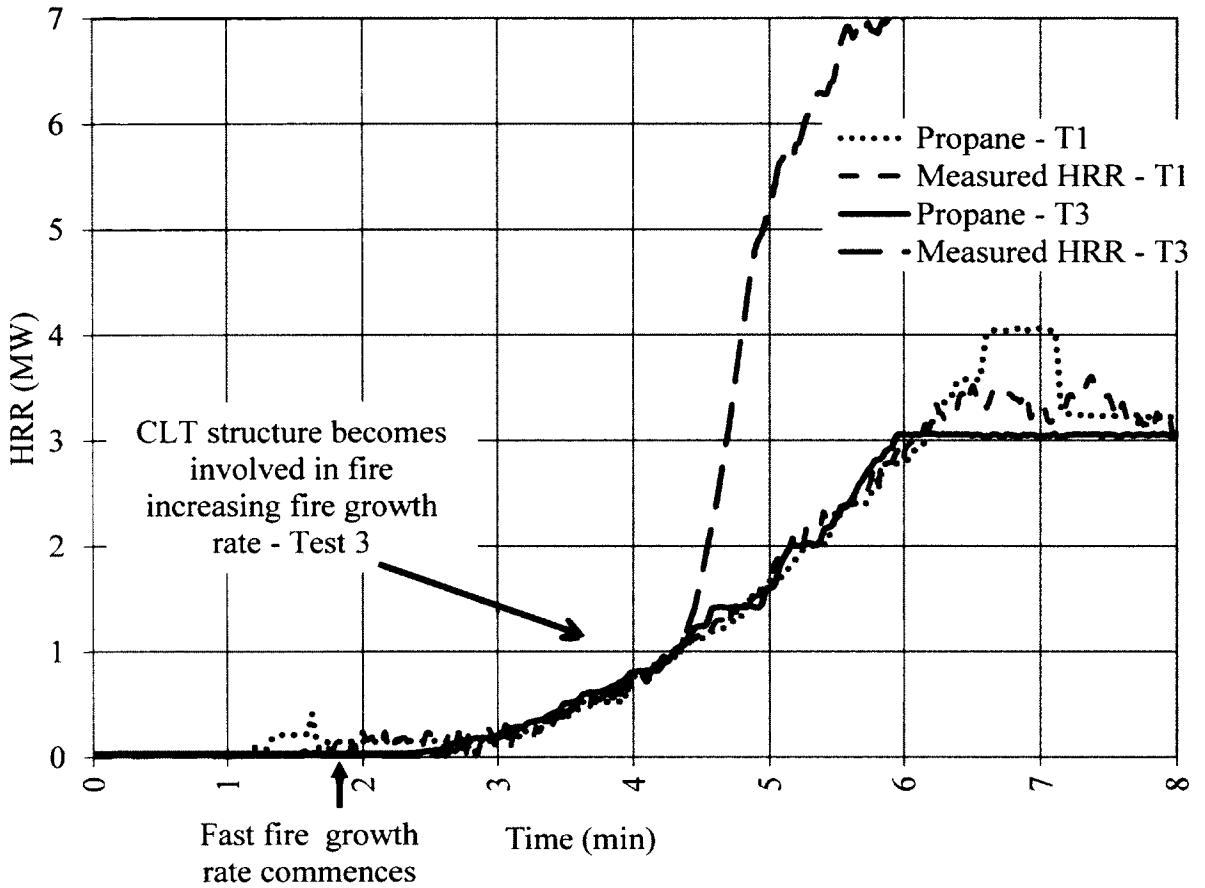
Figure 113 compares the measured flow of propane and the measured HRR from oxygen calorimetry in Tests 1 and 3. A correction of -10 seconds is applied to Test 1 to align for comparison with Test 3 as detailed in Table 17. A large increase in fire growth rate is observed in Test 3 at approximately 1 MW as the CLT panels become involved in the fire. The fire growth rate increased from fast (0.0469 MJ/s^2) to 1.3 MJ/s^2 , exceeding

the ultra-fast classification (0.1896 MJ/s^2) as a result of the involvement of the CLT panels in the fire. The peak HRR of 8.75 MW in Test 3 indicates a peak CLT contribution of approximately 5.75 MW after 7 minutes as seen in Figure 77, almost twice the 3 MW observed before combustion occurred outside the room.

Figure 113 – Comparison of HRR growth rates for propane tests

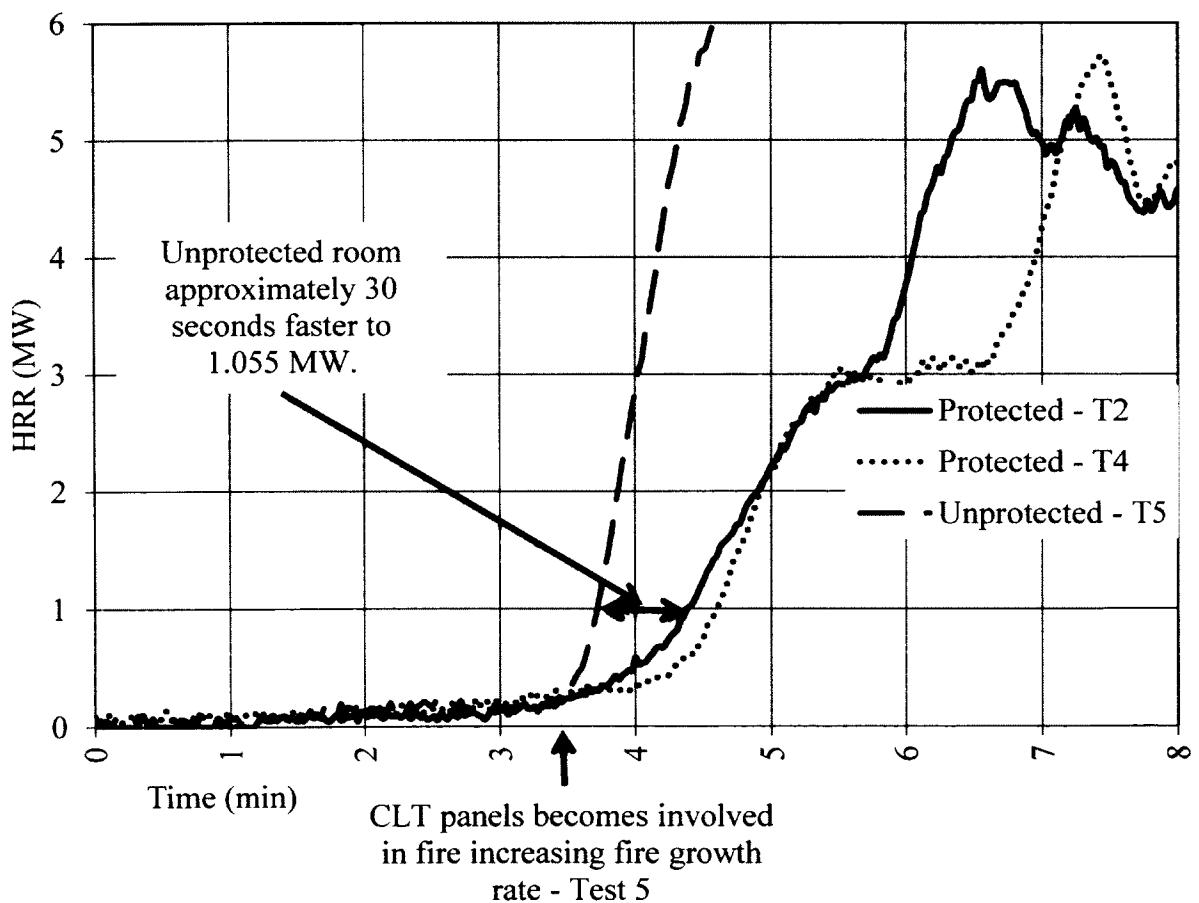
Figure 114 presents the growth rates observed in the Tests 2, 4 and 5 with the furniture fuel source and hardwood flooring. The curves have been corrected and matched at 0.25 MW for comparison. Corrections applied to each of the tests are detailed in Table 17. The growth rates in the protected tests were 0.1876 MJ/s² and 0.4 MJ/s² for tests 2 and 4 respectively, similar to the ultra-fast classification (0.1896 MJ/s²) and faster than the values of 0.055 MJ/s² and 0.06 MJ/s² observed for each of Chen's [40] tests. The faster growth rates between these and Chen's [40] tests may be related to the higher fire loads in these tests.

In Test 5 the HRR began to rise rapidly at 0.4 MW with a fire growth rate of 1.3 MJ/s² similar to that observed in Test 3 and much faster than Tests 2 and 4. The lower value of 0.4 MW in comparison to 1 MW in Test 3, was likely due to the effects of the furniture in the room vs a largely empty room for Test 3 and the elevated seat of the fire on top of the bed exposing the ceiling to direct flames earlier. The fire reaches 1.055 MW approximately 30 seconds earlier than Test 2 and continues to rise to a peak of 7.69 MW. The calculations of contribution of CLT panels to the fire indicate approximately 5 MW, as seen in Figure 102, similar to that from Test 3.

Figure 114 – Comparison of HRR growth phase of furniture tests

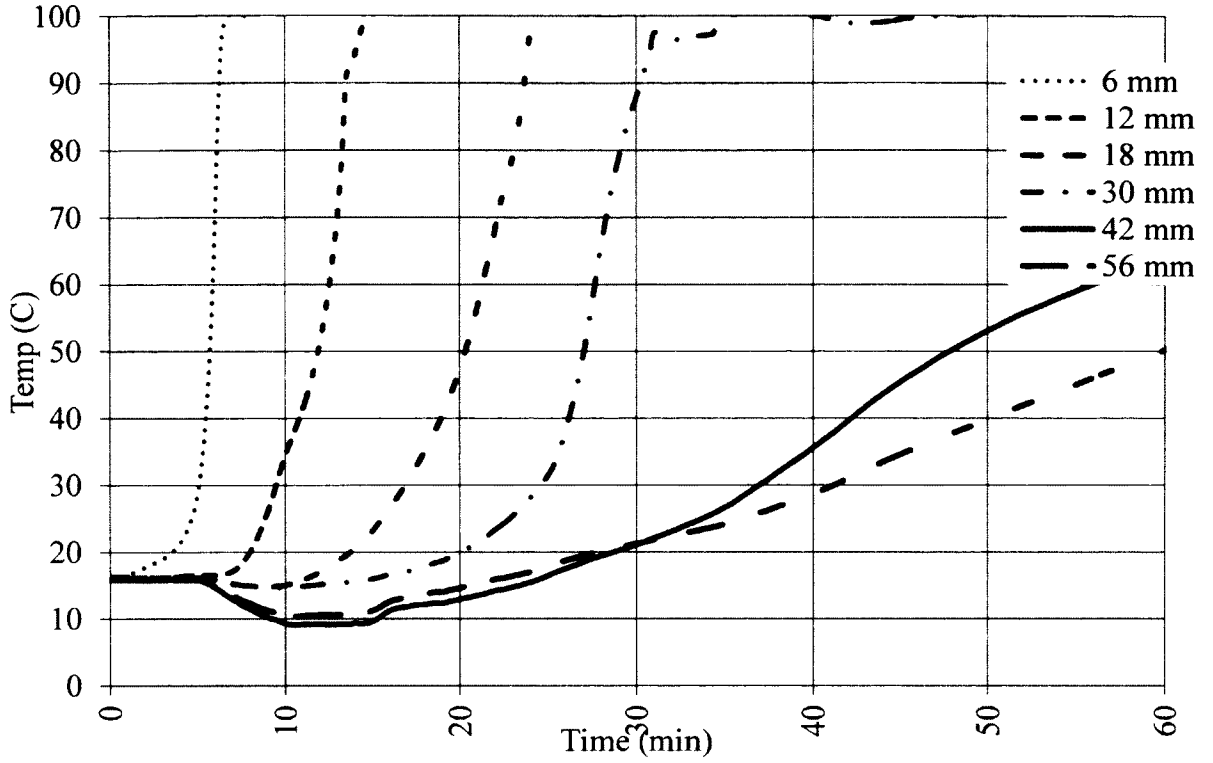
At the beginning of Tests 1 and 3, slight drops in temperature were observed at measuring points embedded in the panels. The temperatures drops ranged from 0.8°C to 6.9°C with the most significant drops shown in Figure 115 from Test 3. Test 4 did not exhibit this phenomenon and there is no information available for Test 2.

It is suspected that this is a result of evaporation of moisture in the wood at the measuring position before heating occurred. This evaporation may have been driven by drying of the wood closer to the fire or a drop in pressure at the location related to the fire conditions in the room. The minimum temperatures observed in the structure for each of the tests remains above the wet bulb temperature of the ambient conditions, calculated using the psychrometric chart in Figure 116, which represents the minimum temperature to which air can be cooled through evaporation of water only.

Figure 115 - Temperatures of embedded thermocouples at position W2 showing the temperature drops – Test 3

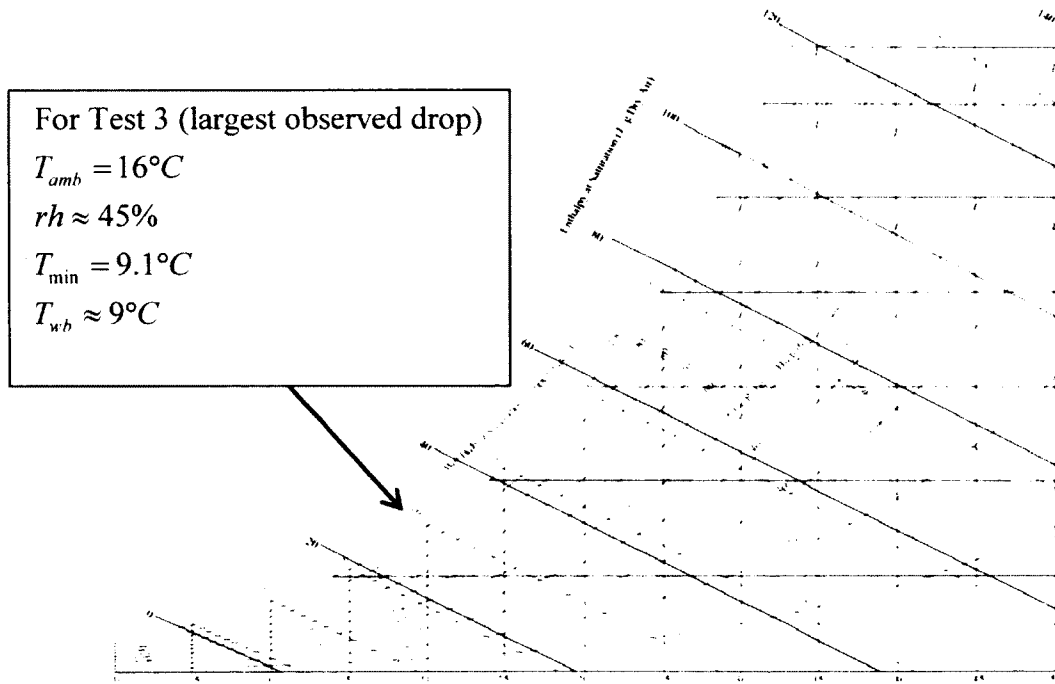
Figure 116 - Psychrometric chart showing wet and dry bulb temperatures [49]

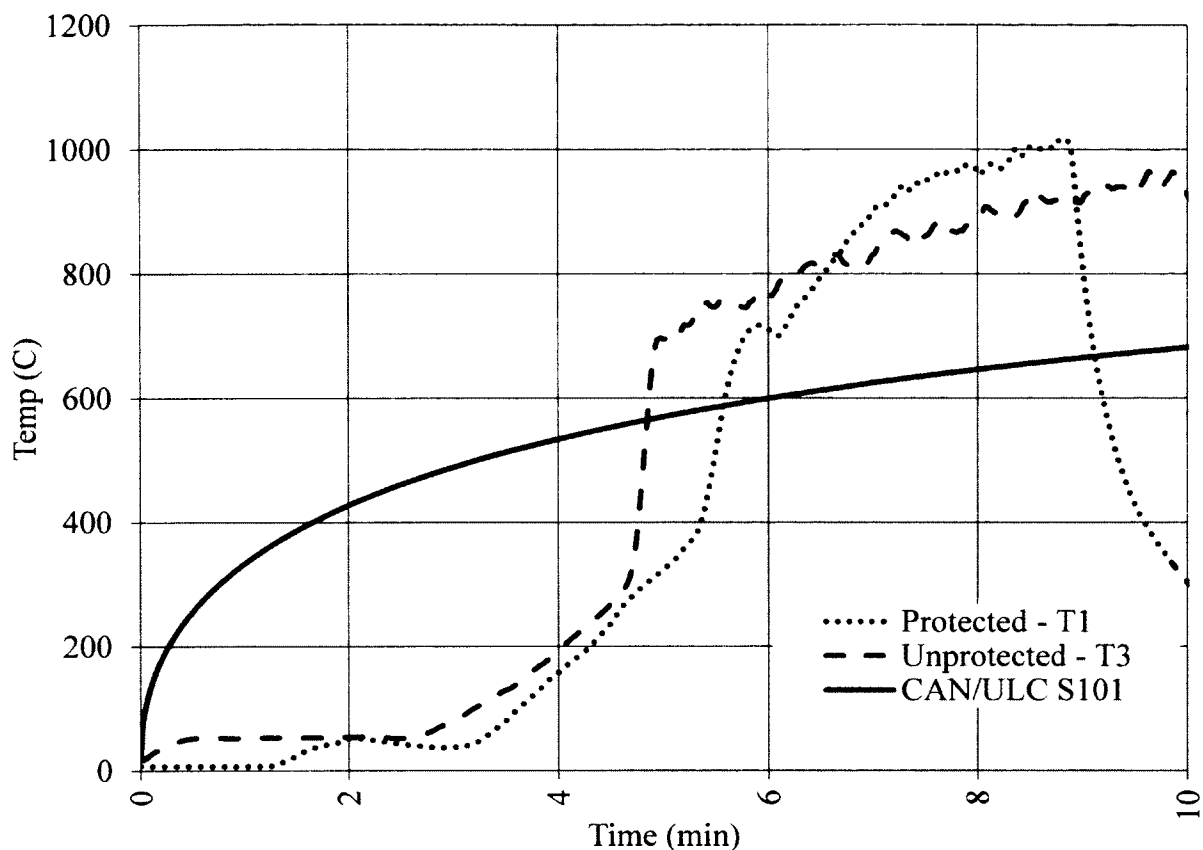
Figure 117 presents the average room temperatures observed during the growth and flashover stages for Tests 1 and 3. Both graphs show similar features after transition from incipient to sustained growth occurs, with an increase in rate of temperature rise observed after reaching 300°C for the unprotected room and 400°C for the protected room . The higher peak in the protected room may be a result of the cleaner burning propane vs the mixture of propane and volatiles generated from the CLT panels.

Figure 117 – Temperature increases observed in propane fires – Tests 1 and 3

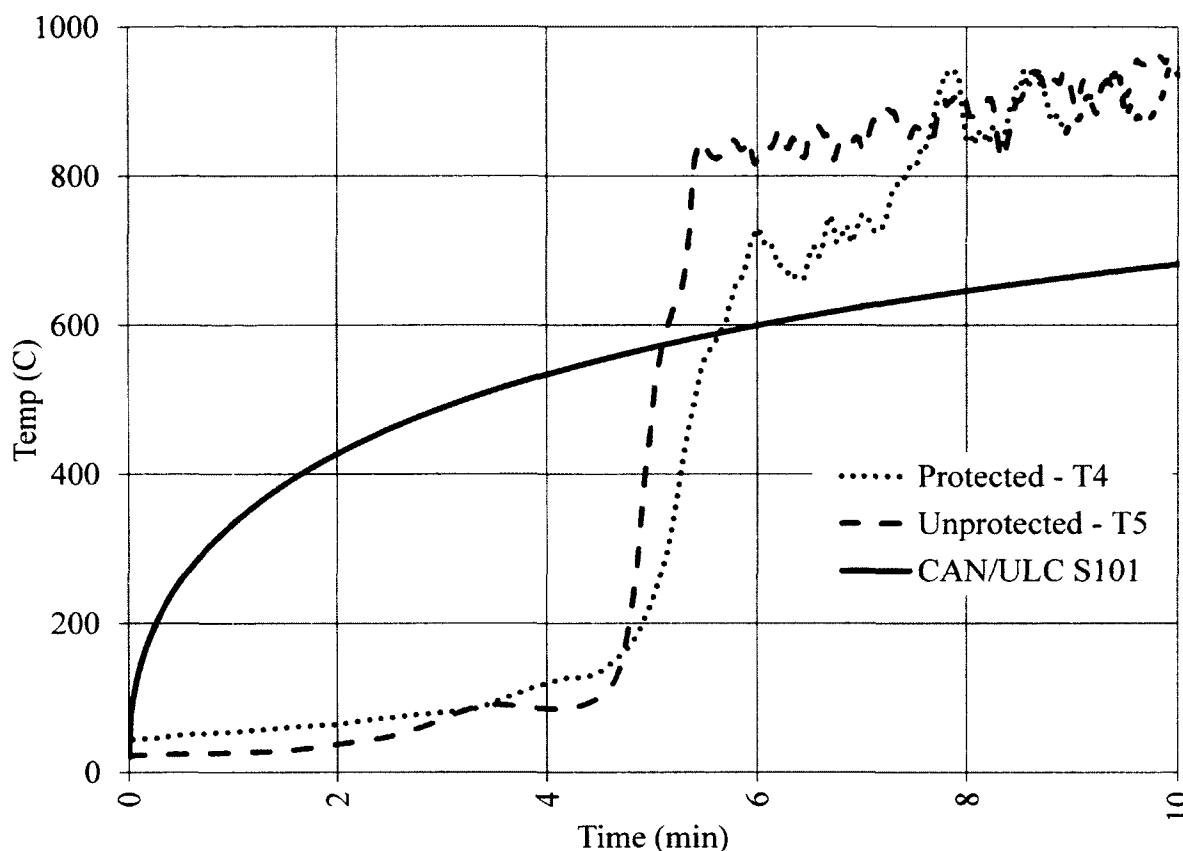
Figure 118 presents the average room temperatures observed during the growth and flashover stages for Tests 4 and 5. Rates of temperature rise for both rooms are similar following transition from incipient to sustained growth and transition to slower rate of rise at approximately 650°C and 850°C for Test 4 and 5 respectively. This difference may be due to the composition of the fire environment, however it occurs at conditions well above those considered tolerable and is of little significance when considering life safety.

Ultimately the two rooms reach a similar peak temperature which approaches 1000°C.

Figure 118 – Temperature growth rates of furniture fires – Tests 4 and 5

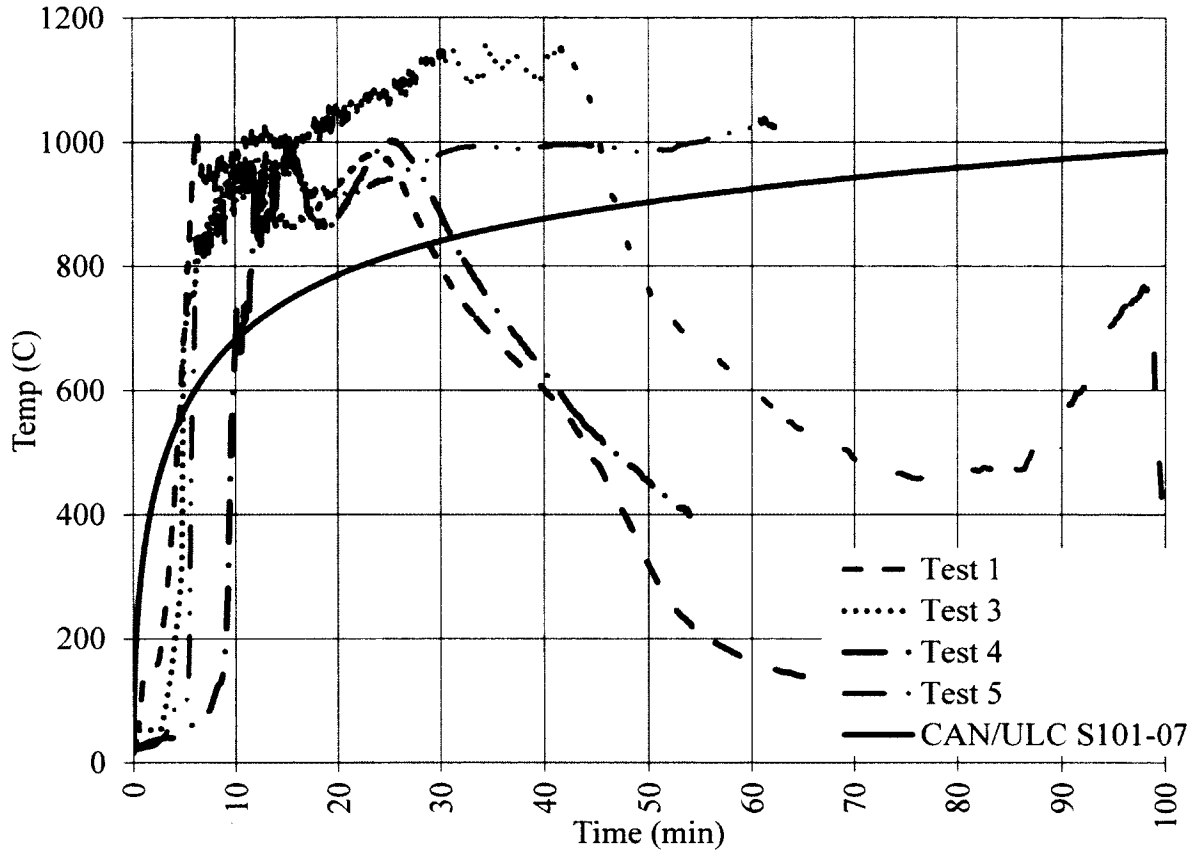
The average room temperatures for Tests 1, 3, 4 and 5 are presented in Figure 119. Rooms experience a rapid temperature rise at flashover before transitioning to a phase of slower rate of rise. The protected room with propane fire in Test 1 yields noticeably higher temperatures which is likely a result of cleaner burning propane and less observed smoke than the other fires which involve furniture and the structure. The sustained temperature increases occurring at flashover are more rapid with higher peaks than those of the CAN/ULC test fire however they quickly decrease once the fuel is consumed. For the unprotected room in Test 5 however, delamination occurred,

prolonging the duration of the fire and maintaining higher temperatures for an extended period resulting in higher severity than the standard test.

Figure 119 - Comparison of Average TCT room temperatures (second start only for Test 1)

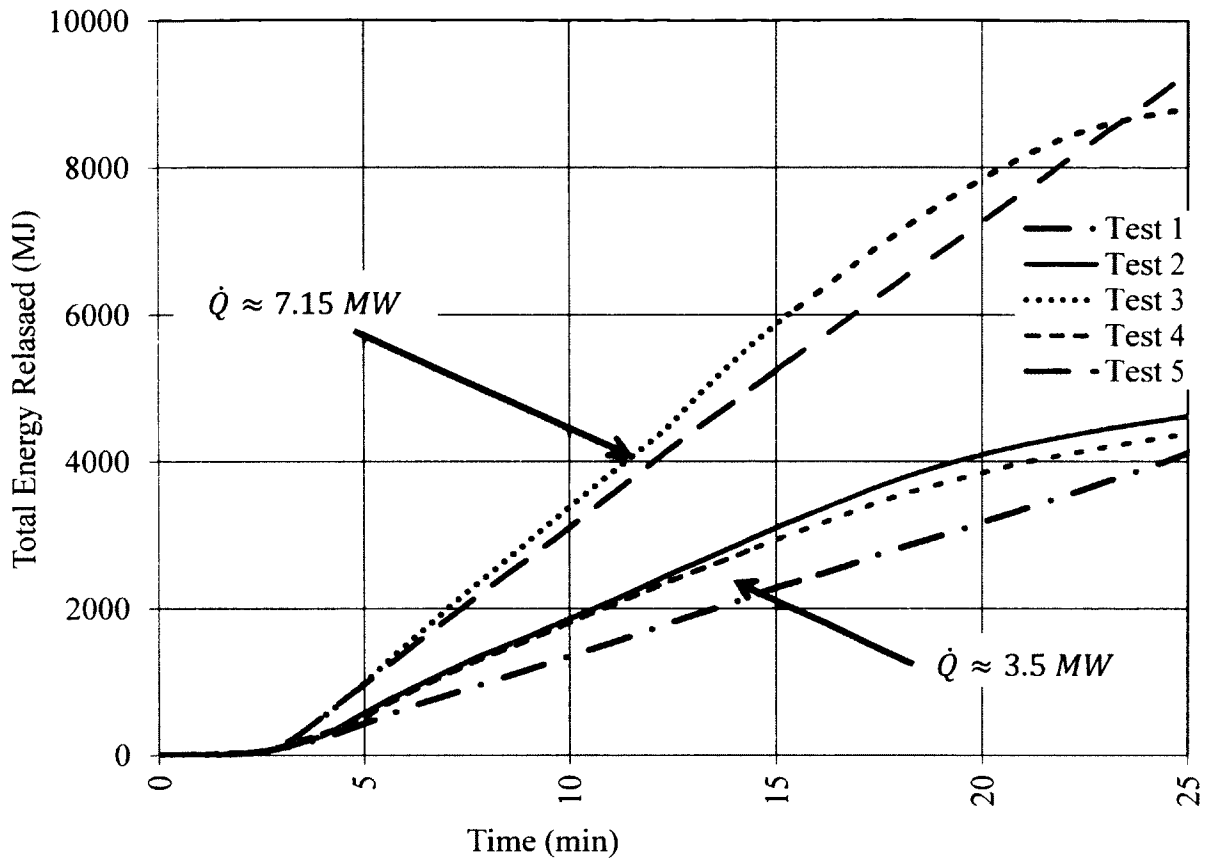
Figure 120 presents the total energy released during each of the tests with corrections to align with the fast propane fire so that HRR values for each test pass through 1.055 MW at 150 seconds. The corrections used are presented in Table 20. In the unprotected configurations, Tests 3 and 5, the energy is released at approximately twice (~7.15 MW) the rate of the protected configurations, Tests 1, 2 and 4 (~3.5 MW), which also corresponds to twice the amount of volatiles and gases released. The increase in fire load associated with the CLT panels is accompanied with an increase in fuel surface area (walls and ceiling) that increases the production rate of volatiles as the fire develops. The increased rate in generation of volatiles increases the risk of fire spread locally when combustion occurs, however can also present a remote hazard through the transport of combustible gases in cases of low ventilation. The corresponding increase in generation of gases and smoke significantly increases the associated life safety hazards.

Figure 120 – Comparison of total energy released for all tests (corrected to 1.055 MW at 150 seconds)

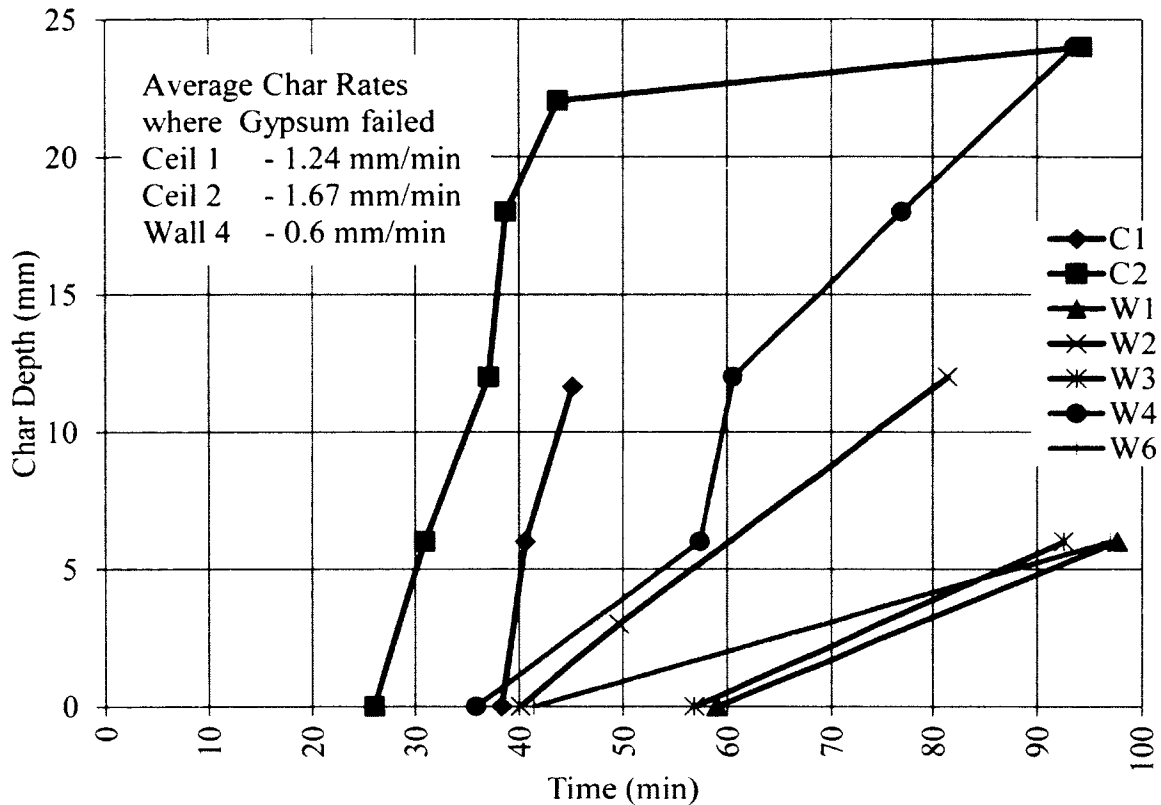
The charring depths observed in Test 1 are presented in Figure 124. Charring starts at different times for each of the measuring points commencing when the gypsum board protection had failed. Very high average charring rates of 1.27 mm/min and 1.67 mm/min were observed at ceiling positions C1 and C2 respectively after the gypsum was observed falling off. These rates are approximately twice that normally expected, however consistent with increased rates of charring following failure of protective system recommended in Eurocode 5 [13]. The lower charring rates experienced at the wall positions can be explained by the gradual failure of the degraded gypsum vs the sudden falling off of entire sheets at the ceiling. Charring continued at wall position W4 well after the propane fire had been turned off. This is an area of the wall where the gypsum fell off and near the position where delamination occurred initiating a second flashover.

Figure 124 - Charring of CLT panels – Test 1

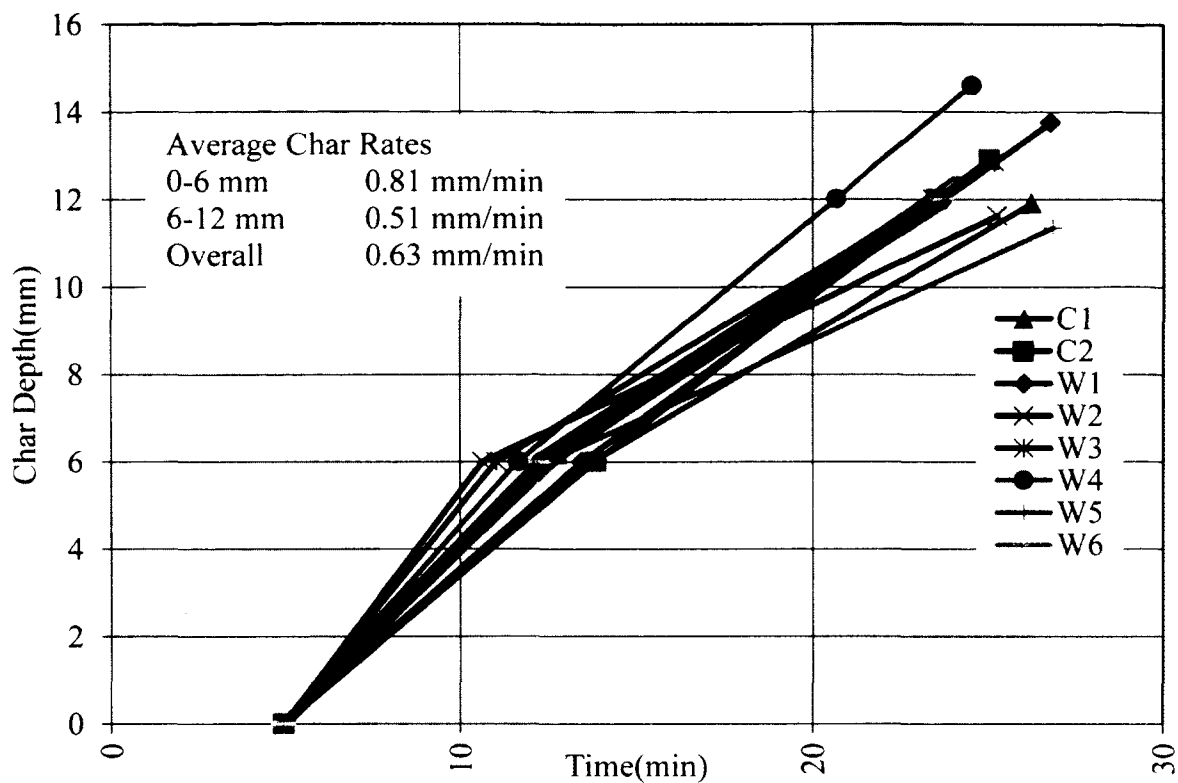
The charring depths observed in Test 3 are presented in Figure 128. Charring occurred at all positions after 5 minutes at which time the room entered flashover and all surfaces became involved in the fire. Rates of charring up to 6 mm in depth are an average of 0.81 mm/min and reduced to 0.51 mm/min over the second 6 mm, likely a result of the char layer developing which acts as an insulator. The overall average charring rate was 0.63 mm/min which is consistent with the Eurocode 5 [13] charring rate of 0.65 mm/min. All charring stopped soon after the propane fire was removed at 25 minutes, similar to what would have been expected from a thick slab of wood [9].

Figure 128 - Charring of CLT panels – Test 3

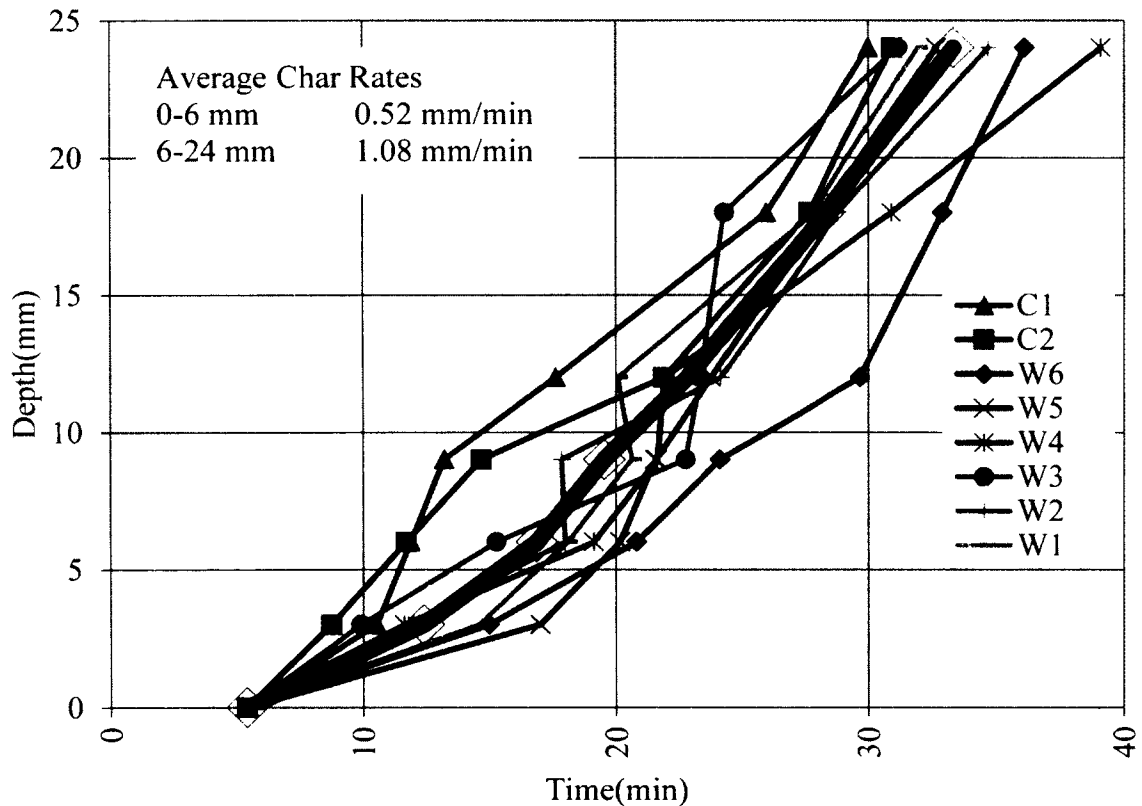
Figure 130 - Charring rates observed in Test 5

The charring depths observed in Test 5, presented in Figure 130, were measured up to depths of 24 mm. Charring at all positions is observed at 5 minutes when the room enters flashover. Average char rates over the first 6mm were 0.52 mm/min increasing to 1.08 mm/min up to the depth of 24 mm. This indicates an increase in charring as depth increases which is unlikely, indicating that the depth of the thermocouples may have been incorrect. The overall average of 0.85 mm/min is higher than the Eurocode 5 [13] charring rate of 0.65 mm/min.
