## Cryogenic Safety Ch. 11 Flynn

## OUTLINE

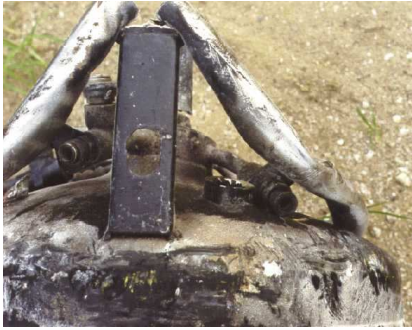
**Cylinder top**

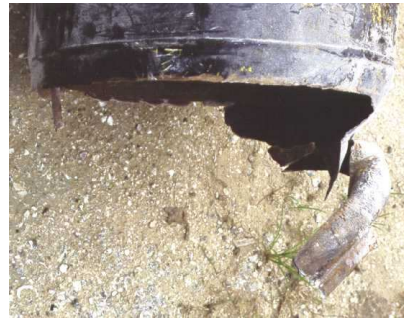
**Cylinder outer shell, bottom**

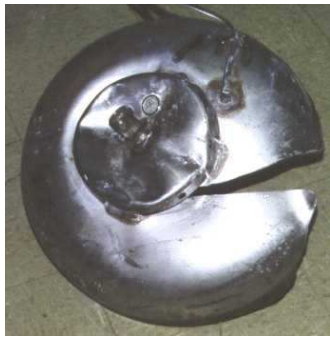
**Cylinder bottom shell**

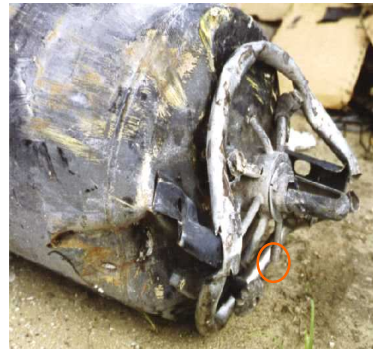
**PRD location was plugged using a threaded cap**

- Jury-rigging fill connections, the first attempt to fill the cylinder resulted in rapid venting through the Pressure Relief Device (PRD)
- **The PRDs were removed and plugged**
- The cylinder was filled while onboard a pickup truck
- The cylinder, which had no vacuum, was now unable to vent excess pressure
- While being transported down a busy highway, the pickup truck experienced a flat tire
- Shortly thereafter, the cylinder exploded with the results shown in the following slides

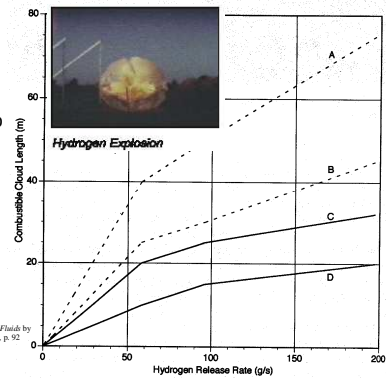
## Hydrogen Combustible Cloud Length

Hydrogen is flammable in air at 1 atmosphere for a concentration of 4% to 74%. Depending on the release rate of the hydrogen, the flammable cloud will extend according to the graphs at right.
