Ohio Department of Natural Resources Division of Water Fact Sheet

Fact Sheet 94-32

Dam Safety: Concrete Repair Techniques

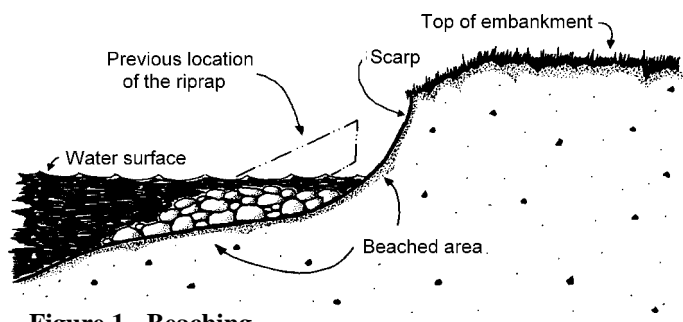
Figure 1 - Beaching

The repeated action of waves striking the embankment surface erodes fill material and displaces it farther down the slope, creating a “beach.” The amount of erosion depends on the predominant wind direction, the orientation of the dam, the steepness of the slope, water level fluctuations, boating activities, and other factors. Further erosion can lead to cracking and sloughing of the slope which can extend into the crest, reducing its width. When erosion occurs and beaching develops on the upstream slope of a dam, repairs should be made as soon as possible. However, an erosion scarp less than 1 foot high may be stable and not require repair.
