Design and Analysis of a Stiffened Composite Structure Repair Concept

Adam Przekop¹

Analytical Services and Materials, Inc., Hampton, VA, 23666

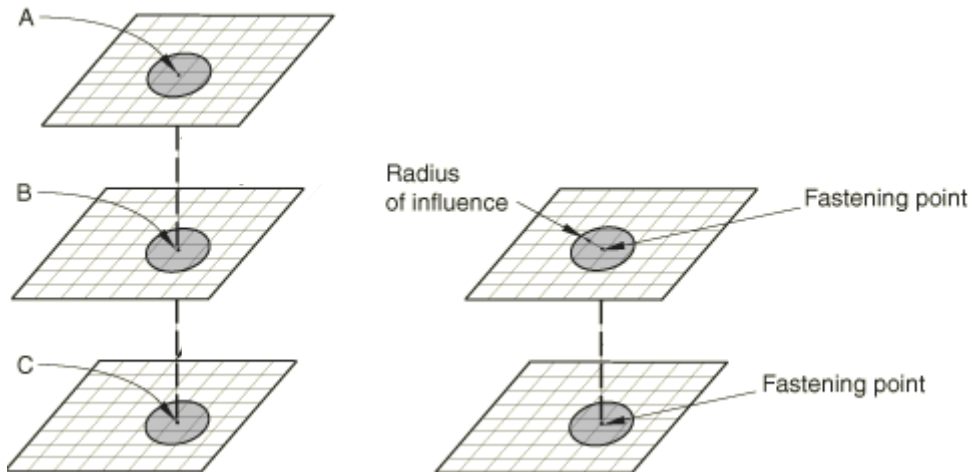
Figure 12. Fastener two- and three-part joint modeling in Abaqus FE code.⁸

As illustrated in Figure 12, the physical number of fasteners in the model is not necessarily equal to the number of the connector elements used to model them. When only two parts are connected with a fastener, one connector element represents one fastener, as seen on the right hand side of Figure 12. Such a configuration is the case, e.g., for the top row of 0.16-in. fasteners above the pultruded rod joining together the two upper repair pieces, shown in Figure 10a. When a single fastener is attaching together three parts, two connector elements are needed in a FE model, each connecting the two parts located next to each other, as seen on the left hand side of Figure 12 where one connector element attaches fastening points A and B and one connector element attaches fastening points B and C. Such a configuration is the case, e.g., for the row of 0.19-in. fasteners connecting the two upper repair pieces and the web in between them, shown in Figure 10a.

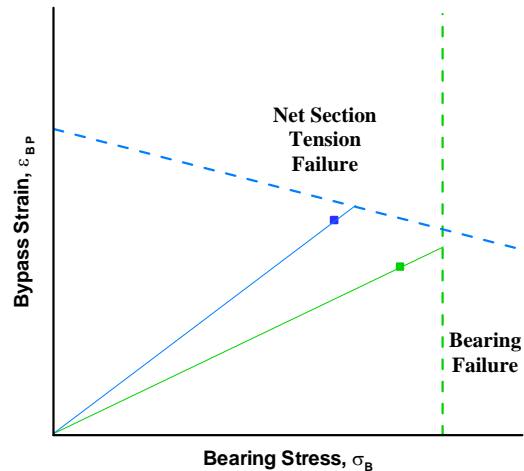
Figure 14. Bearing stress-bypass strain typical trend lines of a composite material allowables under tension loading.¹⁴

where in the present analysis the bearing force, P_B , was obtained from the FE connector element output associated with each fastener. The bearing stress and bypass strain values, obtained as just described, can be plotted for a given location in a fashion presented in Figure 14 with sample blue and green data points. Based on proprietary test data, two distinct failure mechanisms can occur dependent on relative magnitudes of the bearing stress and the bypass strain.^{13,14} These are net section failure and bearing failure. While the bearing failure is independent of the bypass strain level as indicated by the vertical green dashed line, the maximum bypass strain allowable depends on the bearing stress level as presented with a sloped blue dash line. If a particular operating point is contained under the two dashed lines failure will not occur. The margin of safety can be estimated by plotting a straight line through the origin of the coordinate system and a data point until it intersects with either dashed line. The ratio of the total line length until the intersection with a dashed line relative to the distance of a given point from the origin produces the margin of safety value when the value of one is subtracted from it.

Figure 25 presents the results from Figure 23 in the format of Figure 14. While the spatial distribution information is lost, this representation of the results enables assessment of the structural integrity of the design based on test data allowables illustrated in Figure 14. Allowable values representative of the dashed blue and green trend lines from Figure 14 are not plotted in Figure 25 since these values are proprietary. Note, that the points in Figure 25 form a pattern highlighted by a green dashed line with its limits established by the two end fastener locations near the frame and the saw-cut.

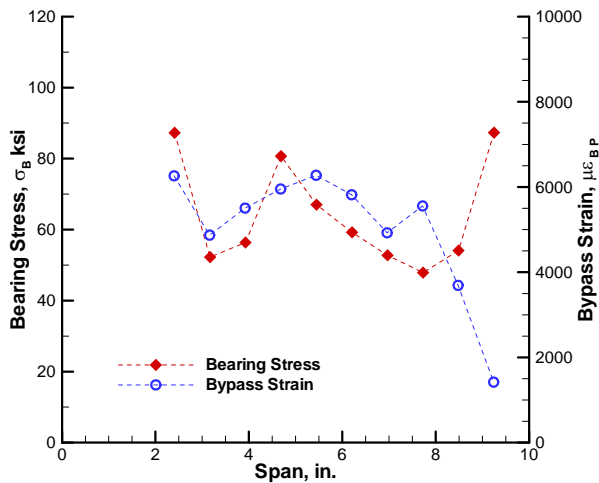
Figure 23. Distribution of the bypass strain and the bearing stress along at the center web.

The results obtained for the upper repair assembly attachment to the stringer's web are illustrated in Figure 23 where two curves represent the distribution of the bearing stress and bypass strain from the frame (0 in.) to the panel mid-length location (10 in.). The repair is symmetric so the results for only half of the repaired section are shown. Bearing stress is shown as a red line and bypass strain is shown as a blue line. Each data point represents one fastener location. It is seen that the bearing stress values peak at the two locations corresponding to the end fasteners presented in the plot. A high value of the bearing stress is also found at the location corresponding to a fastener located closest to the end of the machined slot in the upper Mohawk repair piece. The remaining fasteners transfer significantly lower loads from the panel to the upper repair assembly. While the ideal bearing stress values would approach constant distribution with maximum values less than the allowable levels, a more illuminating discussion can be held by comparing the bearing stresses obtained from the best design arrived to thus far with the one considered earlier in the effort, which was not optimized. Since only one, best solution was being presented in the paper thus far, for the purpose of the subsequent discussion regarding Figure 24, this solution is referenced as 'improved' and the one considered earlier is referenced as 'baseline.' The bearing stress distributions based on the baseline and the improved designs are presented in Figure 24 where the baseline is shown in black and the improved design, repeated from Figure 23, is shown in red. The baseline design did not have the machined slots in the upper repair assembly and the pultruded rod taper in the vicinity of the simulated saw-cut damage was not introduced. Without the machined slots in the upper repair pieces, the fourth fastener from the left is seen to carry much lower load, and the overall bearing stress distribution is characterized by one extensive valley-like shape, rather than two smaller drops. The improvement of the design closer to the simulated saw-cut damage (data points on the right end of the two curves) is also attributable to a more efficient design of the pultruded rod termination. Consequently, the total load that is transferred from the damaged stringer to the upper Mohawk repair assembly is maintained while the peak bearing stress values are decreased. In order to further diminish the differences in the bearing stress level distribution, a continuously varying repair piece cross-section along the span of the repair assembly, or otherwise significantly more complex repair geometry, would be required. Finally, the bypass strain for the improved configuration, presented in Figure 23, has also a fluctuating distribution but excluding the two far right data points the fluctuations are not large. As expected, the most significant drop occurs close to the saw-cut damage since the center stringer needs to be completely unloaded before it is terminated.
