Entune Audio Head Unit Software Update (Panasonic)

Service Category Audio/Visual/Telematics

Section Navigation/Multi Info Display

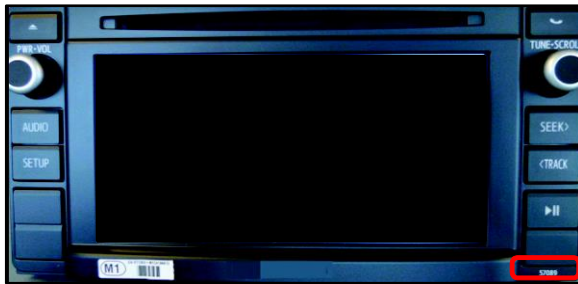
1. Confirm the audio system type by checking the faceplate ID printed on the bottom-right or bottom-center of the head unit. See Table 1 for the applicable model faceplate ID number.

Figure 1. Avalon, Avalon HV, Highlander, Highlander HV, Prius, Prius V, Sienna, Sequoia, Tacoma, and Tundra

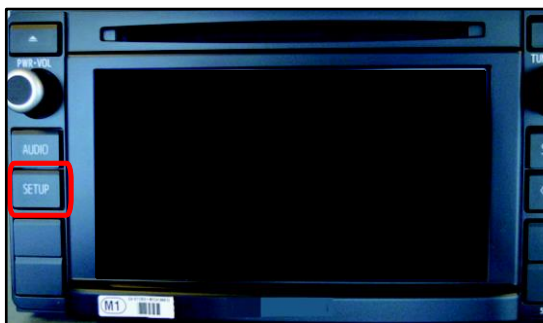
2. Start the engine.
3. Insert the USB flash drive with the downloaded multimedia update file into the vehicle's USB port.
4. Go to the Setup screen.
 - A. For Entune™ Audio: Press the Setup button on the panel.

Figure 3. Tacoma, Prius, Prius V

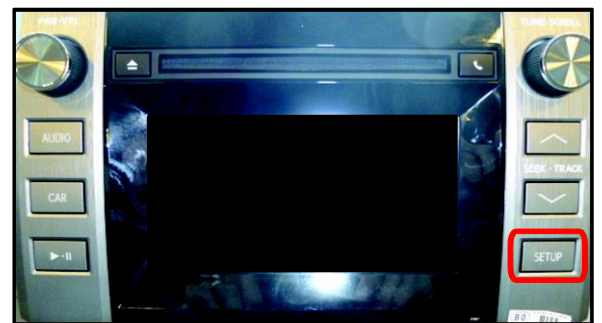
Figure 4. Tundra

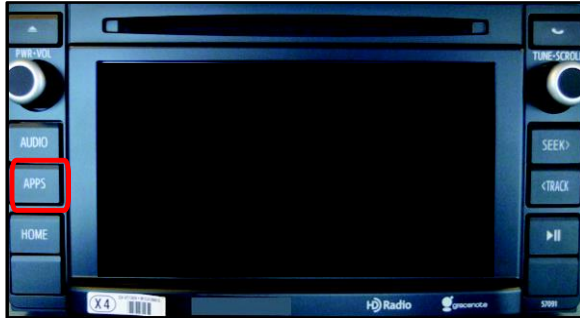
- B. For Entune™ Audio Plus and Entune™ Premium Audio: Press the Apps button on the panel.

Figure 5. 4Runner, Avalon, Avalon HV, Highlander, Highlander HV, Prius, Prius V, Sienna, Sequoia, and Tacoma

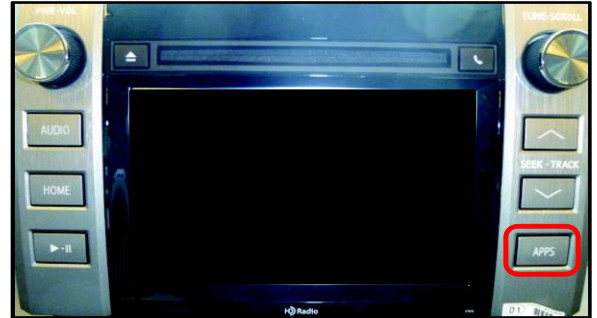
Figure 6. Tundra

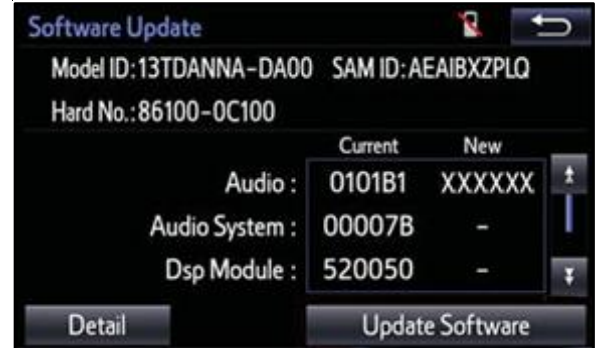
Figure 13.

- Verify that the NEW software is up to date on the Software Update screen.

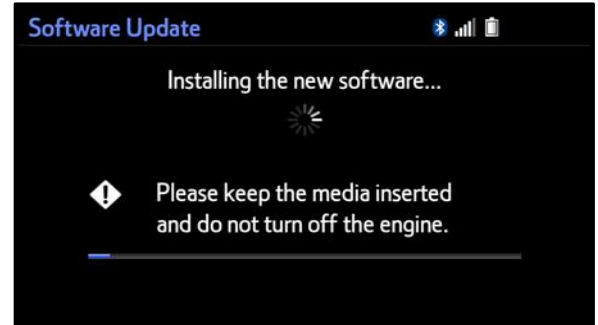
Figure 16.

12. The unit will begin installation. The update will take about 10 minutes.

- Do NOT turn off the engine or ACC before the software is ready for updating.
- Do NOT pull the USB flash drive out of the vehicle's USB port.

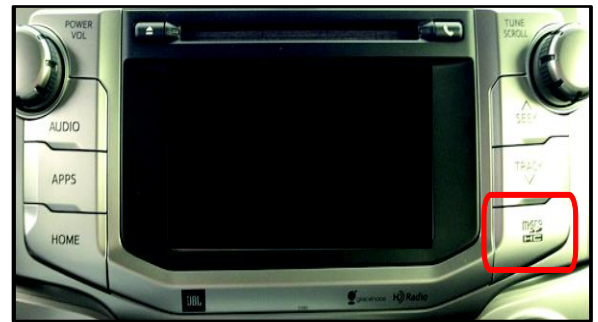
Figure 17.

- If the update fails and the error message “New software is not compatible with the system” displays, cycle the ignition OFF, remove the map micro SD card from the head unit, then repeat steps 3 – 12.
- A software update error is more likely to occur in areas with more traffic information.

Once the update is completed, reinsert the map micro SD card into the head unit, cycle the ignition OFF, then continue to step 13.

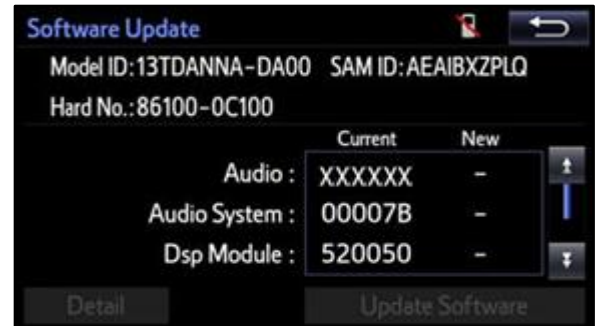
Figure 19.

1. Perform steps 3 – 7 of the Software Update Procedure to re-enter the Software Update screen.
2. Verify that the software information is updated on the Software Update screen. See Table 3 for the current software version.
