Bureau of Mines Report of Investigations/1988

# Evaluation of Refractories for Aluminum Recycling Furnaces

By E. G. Davis

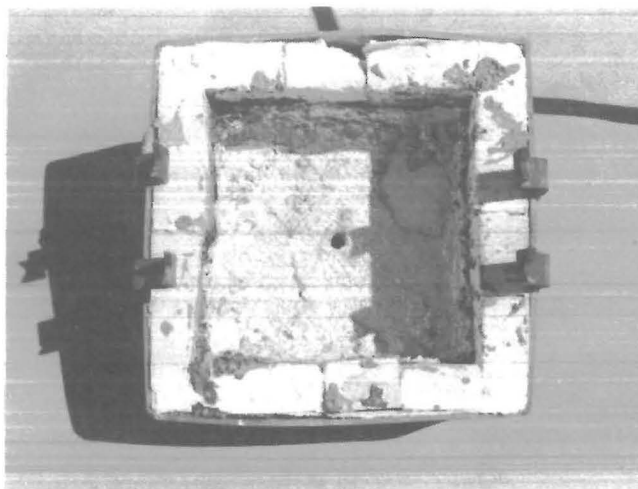
FIGURE 1.—A 12- by 12- by 9-in stainless steel shell with 16 test samples forming refractory lining.

A test apparatus was designed and constructed by the Bureau. It consisted of an electrically heated bottom loading type furnace with a 12- by 12- by 9-in stainless steel shell in which up to 16 refractory samples could be cemented in place to form a refractory-lined cavity (fig. 1). In this cavity, up to 30 lb of molten aluminum alloy was maintained at a temperature of 1,550° F. The bottom of the cavity, made of a castable refractory, had a taphole for discharging the molten metal at the end of an experimental run. The refractories used in this study were all commercially available and are listed in table 1. Some of the samples were soaked in a  $ZrOCl_2$  solution—a technique based on a Bureau patent that resulted in improved high-temperature

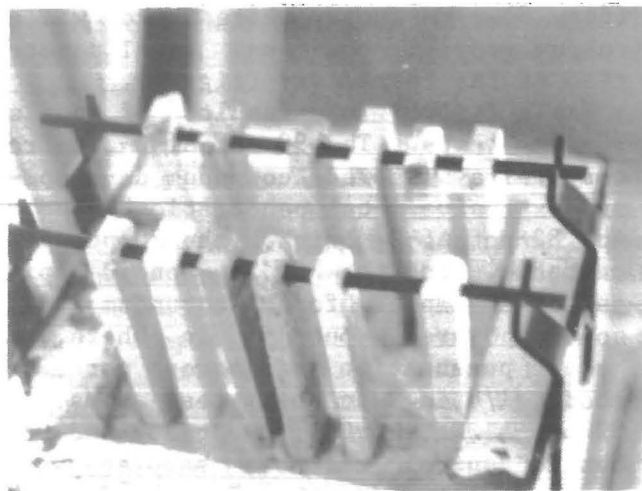
FIGURE 2.—Refractory samples suspended from steel rods.

Based on the results of the 30-day tests it appeared that a period of 14 days would be adequate to satisfactorily evaluate the samples; so 14-day tests were conducted. In these tests, samples were suspended from a steel rod spanning the molten metal (fig. 2). This arrangement allowed the samples to be exposed to molten aluminum without being in contact with each other. This eliminated the

problem observed in the 30-day tests where extensive development of corundum on a sample resulted in the corundum formation, in some cases, migrating to adjacent samples. The submerged part of the samples were exposed on all four sides to the molten aluminum.

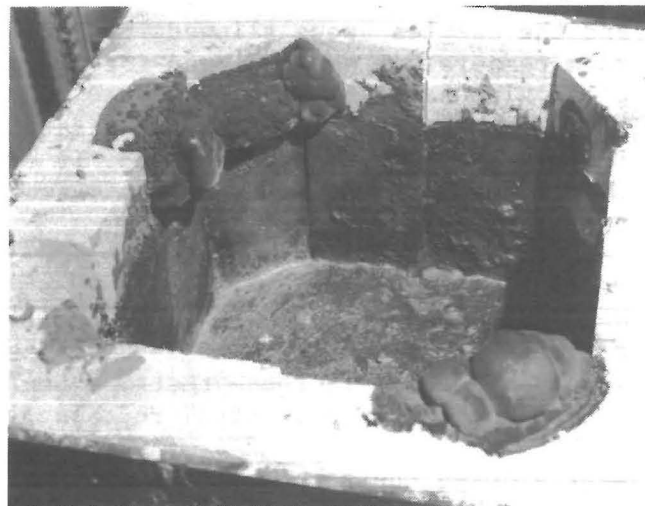
FIGURE 3.--Corundum formation on some refractory samples after 30-day exposure.

The results of the 30-day tests show that corundum develops on some of the refractories above the metal line similar to the corundum formation observed in commercial recycling aluminum furnaces (fig. 3). Further, where there was corundum growth, there was metal penetration of the refractory (fig. 4).

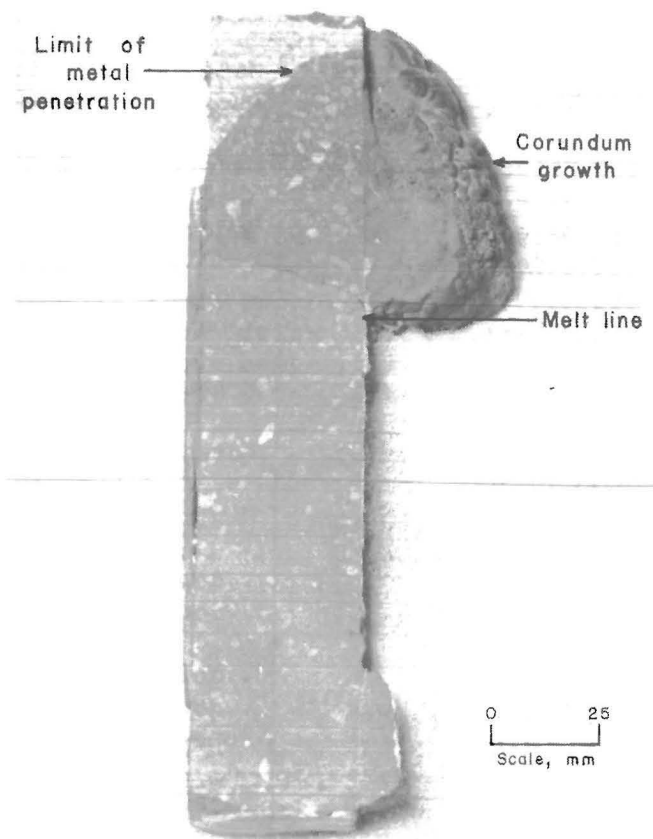
FIGURE 4.—Cross section of refractory sample showing metal penetration and corundum growth.

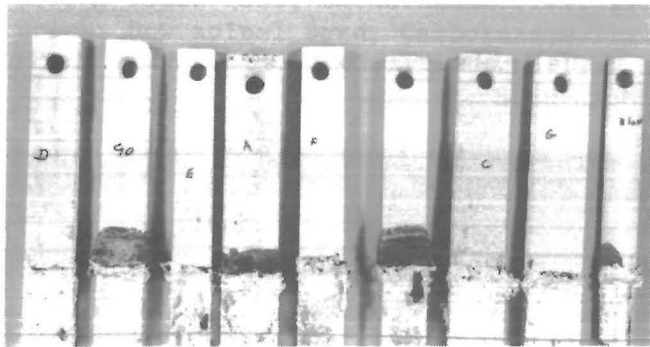
FIGURE 5.—Set of samples after exposure in 14-day test.

The 14-day test results confirmed the observations of the 30-day tests; i.e., corundum formed on some refractories and when metal penetration of the refractory occurred, corundum was formed. Table 3 shows the results of four 14-day tests where the refractories were exposed to recycled aluminum melts. Figure 5 shows

a set of samples after one of the 14-day tests. The 90- and 94-pct- $\text{Al}_2\text{O}_3$  brick samples always developed corundum and had extensive metal penetration when exposed to the alloy melts. The 99- and 70-pct  $\text{Al}_2\text{O}_3$  samples developed some corundum and showed slight metal penetration. The phosphate-bonded 70- and 82-pct- $\text{Al}_2\text{O}_3$  refractories, the zircon, and the spinel refractories all showed no corundum formation. The 70- and 90-pct- $\text{Al}_2\text{O}_3$  refractories that were treated with phosphoric acid or coated with spinel mortar and fired to  $1,000^\circ\text{F}$  showed no corundum development or metal penetration. Table 4 lists the results of exposures of refractory samples to a high-purity aluminum melt, a recycling alloy melt (0.6 to 1.0 Mg), and a high-magnesium (2.5 to 3.0 pct Mg) aluminum melt. No major differences in corundum formation or metal penetration were noted. Visual observations indicated, however, more metal penetration of samples by the high-purity aluminum melt. Also, when corundum developed on samples it appeared to develop faster when magnesium was present in the melts.

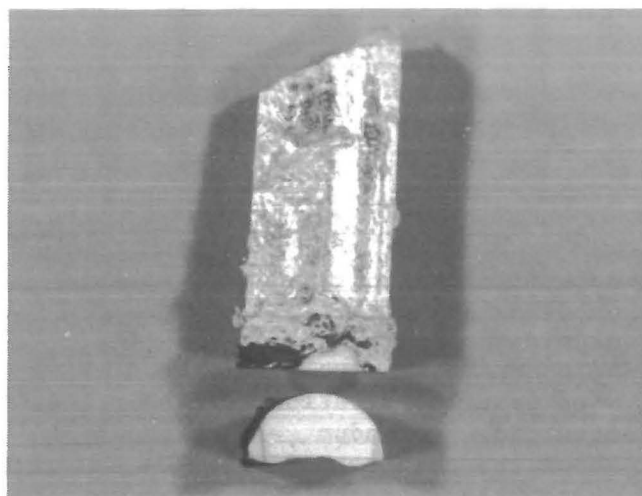
FIGURE 6.--Corundum formation on dense 99-pct-aluminum sample at location of thermal crack.

The test results suggest that the molten metal penetrates the porous refractory, migrates upward above the metal line to the refractory surface, then is exposed to an oxidizing atmosphere where corundum develops. This is dramatically demonstrated in a high-density 99-pct- $\text{Al}_2\text{O}_3$  sample where a thermal crack in the sample extended from below the metal line to above it. As shown in figure 6, corundum did form on this sample at the point where the crack exposed the molten aluminum to the furnace atmosphere. The presence of magnesium in the recycled

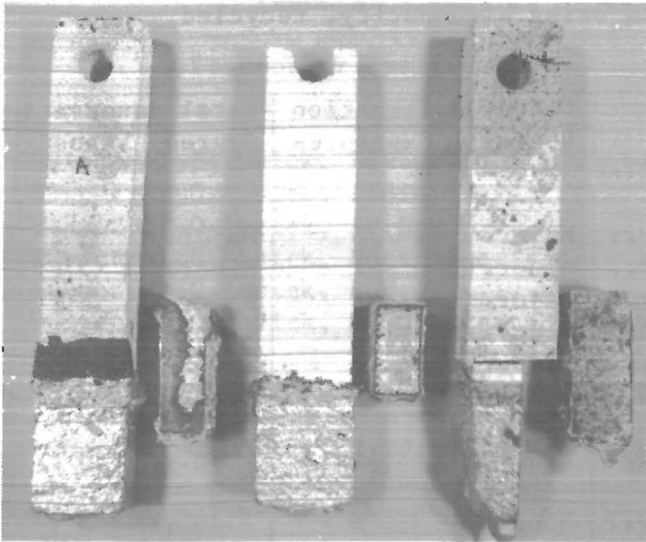
FIGURE 7.—Samples and cross sections of samples showing, from left to right, untreated, phosphoric acid treated, and spinel mortar coated 70-pct- $\text{Al}_2\text{O}_3$  refractory.

Corundum did not develop on the phosphate-bonded alumina or spinel refractories. This was also the case when the 70- and 90-pct-Al<sub>2</sub>O<sub>3</sub> refractories were treated with a phosphoric acid solution or coated with a thin layer of spinel mortar (figs. 7-8). This may be due to

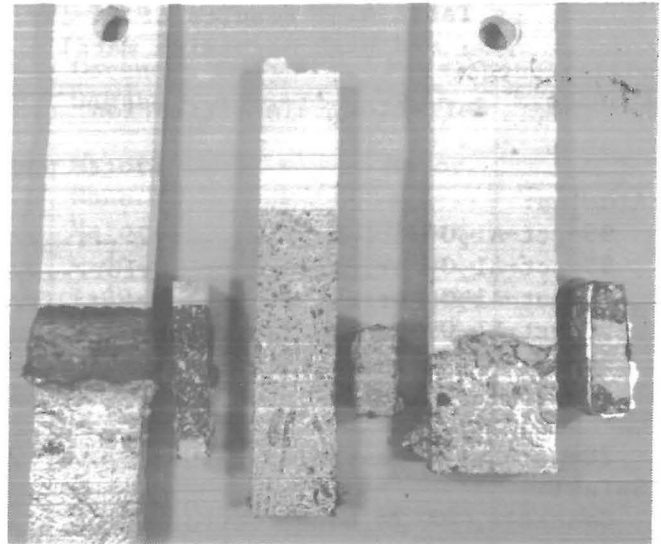
FIGURE 8.—Samples and cross sections of samples showing, from left to right, untreated, phosphoric acid treated, and spinel mortar coated 90-pct- $\text{Al}_2\text{O}_3$  refractory.
