FAÇADE CONDITIONS

An Illustrated Glossary
of Visual Symptoms

Edited by Dan Eschenasy, PE
Chief Structural Engineer
NYC Department of Buildings

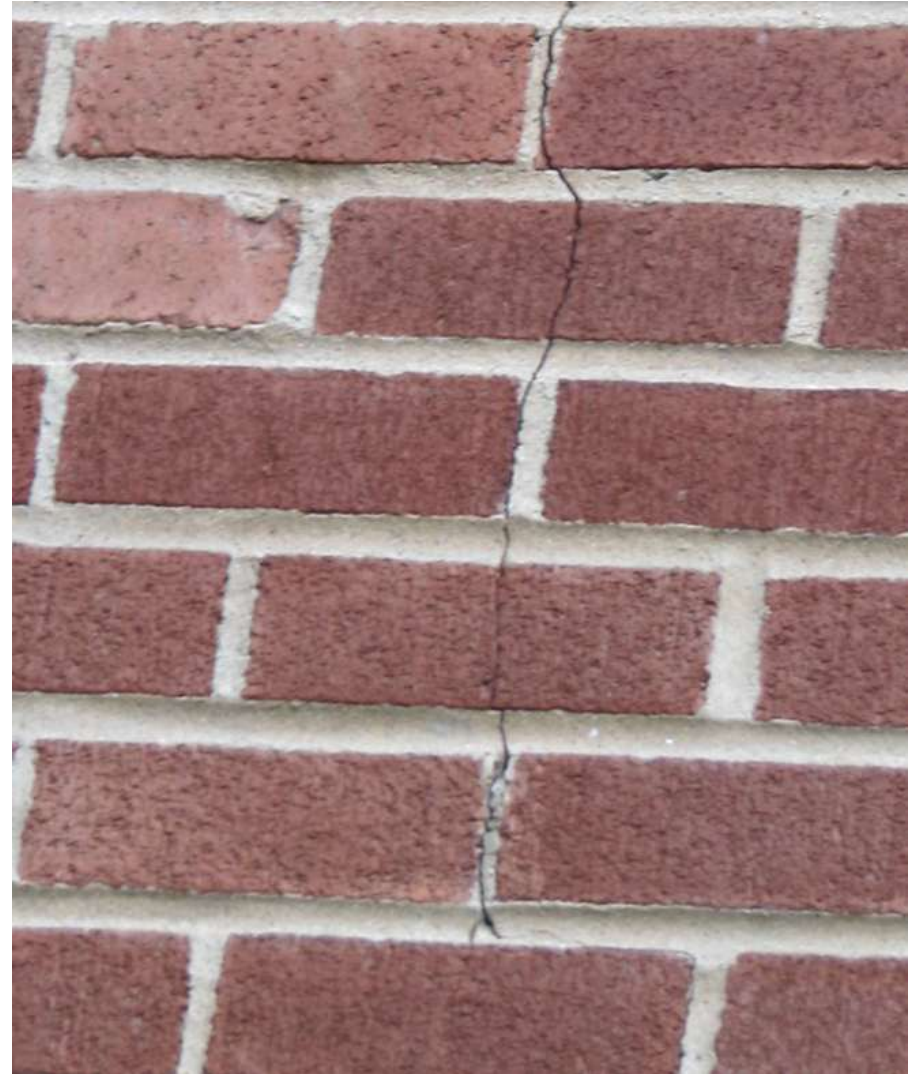
3.1.25.b Slight Vertical Crack in Masonry

Cracks are always the result of stresses in masonry that exceed resistance of brick or mortar or both. See various type of wall construction for specifics.

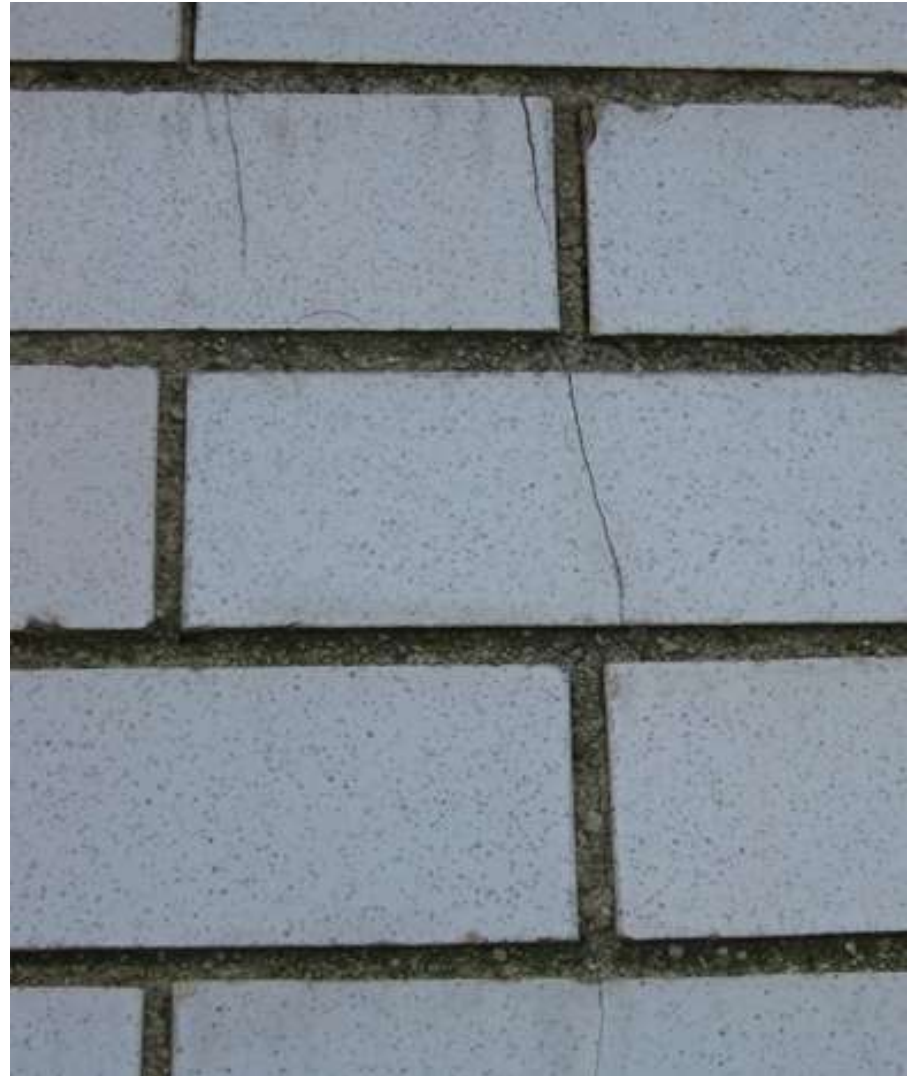
3.1.26.a Longitudinal Crack – Joint Only

The bond between the unit and the mortar is usually the weakest component of brick masonry. Horizontal cracking or debonding is usually the result of failure under tensile stresses.

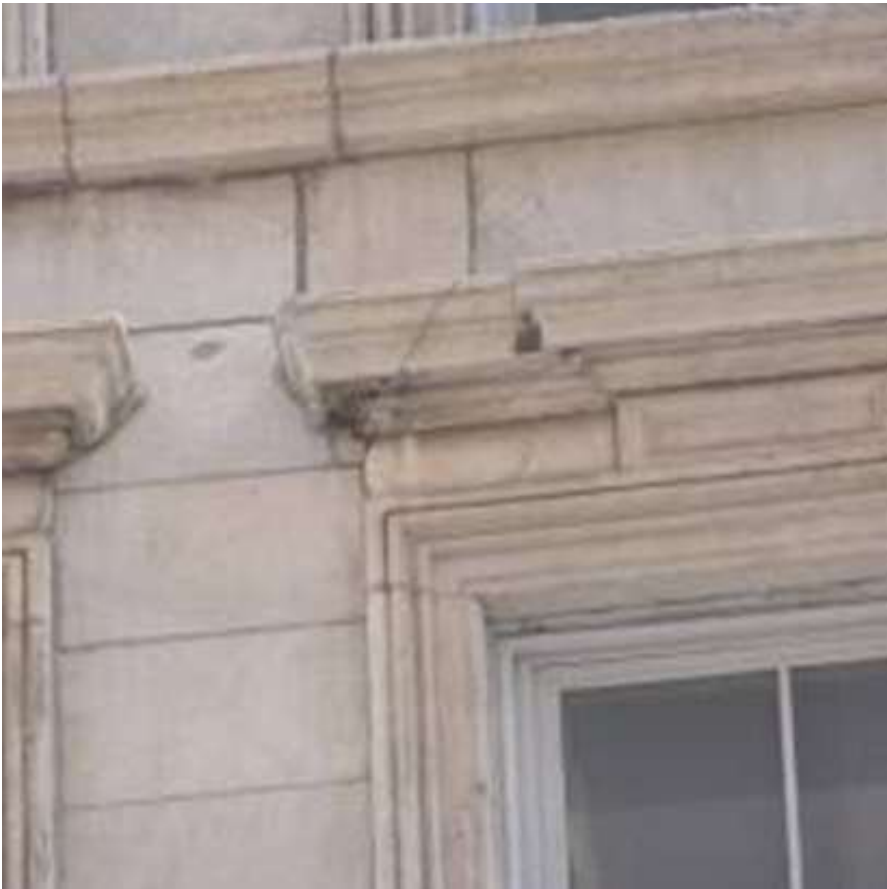
Limestone

3.4.1.a Crack in Various Types of Stone

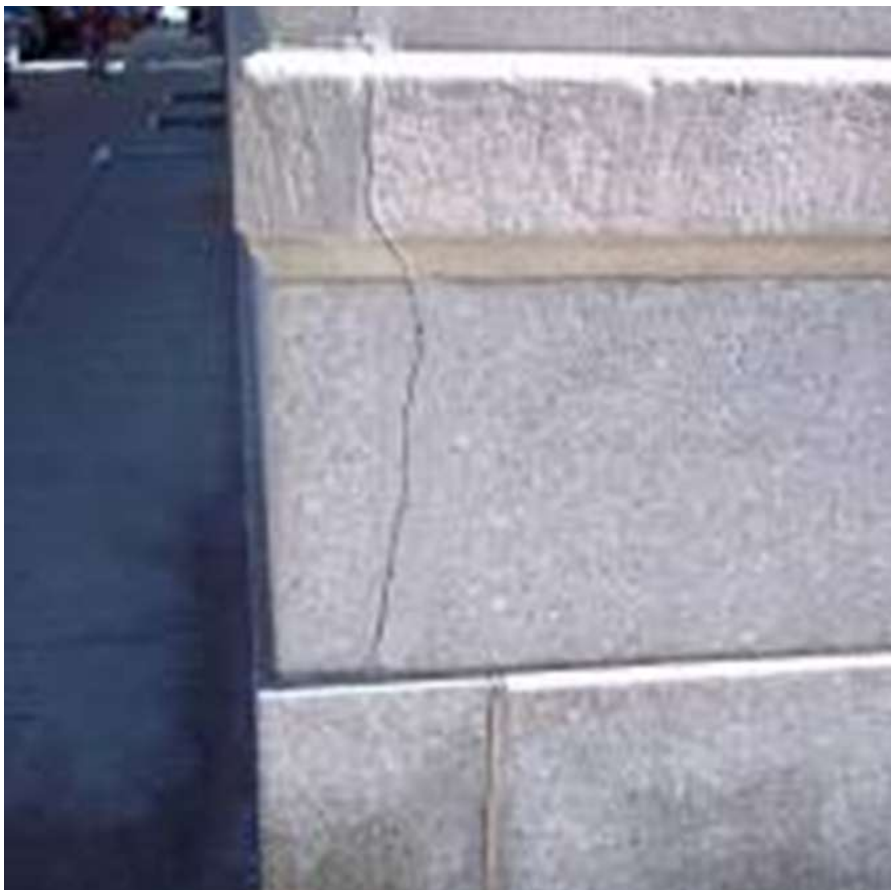
Granite

3.4.1.a Crack in Various Types of Stone

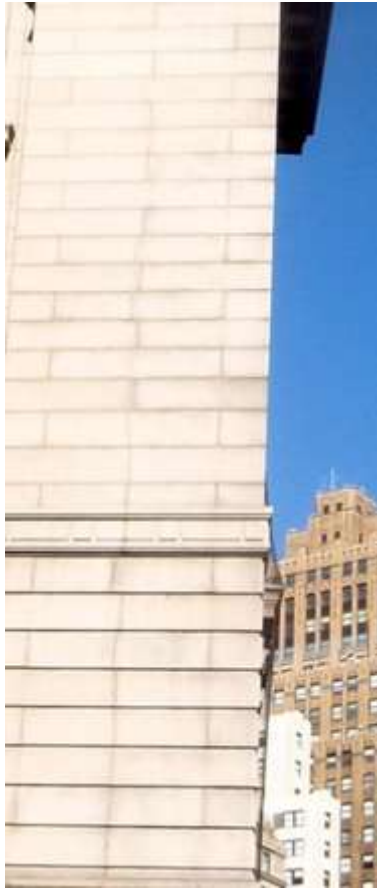
Vertical Crack

3.4.1.b Crack By Directionality

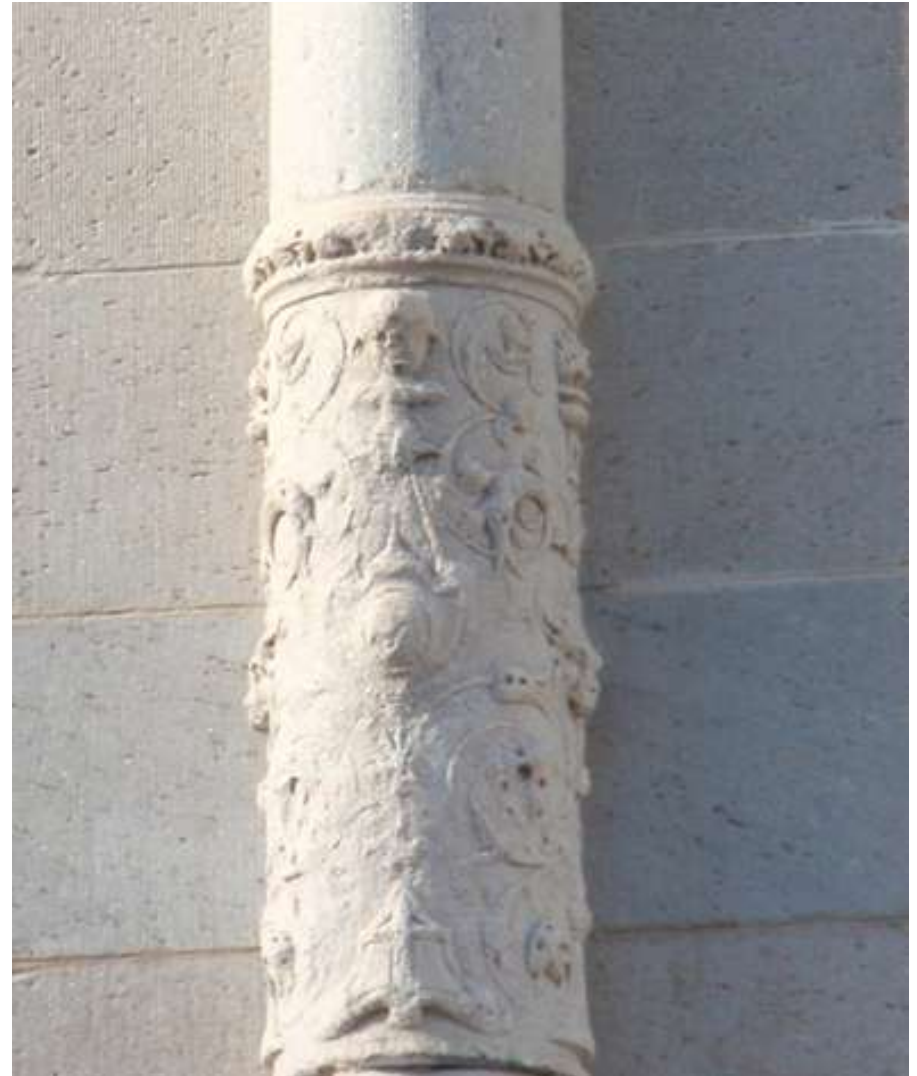
3.4.7 Erosion of Stone

Slow wearing away of stone surface and edges. Especially noticeable around decorative sculptures or carvings.

Long term action of wind and rain.

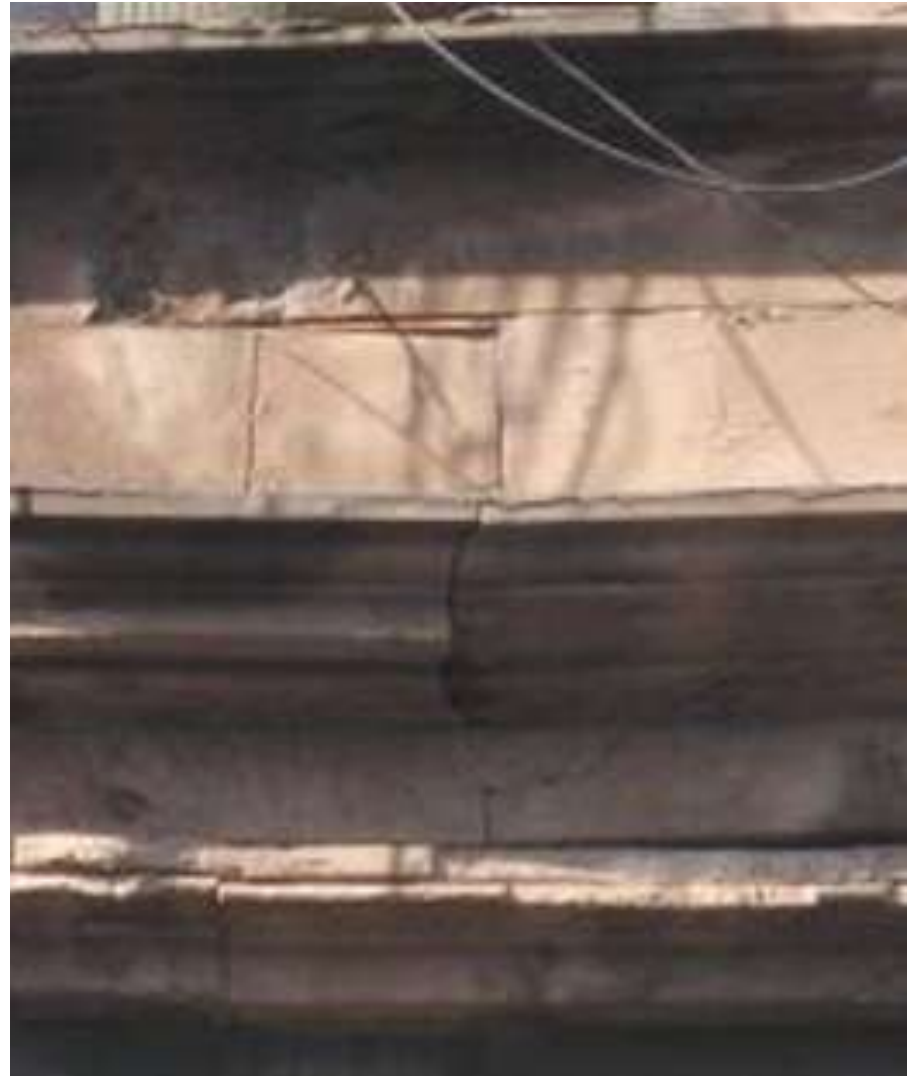
3.5.4 Sagging Brownstone Lintel

Separation of stones, deterioration or opening of joints between stone pieces.
Deterioration of entire stone assemblage.

Improper original setting of brownstone.
Deterioration of brownstone attachment to support. Deteriorating stones and joints allow water access and subsequent corrosion of the supporting steel.

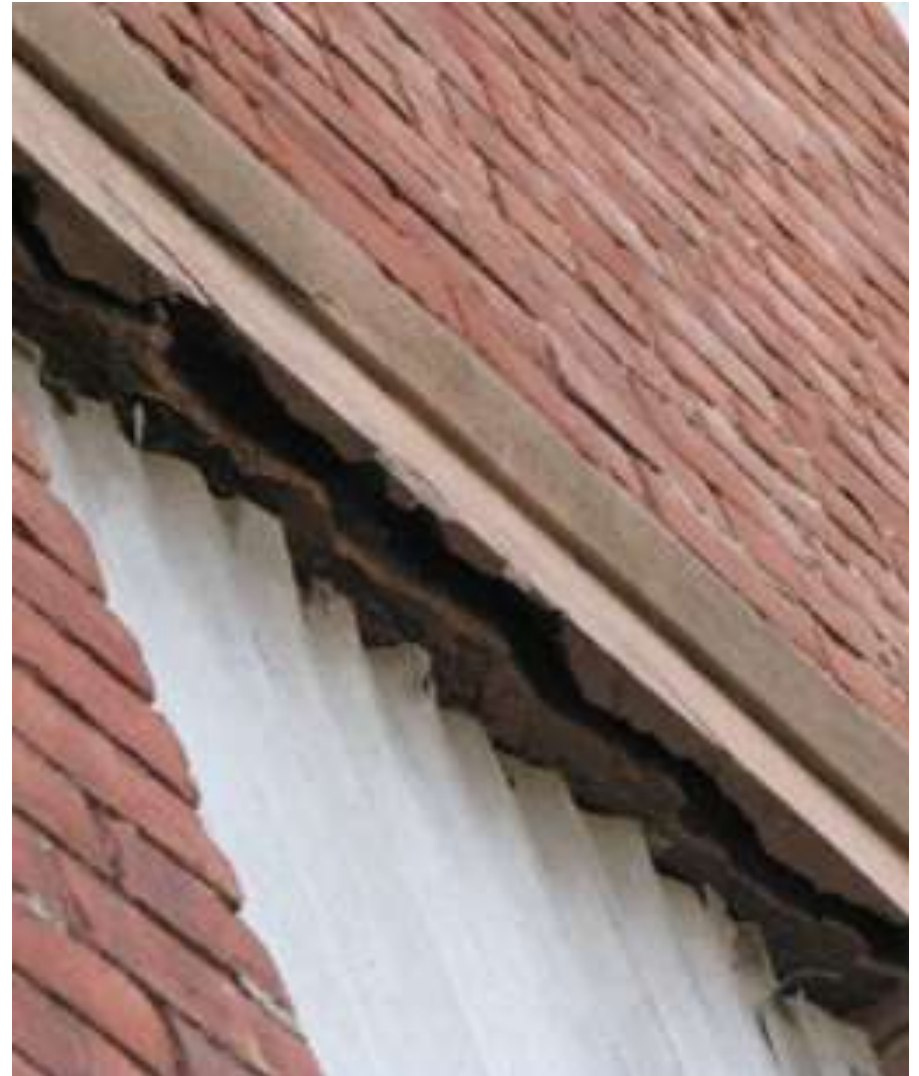
4.2.7 Crack at Underside of Stone Lintel

Condition of decorative stone/concrete covering steel lintel. Observe from below.

Rust jacking allowed by insufficient or missing corrosion protection. Differential deformation lintel and stone covering.

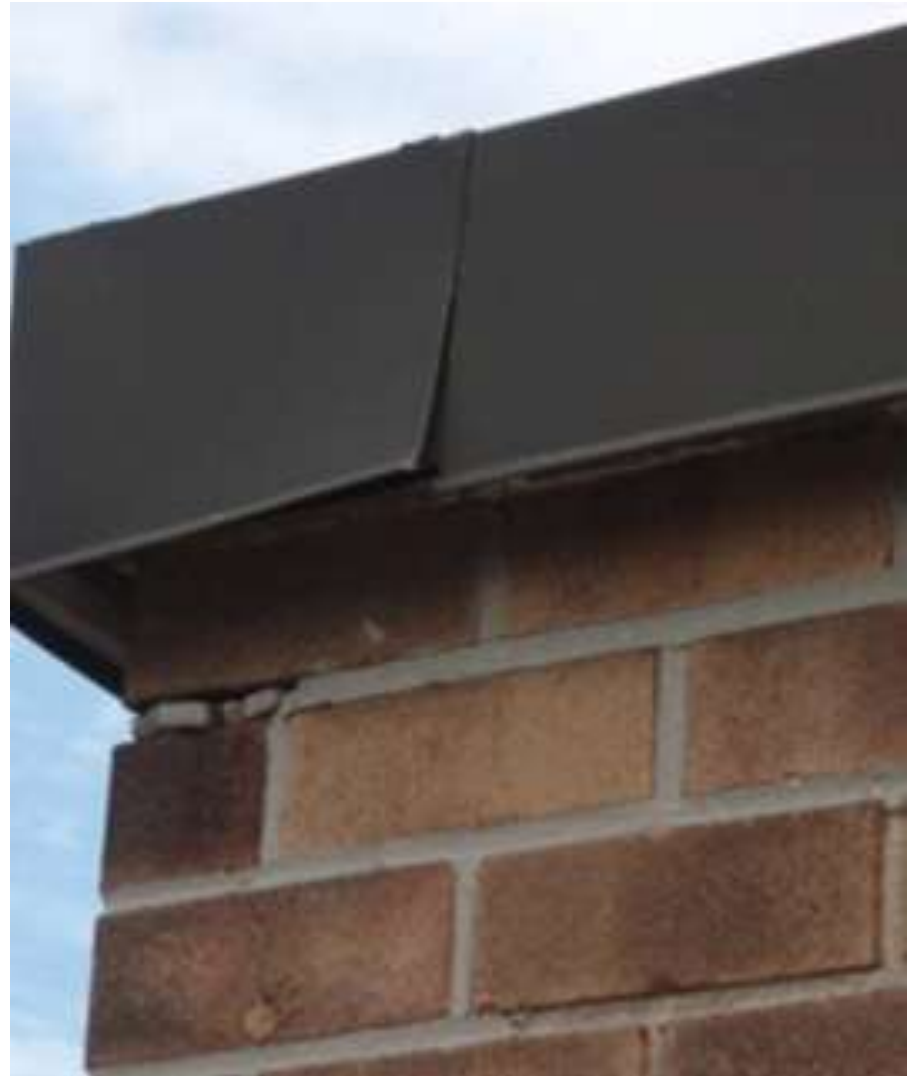
4.3.4 Deformation of Metal Coping

Condition of metal coping, alignment of metal coping.

Deterioration of cleats, fasteners. Poor original quality.

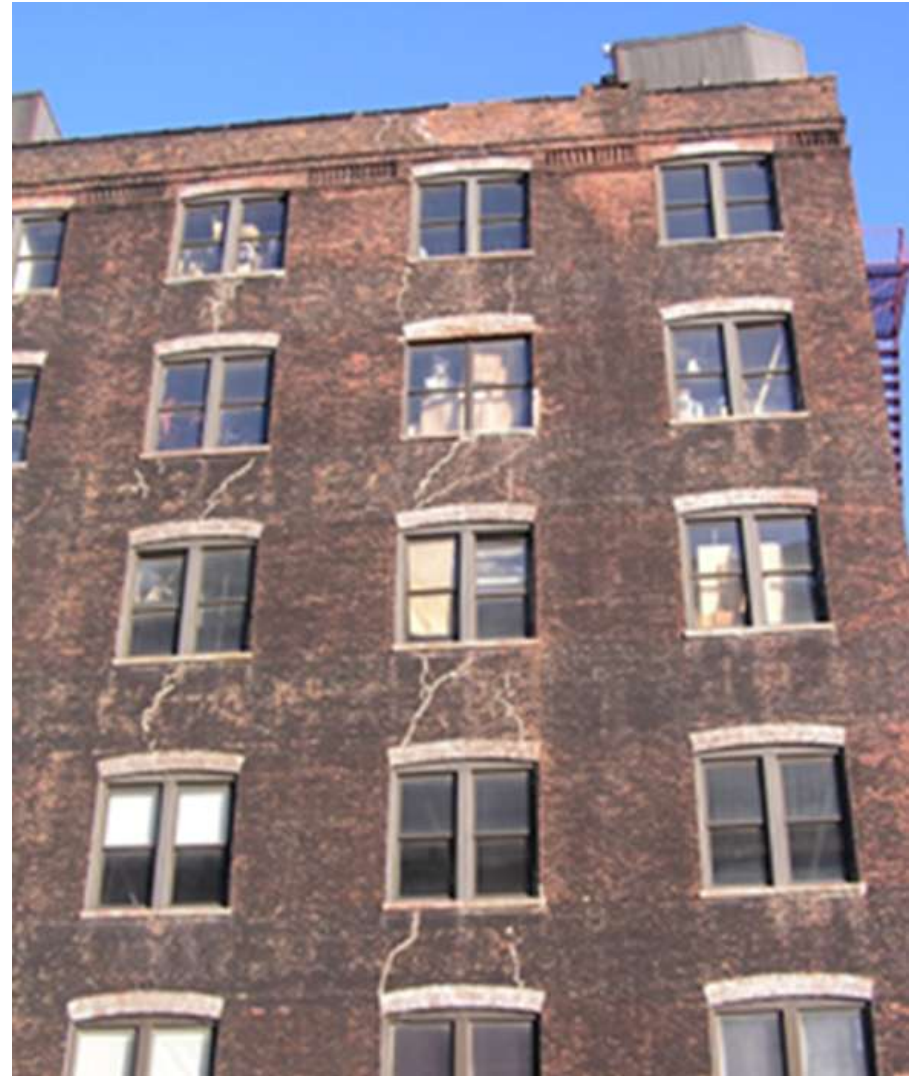
5.1.1 Façade Bowing Inwards (or Outwards)

Requires structural engineering analysis.

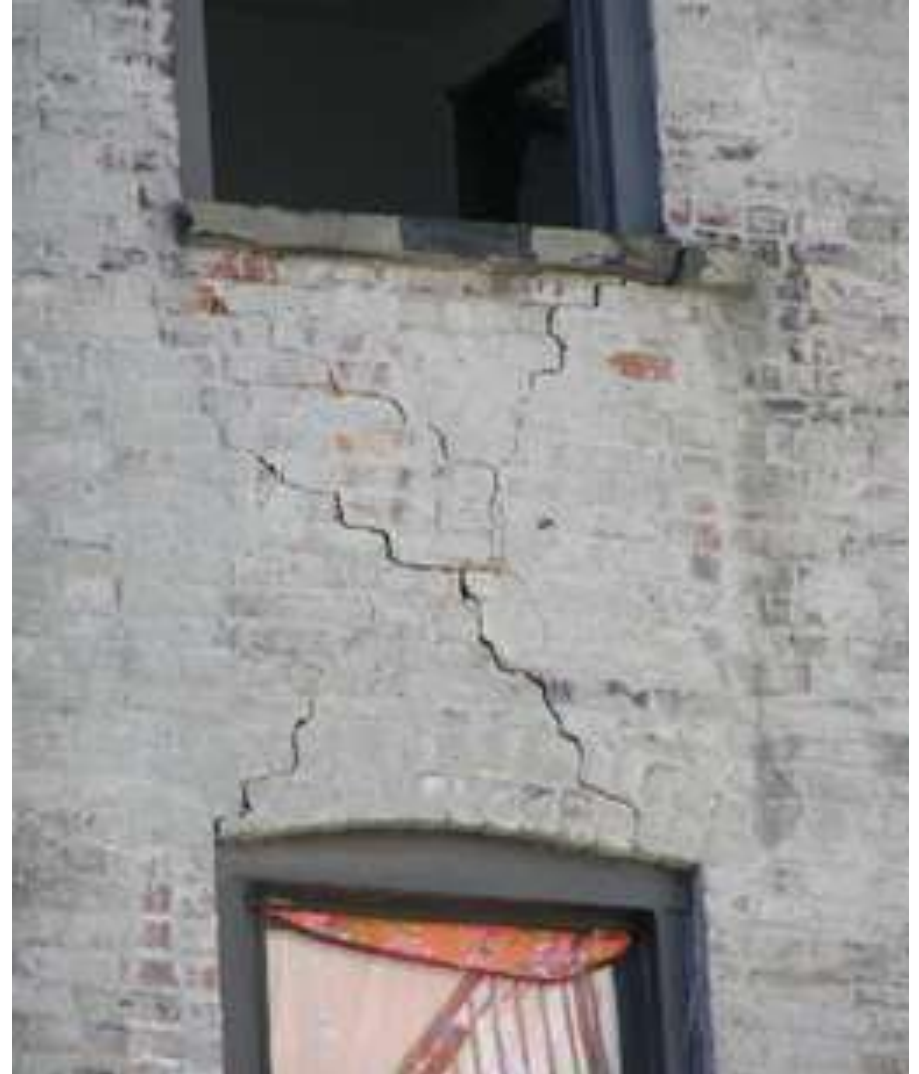
5.1.6 Inverted “V” Crack at Lintels

Inverted V shaped stepped cracks. More commonly originating at lintel.

Deflection of lintel. Crack forms along the lines of the *relieving masonry arch*
Condition might have appeared soon after erection. Differential settlement under load (spandrel/pilaster)

Presence, condition of steel lintel needs to be investigated.

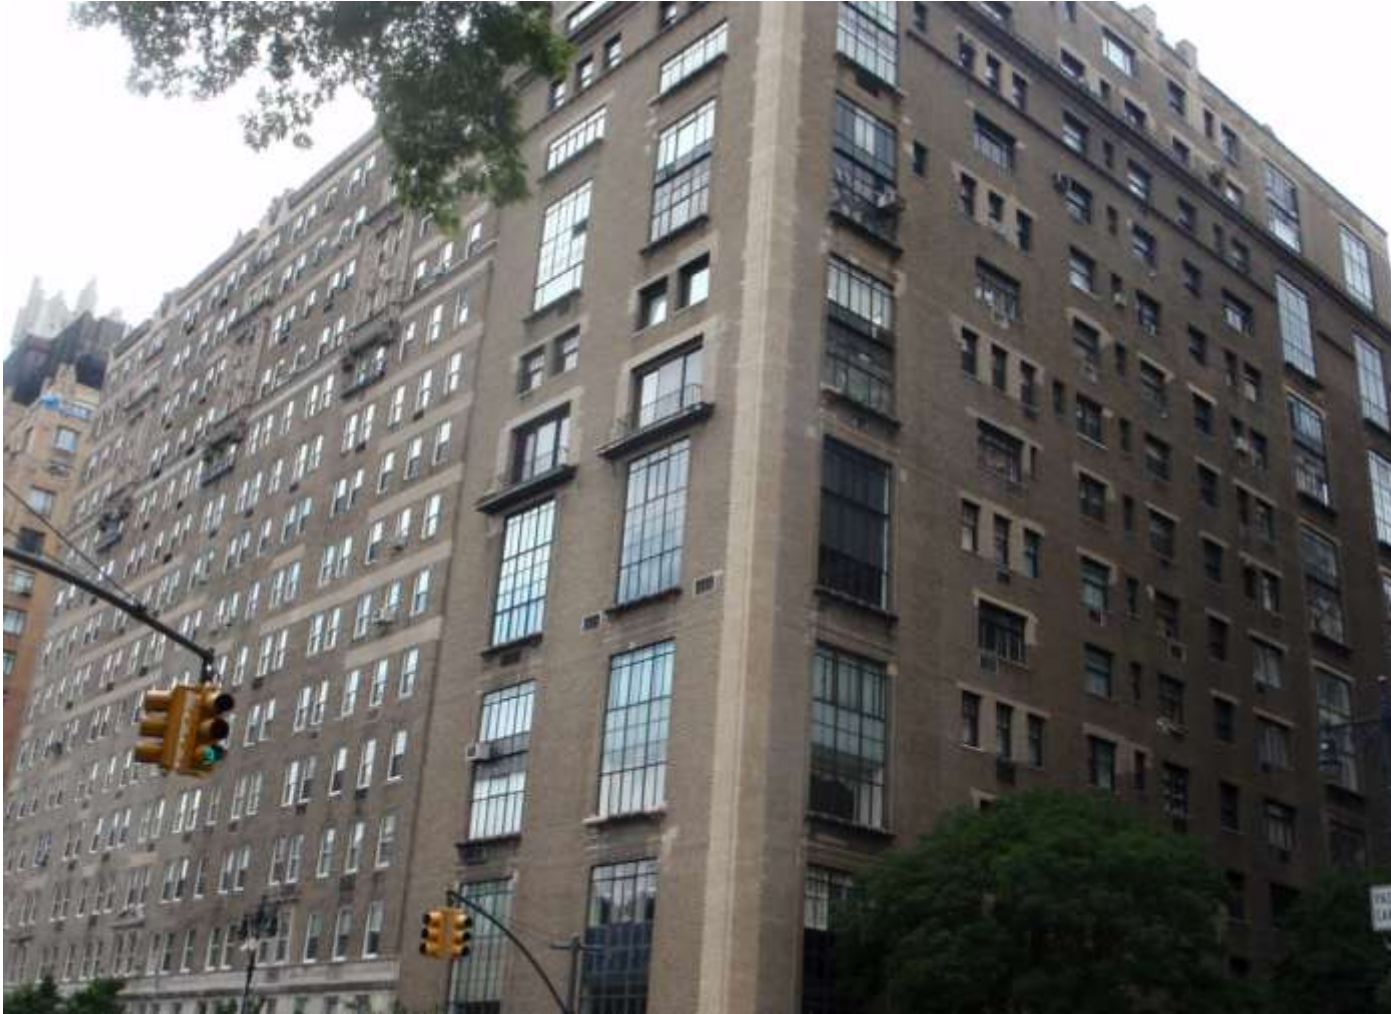
Transitional Masonry Facades

In transitional facade systems, the masonry infills the space between the skeleton elements. Masonry might also have a shear wall.

As it is surrounded by masonry, the structural framing system blocks the vertical or horizontal expansion of façade material. Water is not flushed out of façade

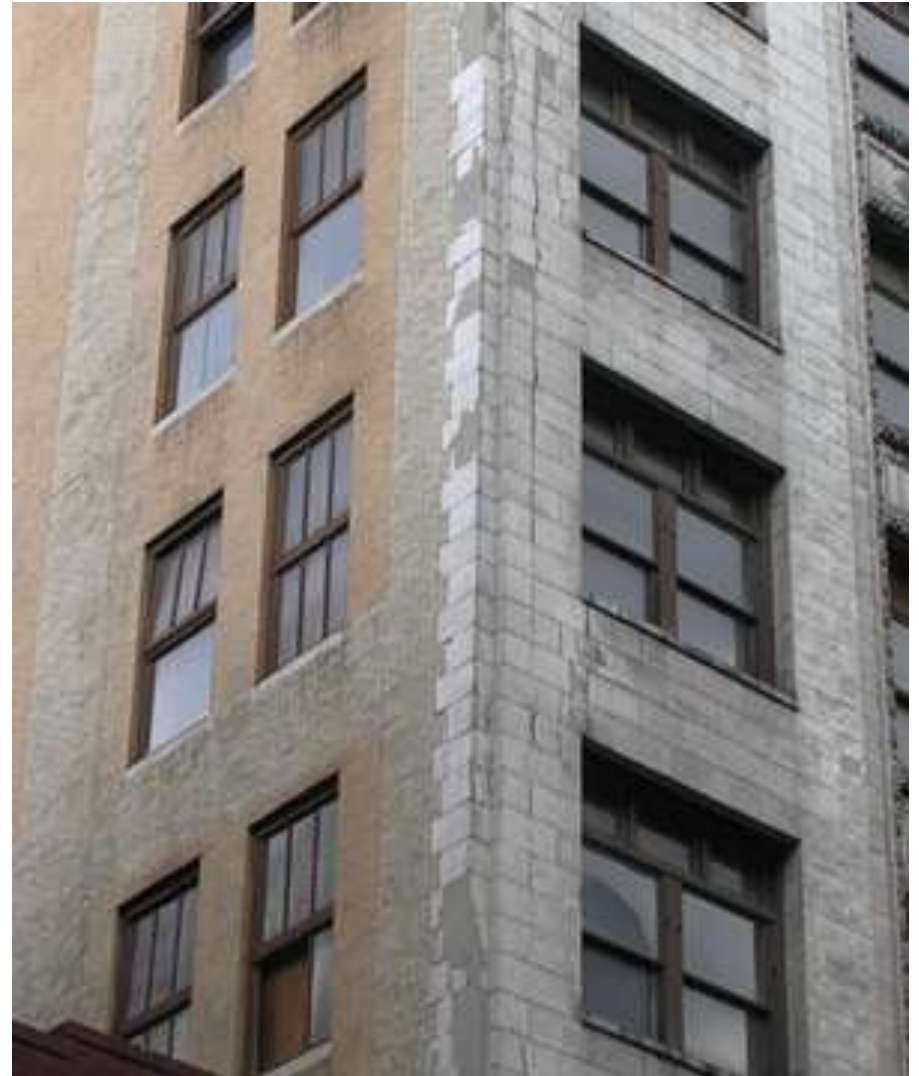
Collapse of Brick at Improper Corner Repair

Repair included cutting vertical joints on both sides of the corner. Masonry in transitional facades was not anchored to columns. Losing attachment as a result of the repair, some bricks fell.

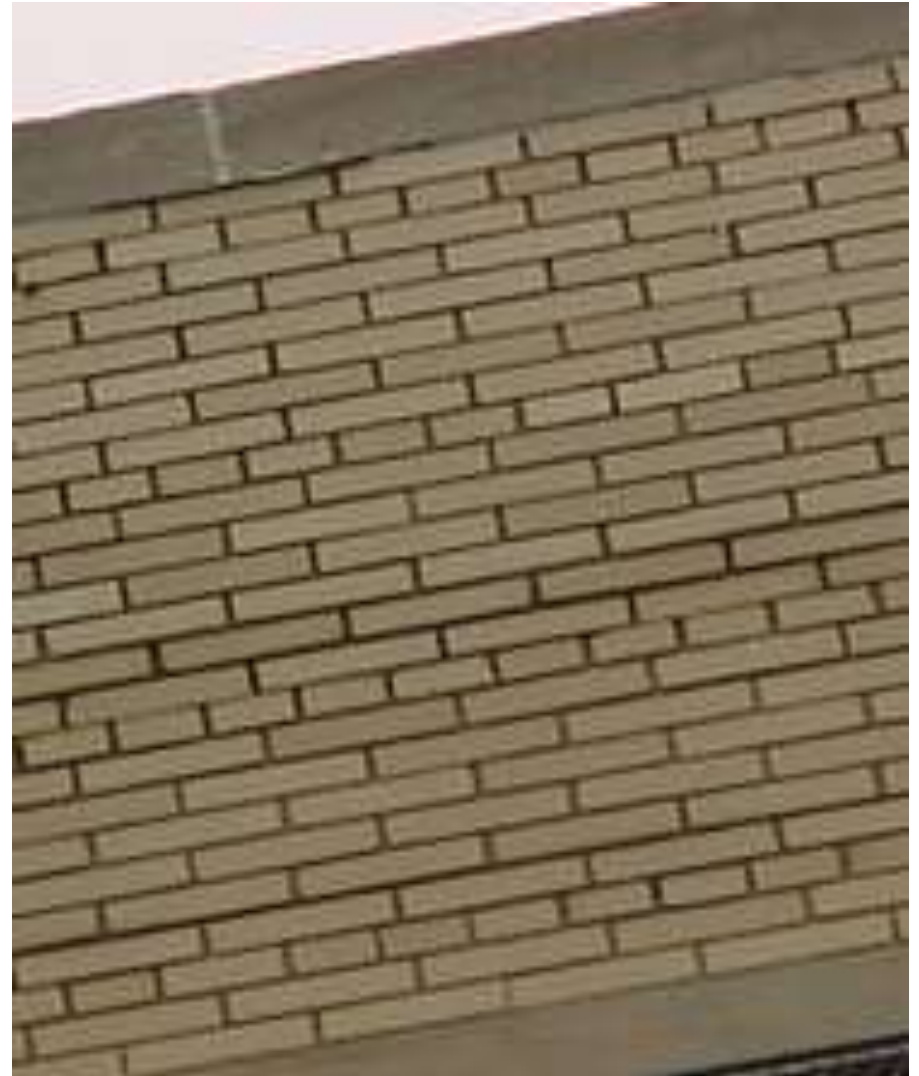
5.2.3 Crack At Parapet Along Spandrel Beam

Position of crack relative to the structural supporting elements, verticality of parapet. Alignment of parapet. Separation of parapet from masonry below. Condition of back-up masonry.

Probable Causes/Deficiencies: Corrosion of supporting steel, thermal movement of parapet, creep and deflection of parapet under wind loads, possible water penetration due to failed roof flashings.

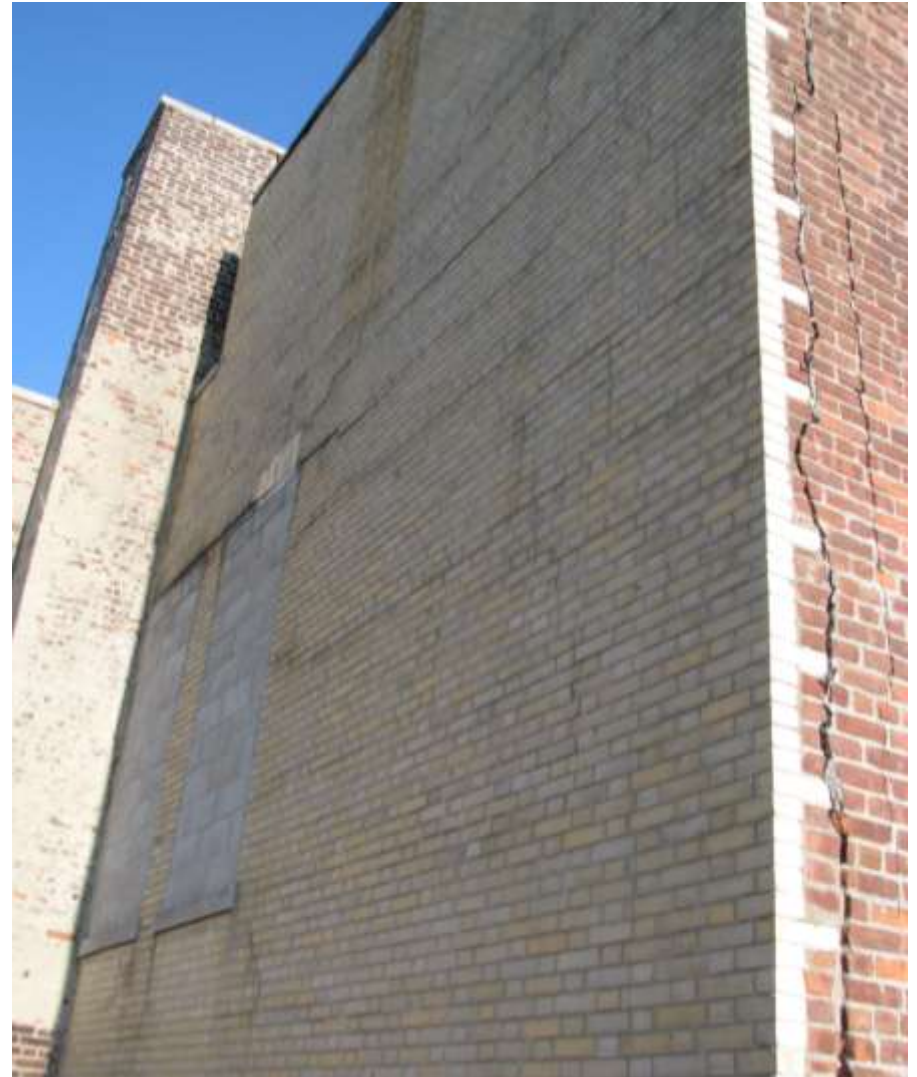
5.2.7 Bulge and Crack at Face Masonry

Out of plane displacement of face brick.
Swelling of masonry. Location of bulge in relation to structural steel.
Presence of cracks.

Corrosion of steel spandrels. Shearing of brick headers at steel support. Freezing of water trapped (ice buildup) in the crack space.

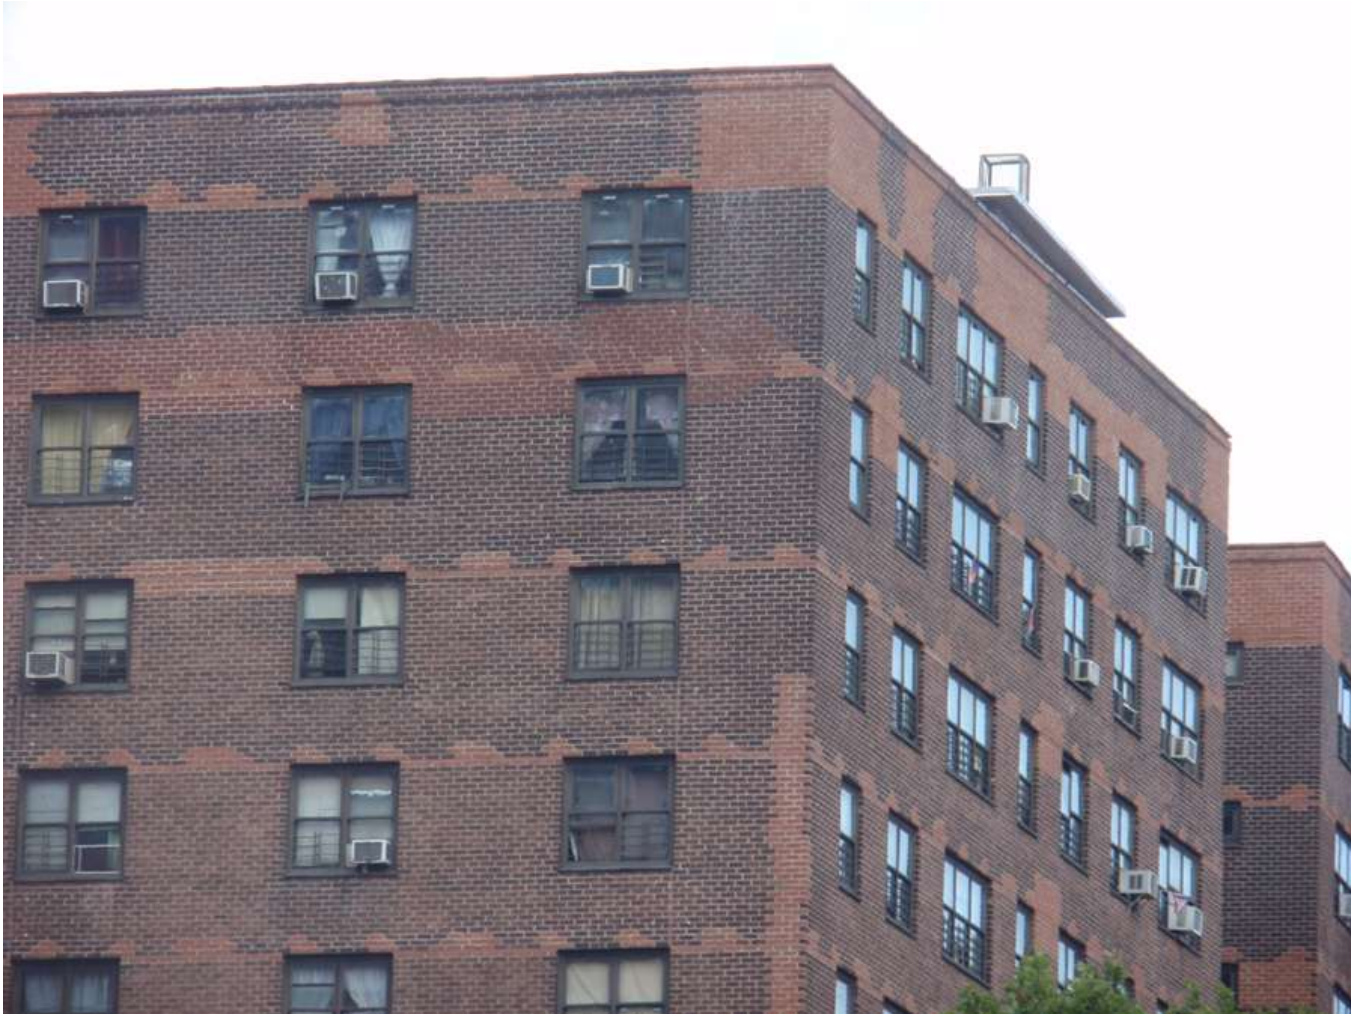
Characteristics Veneer Cavity Walls

- Exterior Brick Veneer
- Back up system usually concrete masonry units.
- Metal ties from the back-up wall to the brick veneer.
- Lintels or shelf angles that provide vertical support.
- Flashings, weeps,
- Soft Joint - The joint immediately below a gravity support.
- Expansion Joint - a joint in the veneer designed to accommodate movement in the veneer.
- G-locks - metal components typically cast into reinforced concrete frame to provide gravity (G) hold for shelf angle anchor.
- Functioning drainage system

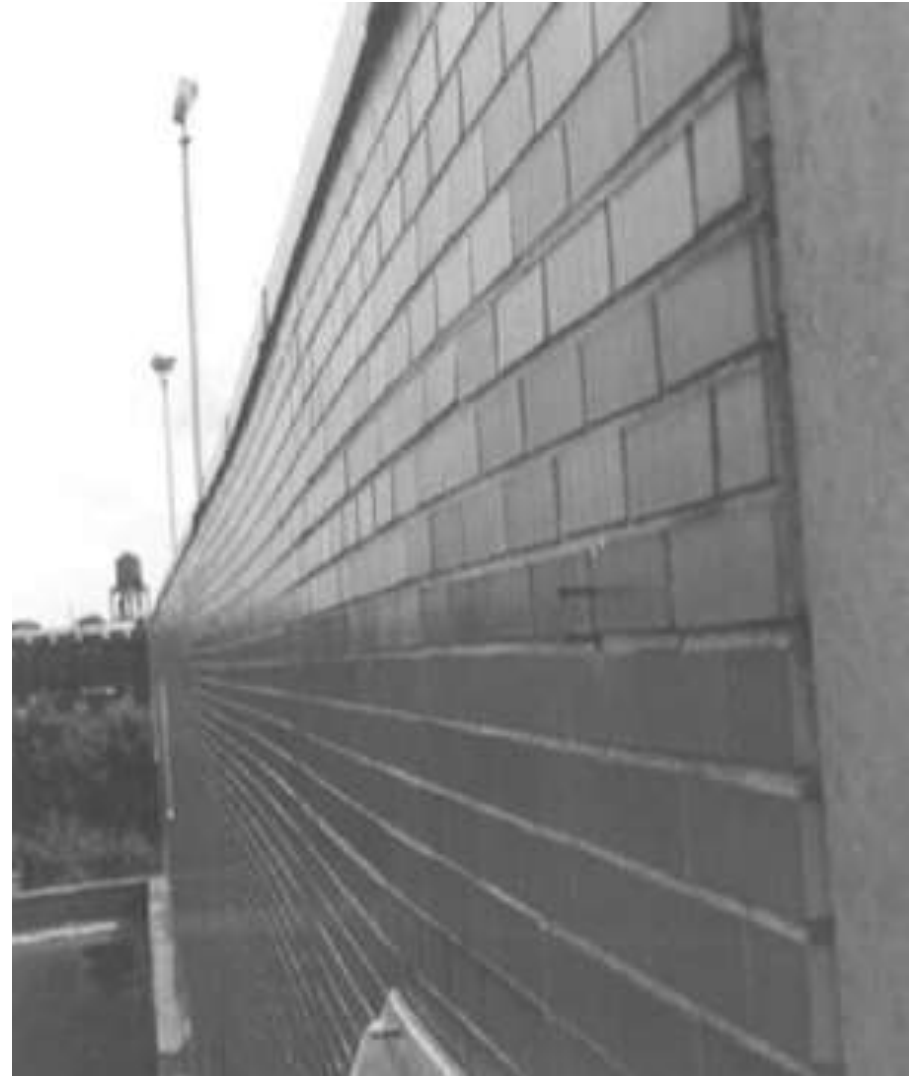
5.3.8 Vertical Cracks in Veneer at Corner

Horizontal expansion in the plane of the veneer is not accommodated at the vertical control/expansion joints. Joint dimension is insufficient. Lack or improper placement of joints.

The thermal expansion develops forces that crack the brick veneer.

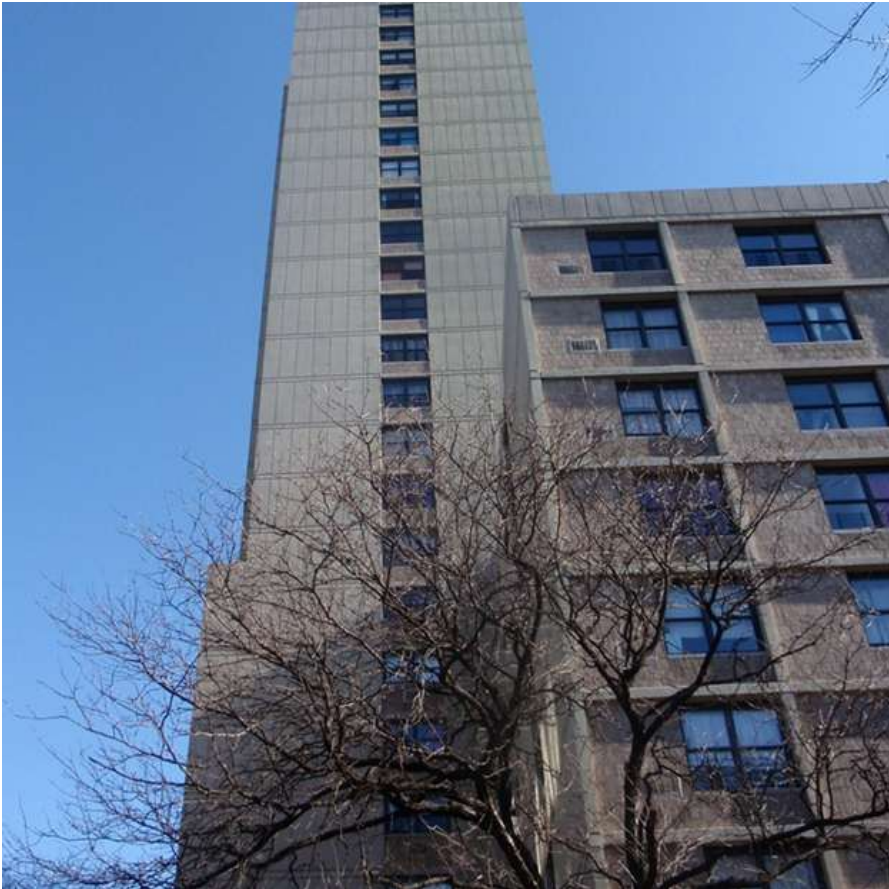
Precast panels

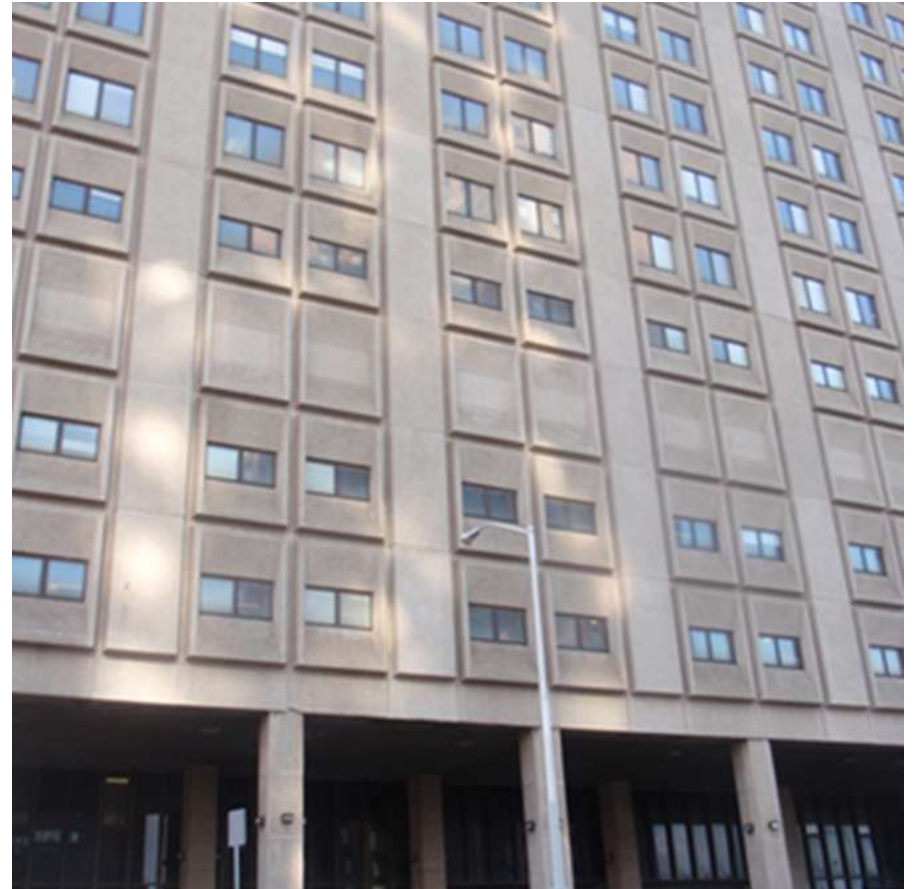
5.4.1 Delaminating of Concrete Facade

Delamination or spall of concrete at exterior of building.

Corrosion of reinforcing due to insufficient cover or significant air pollution.

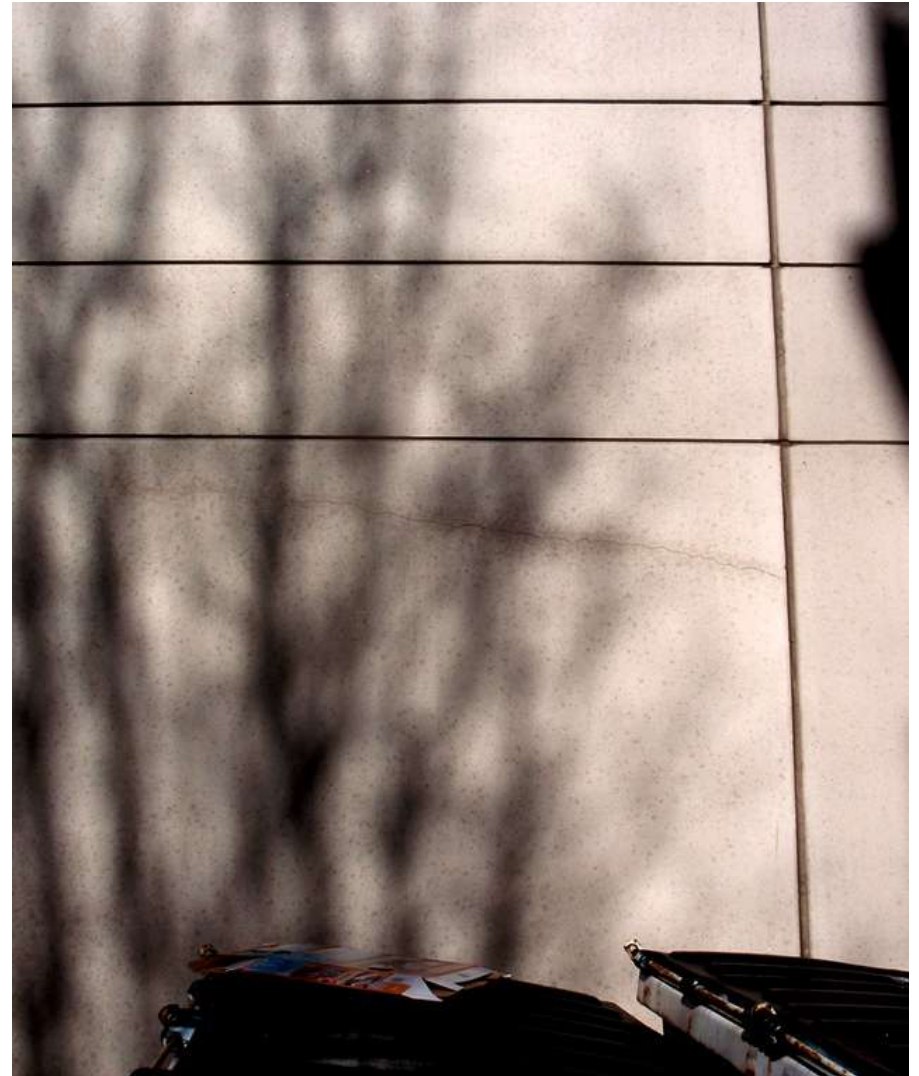
5.4.4 Surface Spalling of Precast Concrete Panel

Surface spalling; Stone displacement;
Evidence of an applied coating.

Use of non-breathable coating.

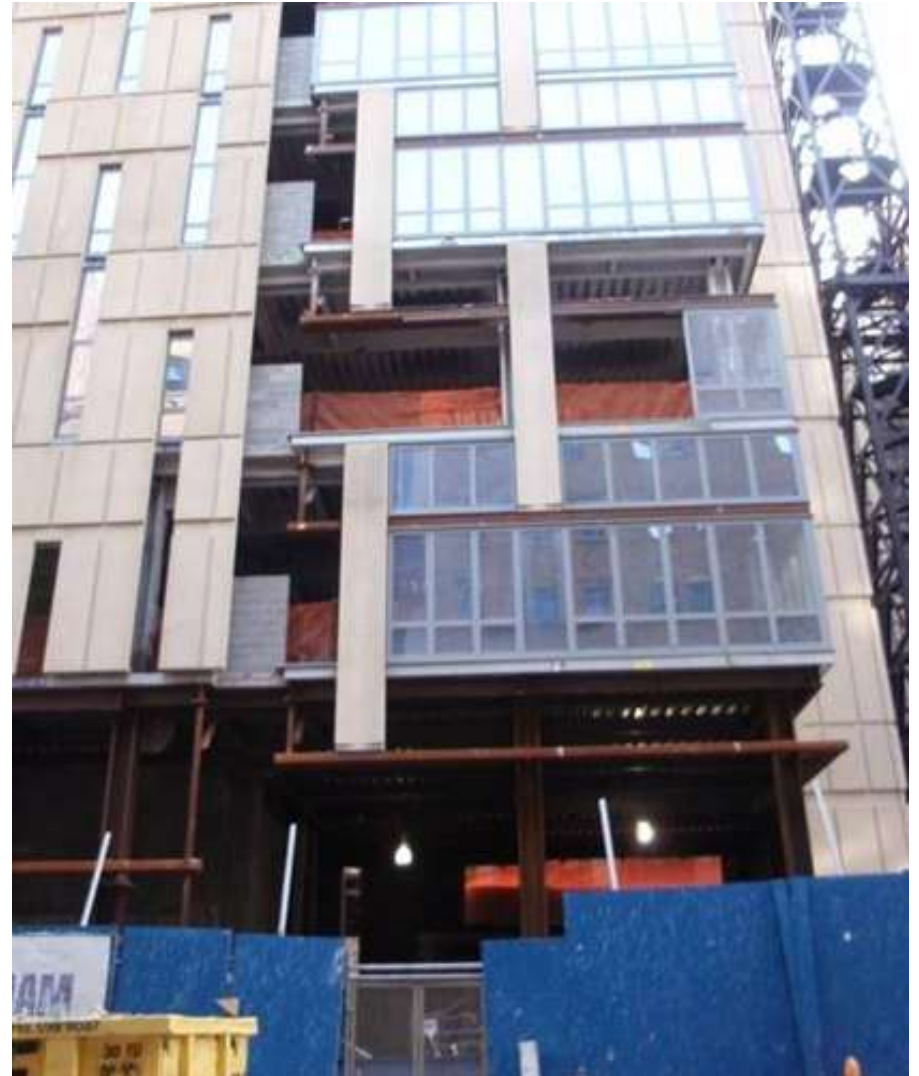
Unit System

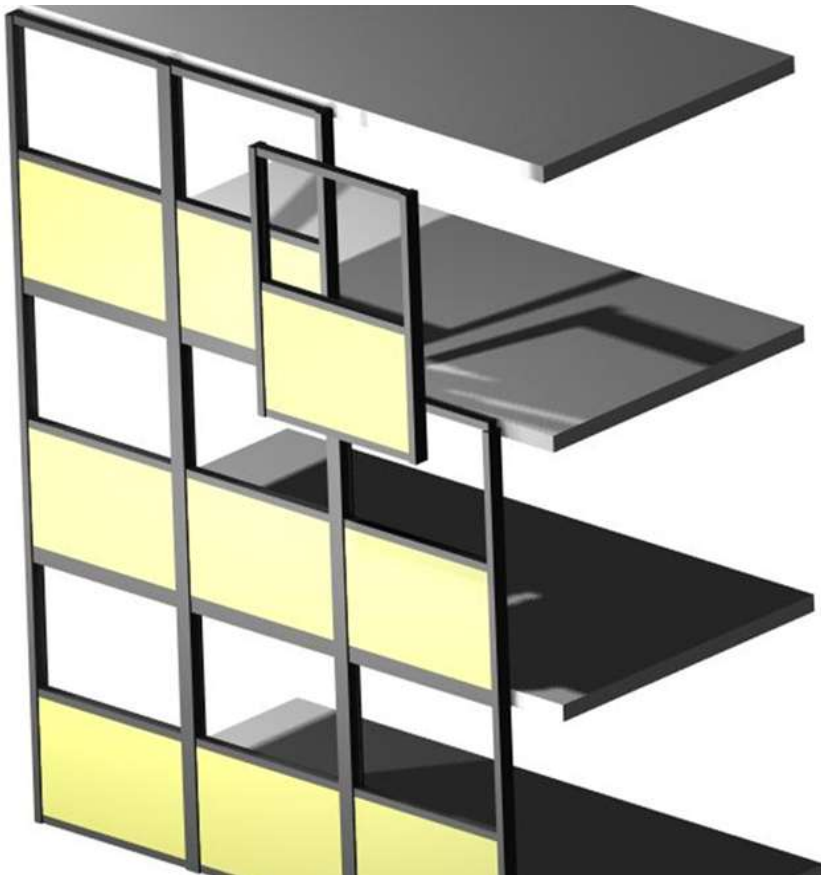
Stick System

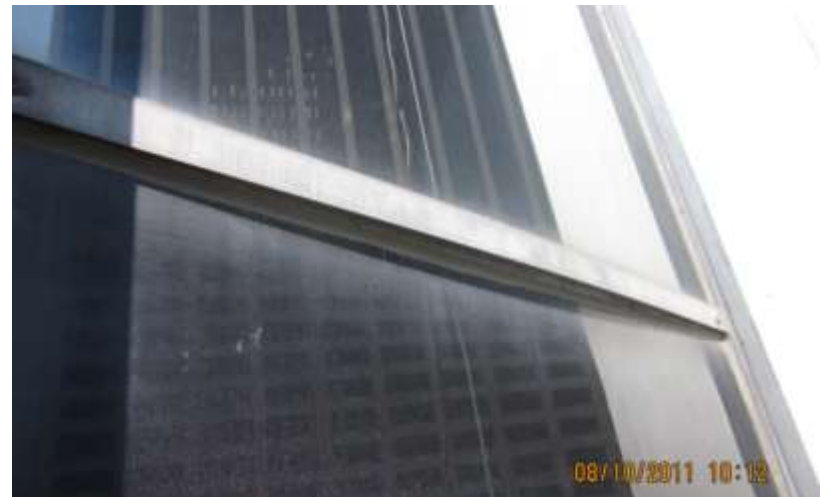
6.1.3 Snap-on Trim Back Out

Obvious signs of movement. Condition of hardware elements. Loose snap-on caps of metal curtain Wall Elements

Building element separation, original design failure, metal fatigue.
