FAÇADE CONDITIONS

An Illustrated Glossary
of Visual Symptoms

Edited by Dan Eschenasy, PE
Chief Structural Engineer
NYC Department of Buildings

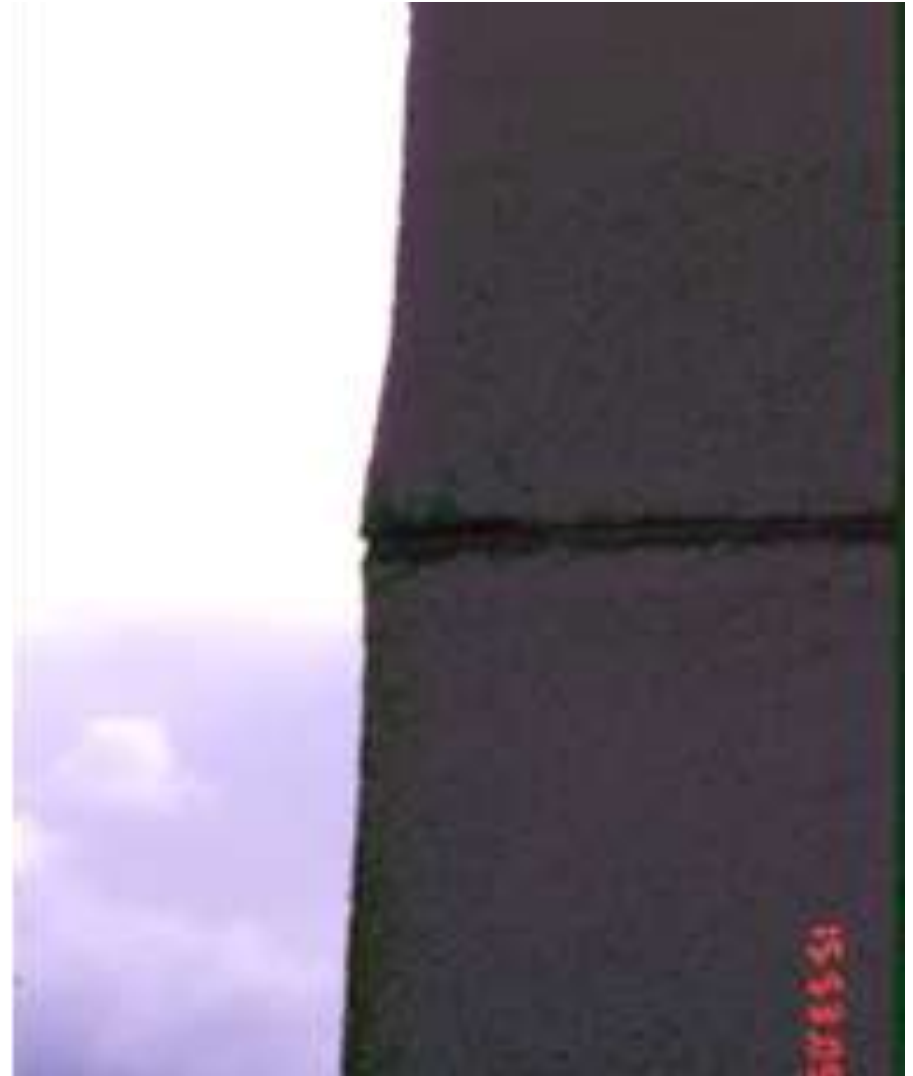
6.2.2 Mitered Outside Corners of EPS Board - EIFS

Active water leaks: Exposed reinforcing mesh at corner; Bulging at corner.

EPS (aged) boards are not interlocked at corners.

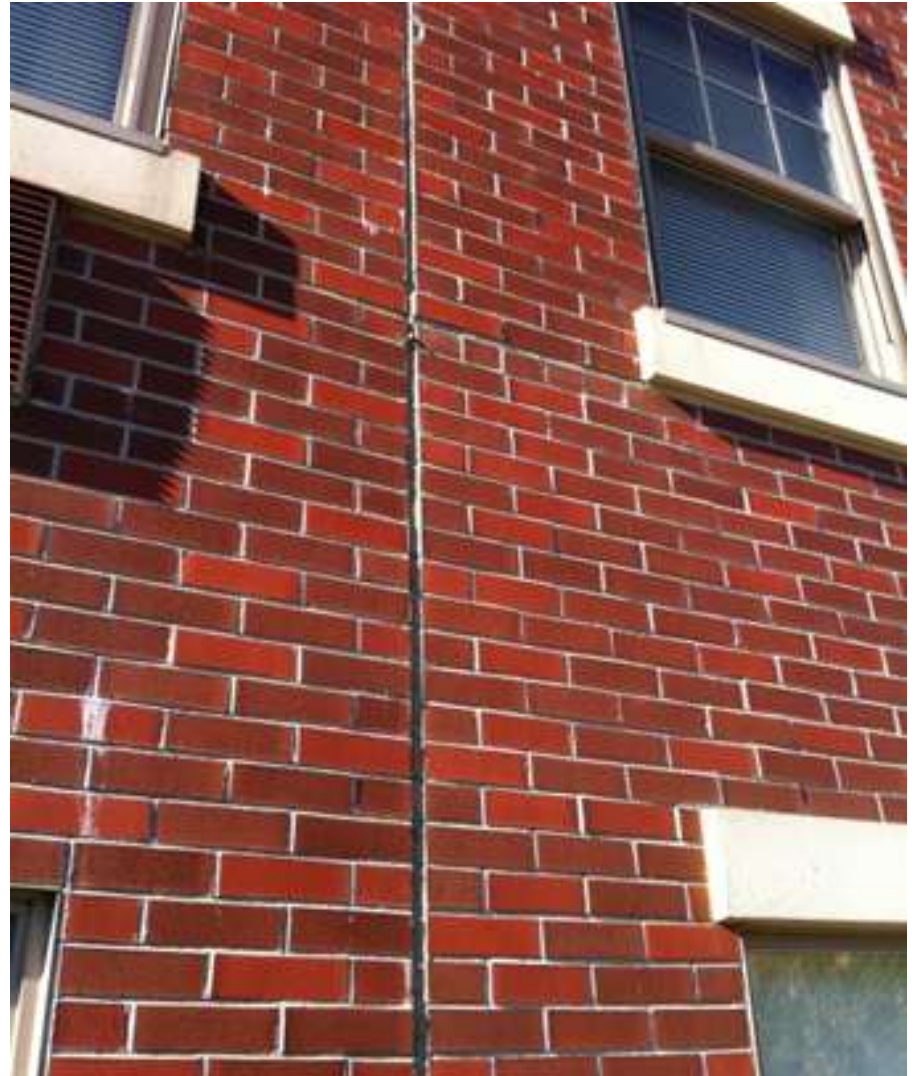
6.3.1 Sealant Joint Failure

Active water leaks. Sealant recessed in joint.

Water accumulating along interface of sealant and substrate. Improper use of foam backer rod.
