# FINDING OF EFFECT MEMORANDUM

Prepared by ICF at the request of Marin Housing Authority in partial fulfillment of Section 106 Review requirements

<b>Historic Property:</b>	Golden Gate Village
<b>Project Name:</b>	French Drain Installation
Street Address:	101-429 Drake Avenue & 1-99 Cole Drive, Marin City
<b>Project Applicant:</b>	Marin Housing Authority; County of Marin
Lead Agency:	County of Marin, on behalf of the Department of Housing and
	Urban Development
Contact:	Evan Smith, esmith@marinhousing.org

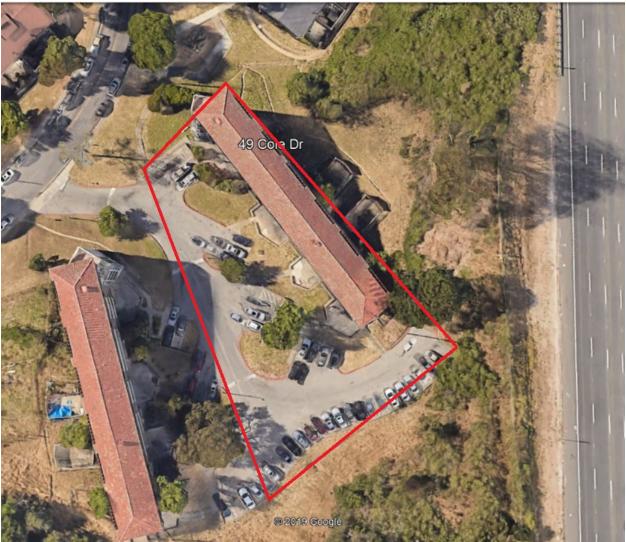
Figure 1: An aerial site plan illustration of the APE for the 6-inch French drain installation, shown in red. North is up, Highway 101 is to the east. Courtesy: Google Earth, 2019.

east, west, and south facades. Therefore, the APE for this undertaking is defined as the entire Building 49 footprint, and includes associated hardscaping features such as the building's pentagon terraces, parking terraces, and driveway to its west; the concrete ditch that runs along the building's east façade; and the additional parking to the south (Figure 1).

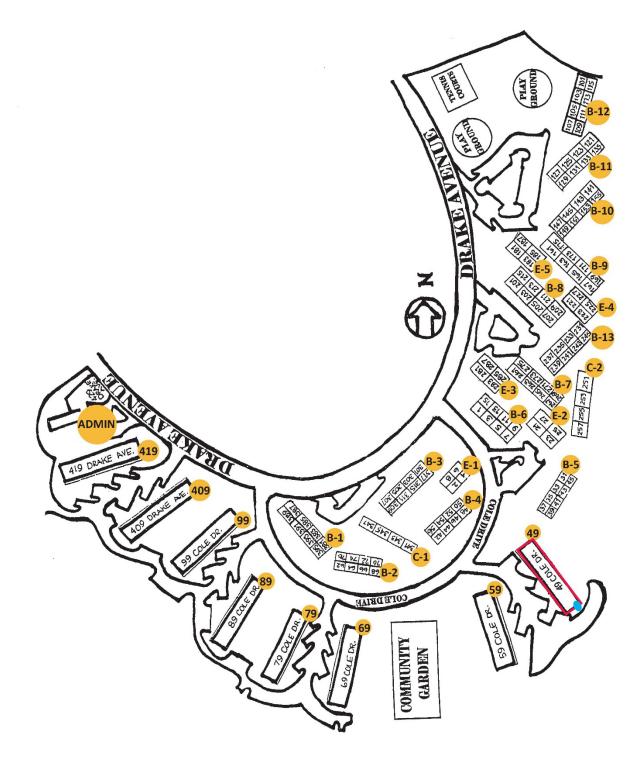
Figure 2: A site plan illustration of Golden Gate Village. Building 49 is outlined in red. The location of the French Drain installation is indicated by the blue dot which is not to scale. North is up, Highway 101 is to the east; map not to scale. Courtesy: Marin Housing Authority, with illustration by ICF.

A site plan is included on the following page to illustrate the layout of the complex and the location of Building 49 (Figure 2).

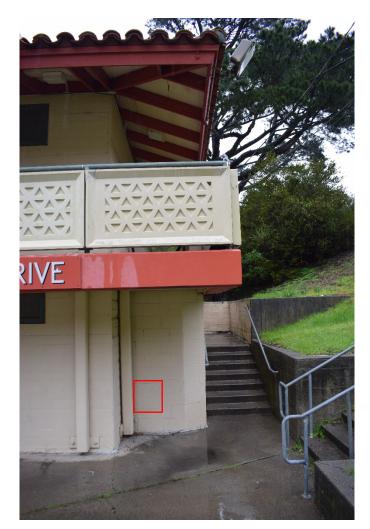
Figure 3: Photograph of the proposed insertion point of the French drain (outlined in red), located at the south end of the primary (west) façade of Building 49, facing east. Courtesy: ICF 2020.

The French drain would be inserted into the south end of the primary (west) façade through an existing access point in the concrete that is presently covered by a square metal panel (Figures 3-4). From the access point, the new drain would be inserted under the stairway and would extend up to the ground level landing. It would run west to east, along the building's south façade within the concrete landing (Figures 5-6). The French drain would empty water through a weep hole in the east wall of the existing stairway into an existing concrete ditch located on the slope at the building's rear (east) façade (Figure 7). The concrete ditch would carry water from the French drain to the south, running parallel to Building 49's rear (east) façade. The existing concrete ditch runs below a wood fence that extends past the exterior rear façade of unit #15.

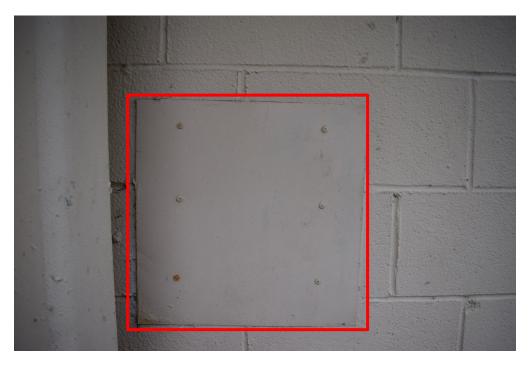
Figure 4: Close-up of the proposed insertion point of the French drain (outlined in red), located at the south end of the primary (west) façade of Building 49, facing east. Courtesy: ICF 2020.

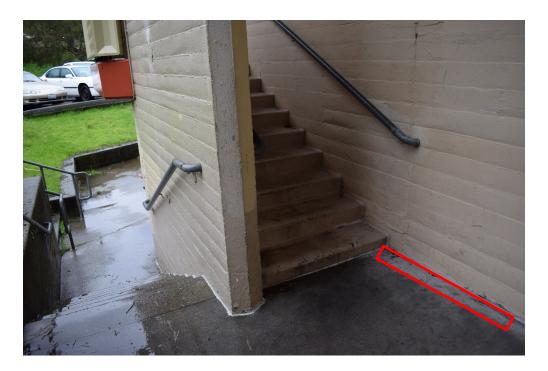
Figure 5: Photograph of the proposed French drain location (outlined in red), which would run under the existing stairway and up to the ground level landing, and continue east along the building's south façade, roughly within the area outlined in red. Courtesy: ICF 2020.

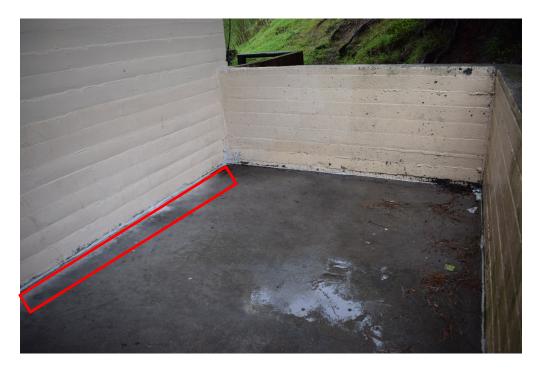
Figure 6: Photograph of the proposed French drain location (outlined in red), would be located within the ground level landing in the south stairway at Building 49. Courtesy: ICF 2020.

The length of the new drain would be concealed within the concrete floor of the ground level landing but would require a new strip of concrete to be installed over the drain. A change in the color of the concrete where the drain would be installed would be visible from limited locations adjacent to the south end of Building 49, at the east, west, and south facades, until it is weathered.

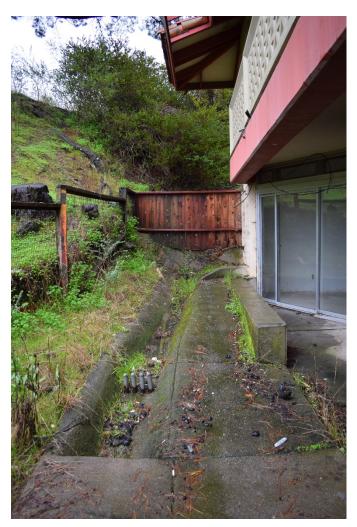
Figure 7: Photograph of the concrete ditch into which the proposed French drain would empty, and existing wood fence. Courtesy: ICF 2020.
