G1000 / GFC 700 System Maintenance Manual

Model C90A/C90GT King Air

**Contains Instructions
For Continued Airworthiness
For STC #SA01456WI-D**

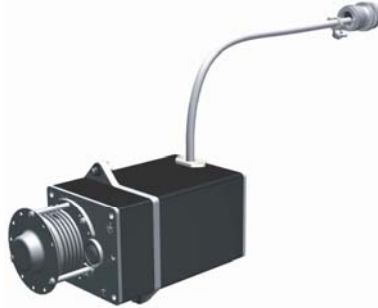
The GSA 81 (low-torque) Servo Actuator is an electromechanical unit that will provide automatic control of pitch trim. The Garmin GSA 80 (high-torque) Servo Actuator is an electromechanical unit that will provide pitch, roll and yaw damp and turn coordination. The GSA 80/81 contains a motor-control and monitor circuit board, as well as a solenoid and a brushless DC motor. The GSA 80/81 servo receives serial RS-485 data packets from the GIA 63Ws. The roll servo is located in the lower fuselage at F.S. 185. The pitch, yaw, and pitch trim servos are located in the tail. Power to the servos is received from the avionics No. 2 bus. All servos mount to a Garmin GSM 85A Servo Mount. The GSM 85A is responsible for transferring the output torque of the GSA 80 /81 servo actuators to the mechanical flight control surface linkage

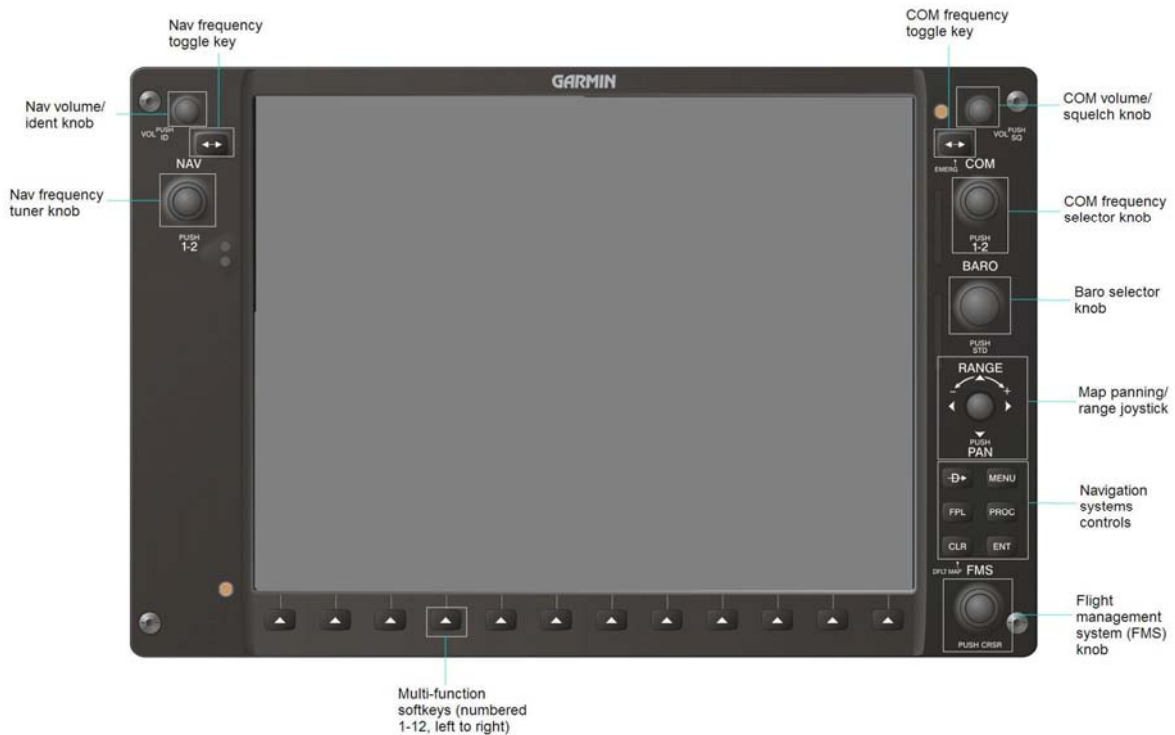
Figure 3-1. GDU 1040A Control Interface

Figure 3-1 and Figure 3-2 provide identification of the GDU 1040A PFD and GDU 1500 MFD controls.

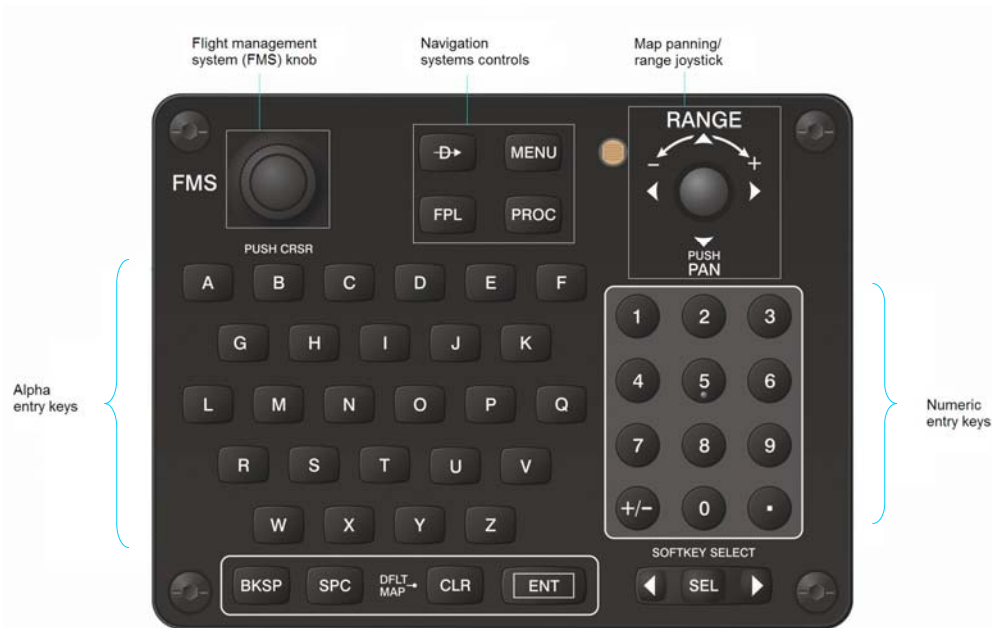
Figure 3-4. MFD Controls (GCU 475 shown)

The MFD controls are located on the GCU 475 as show in Figure 3-4.

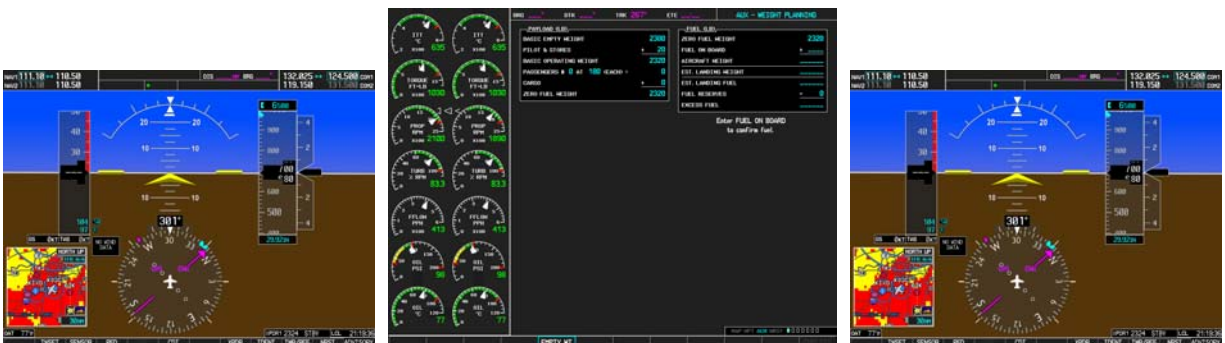
Figure 3-7. Normal Mode

The G1000 system is now powered in the normal mode. In the normal operating mode, data fields that are invalid have large red X's through them. A valid field does not display a red X. Allow the displays to initialize for approximately one minute. The GDC 74Bs requires a longer initialization period than do the other LRUs. During normal operation, this causes the airspeed, altitude, vertical speed, and OAT fields to be invalid during the first ~40-60 seconds of PFD power-up. The PFDs and MFD will function as specified in the G1000/C90A/C90GT Cockpit Reference Guide, when the system has been correctly installed and configured.

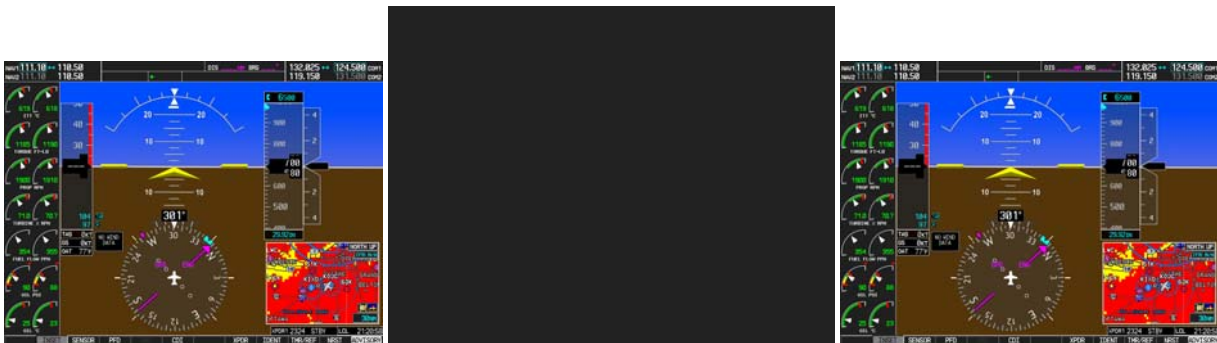
Figure 3-8. Manual Reversion with MFD failure

Reversionary mode allows for display of information related to safe flight in the event of a display communication or hardware failure. On this 3-display system, only a manual reversionary mode is possible. Manual reversionary mode allows the operator to force the pilot or copilot's PFD into reversionary mode by pressing the large red button labeled 'DISPLAY BACKUP' on the respective GMA 1347 audio panel.

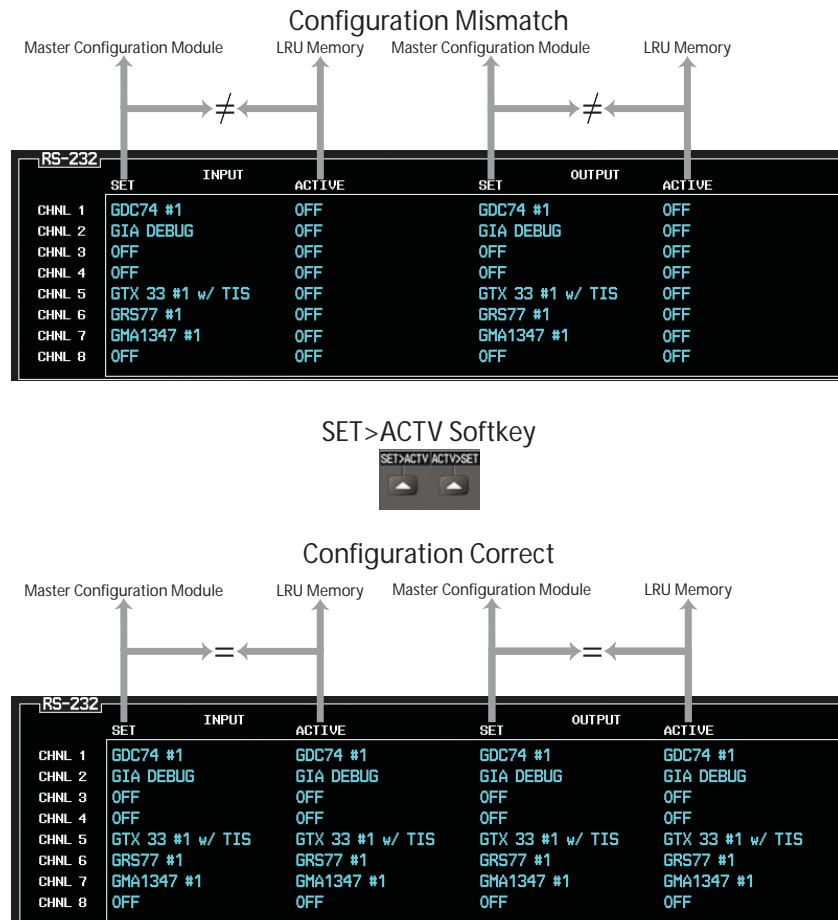
Figure 3-10. SET>ACTV Diagram

In the first example shown in Figure 3-10, the SET columns do not match the ACTIVE columns. The inequality between SET and ACTIVE indicates a configuration mismatch. By pressing the SET>ACTV softkey, this copies the SET column to the LRU unit's configuration memory. The settings then become the ACTIVE settings for the LRU being configured.

When troubleshooting the system, technicians can look for inequalities between SET and ACTIVE columns. Certain problems can be resolved simply by pressing the SET>ACTV softkey, which reloads settings to the specific LRU from the PFD. (Note that this can also be accomplished by reloading the configuration files for the LRU, using the software loader card. Section 7 describes this process for each LRU).

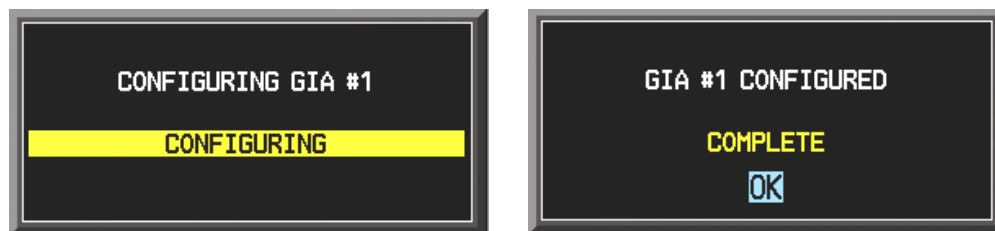
Figure 3-12. Configuration Status

When configuration settings are changed, the technician receives on-screen prompts and/or confirmations such as those shown in Figure 3-12. Section 7 shows other prompts encountered during the configuration process.

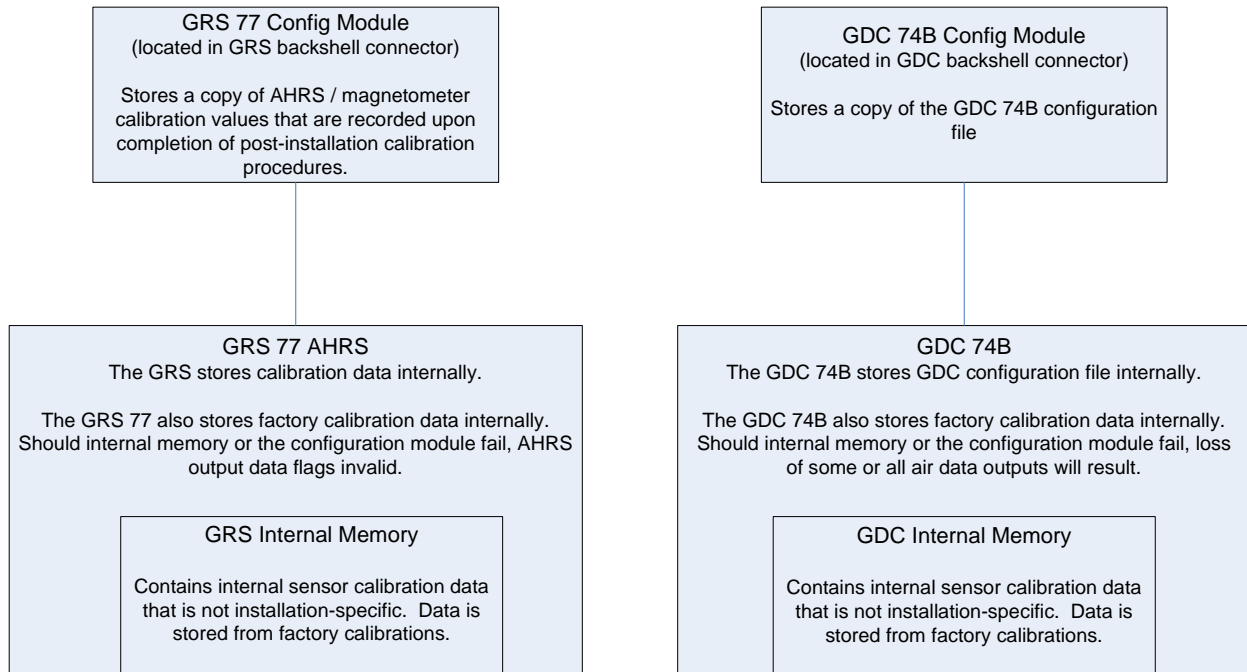
Figure 3-15. GRS/GDC Configuration Settings Storage

The GRS 77 and GDC 74B configuration modules function differently than the rest of the system. The GDC 74B's configuration file is loaded directly to GDC internal memory. A copy of the file is stored in the GDC configuration module.

The GRS 77 configuration module does not store any configuration settings. Instead, it stores calibration data recorded during installation calibration procedures.

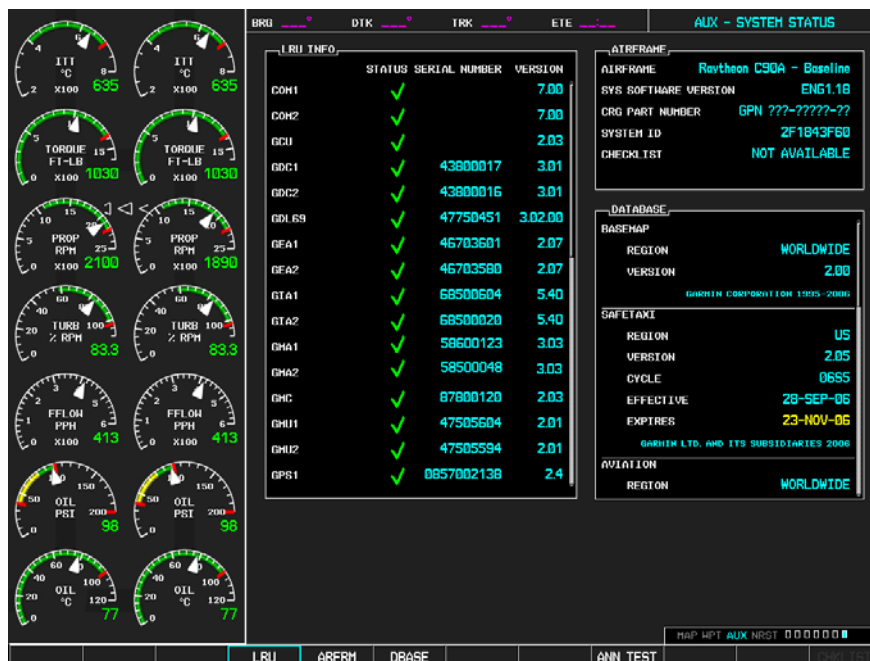
Figure 5-1. AUX – System Status Page

The AUX – System Status page is the 5th page in the AUX Page Group and displays the following information for each LRU and sub-function:

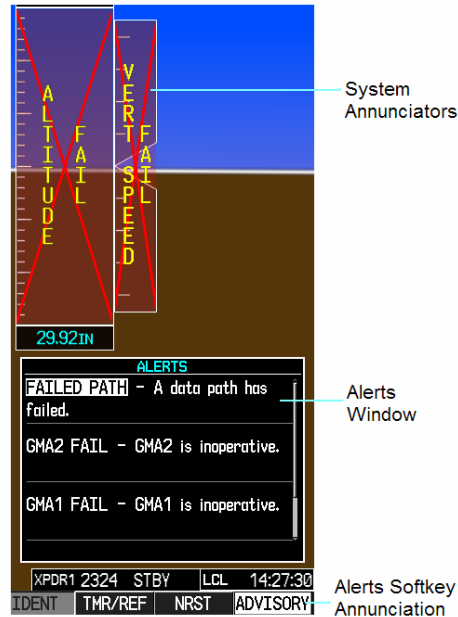
Figure 5-2. Alerts & Annunciations

The G1000 Alert System conveys alerts to the pilot using combinations of the following features:

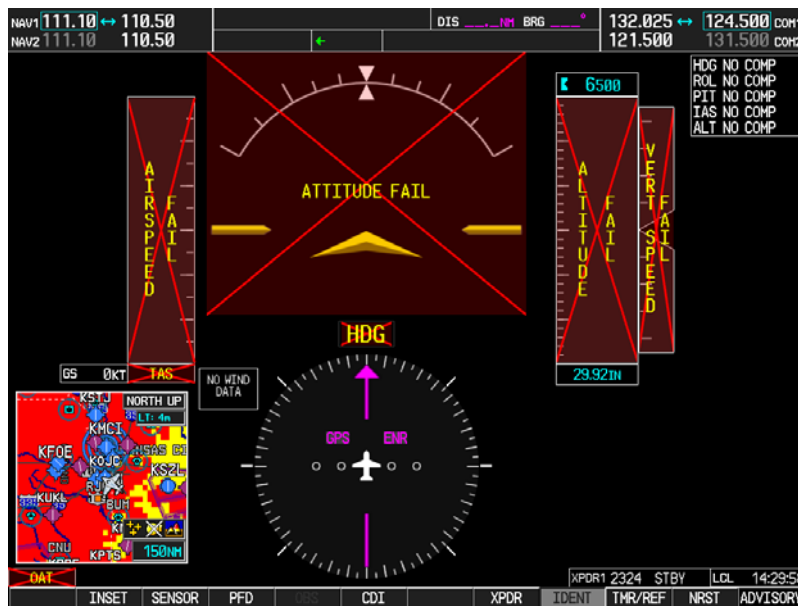
Figure 5-6. System Annunciations

If data fields become invalid due to an LRU failure, the PFD/MFD typically annunciates the failure with a large red X, as shown in Figure 5-6.

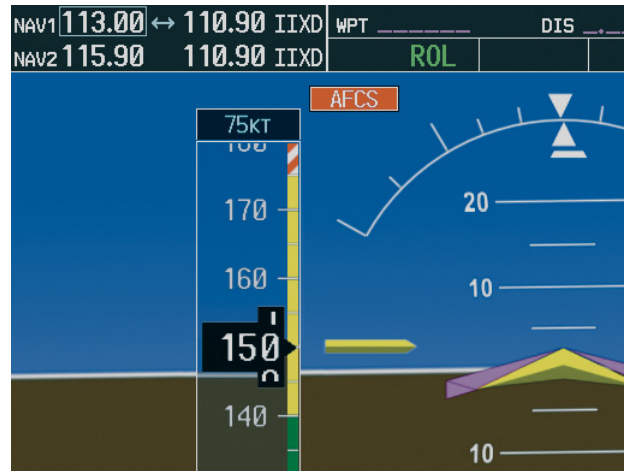
Figure 5-7. AFCS Annunciation Field

The GFC 700 AFCS Annunciation field is located above the airspeed tape on the PFD as shown:

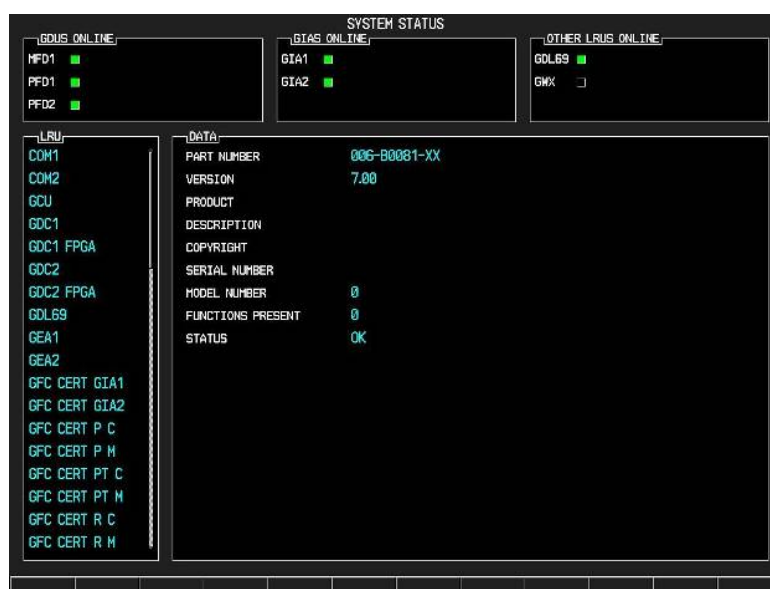
Figure 6-1. System Status Page (Configuration Mode)

2. The System Status page shows a list of LRUs in the LRU window. Activate the cursor and use the FMS knob to scroll through the list in the window and select from the following items:

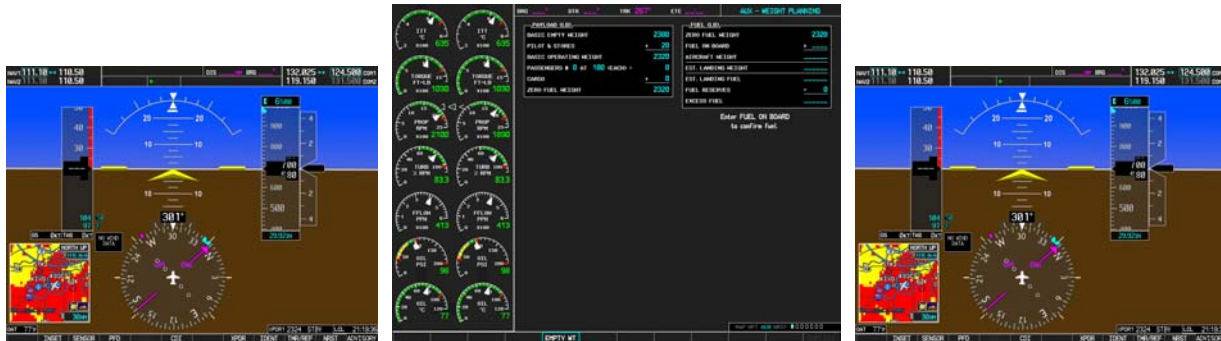
Figure 7-1. G1000 Normal Mode Check

3. Check that attitude, heading, altitude, airspeed, vertical speed and OAT fields are valid within 2 minutes of power up on both PFDs.
4. Press the SENSOR softkey on each PFD and switch between ADC1 and ADC2. Verify that data from both GDC 74Bs is valid on both displays.
5. Press the SENSOR softkey on each PFD and switch between AHRS1 and AHRS2. Verify that data from both GRS 77s is valid on both displays.
6. Check that the engine instrument fields are valid on the MFD.

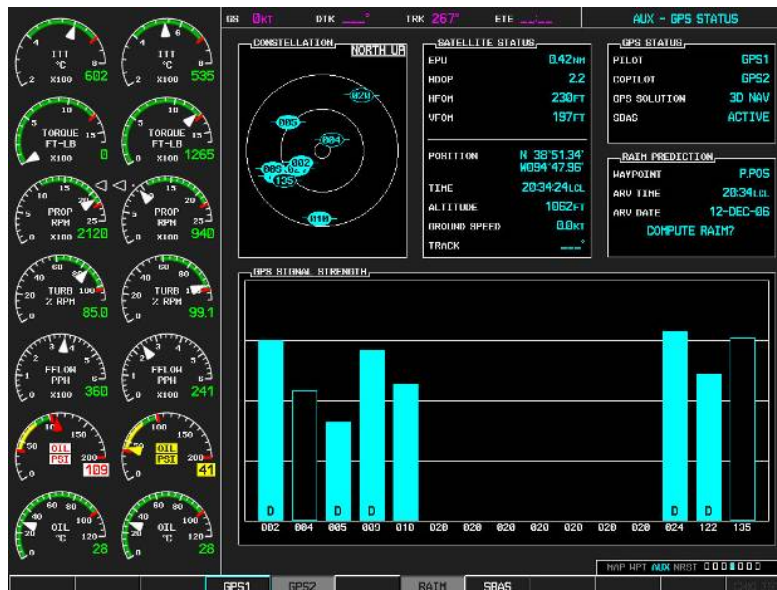
Figure 7-3. AUX – GPS STATUS Page (MFD)

The GIA 63W units should normally acquire a GPS navigation solution within 5 to 10 minutes of startup, provided the aircraft is outside (or indoors with a GPS repeater). Select the GPS STATUS page on the MFD (4th page in AUX group). Two softkeys on the bottom of the display allow the user to toggle between GPS 1 and GPS 2. Verify that both receivers show 3D DIFF NAV on the MFD.

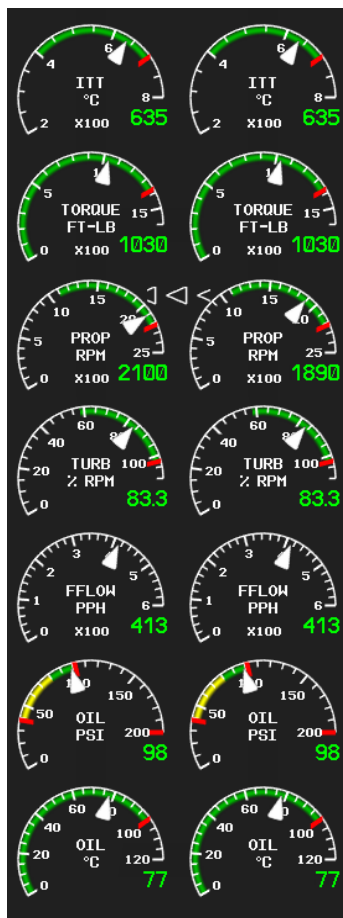
Figure 7-4. Normal Engine Instrument Markings (MFD)

In general, verify all engine and system instruments show valid static normal values and markings, with no red Xs or erratic indications. Reference figure below (Baseline configuration instruments shown) for normal engine instrument markings.

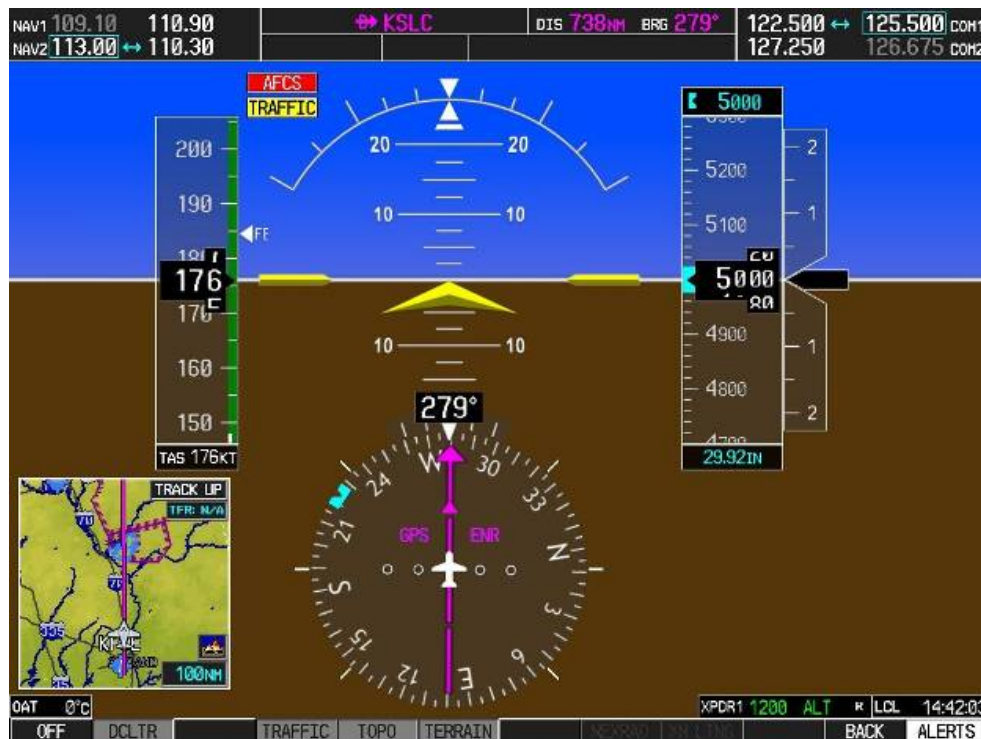
Figure 7-5. Normal Mode AHRS Check

The aircraft can now be taxied back and the engine can be shut down for final testing. Restart the displays in normal mode to conduct final system checks. When the PFDs power up in normal mode, the AHRS attitude and heading information displayed should become valid within 1 minute of power-up, as shown in Figure 7-5 (provided both GPS receivers have a valid position; if GPS is unavailable, AHRS initialization may take as long as 2 minutes).

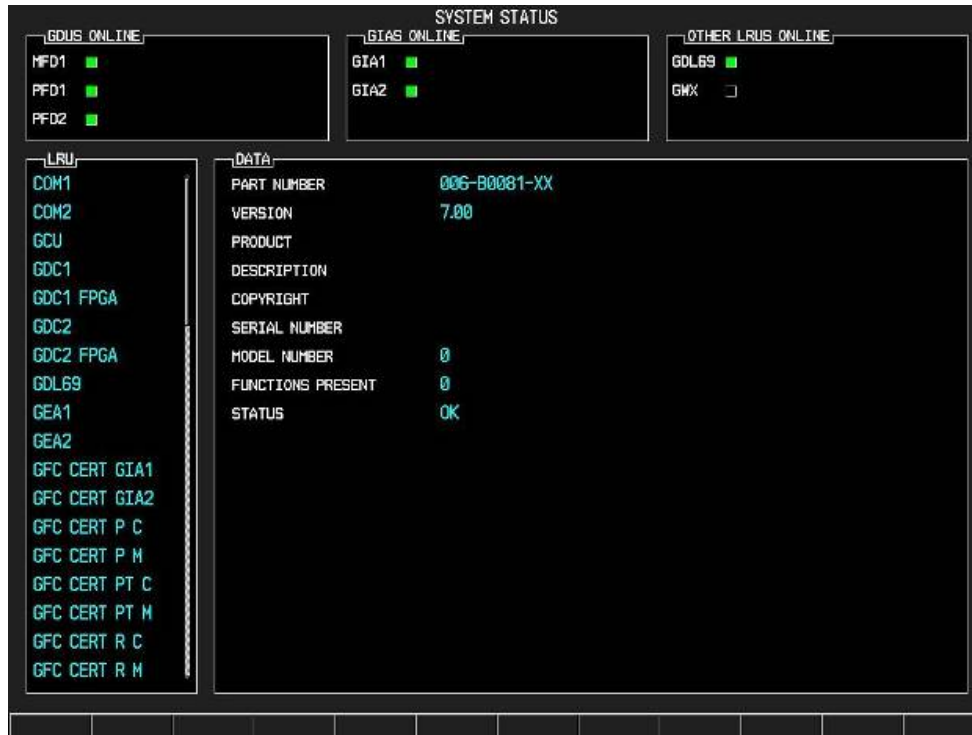
Figure 8-1. System Status Page (Configuration Mode)

2. The PFD System Status page shows a list of LRUs in the LRU window. Activate the cursor and highlight the LRU window. Use the FMS knob to scroll through the list in the window and select from the following LRUs.

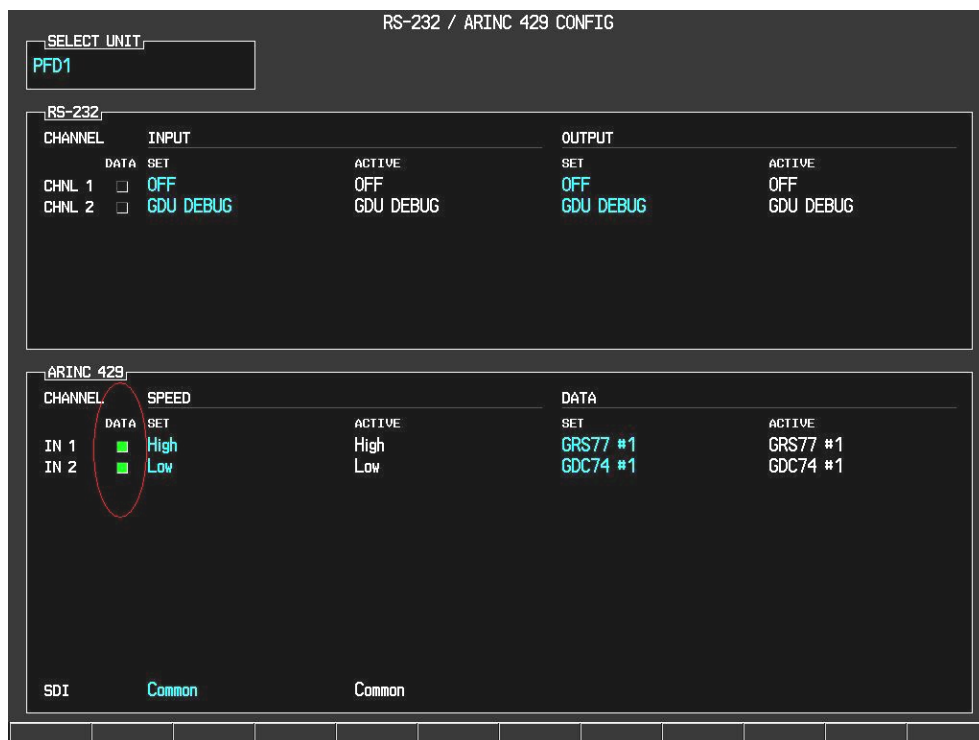
1. Remove power from the displays by pulling the following circuit breakers:
 - a. PFD1 PRI
 - b. PFD1 SEC
 - c. PFD2
 - d. MFD
2. Reboot PFD1, PFD2 and MFD while holding the ENT key on each display (far right key on MFD) until the words INITIALIZING SYSTEM appear.
3. In configuration mode, go to the GDU Page Group on PFD1.
4. On PFD1, activate the cursor and select PFD1 in the SELECT UNIT field and press ENT.
5. Observe the GRS 77 and GDC 74 DATA indicators in the ARINC 429 window.
6. Verify both indicators are GREEN, indicating the channels are receiving data as shown below:

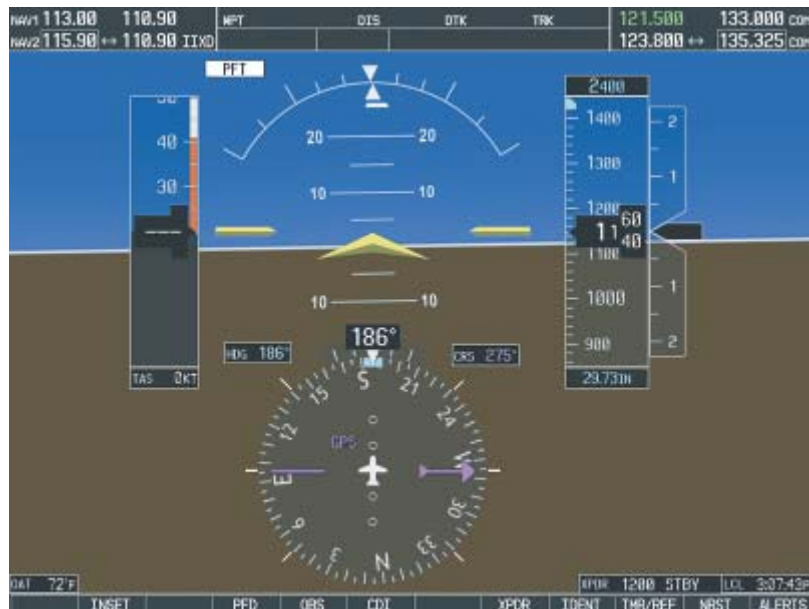
Figure 8-2. Pre-Flight Test

1. If selected ON, select the AVIONICS MASTER switch and ground power unit to OFF. After 30 seconds select the ground power unit and AVIONICS MASTER switch to ON. Verify the GFC 700 begins an automatic pre-flight test after AHRS and ADC parameters become valid.
2. Verify that a white 'PFT' annunciation is displayed on PFD1 and PFD2, as shown in Figure 8-2
