HLK2 Troubleshooting Guide

For the Plexon MAP System

Plexon Inc

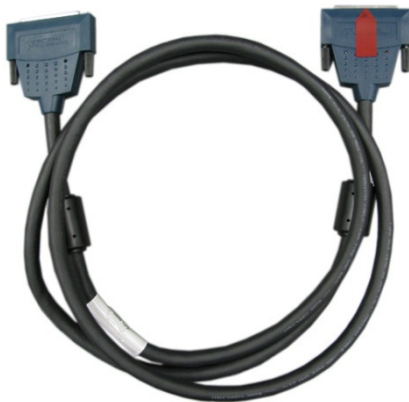
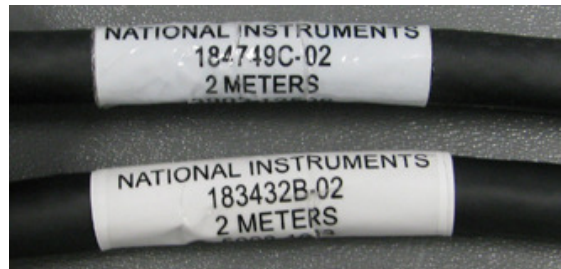
The HLK2 cable is a National Instruments digital link cable. There is another National Instruments cable that Plexon uses to connect 16 channel A/D boards in some MAP systems that looks identical, but is not compatible. The National Instruments cable used for the HLK2 subsystem will have a red sticker on the connectors, and can also be identified by the white cable sleeve number

The HLK2 cable sleeve will read “183432B-02”.

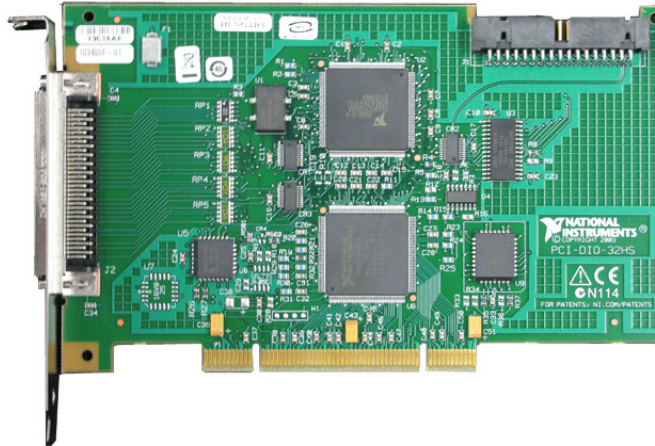
The HLK2 PCI card that sits in the host PC is a National Instruments PCI-6533 card. It is identified in the Windows Device Manager and the National Instruments Measurement & Automation (NIMAX) software as a PCI-DIO-32HS.

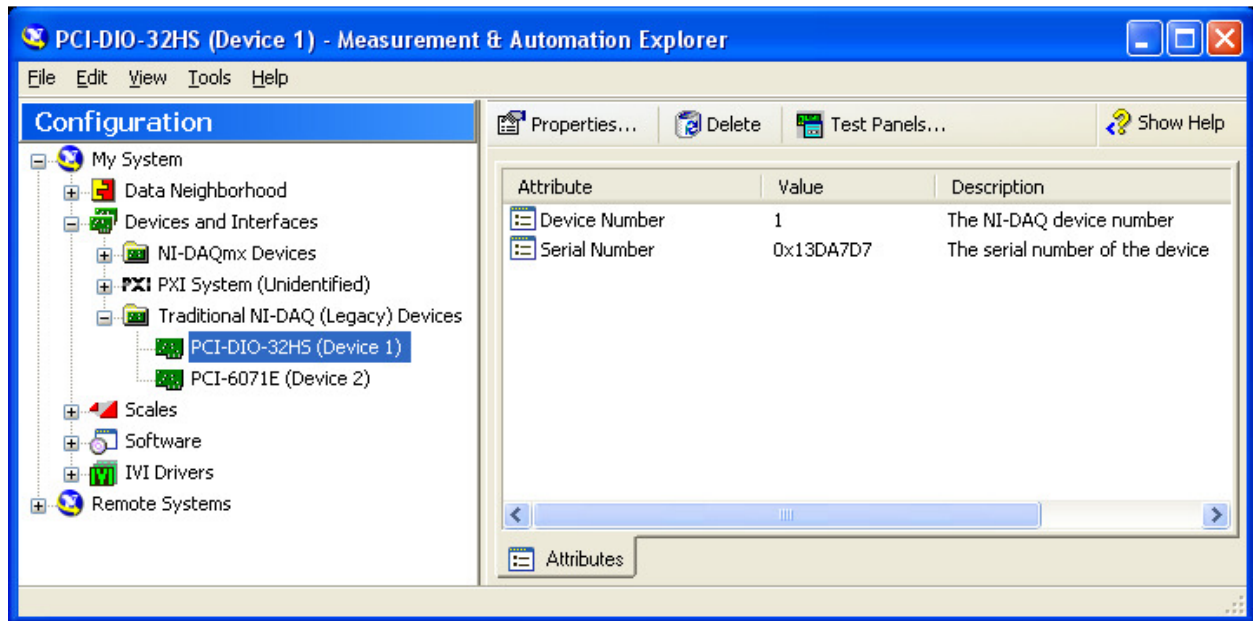
Open NIMAX (under Start->Programs->National Instruments->Measurement & Automation) to view any NI devices on the PC. You can see them under the “Devices and Interfaces->Traditional NIDAQ Devices” branch. NIMAX has to be run at least once for the viewing utility in Server to function, and sometimes after a hardware problem it will need to be run again.
