World Housing Encyclopedia

HOUSING REPORT

Dhajji Dewari

Report #	146
Report Date	10-08-2011
Country	PAKISTAN AND INDIA
Housing Type	Timber Building
Housing Sub-Type	Timber Building with Masonry/Stone Infill
Author(s)	Kubilay Hicyilmaz, Jitendra K Bothara, Maggie Stephenson
Reviewer(s)	Randolph Langenbach, Dominik Lang

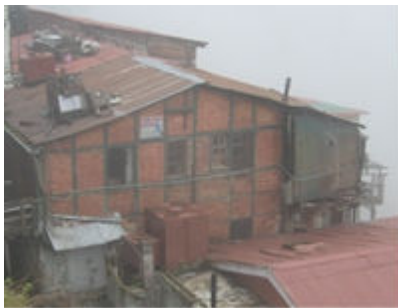
Figure 1 1. A Dhajji building in Simla, India without bracing elements.

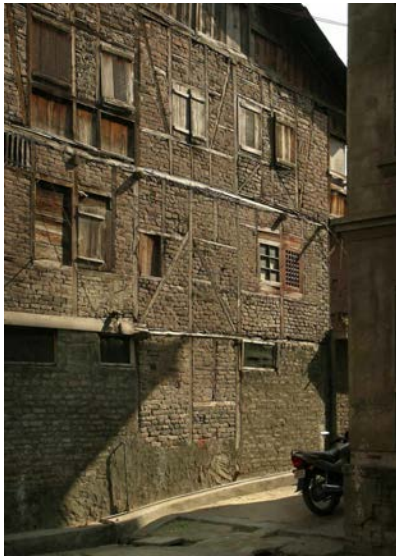
Figure 1 2. Multi-storey Dhajji building in Shrinagar, India. Photo source: © Randolph Langenbach.

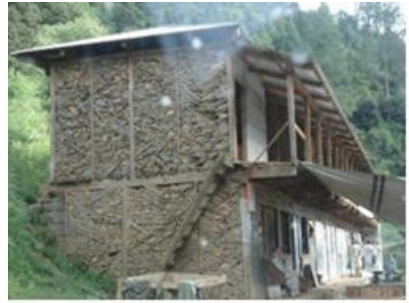
Figure 1 3. A two storey Dhajji building that survived the 2005 Pakistan earthquake whilst most buildings around it fell down.

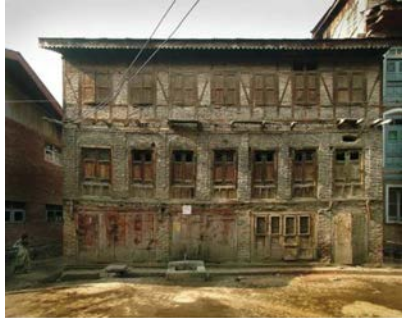
Figure 1 4. A building with Dhajji in upper most storey only from Srinagar, India. Photo source: © Randolph Langenbach (see Ref. 2).

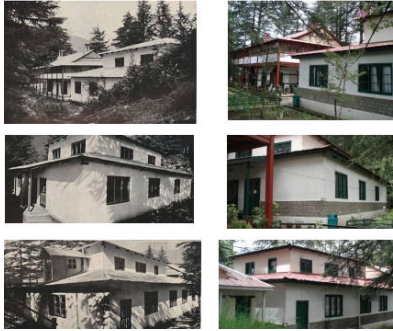
Figure 1 5. Examples from Northern India [Headquarters and Medical Research Laboratories at Naggar, Kulu, Punjab, India from article written around 1930s (See Reference 26)], Colour Photos taken in August 2009 (See Ref. 27).

Typically these houses are found in the mountainous northern parts of Pakistan and India and a good example is shown in Figure 1 5 which was built in the 1930s at the time of the last great depression by a western funded research institution, for which some limited documentation was found on the web. A recent field trip by Arup engineers working in the region in August 2009 has confirmed that this particular Dhajji building is still in existence and is now being used as a museum.

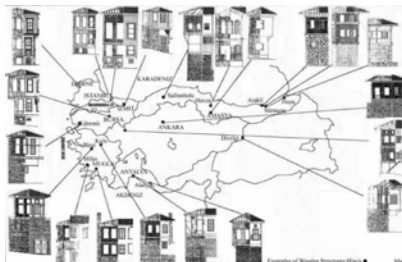
Figure 1 10. Examples of similar types of construction from Turkey (See Ref. 25).

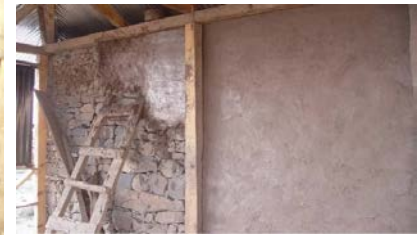
Figure 2.6. Plastering with cement sand plaster or mud mixed with natural fibres (note that the wall is not a Dhajji wall).

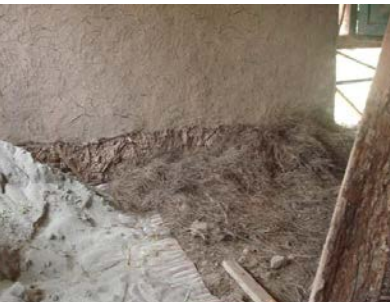
Figure 2.7. Plastering with cement sand plaster or mud mixed with natural fibres.

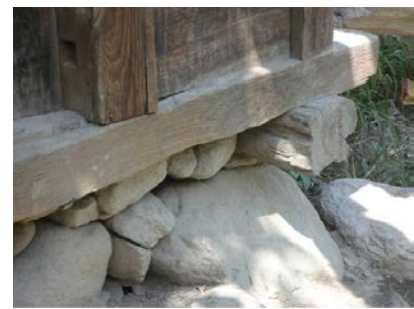
Figure 3 3. Foundation below plinth beam, note no connection between plinth wall and timber beam (existing building).

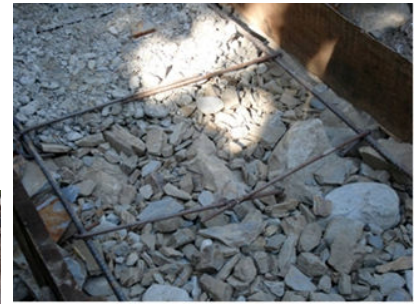
Figure 3 6. RC plinth band under construction (note poor splicing of stirrups) (Note: This was constructed for ERRA reinforced masonry. Picture was taken in Leepa in September 2006 before dhajji decision from ERRA. Picture from an area with no prior knowledge of reinforced concrete construction.)

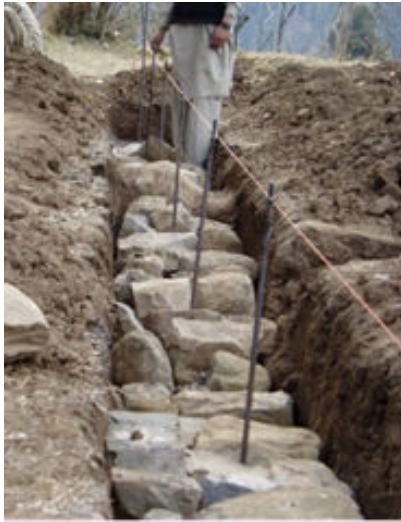
Figure 3 7. Bolts in the foundation to tie-up plinth timber.

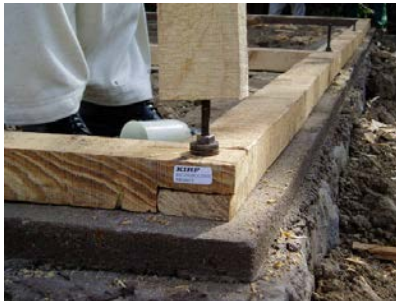
Figure 3 8. Bolting of plinth band with foundation. Note that a damp proof course has not been used.

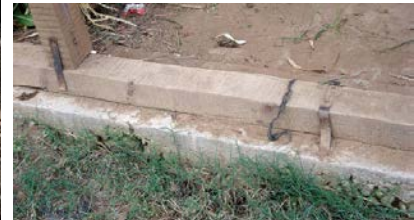
Figure 3 9. Timber ground beam (or sill beam) raised above the ground to protect the timber frame from rotting. Note attempted connection of the timber beam with the foundation. Damp proof course not provided.

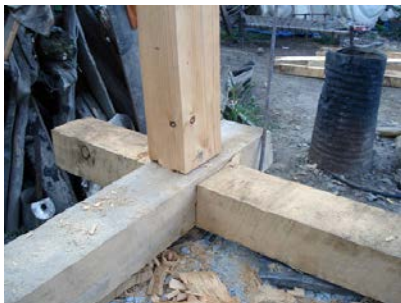
Figure 3 10. Corner connection detail with generous overlaps.

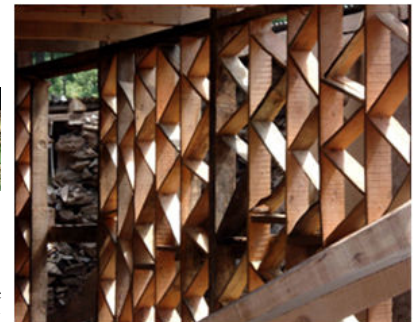
Figure 3 12. Timber frame ready to receive stone infill. Bracing has a zigzag pattern and bracing does not coincide/node-out.

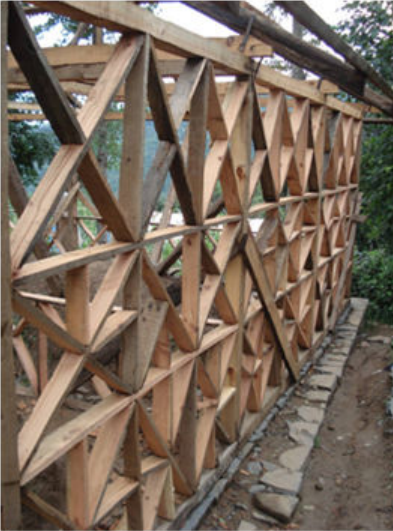
Figure 3 13. Timber frame ready to receive brick or stone infill, bracing is very much in the form of x-bracing.

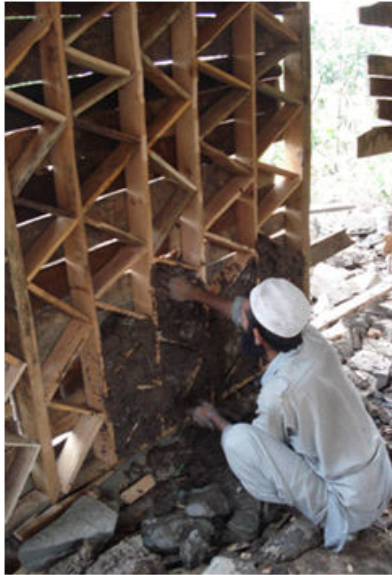
Figure 3 14. Construction of wall with stones and mud mortar. The planks on the other side of the wall act as formwork and will be removed after the infill placement is completed.

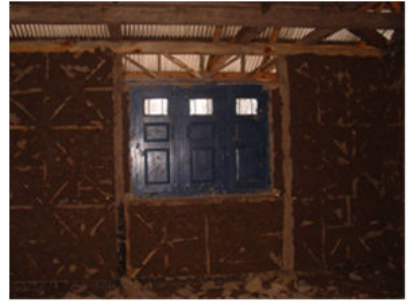
Figure 3 15. A wall ready to receive final coats of mud plaster (view taken from inside a building).

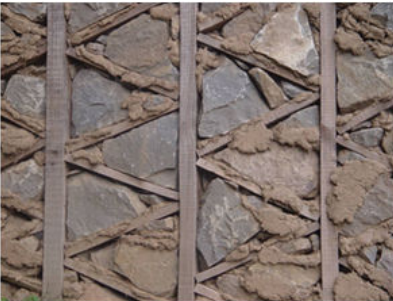
Figure 3 16. A completed wall, note large stones. (Note: This was built before the earthquake; it is a cheap commercial building. Mostly for houses people use smaller stones and are afraid of large stones falling on them. They may use chicken wire or timber boards to brace or line the upper few feet of the internal wall to restrain stones from falling.)

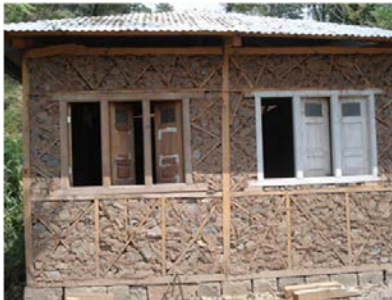
Figure 3 17. A completed wall. Note that the entire building has been raised above the ground level by a stone masonry foundation.

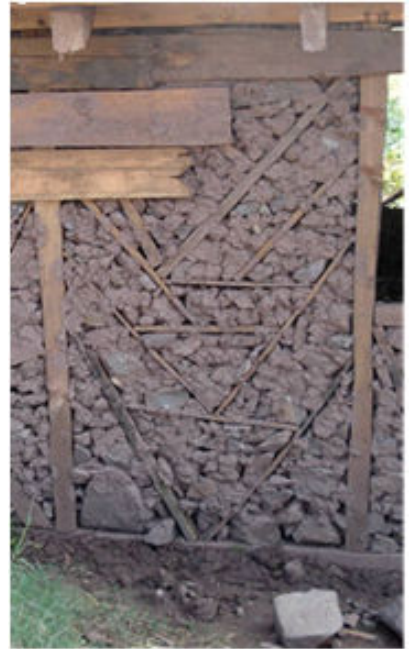
Figure 3 18. Inverted A-bracing pattern.

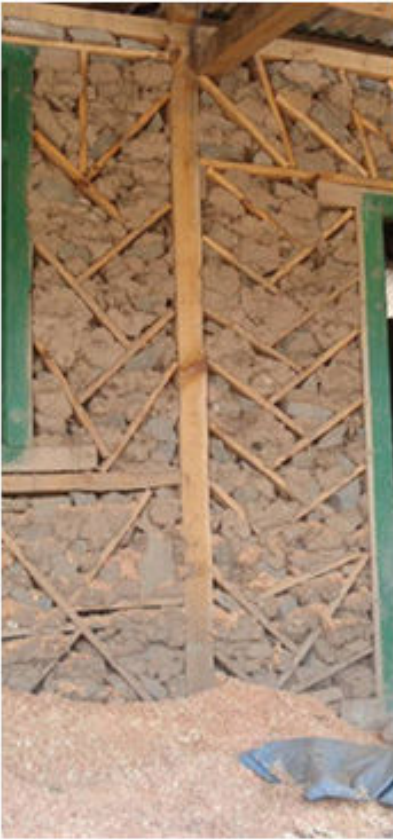
Figure 3 19. Herringbone bracing pattern.

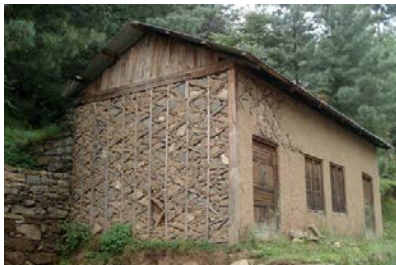
Figure 3 20. A dhajji building with gable wall with planks.

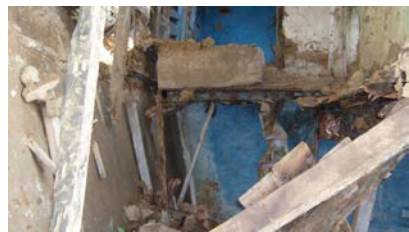
Figure 3 21. Collapsed timber floor structure of an abandoned house in Simla, India. (Note: Layer of mud laid on floor structure).

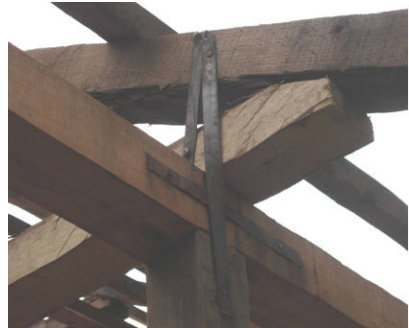
Figure 3 24. Tie-up of roof with wall structure.

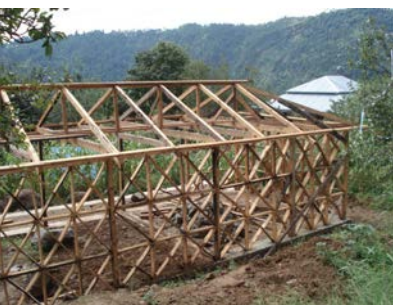
Figure 3 25. A view showing roof and braced timber frame.

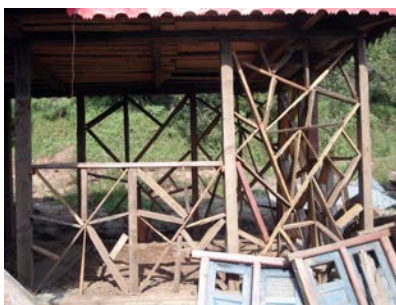
Figure 3 26. Mixed bracing pattern making use of salvaged timber and window frames.

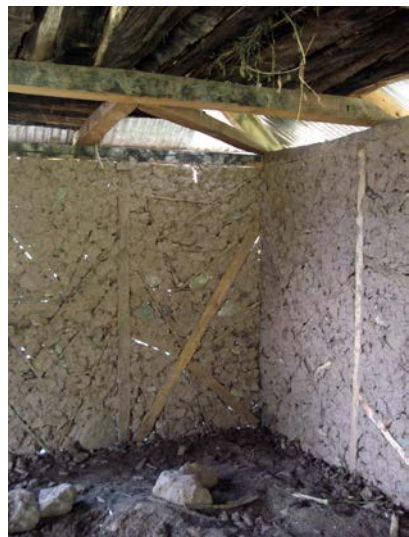
Figure 3 27. Internal view of completed wall. Note that the timber frame is not protected from getting wet as it is built straight in to the ground.

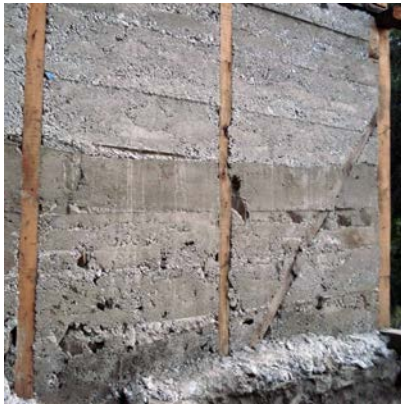
Figure 3 28. Timber, stone laid in concrete. This is not traditional dhajji construction. There is a risk that the entire panel may fall out as a rigid object during an earthquake.

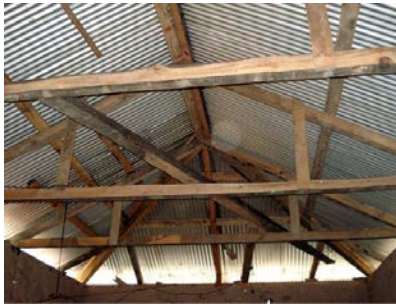
Figure 3 29. An internal view of a hipped roof. Apart from the CGI sheets there is no bracing to stiffen the roof structure. (Note: This roof is likely for storage/use. There will be a floor and ceiling of some kind added at a later date depending on the budget available.)

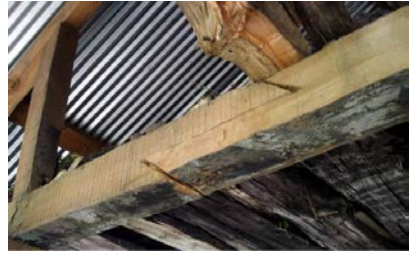
Figure 3 30. Timber connection details. Unless nails have been used this connection will not have very limited tension capacity to poor joint interlock.

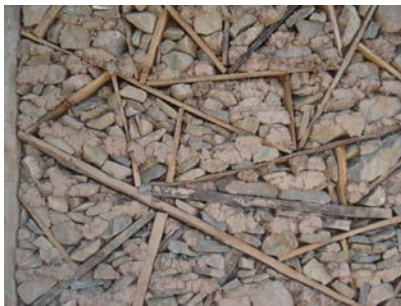
Figure 3 34. Common random bracing in small panels.

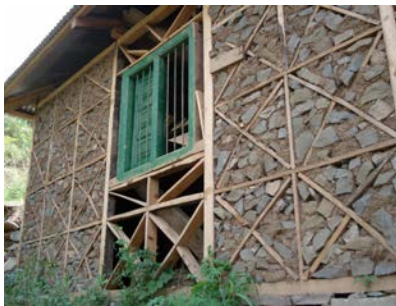
Figure 3 35. X-bracing pattern using partially cut stone.

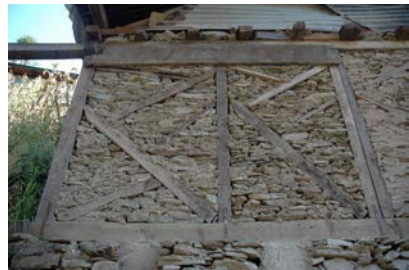
Figure 3 36. Bracing using large timber braces as timber resources are less constrained in the higher altitude. Note the more layered infill effect due to the type of locally available rock.

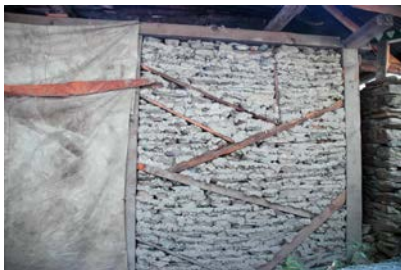
Figure 3 37. Large panel that appears to be in poor contact with the timber frame. Lack of tight fit may result in the entire panel falling out-of-plane. Again note the layering of the infill due to local rock characteristics.

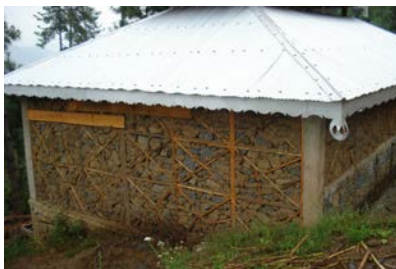
Figure 3 38. Mixed reinforced concrete and timber framing in dhajji style using X-bracing pattern.

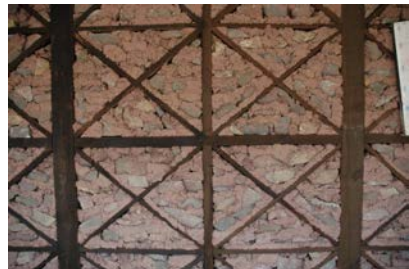
Figure 3 39. Reasonably cut stone laid with a lot of mud mortar. Note that the timber has been soaked in old engine oil as a way to give it some better protection against rotting.

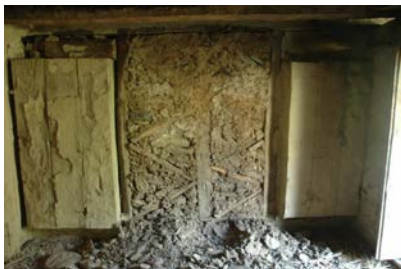
Figure 3 40. Wall built before the 2005 earthquake.

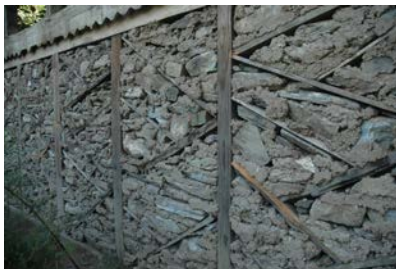
Figure 3 41. Wall built after the 2005 earthquake.

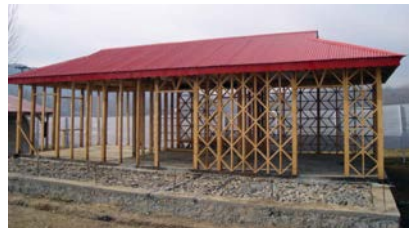
Figure 3 42. Zigzag bracing that nodes out. Note that the roof is erected early as it helps to stabilise the walls before their completion and helps keep the work dry. Also note the hipped roof giving stiffness in both principle building directions. Note 1: anchor rods in the foreground and that a damp proof course is not used. Note 2: The whole

building is over 1 ft off the ground. The veranda is protection for the building. The dassa is treated. There is a curious issue that the concrete band is referred to as damp proof course. It is usually not reinforced, but perceived as having another function. In some areas they are using flat galvanised sheeting wrapped around the timber, but there is not a perceived need to protect from ground water.

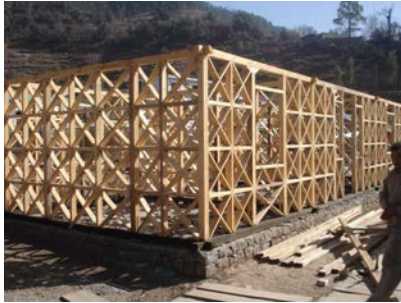
Figure 3 43. Engineered dhajji building frame under construction.

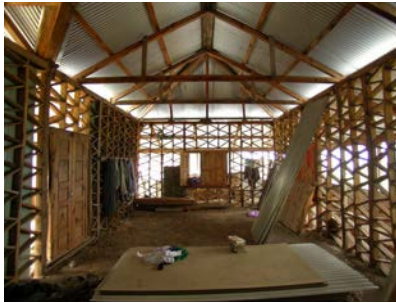
Figure 3 44. Inside view of a 1 storey house under construction. Note that the timber frame is in direct contact with the ground.

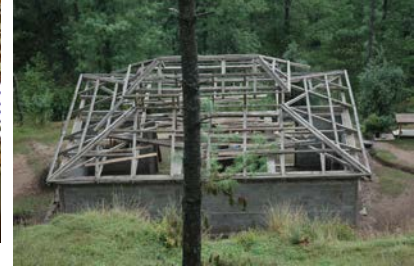
Figure 3 45. Preferred roof framing for those who can afford more

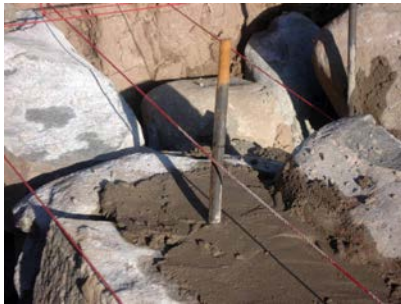
Figure 3 46. Anchor bolt in stone masonry wall laid in sand and cement mortar. Note that the mortar is only used locally around the anchor. Also note that the bolt is already rusting and is unlikely to receive any rust treatment prior to connecting to the frame base plate apart from being maybe treated with old engine oil which is very commonly done.

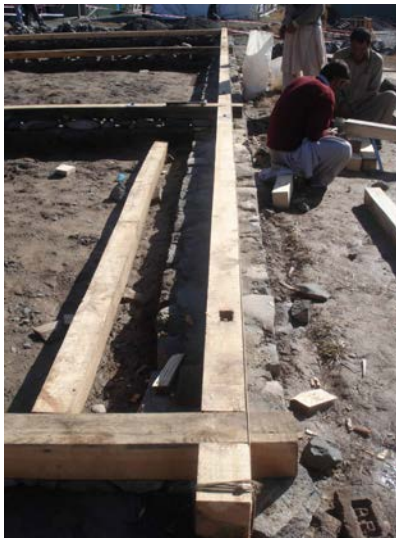
Figure 3 47. Base plate corner detail and bolt anchorage holes. Note that orthogonal walls are already planed and interconnected with the perimeter timber ring beam.

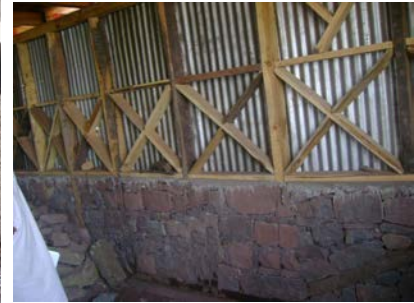
Figure 3 48. Mixed construction form. Dry stone wall with dhajji timber frame on top but without traditional infill material. Note: This is only a stage in construction. This is always infilled later. The corrugated galvanised iron sheets will be used as permanent shuttering / weather protection.

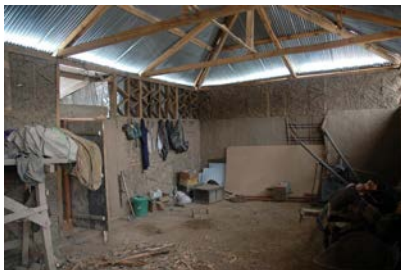
Figure 3 49. Internal view of large room with partially completed infill walls. Note the lack of bracing in any direction from the roof and apparently large distances between orthogonal walls. The system may be too flexible without enough support to the walls. There was some buttressing by walls of external rooms. This room is a hall for social occasions and shared use in winter, most families will not subdivide this room.

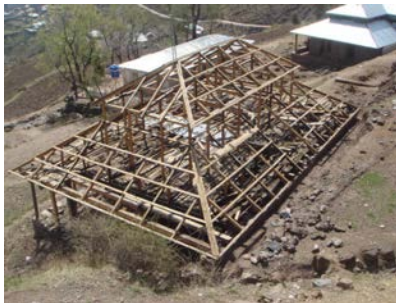
Figure 3 50. Double storey hipped roof built in to the slope on one side.

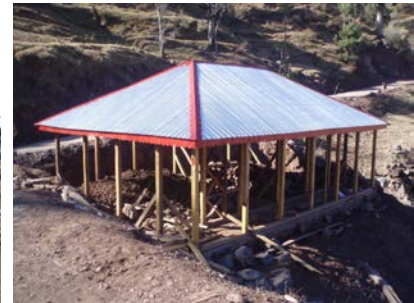
Figure 3 51. Simple frame at the start of the process of converting the posts into dhajji walls with hipped roof. Note that gutters are not provided to any of the roofs. (Note: This is an early stage construction photo. There are now many houses with gutters either for water or to control splash, and a big programme to increase rainwater harvesting.)

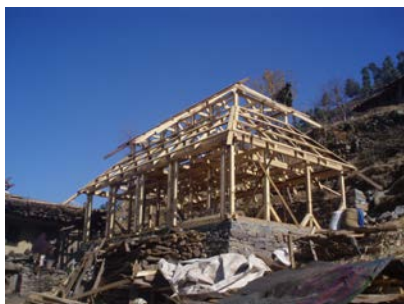
Figure 3 52. Dhajji frame under construction. Note that the front sits on top of a retaining wall and the back is partially a retaining wall. (Note: Front retaining walls are usually constructed too steep without the required inclines.)

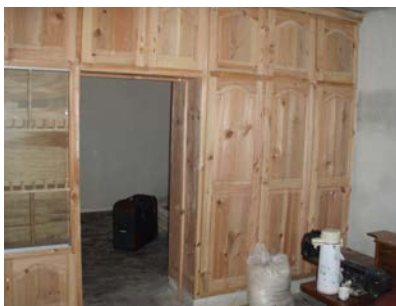
Figure 3 53. Full height built in wardrobe with reasonable thick solid timber back possibly it acts in part as a timber shear wall but it is not a detail that the engineering solution should depend upon. Note: The wardrobe back wall is usually solid 1/2 inch timber.

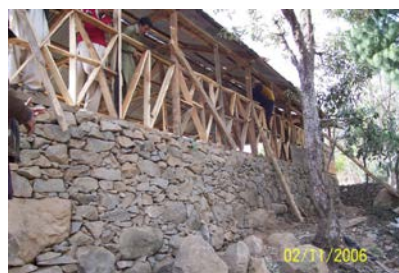
Figure 3 54. Dhajji frame built on a poor quality dry stone wall.

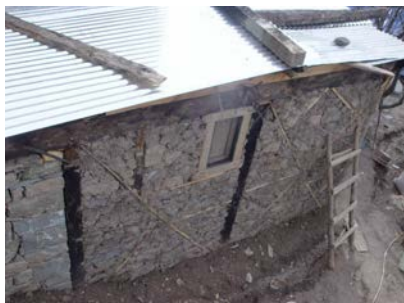
Figure 3 55. Mixed wall construction. Dry stone wall on the left hand side and dhajji construction on the right hand side. Note: The stone wall looks like it is against the slope; these are not strictly built as retaining walls, but as stone walls with loose fill behind.

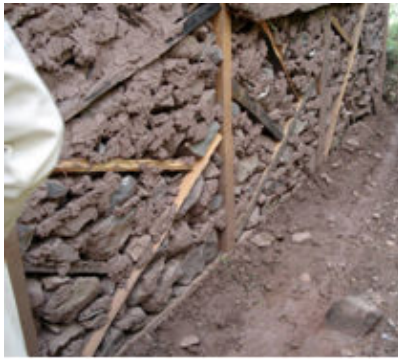
Figure 5 13. Timber frame that is not protected from moisture a major cause of timber rotting due to direct contact with the soil.

Seismic Deficiency	Description of Seismic Strengthening provisions used
Foundations may not have been provided (or not raised enough) placing the timber frame in direct contact with the ground.	Slowly install at least a stone base under the timber frame to help spread the load a little and possibly more importantly try and keep the timber frame dry.
General deficiency: drainage not provided to the foundations away from the building	Install stone/gravel drains away from the building thereby ensuring the timber frame stays as dry as possible.
Built directly on to the ground leading to rapid rotting of the timber frame. Or built directly on to masonry or concrete base.	Slowly install at least a stone base under the timber frame to help spread the load a little and possibly more importantly try and keep the timber frame dry. Try and insert a damp proof course to prevent moisture travelling up to the timber frame. Treat timber with preservatives if possible.

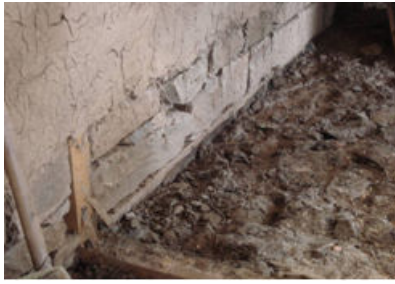
Figure 5 14. Timber sill beams and columns in direct contact with the ground exposing the timber to moisture. Note that the infill looks more like a dry stone wall.

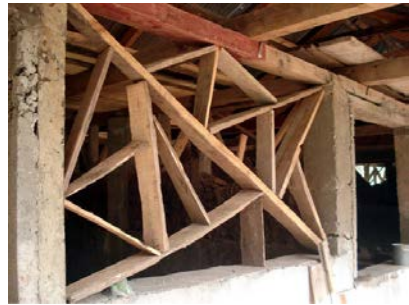
Figure 5 15. Mix of concrete columns with timber dhajji. Note poor quality compaction of the concrete and large cracks in the concrete column.

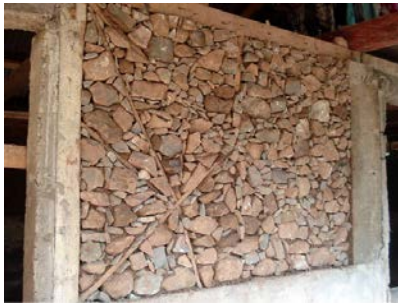
Figure 5 16. Mix of RC columns, dhajji infill construction (note the large panels of stone infill and limited amounts of timber bracing).

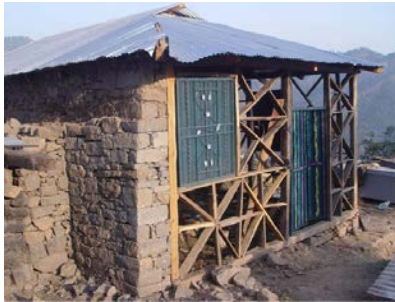
Figure 5 17. Dhajji in one direction and unreinforced stone masonry in other. Back wall of the house also acts as a retaining wall. It is not known if the wall perpendicular to the back wall of the house has buttresses to give it additional strength

On hilly sites slopes are sometimes retained by the back wall of the house.	Build well detailed retaining wall away from the house (also ensures water seepage through the retaining wall does not enter the house directly) If a retaining wall is part of the house ensure the wall is adequately engineered to resist the forces from the building as well as the retained ground and that there is good external drainage to guide water away from the house.
Timber base ring beam anchored to the foundations	Fixity to the foundations ensures building does not fall off its base, especially if the house has been built on a slope where the downhill side of the building is raised much more than the back of the house
When more than one storey columns are rarely continuous from floor to floor. Always a platform frame and each storey is constructed as a separate box.	Continuity of main timber columns ensures load path continuity but having discontinuous columns may provide a form of limited seismic isolation as long as the upper columns cannot get dislodged. Engineering study required to gain a better understanding of this. As a minimum ensure that the tendons connecting the upper post to the lower frame is long so that it is a good shear key. Where it is known that shear keys are not provided alternative ways to ensure upper columns do not dislodge and fall down need to be investigated, such as extending the size of the seat on to which disconnected timber columns may be bearing.

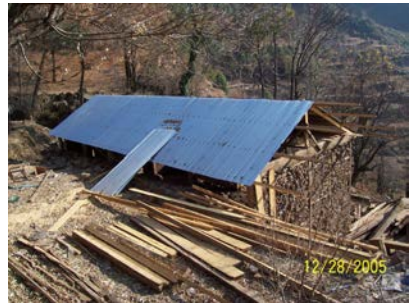
Figure 5 18. Dhajji house built into the hill side making the building act as a retaining wall. There is likely to be a stone wall at the back called a breast wall locally.

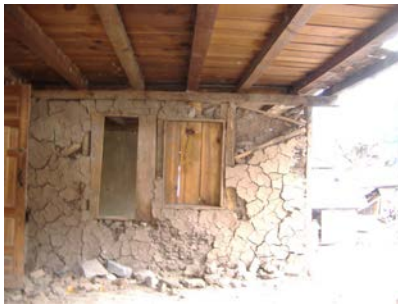
Figure 5 19. Isolated collapse of infill panel in dhajji house.

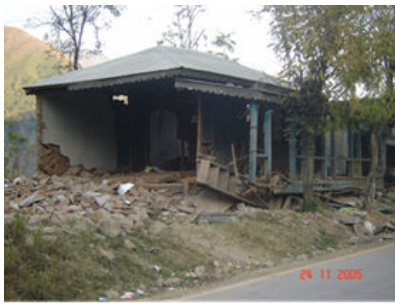
Figure 5 20. A building with dhajji in one direction, and stone URM wall in orthogonal direction

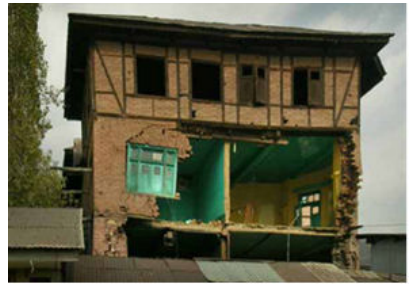
Figure 5 21. A building with dhajji in upper storey surviving although brick URM walls of lower storey toppled (Ref.: R. Langenbach, www.traditional-is-modern.net).

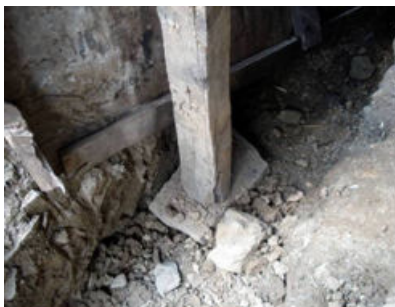
Figure 5 23. Example of effort to provide foundation to a timber post to reduce the immediate settlements under the post and provide limited protection to the timber end grain from moisture.

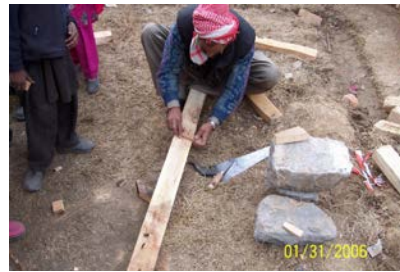
Figure 6 5. Improved tools to guide the carpenter made from scrap wood and nails on an ad hoc basis.

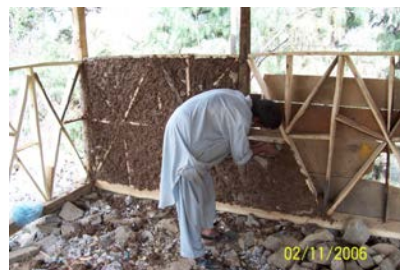
Figure 6 8. Infill construction from stone, mud and backing board that acts as temporary form work. Note: CGI as sometimes used for the form work these days and sometimes left then as permanent formwork/weather protection (used for this reason rather than to stiffen the frame). It is still the case that timber planks are most common.

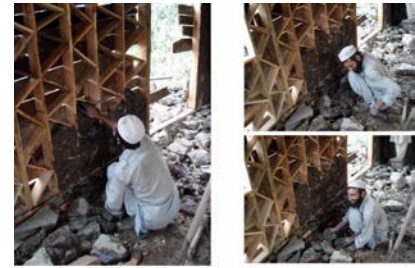
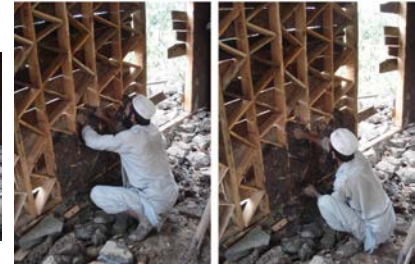
Figure 6 11. Construction of the infill walls. Note the very thin timber section sizes being used for both vertical and zigzag bracing pieces.

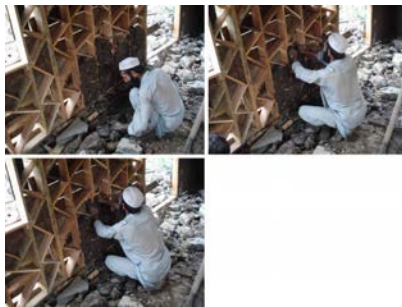
Figure 6 13. Construction of the infill walls continued. Note: Note he was breaking the stones as he went along. Previously large stones from an old unreinforced stone house on the same site.
