Incidents Associated with Oil and Gas Operations

Outer Continental Shelf 1998

This report can also be obtained on MMS's homepage at <http://www.mms.gov>

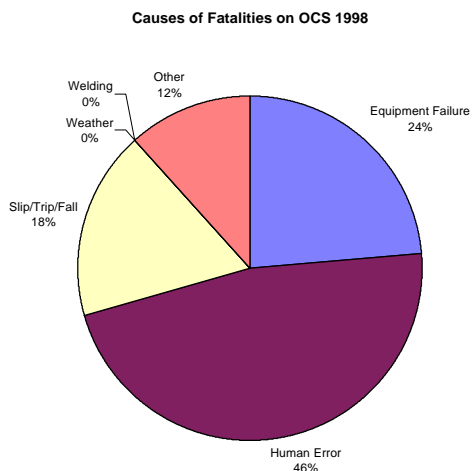
Overall, the main cause of incidents in 1998 was human error, followed by equipment failure. The majority of these incidents occurred during production operations. Fires were the most frequent type of incident reported to the MMS in 1998, followed by injuries. Both the number of fires and number of injuries recorded in TIMS tripled from 1995 to 1997 (Appendix A). Part of this increase may be a result of changes in Gulf of Mexico (GOM) record keeping requirements effective August 1996. The 1998 fires and injuries showed a return to the 1996 levels. The majority of the reported injuries were minor.

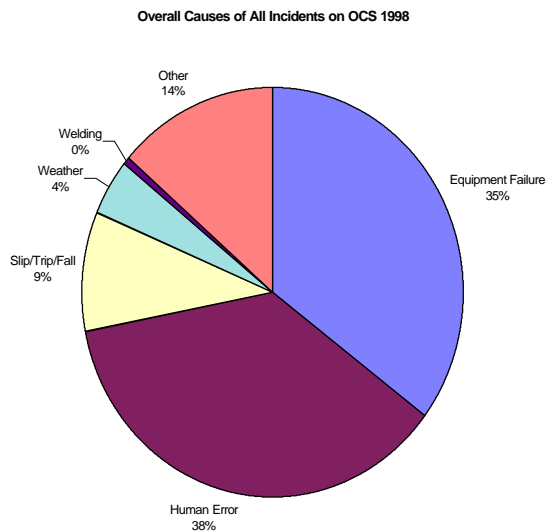
- The primary causes of fatalities (14) were human error (8) and equipment failure (4). The 14 deaths were the result of 11 individual incidents. Three of the 11 individual incidents resulted in multiple fatalities.
- Explosions (4) were a result of equipment failure (2) and human error (2), resulting primarily from production operations.
- Overall, the main cause of incidents in 1998 was human error (75), followed by equipment failure (72).

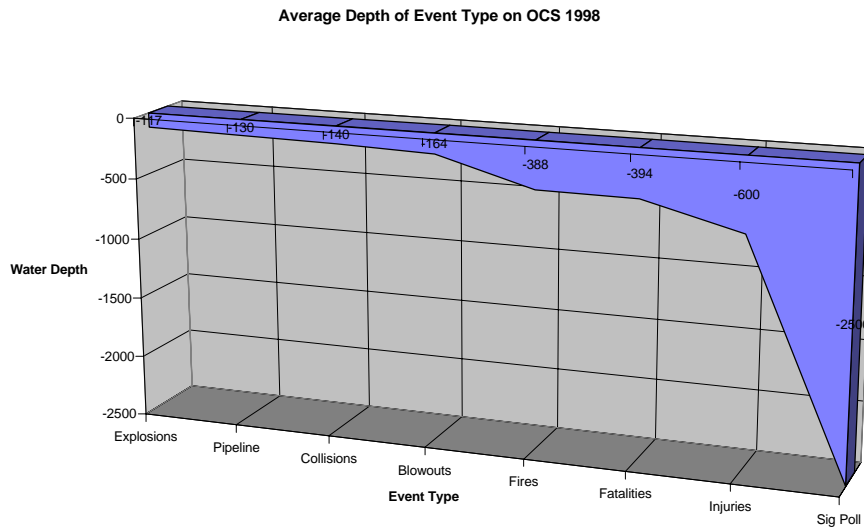
The chart below shows the average water depth of each of the types of incidents on the OCS. Most of the incident types occurred in water depths less than 1,000 feet. The only exception was significant pollution events. These greater than 50 bbl spills occurred at an average water depth of 2,500 feet, significantly deeper than the rest of the incidents.

There were at least 21 deepwater incidents in 1998 according to the Accident/Incident forms and the Accident Investigation Reports contained in our TIMS database. Incidents were mostly minor, involving personnel injuries and fires. There were eight injuries and eight fires. There were also four significant pollution events in deepwater with an average spill size of 100 bbl.
