Intel Atom[®] Processor E3800

Specification Update

(Formerly Bay Trail -I SoC)

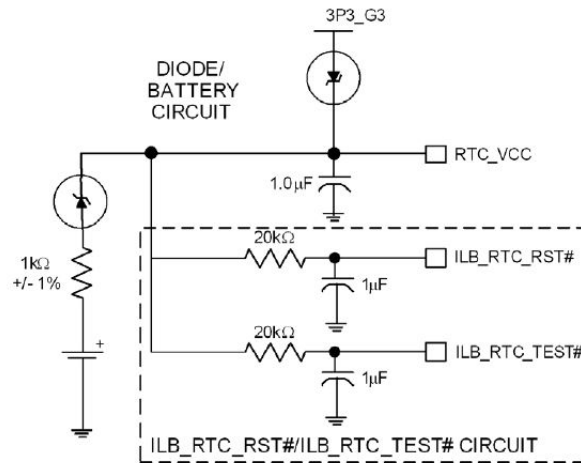
The RC delay between RTC_VCC to ILB_RTC_TEST and ILB_RTC_RST, Figure 21-4 in Section 21.2.3 of the PDG (Doc ID #512379) is obtained by using the formula $t = -\ln((RTC_VCC - V_{ih\ min})/RTC_VCC) * R * C$ and the added circuit is as follows:

The SoC RTC requires some additional external circuitry. The ILB_RTC_RST# and ILB_RTC_TEST# signals are used to reset the RTC well. The external capacitor and the external resistor between ILB_RTC_RST#/ILB_RTC_TEST# and RTC battery (VBAT) were selected to create an RC time delay, such that ILB_RTC_RST# and ILB_RTC_TEST# go high sometime after the battery voltage is valid. The RC time delay should be in the range of 18-25 ms. When ILB_RTC_TEST# is asserted, bit 2 (RTC_PWR_STS) in the GEN_PMCON_1 (General PM Configuration 1) register is set to 1, and remains set until software clears it. Hence, when the system boots, the BIOS recognizes that the RTC battery is removed.

2. ILB_RTC_TEST# and ILB_RTC_RST# RC Time Delay Calculation Formula
