IV. OPERATIONS RESUME, DSDP, LEG 36

Otis M. Moore, Amoco Production Company, Lafayette, Louisiana

INTRODUCTION

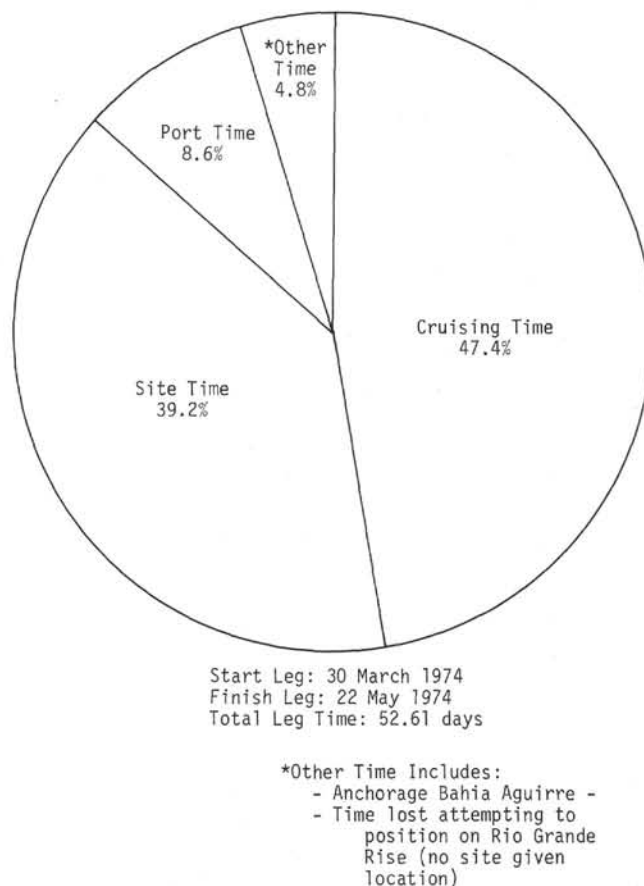
Figure 1. *Deep Sea Drilling Project total time distribution, Leg 36.*

Time distribution for the 52.61 days total leg time was 24.93 days cruising, 20.65 days on site, 4.52 days port time, and 2.51 days other time (Figure 1). Total site time of 20.65 days was divided into 6.09 days coring, 1.79 days drilling, 5.52 days trips, 5.55 days wait on weather, 1.04 days lost to dynamic positioning problems, 0.66 days other time (includes mechanical downtime, routine maintenance, etc.). (See Figure 2.)

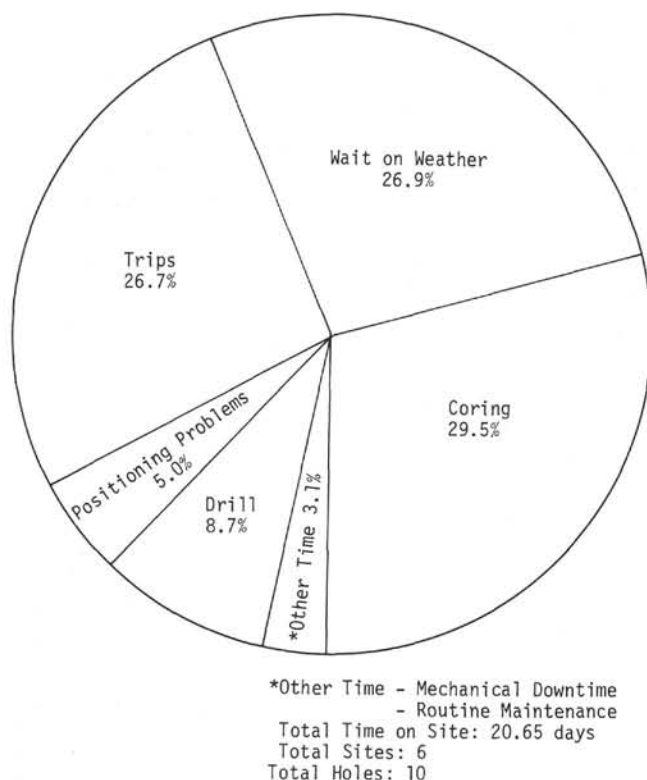
Figure 2. Deep Sea Drilling Project site time distribution, Leg 36.
