REDUCING EARTHQUAKE DAMAGE THROUGH QUALITY CONSTRUCTION

CREATED BY **MARYANN PHIPPS**

This presentation was created and originally presented by Maryann Phipps, formerly Principal, *Degenkolb Engineers*, at the EERI Workshop on Construction Quality and Seismic Education, April 1997.

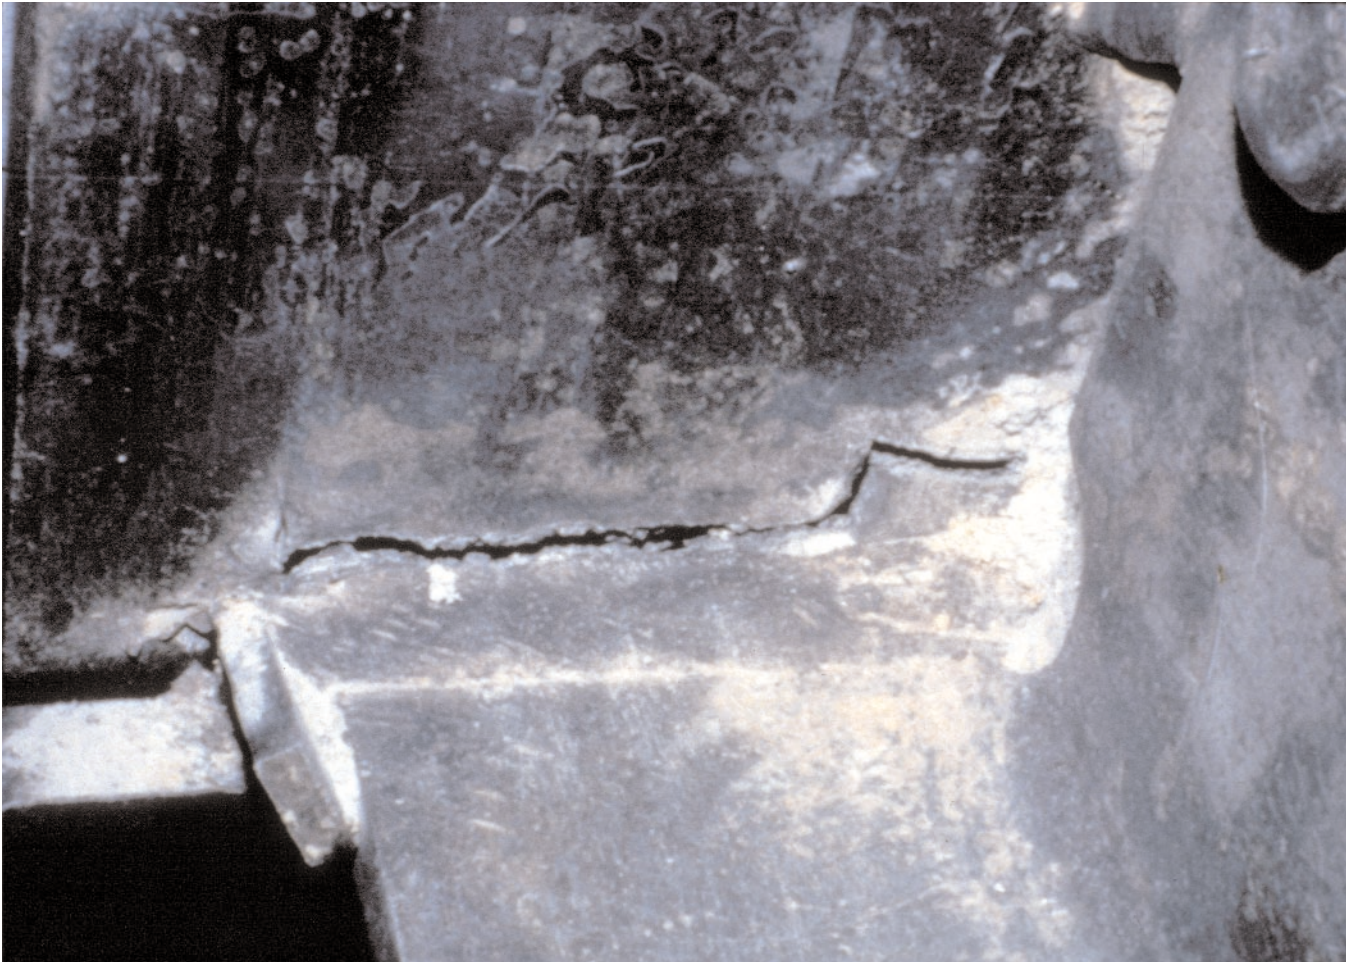
Slide #6

We learned in the Northridge, California earthquake in 1994 that without excellent quality control during the construction of welded moment steel frame buildings, we can end up with cracking in the connections. We need good quality inspectors overseeing good quality welders. Here we see a crack in the column where the bottom flange of a beam frames into the column. This connection is in a welded steel moment frame damaged in Northridge.

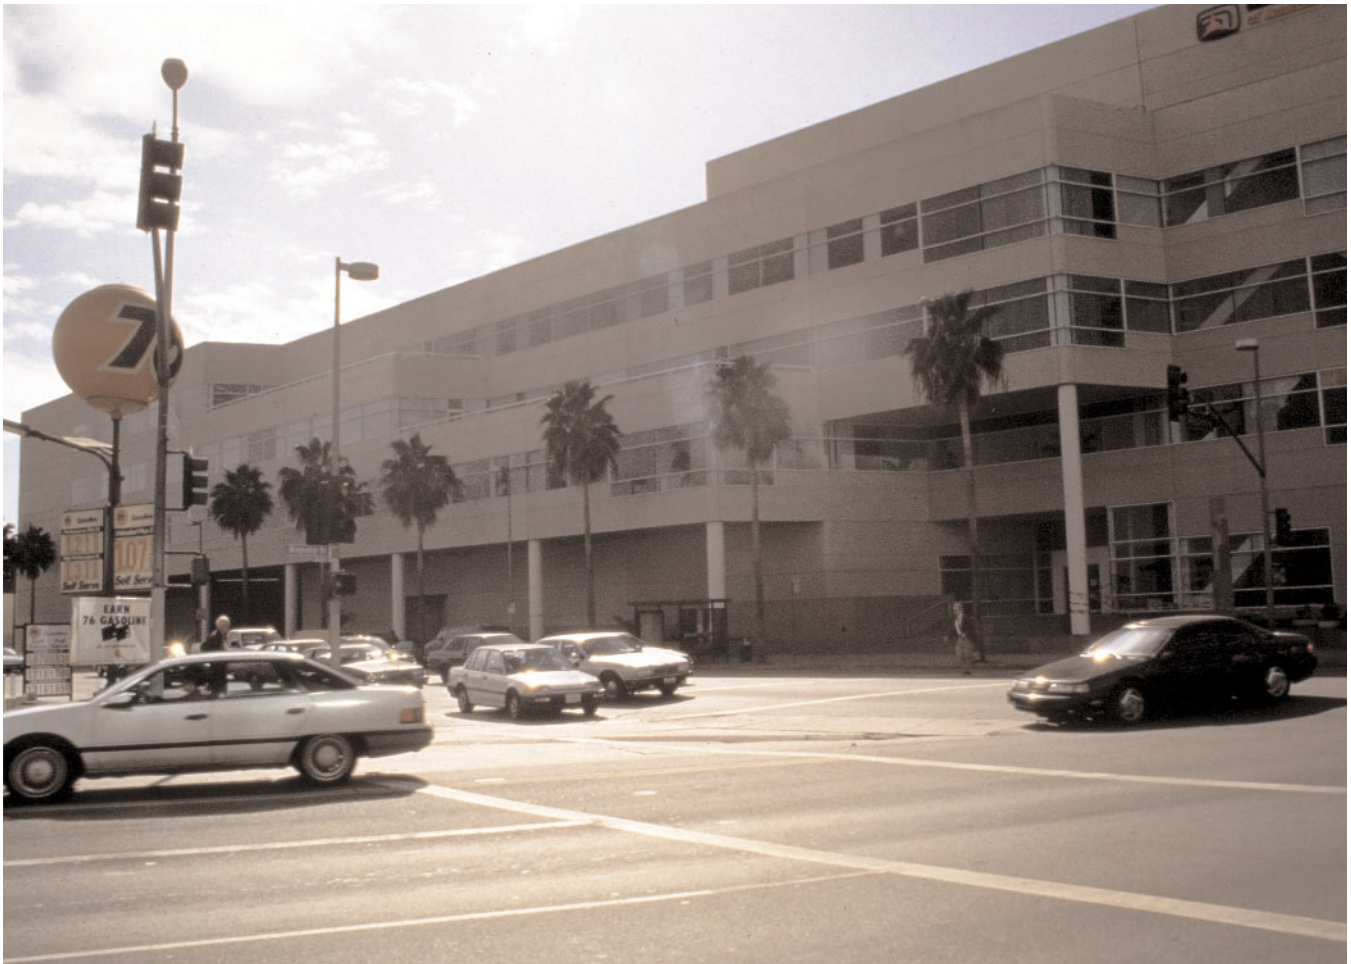
Slide #7

This is an exterior elevation of a four-story steel braced frame building damaged in the Northridge earthquake. The building was designed in accordance with the 1985 Uniform Building Code.

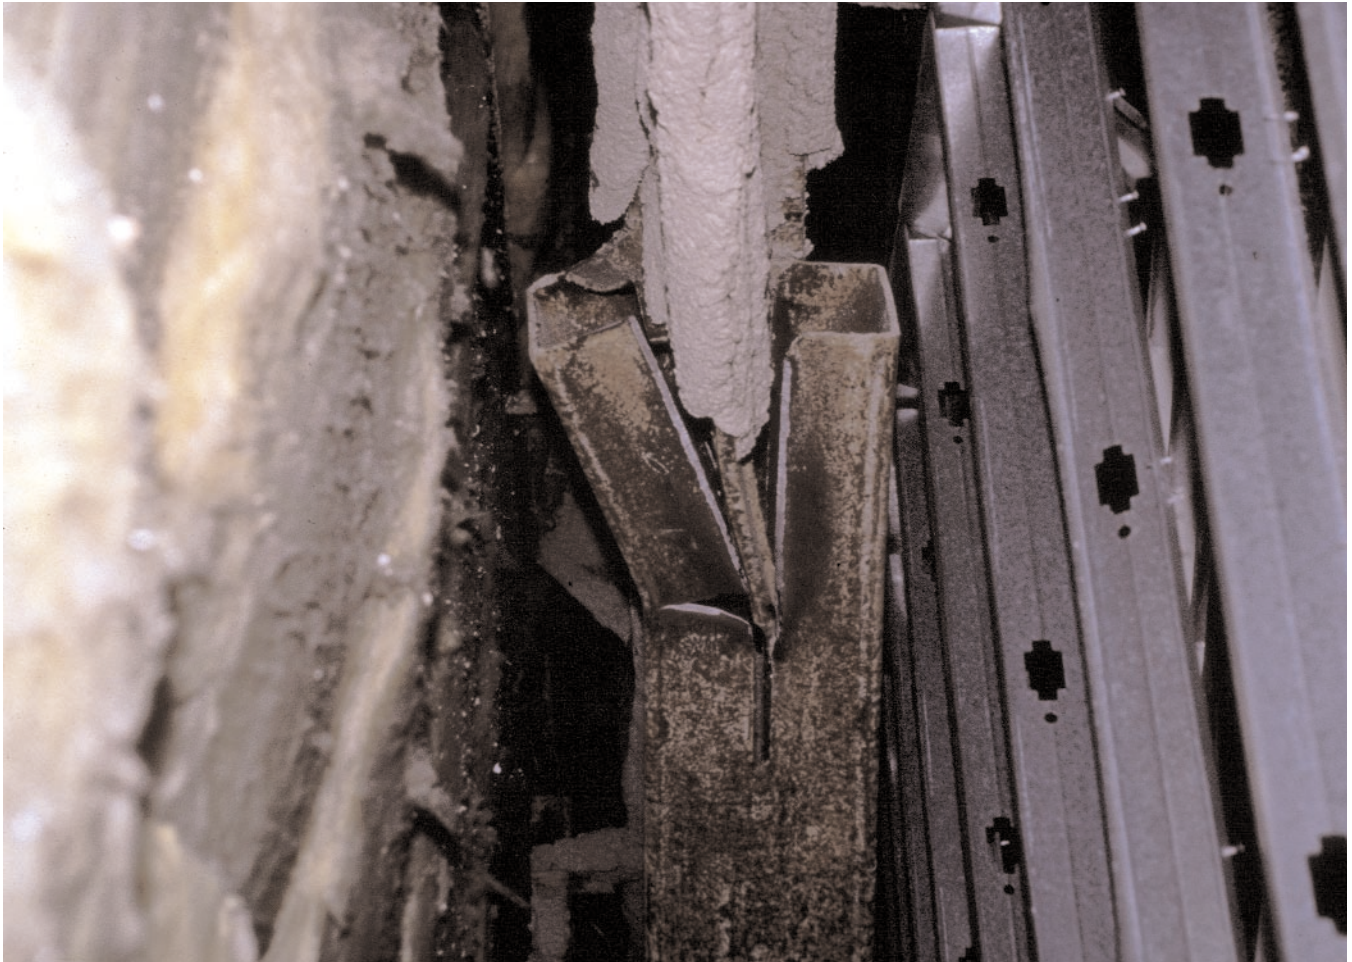
Slide #8

Dozens of steel braces failed in this building. One reason is because of incomplete welding of the brace to the gusset plate. The right side was welded and the left side was not.

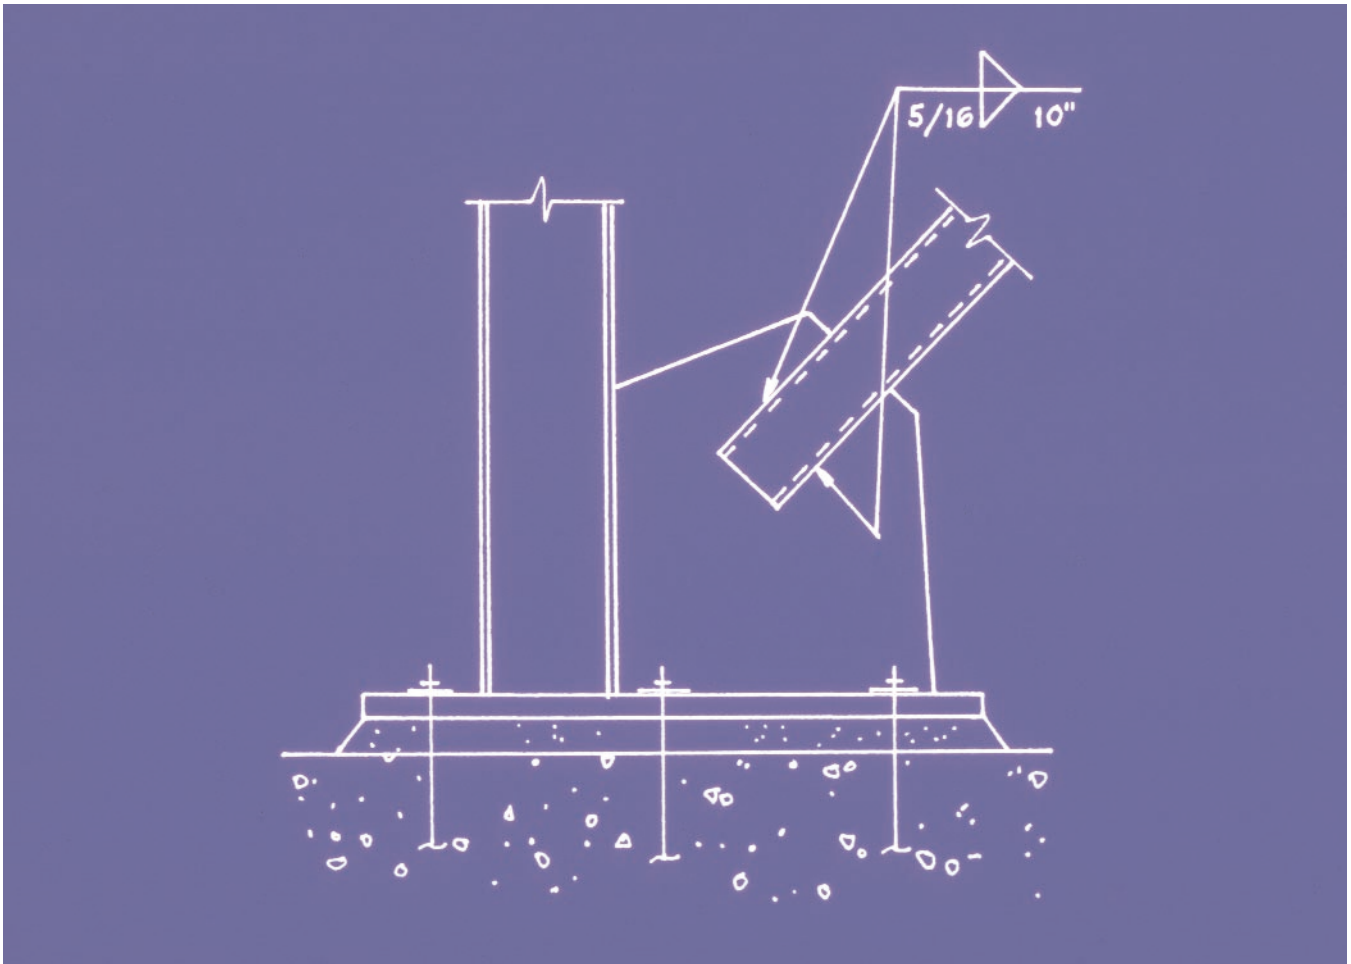
Slide #9

This is a connection detail drawing showing a correct weld symbol for both side welding of a brace to a gusset plate.

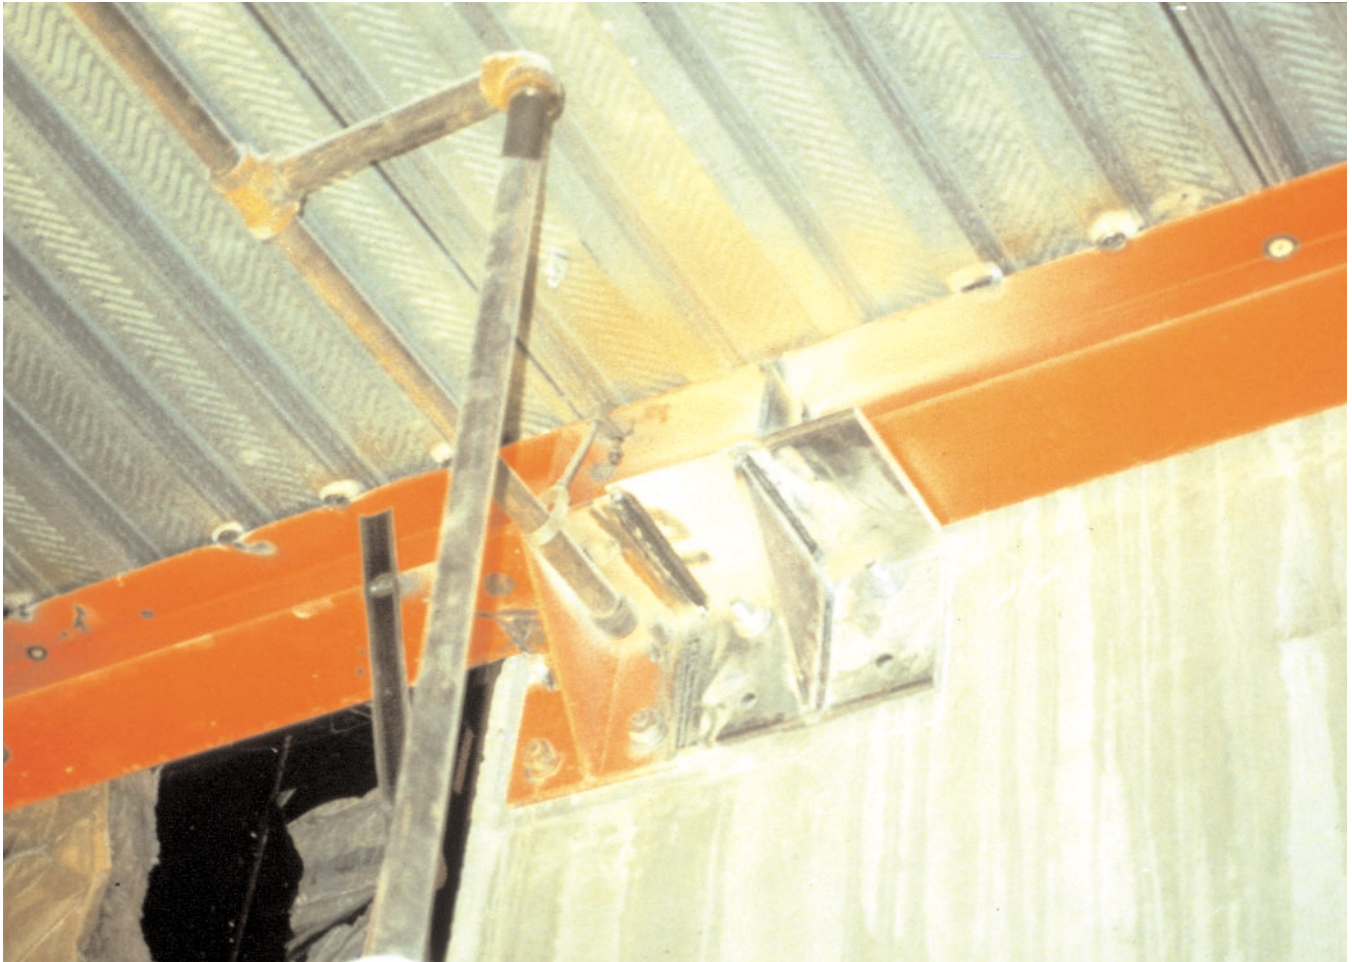
Slide #10

This is the inside of a two-story steel braced frame in Palo Alto, California damaged in the 1989 Loma Prieta earthquake. Problems were caused in that earthquake because the roof diaphragm has to be able to transfer the load to the steel braced frame. As you can see here the roof deck was a steel metal deck without concrete fill. This deck acts as a diaphragm and the load should have been transferred through a direct connection between the deck and the frame.

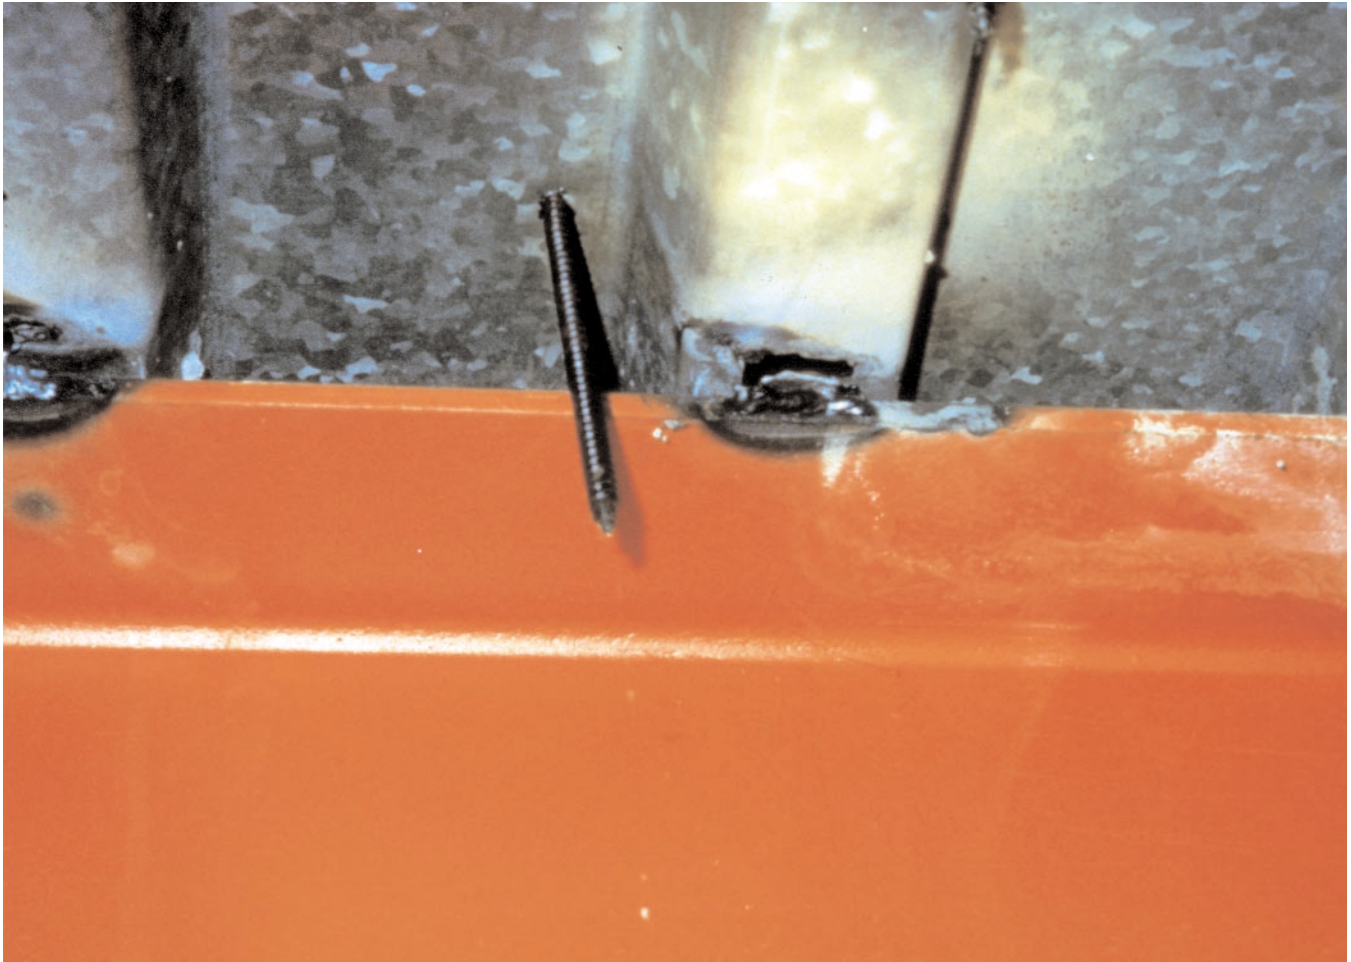
Slide #11

Unfortunately the welder welded right through the deck. There was poor quality control on the welder's part in making the connection, and poor control on the part of the inspector who didn't notice or didn't have time to check. Of all the deck to beam welds that were made, these are the most critical because it is at this location that horizontal earthquake forces are transferred to the frame that is designed to resist those forces.

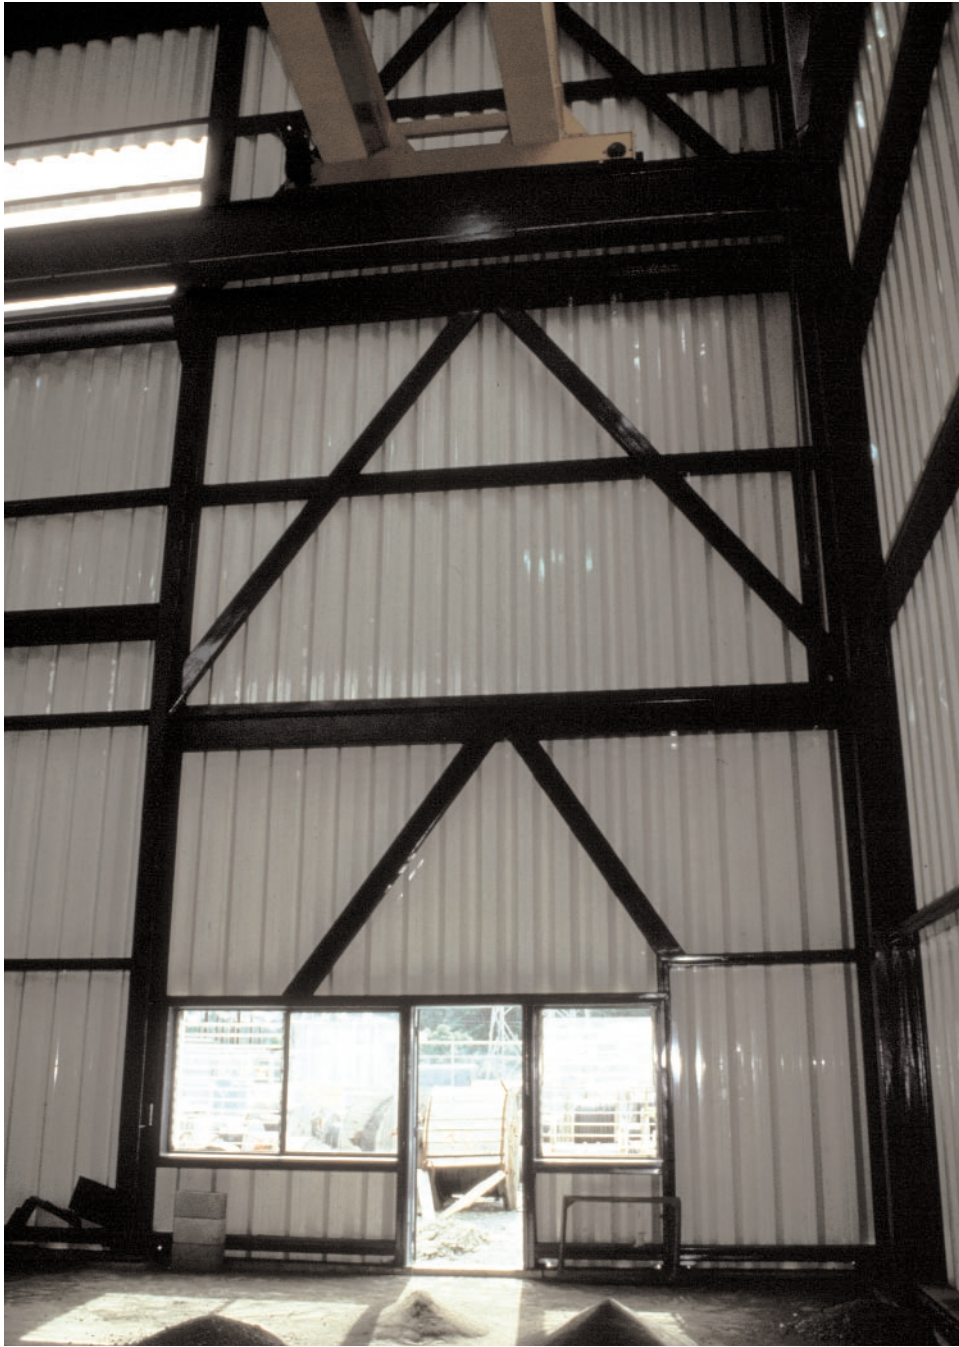
Slide #12

Quality control doesn't end with the construction of the building. It continues on with maintenance. This is a light steel braced frame building. After construction the windows were added, cutting off the braces. This modification completely obliterated the lateral system in this location.

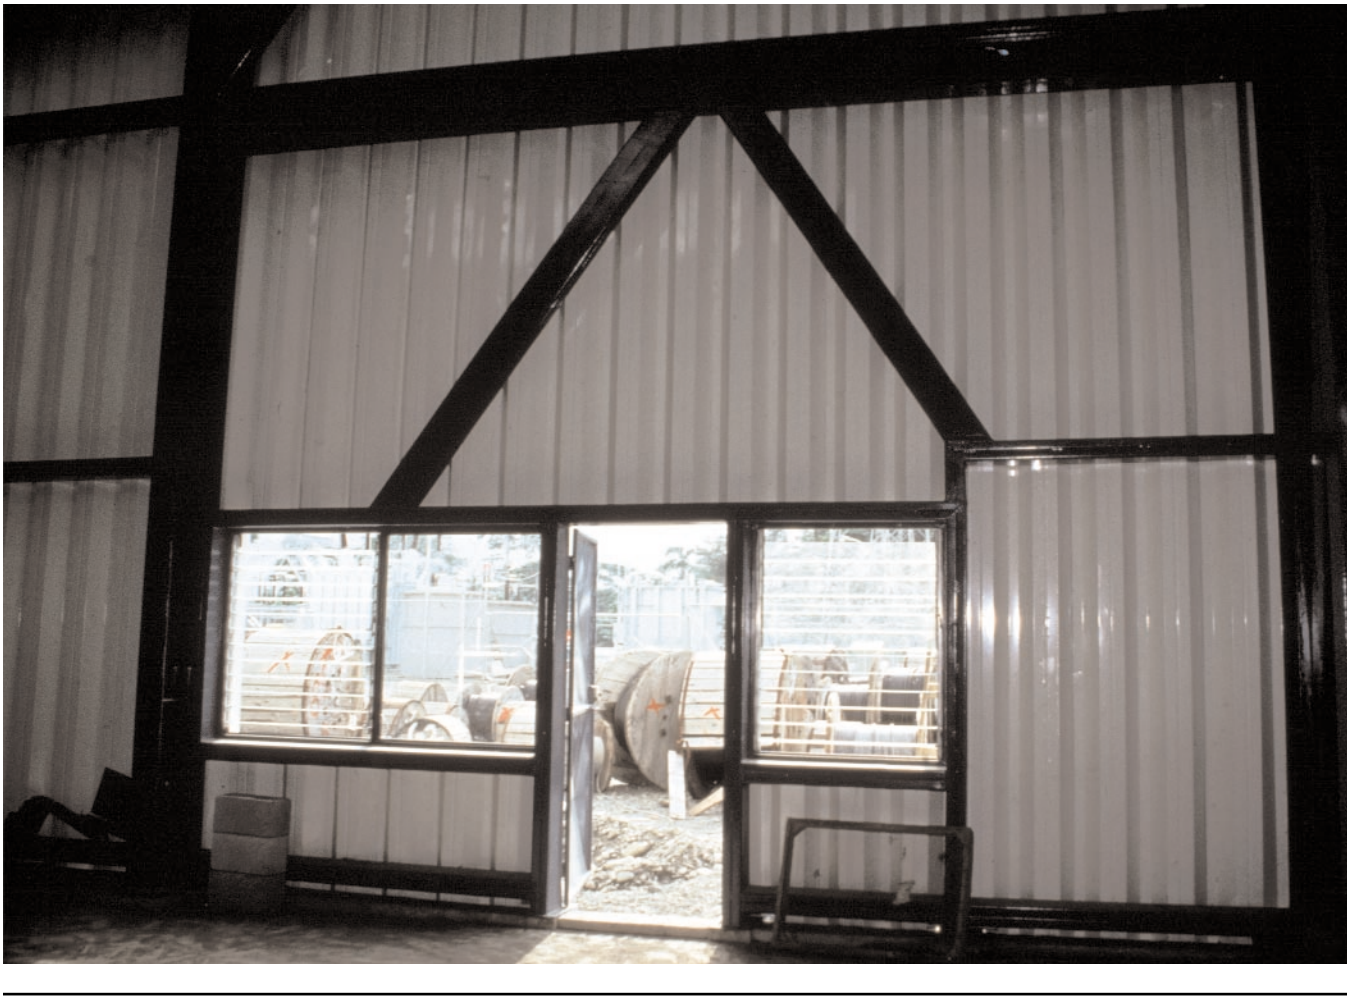
Slide #13

The bottom braces won't do any good in an earthquake because they are unable to transfer any kind of earthquake load from the frame above to the foundation.

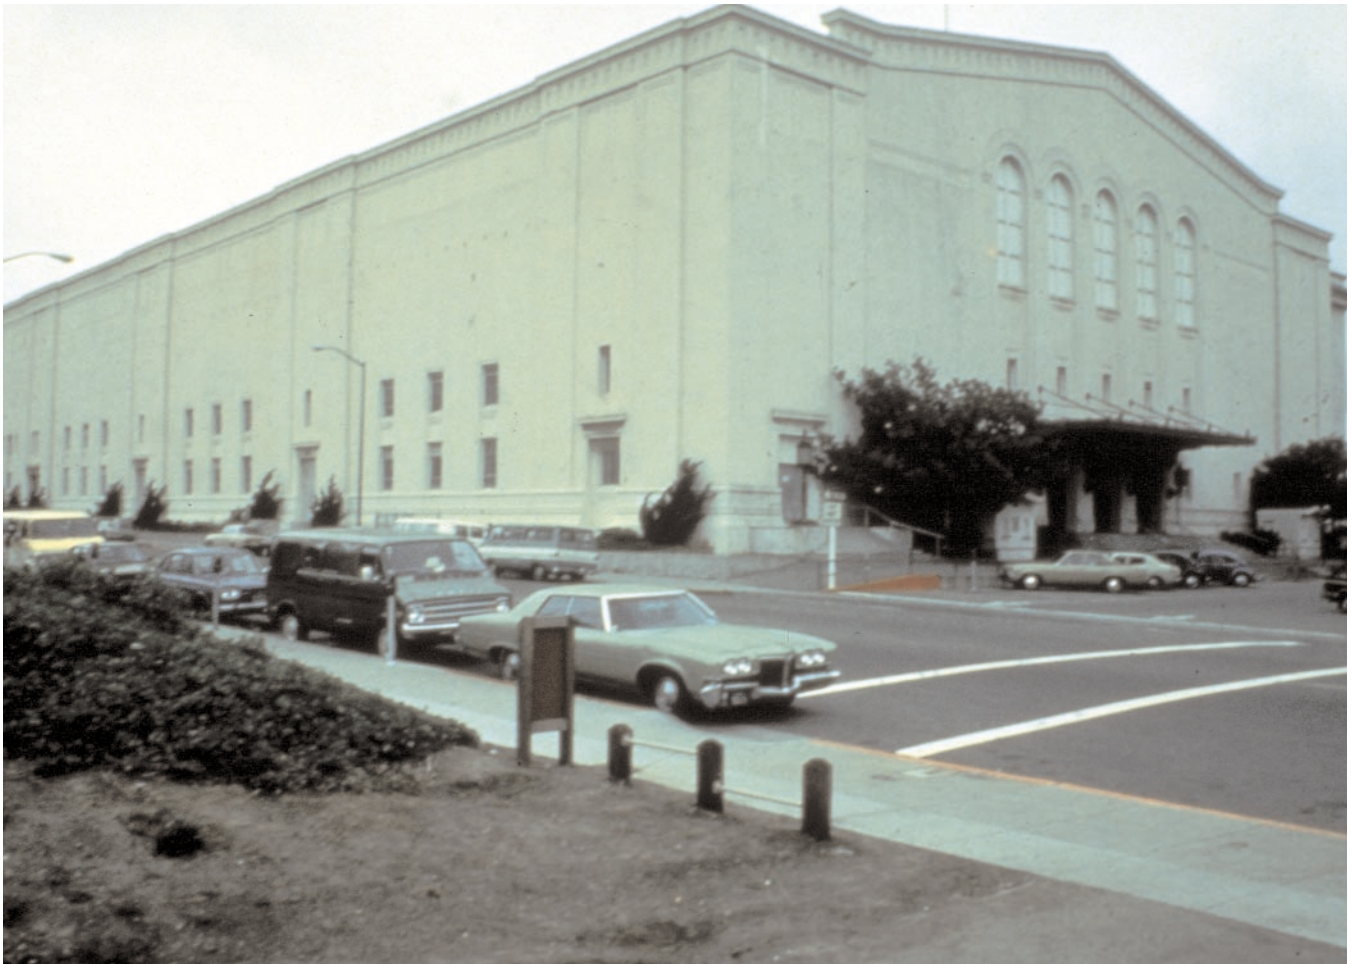
Slide #15

This is the Kaiser Convention Center in Oakland, California. During an evaluation of the expected seismic performance of the building, conducted as part of a renovation, concern was expressed about the quality of the concrete in the walls. The engineers listened, by tapping along the walls at various intervals and decided that the walls sounded hollow.

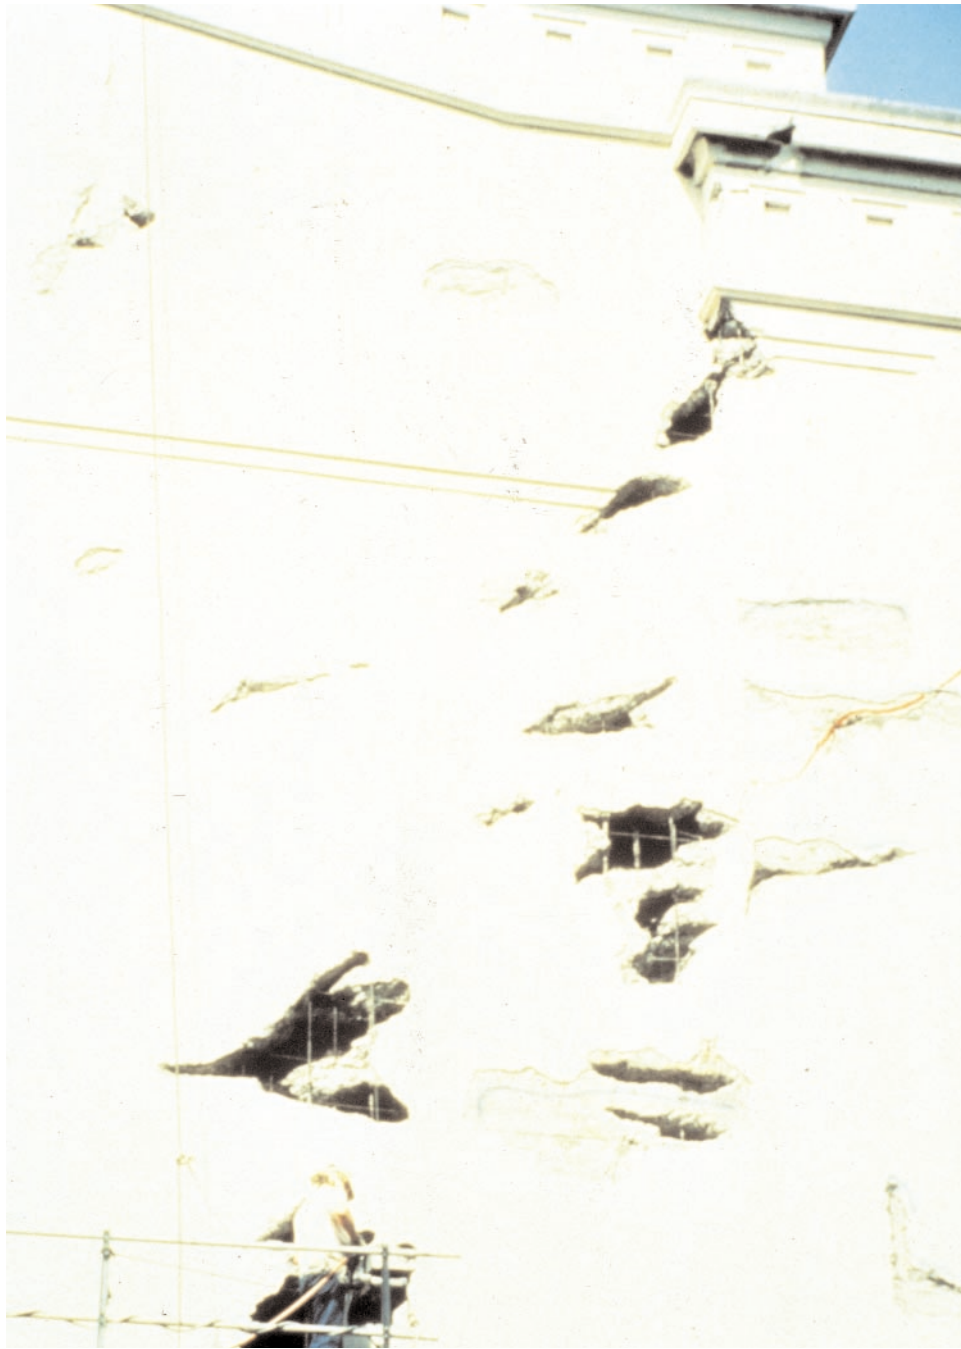
Slide #16

They took out a lot of loose material. Without appropriate vibration to consolidate the concrete as it is poured, and close observation by inspectors during concrete pouring operations you can get rock pockets and voids which seriously weaken the walls.

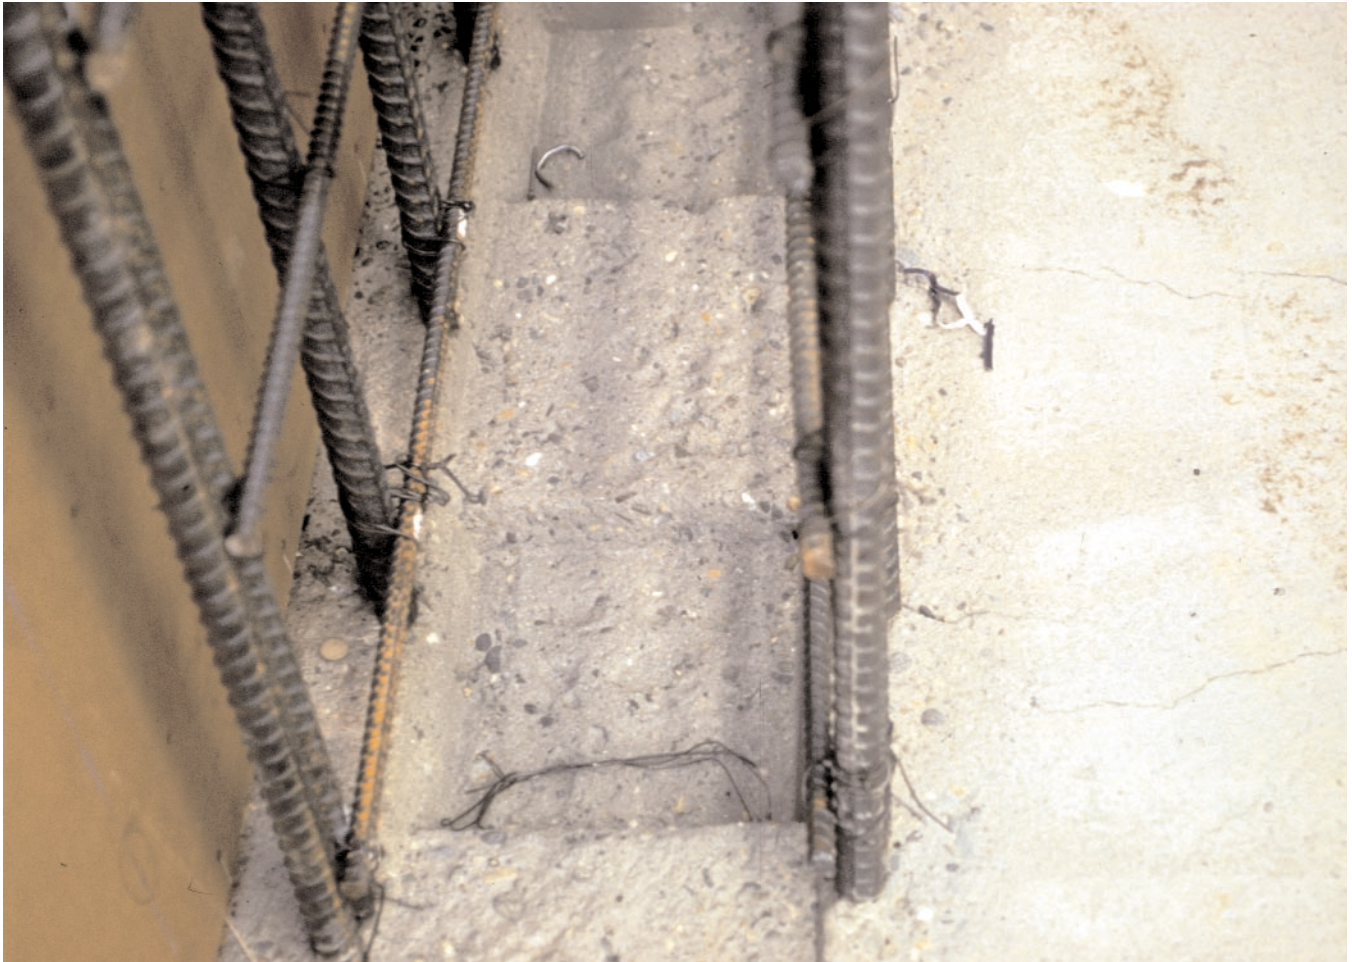
Slide #17

This is a horizontal construction joint in a wall. This is a very vulnerable element in a building. It is a weakened plane to begin with, and the joint is critical to the ultimate quality of the wall. Just before you pour the concrete you must make sure the joint is clean. Otherwise, during an earthquake, there will be a tendency for sliding along the joint.

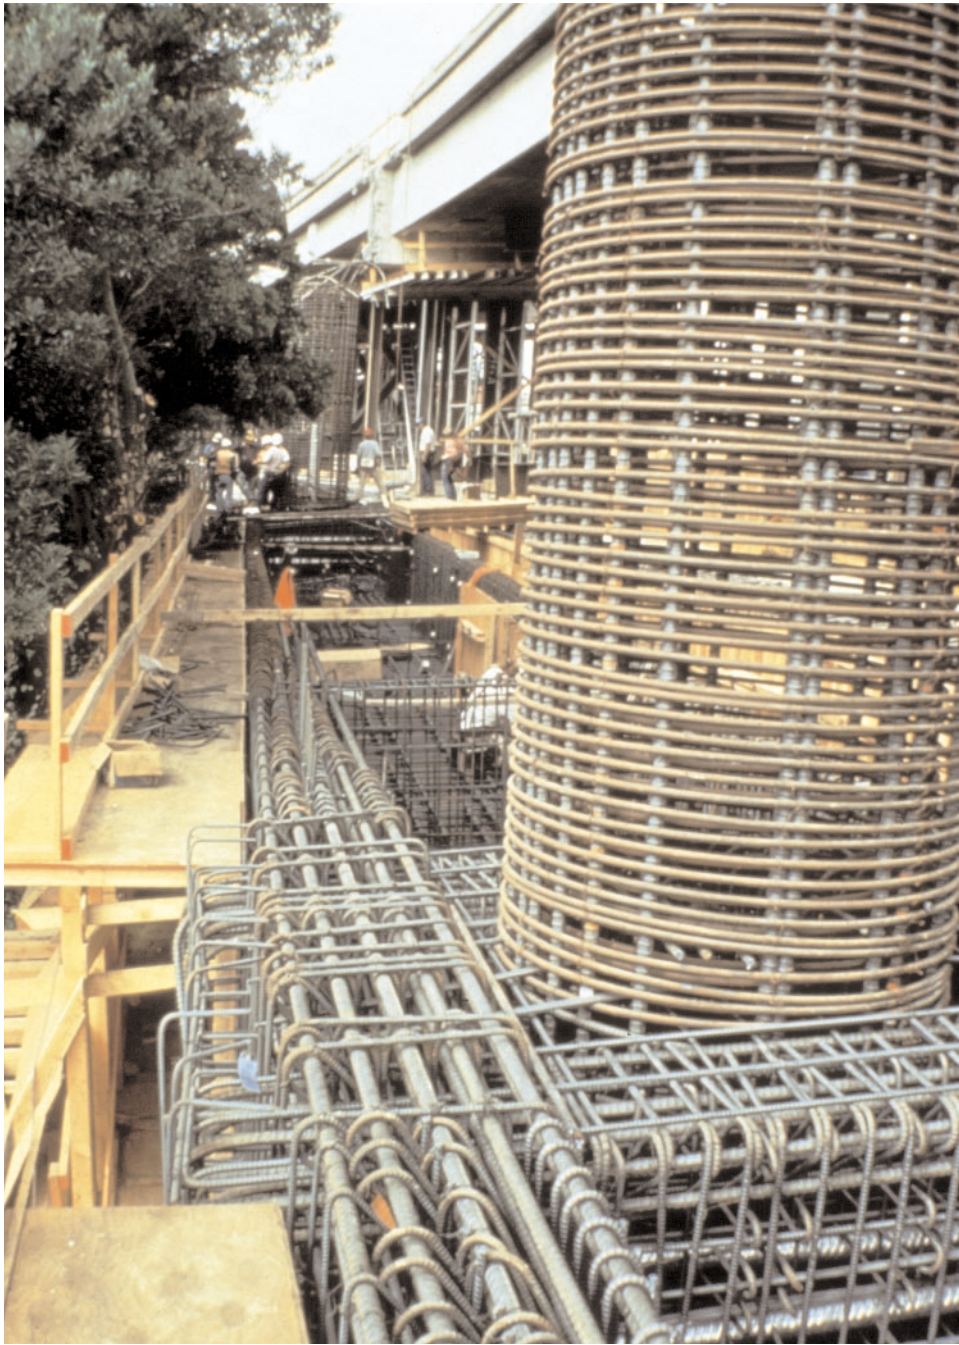
Slide #19

In earthquake country reinforcement is used to provide confinement for the concrete. Confinement is what gives concrete its ductility. Without proper confinement, concrete is brittle, and breaks apart under the movement caused by an earthquake.

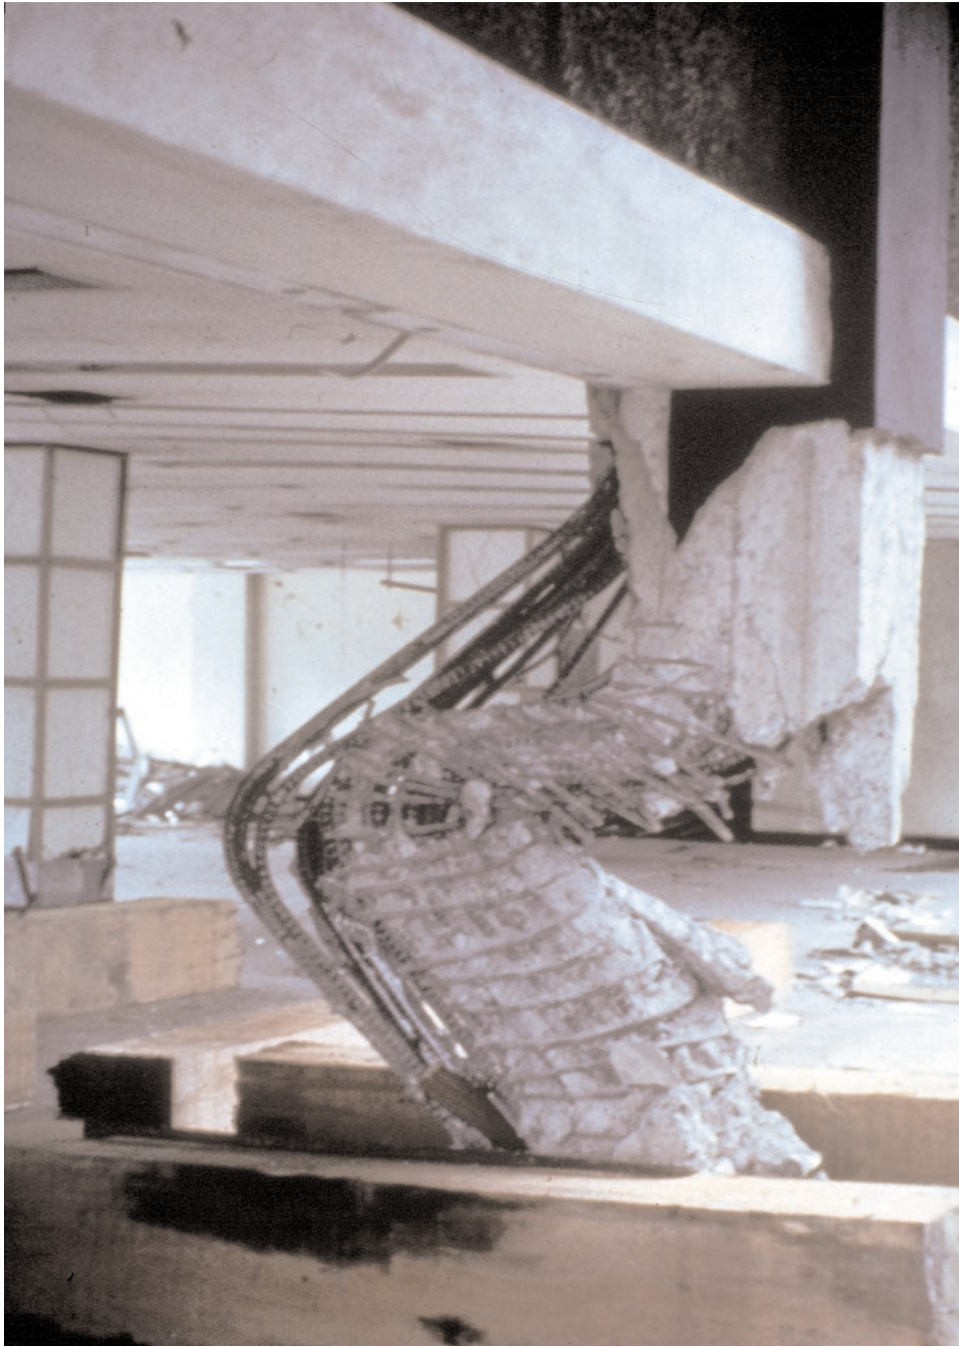
Slide #20

This is a concrete column that supported a 5-story concrete office building that was damaged in the 1972 Philippines earthquake.

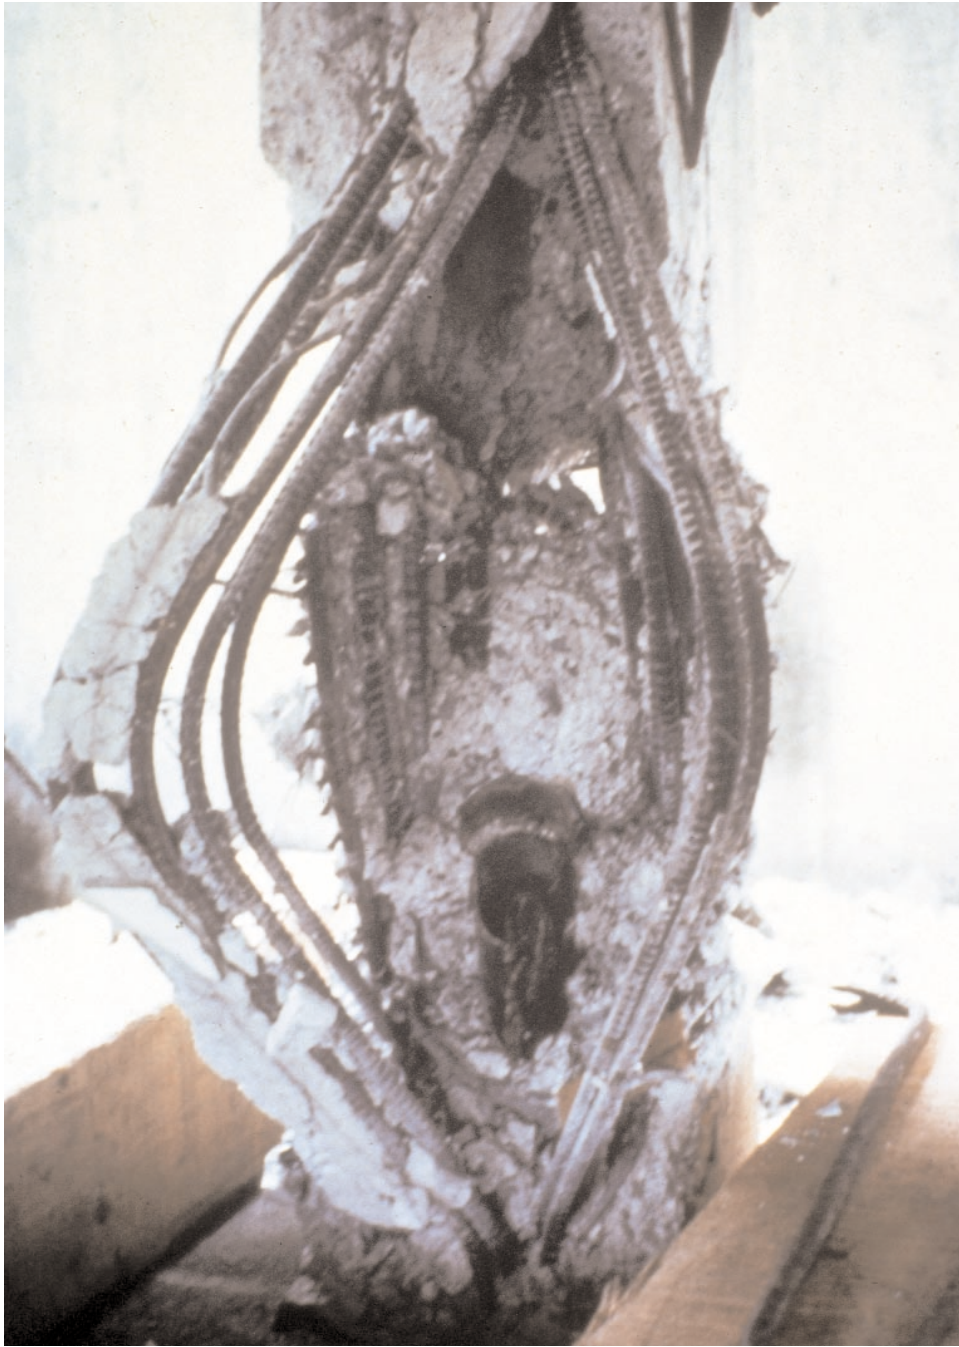
Slide #21

The column failed because all of the column ties were cut so a roof drain could be installed. This is what happens if you have no ductility. This is a dramatic illustration of the effect the "non-structural" trades can have on a building's performance in an earthquake.

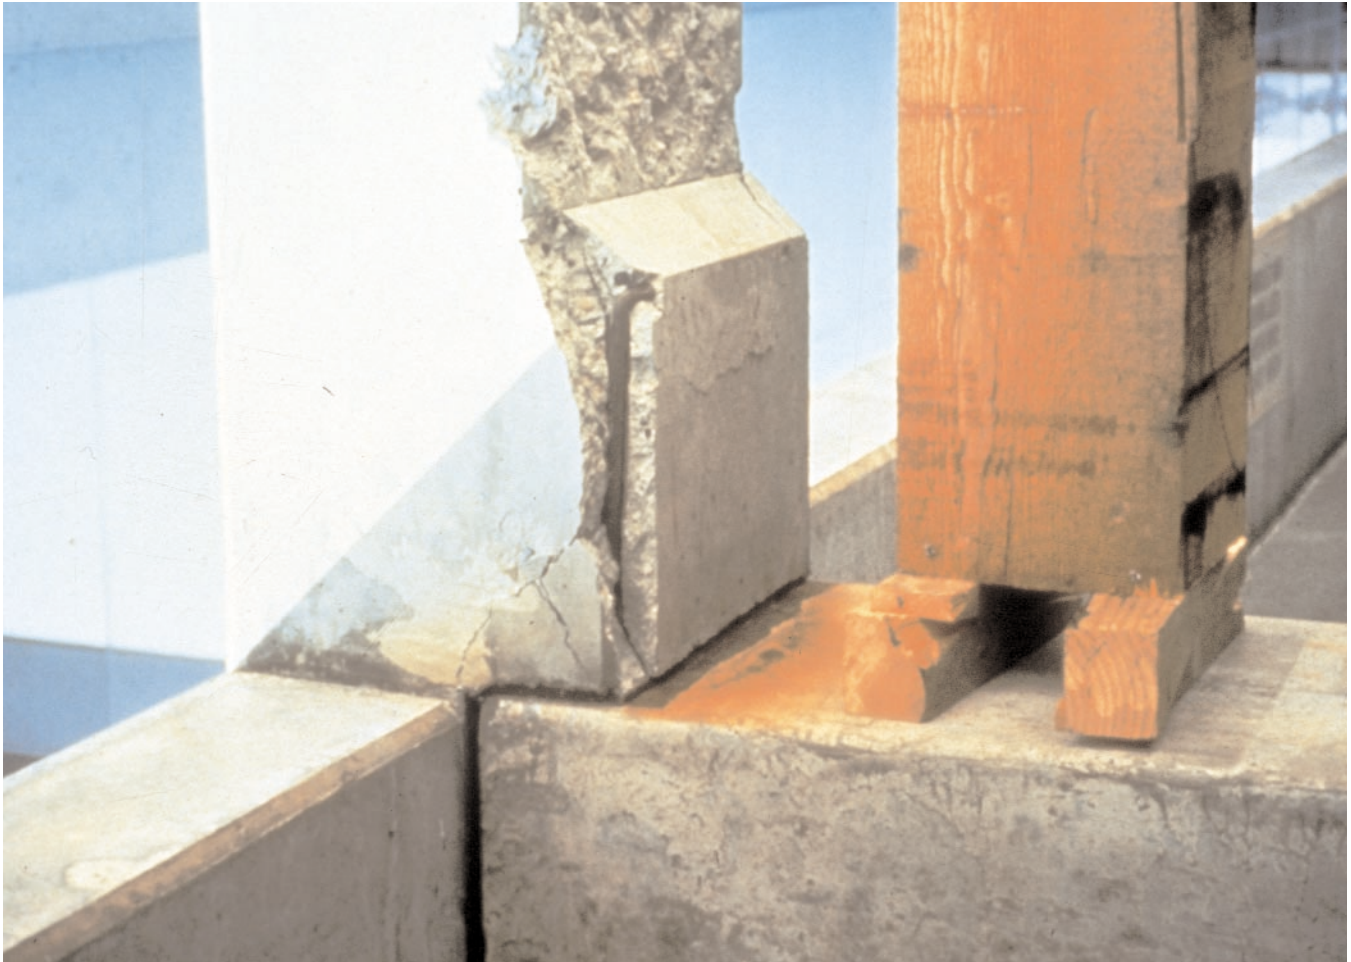
Slide #22

In this slide we can see a rebar anchor that had been placed too close to the edge. Location is critical to rebar performing as it should during an earthquake. When it is too close to the edge, as here, it won't be able to provide the necessary confinement for the concrete. The placement of rebar is very important. Even small deviations in rebar location can significantly reduce concrete's strength and ductility.

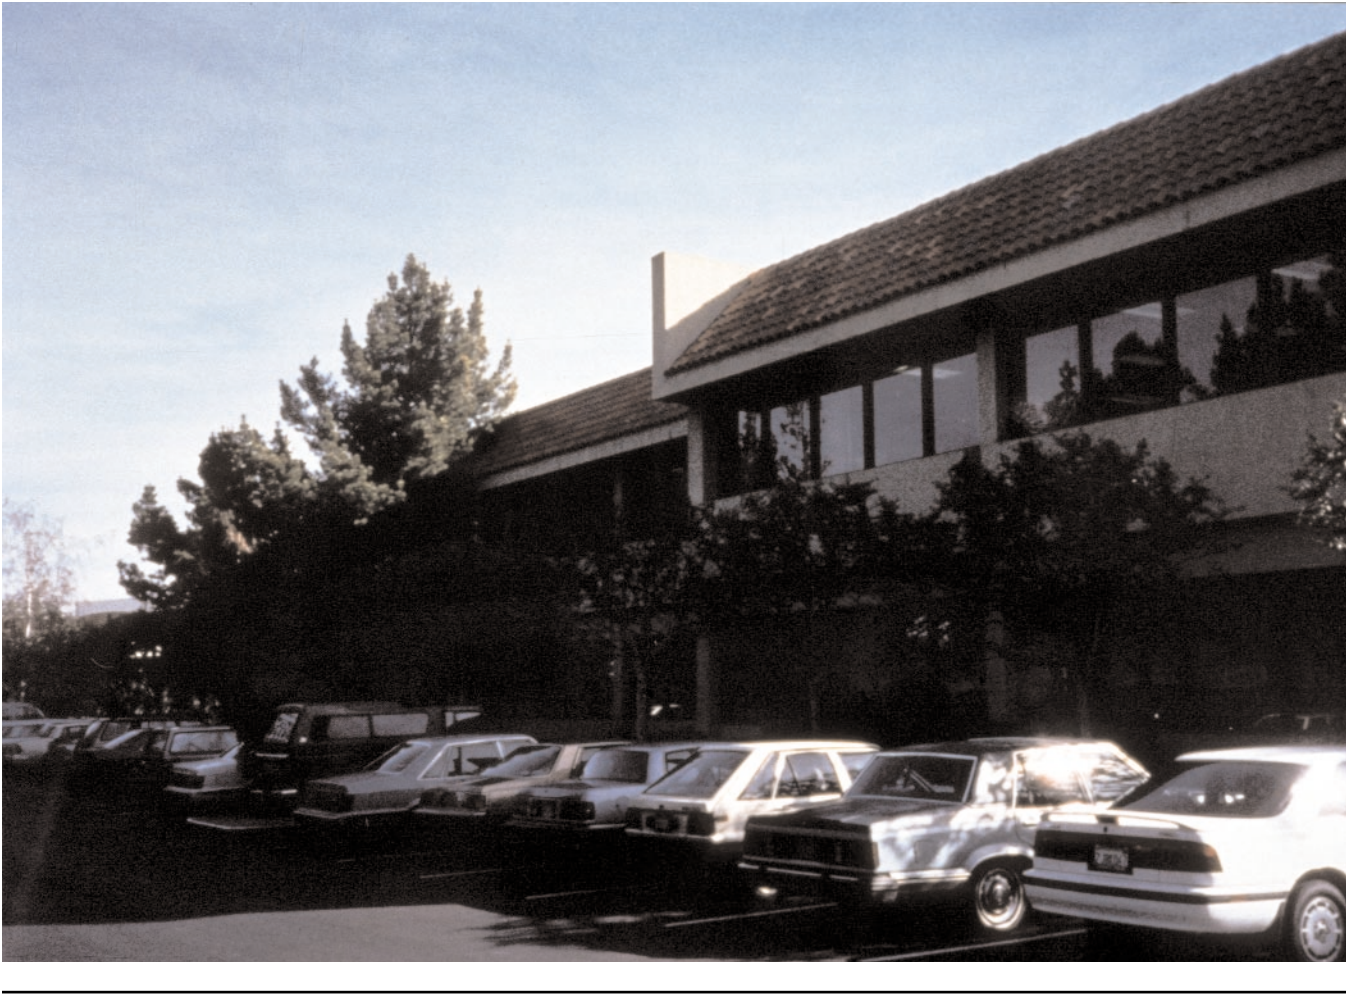
Slide #23

This is a two story steel braced frame building that was damaged in the Loma Prieta earthquake.
