REDUCING EARTHQUAKE DAMAGE THROUGH QUALITY CONSTRUCTION

CREATED BY **MARYANN PHIPPS**

This presentation was created and originally presented by Maryann Phipps, formerly Principal, *Degenkolb Engineers*, at the EERI Workshop on Construction Quality and Seismic Education, April 1997.

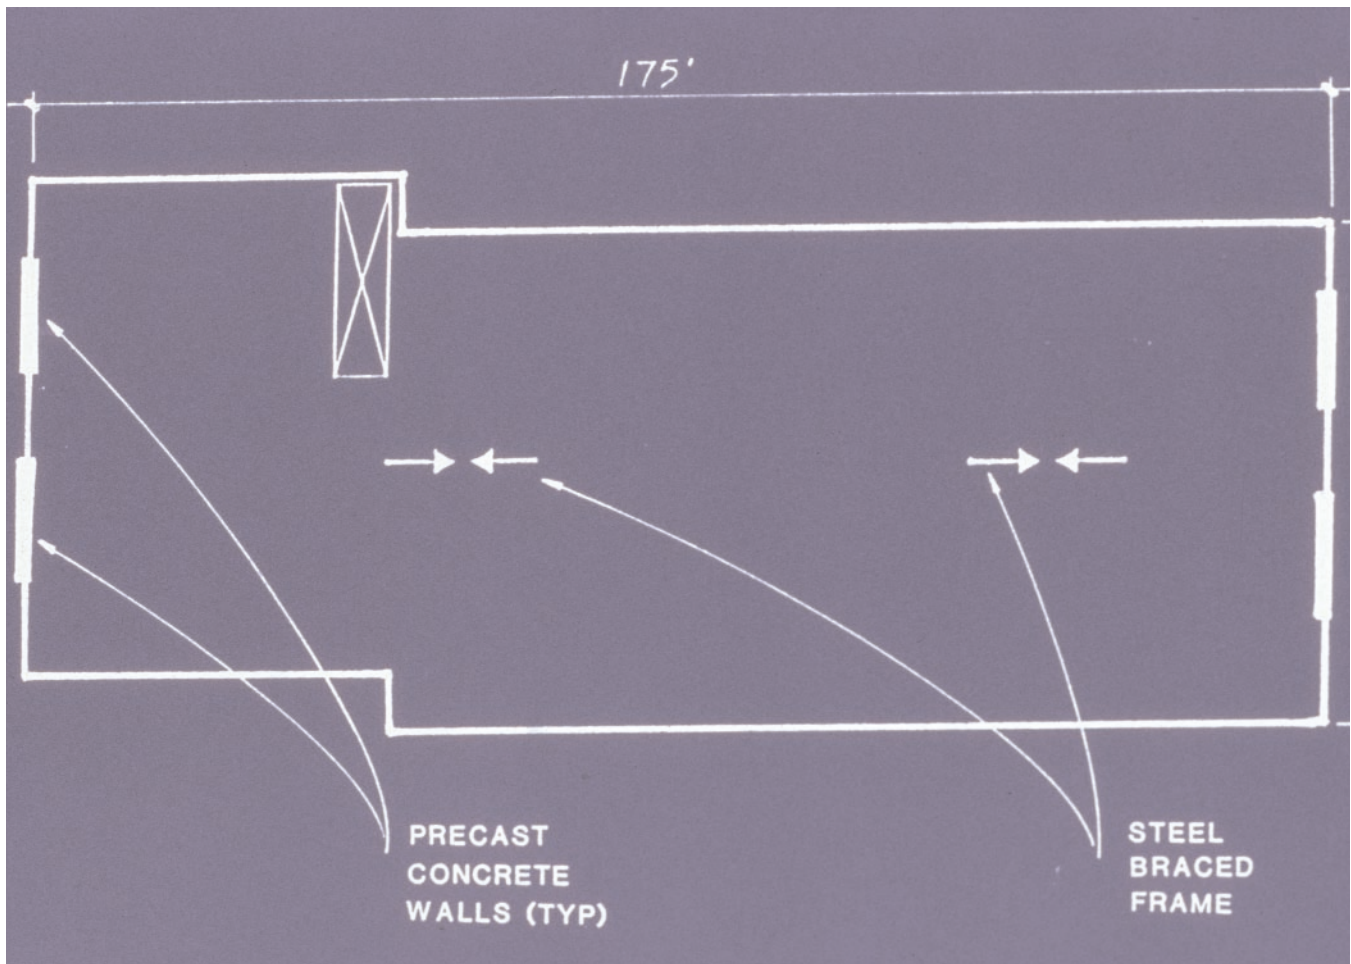
Slide #24

This is a floor plan of the building. You can see that the lateral system for the building in the short dimension direction, also called the transverse direction, consists of concrete shear walls at both ends of the building.

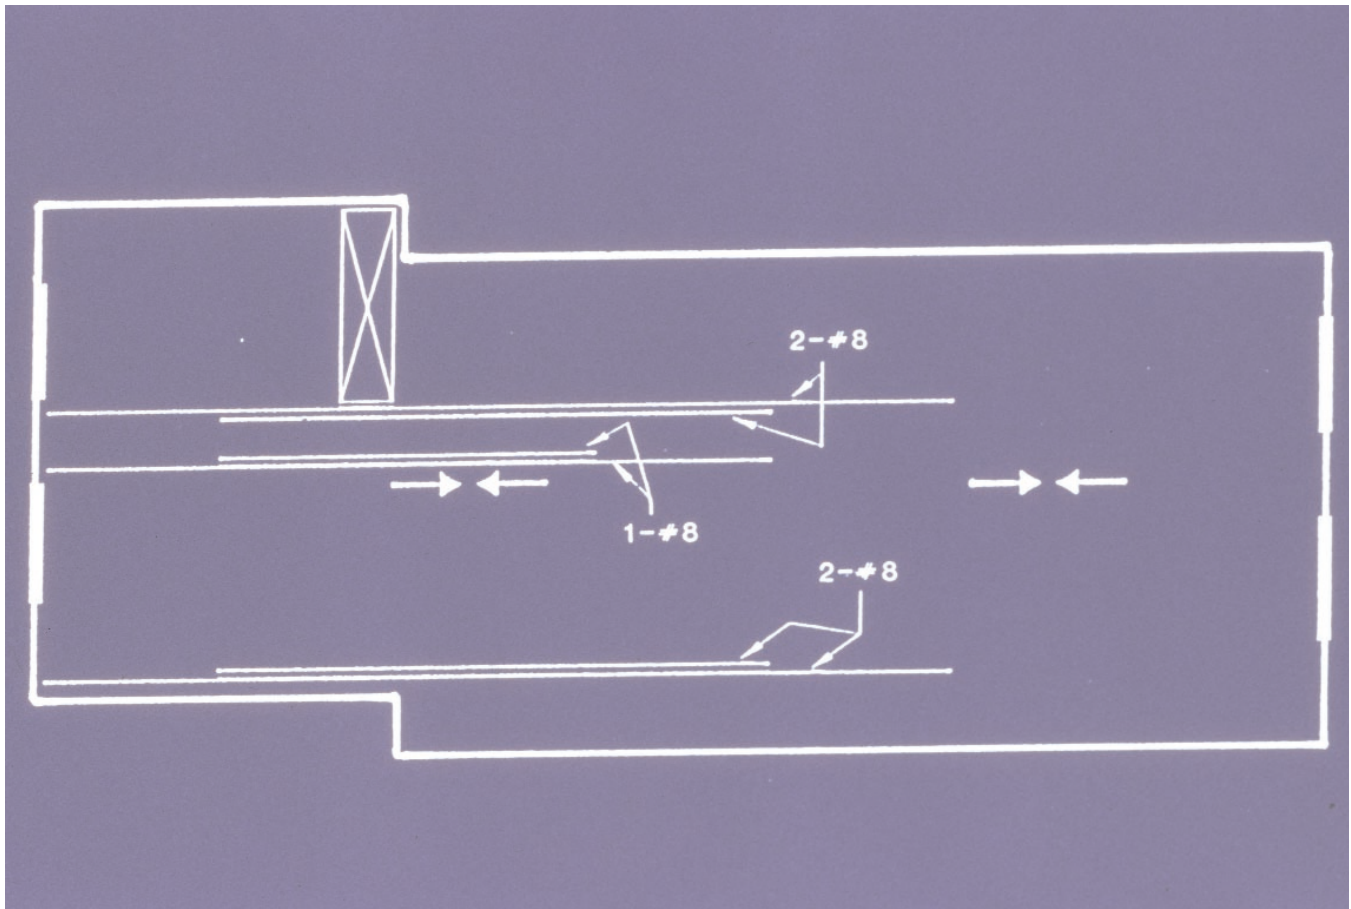
Slide #25

Remember from some of our earlier slides that the floor diaphragm transfers the seismic loads to the walls. When you have large openings you have to think through your design carefully to make sure the load path is continuous. Because of the presence of the stairway opening in this building, the designer specified additional rebar in the floor diaphragm. This plan view shows the additional rebar that the engineer indicated to complete the force or load transfer around the stair opening.

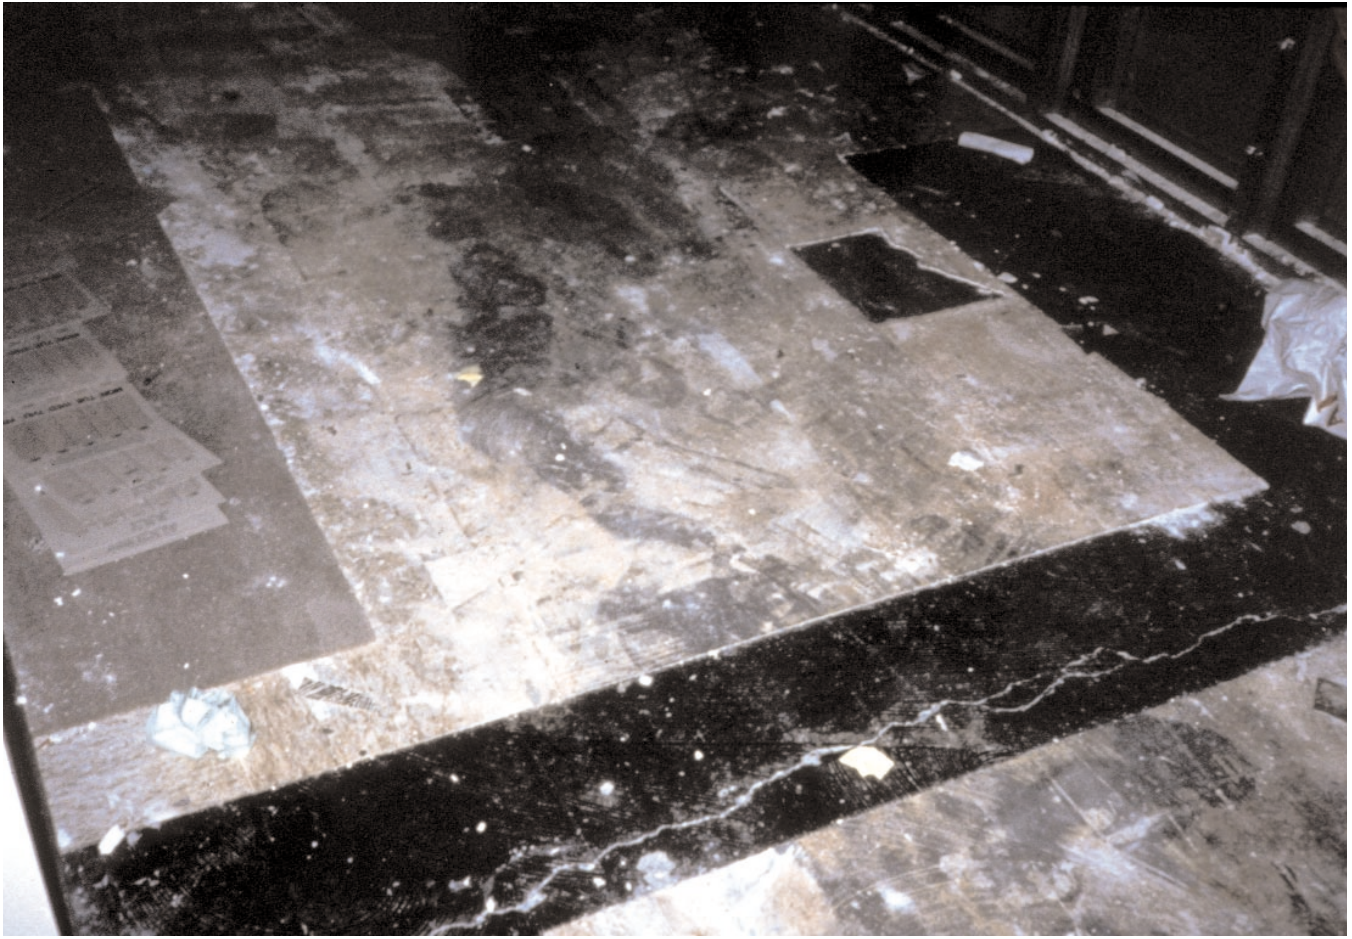
Slide #26

During the Loma Prieta earthquake a huge crack opened up in the floor diaphragm at the corner of the stair opening.

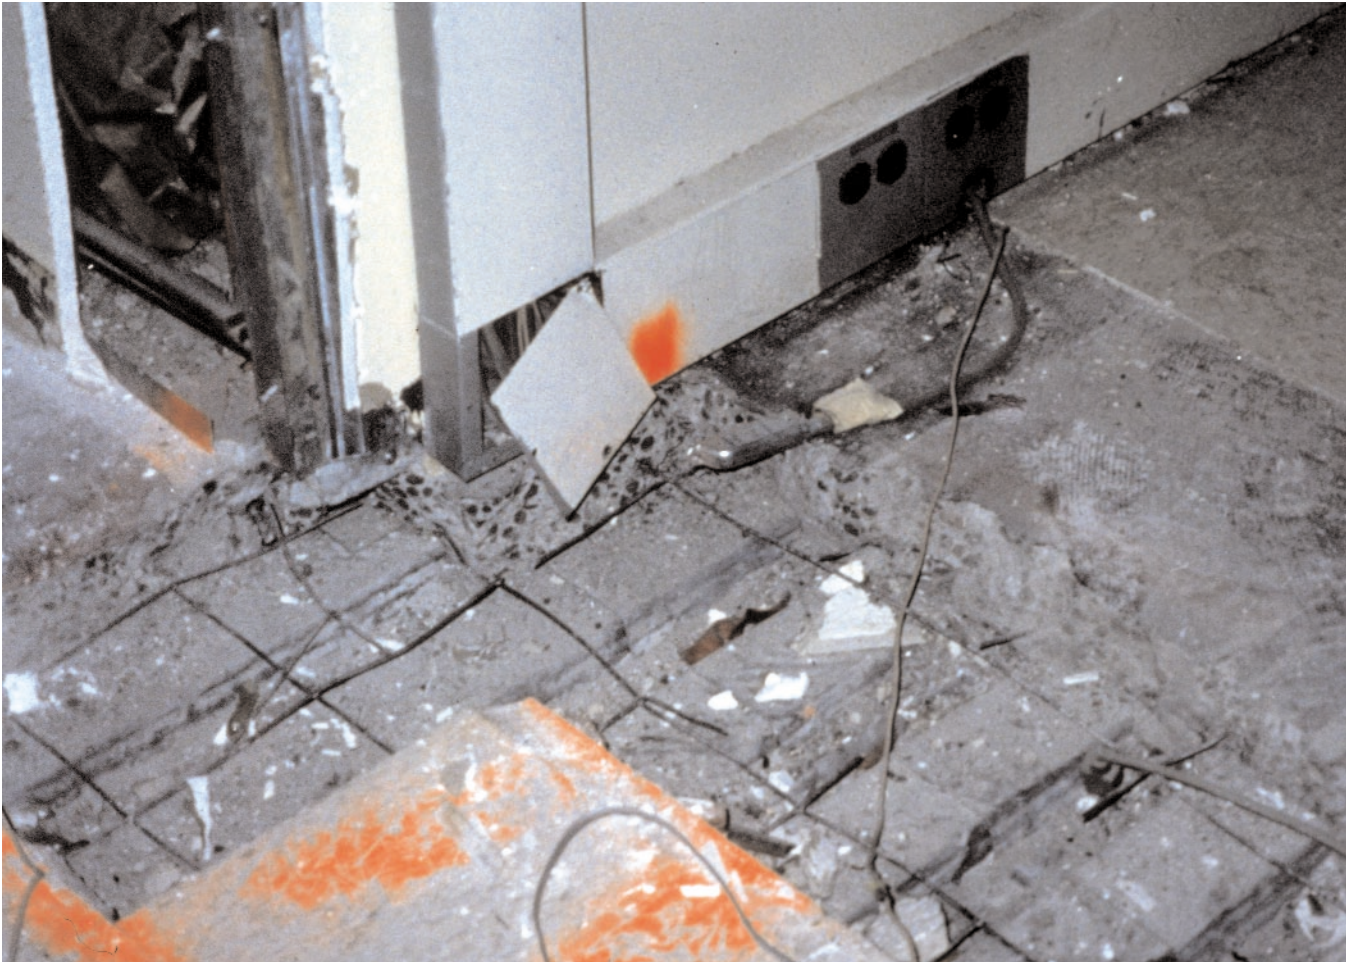
Slide #27

Upon investigation it turned out that the bars were never installed. There was no way to get the load to the walls at each end of the building. Ideally we need a system of checks and balances where if the contractor misses the placement of these bars the inspector catches it. Or even if the bars were missing on the shop drawings, the contractor should have asked why the engineer's plans and the rebar detailer's plans did not match.

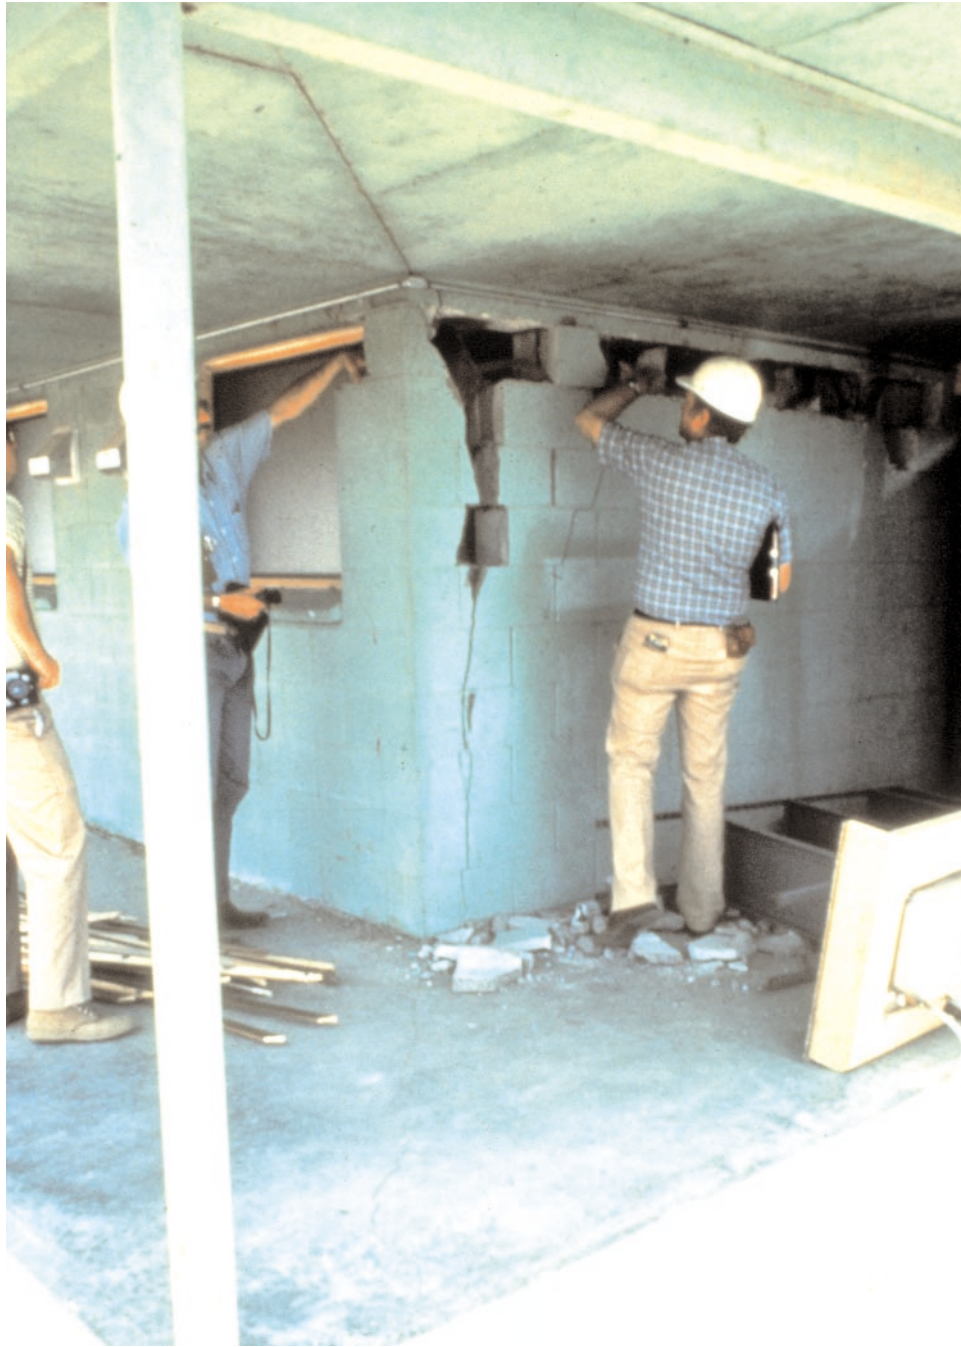
Slide #28

Let's take a look at concrete block or masonry construction for a minute. In order to perform well in an earthquake, the masonry block and grout has to meet specified strengths and the rebar has to be placed in accordance with the drawings. Here we see what happens when construction workers are unclear on the concept of transferring the load. When finishing off the top of the wall, they closed off the top of the concrete block cell with paper, and then put concrete on top of the paper. The paper prevented a positive connection between the wall and the slab above; breaking the load path and resulting in this kind of damage.

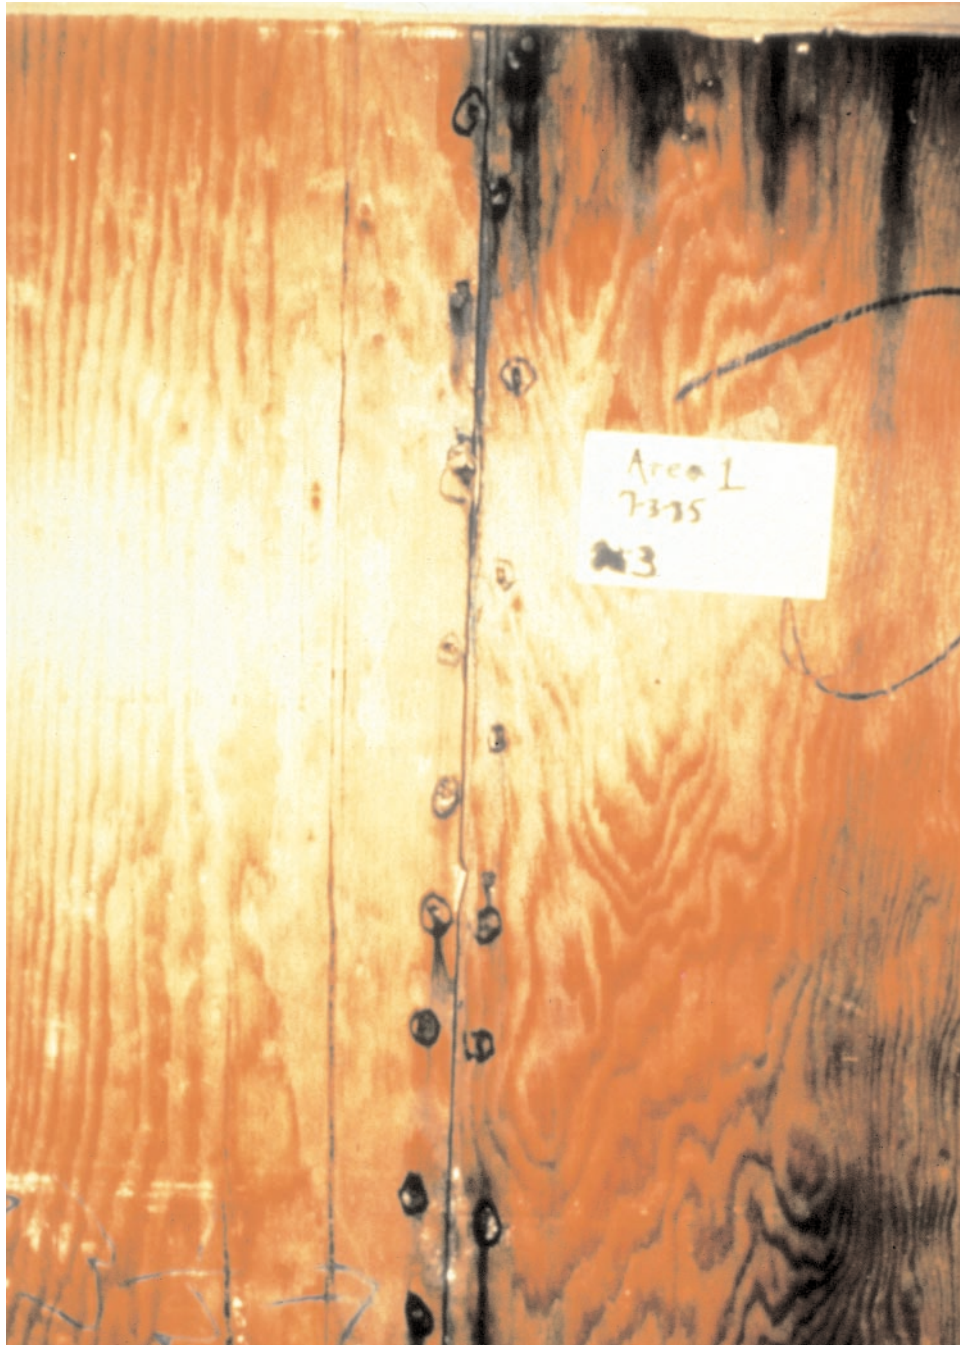
Slide #30

Plywood walls provide excellent earthquake resistance in earthquakes if they are installed properly. In order for a plywood wall to be effective, it relies on nails. These nails must be of the proper size, spacing, and with the proper edge distance. They cannot be overdriven, or the plywood will lose its strength.

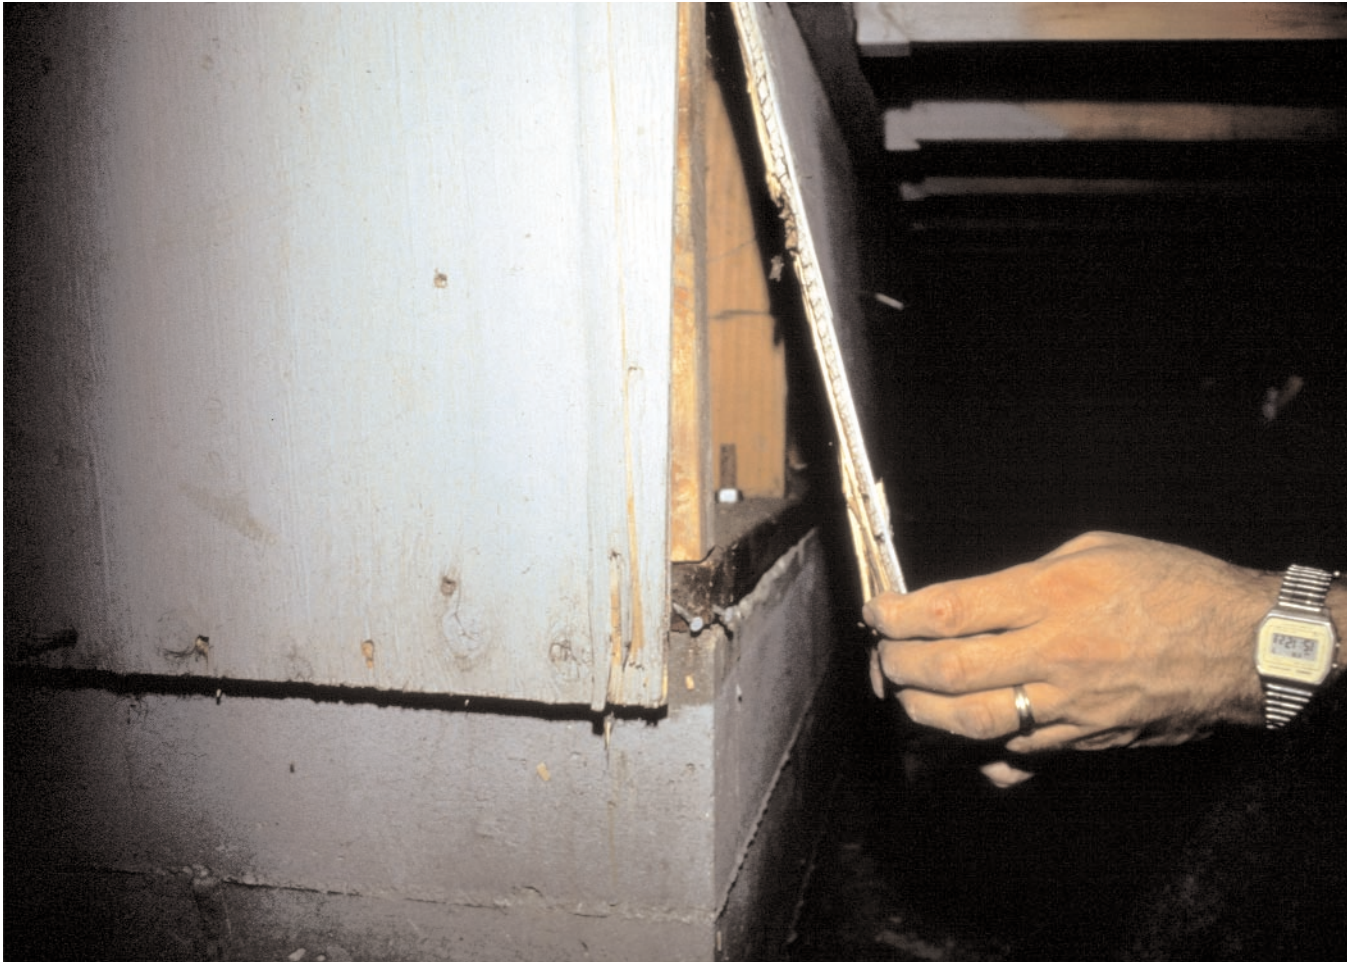
Slide #31

In Big Bear, California, after the 1992 earthquake there, we saw tremendous damage in modern wood frame construction, caused by construction and inspection errors. Here we can see damage caused by nails that were overdriven or placed wrong. In addition, the vertical edge nails were missing. The plywood just peeled off, unable to transfer the load.

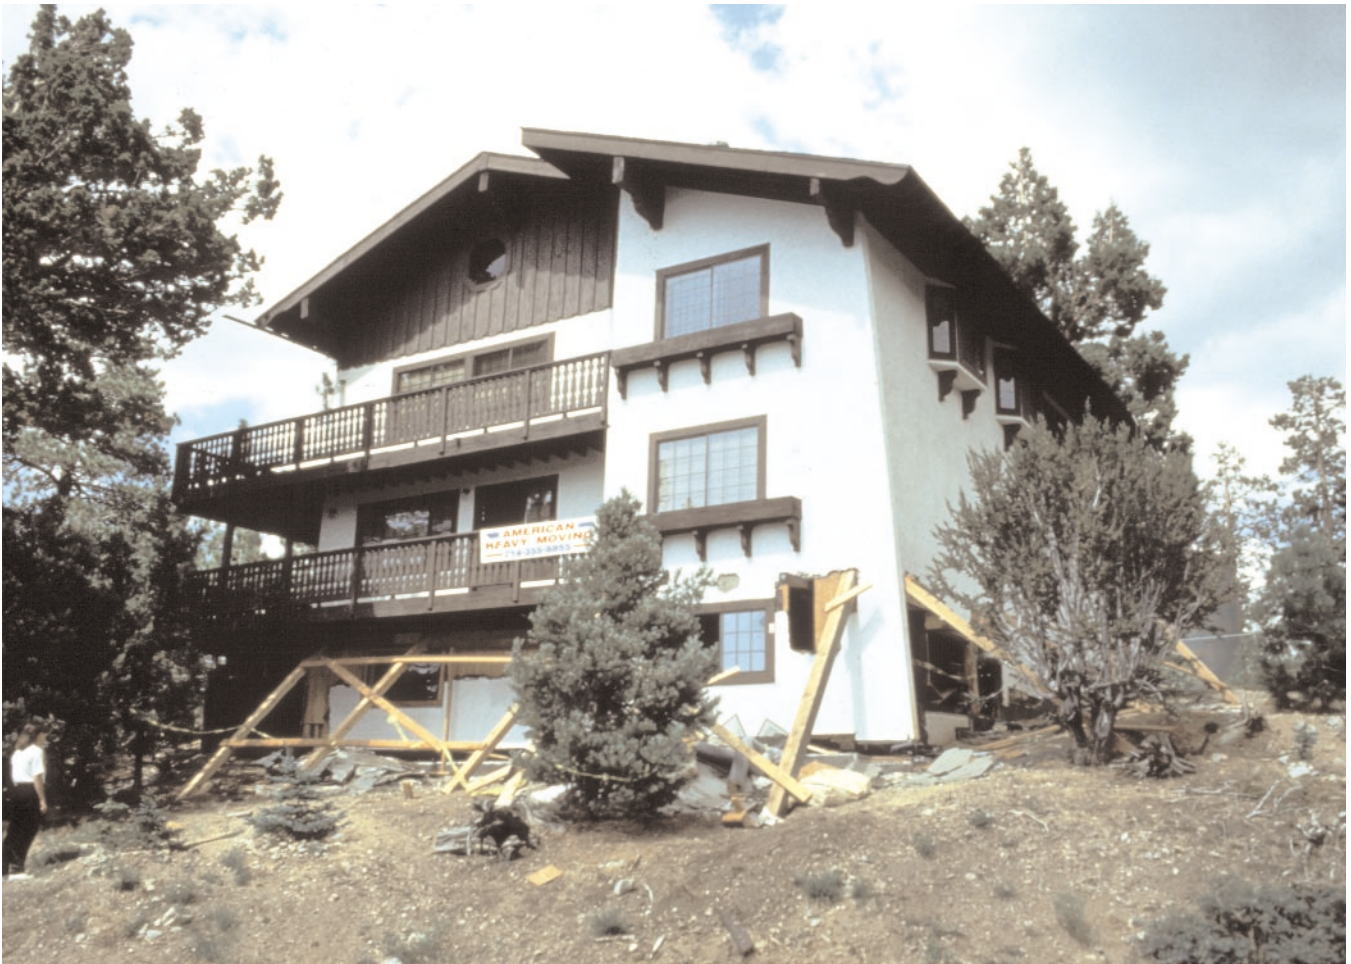
Slide #32

Here's a brand new beautiful house in Big Bear that suffered significant expensive, but unnecessary, damage in that earthquake. Unnecessary because the carpenters were unclear on the concept of a load path and installed the plywood only from the first floor up.

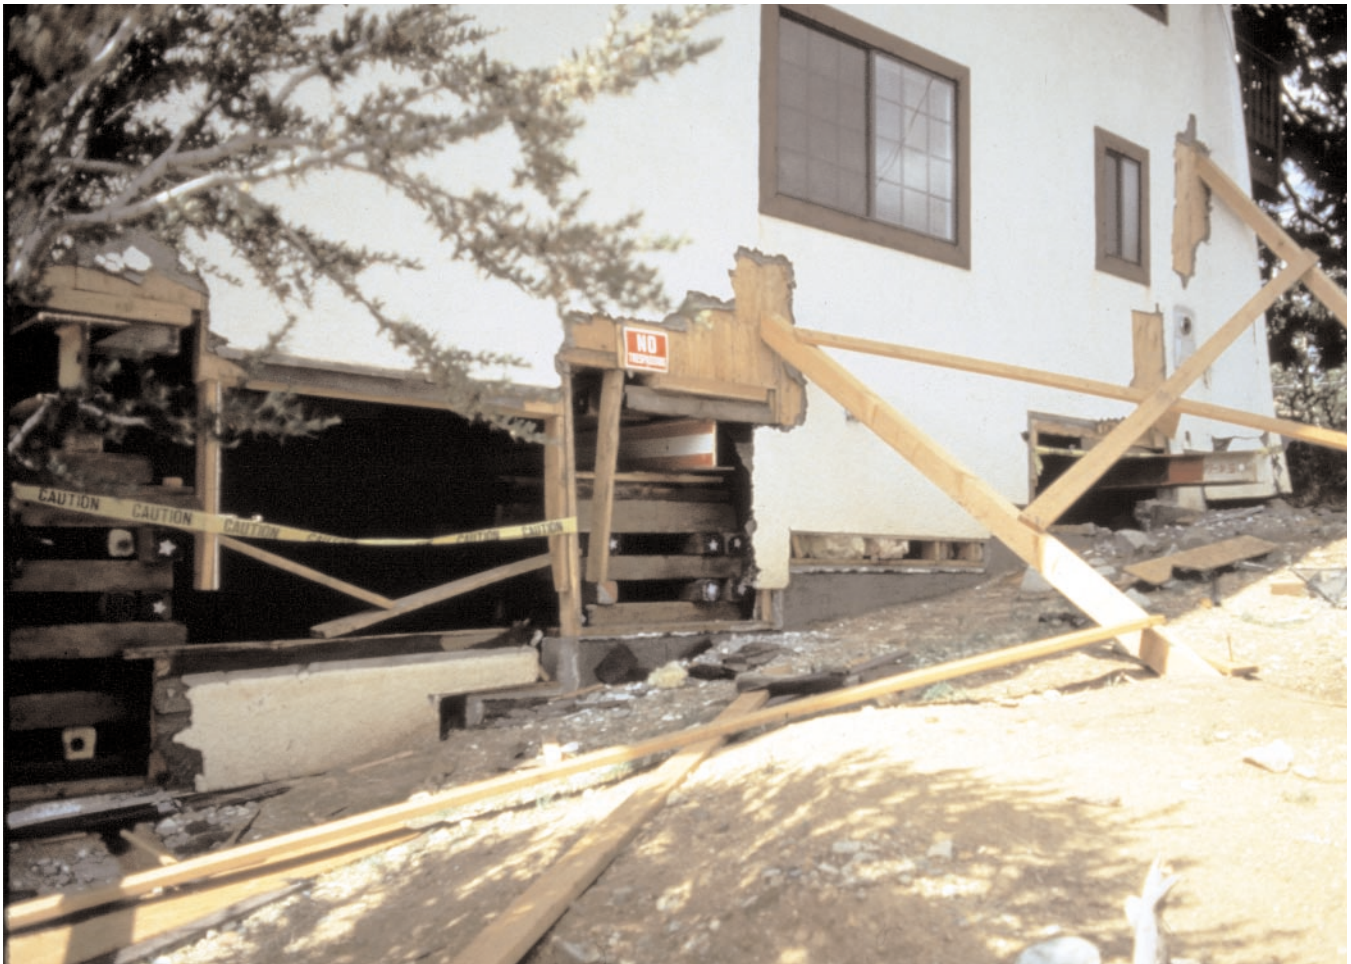
Slide #33

They put no plywood on the cripple wall between the foundation and the first floor. This critical portion of the house receives the earthquake loads from all the walls, floors, and roof. Earthquake forces exerted on a building accumulate in the lower portions of a structure, making the cripple wall construction critical. It receives the highest demand and must transfer the loads to the foundation. It was unable to do so in this case, due to the lack of plywood.

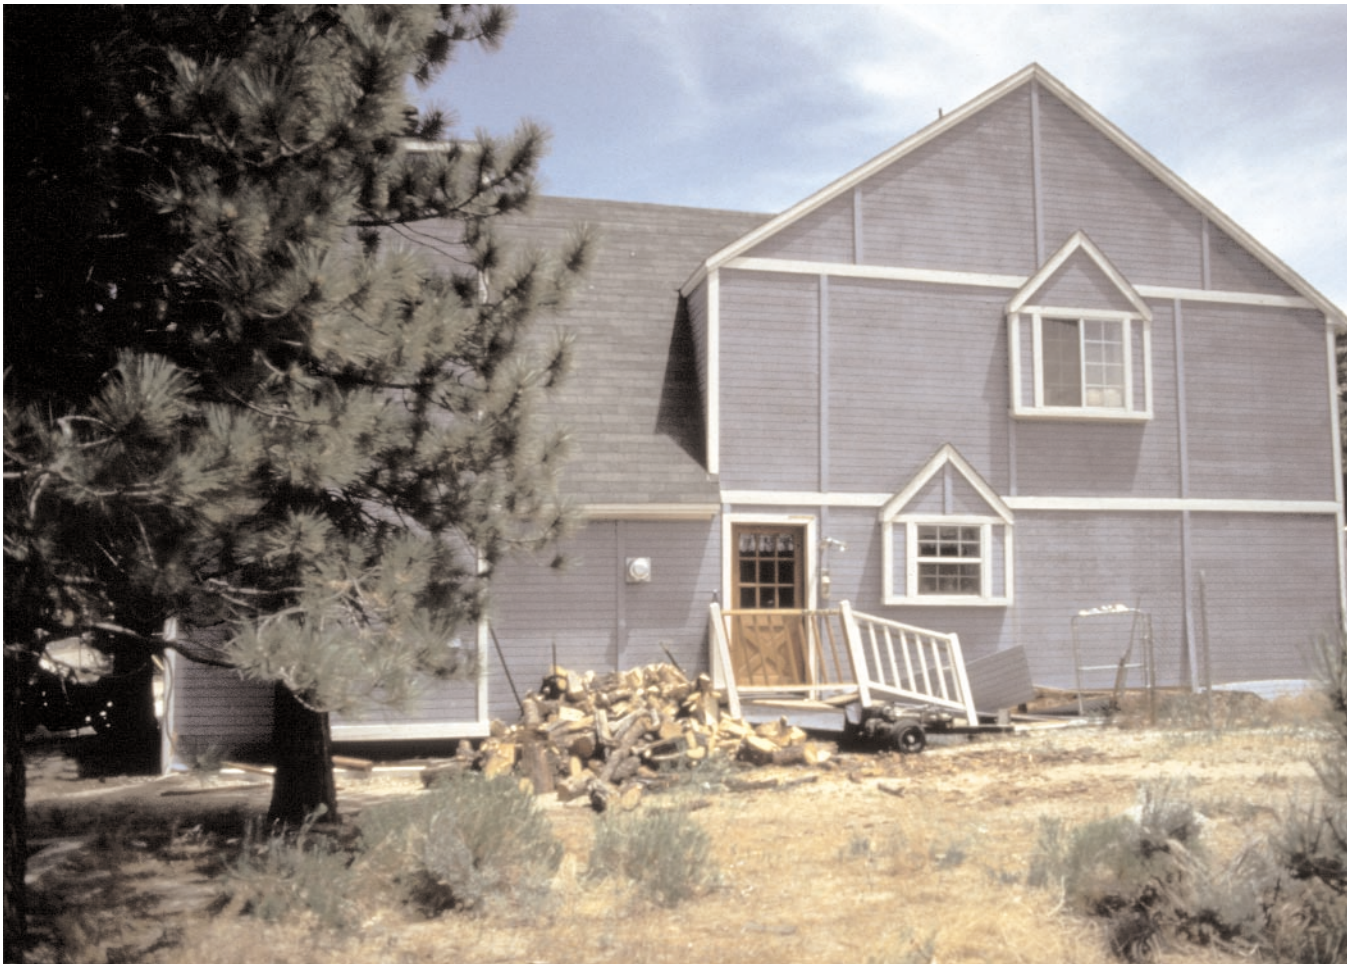
Slide #34

Here is another brand new big house in the same earthquake, two stories, knocked off its foundation.

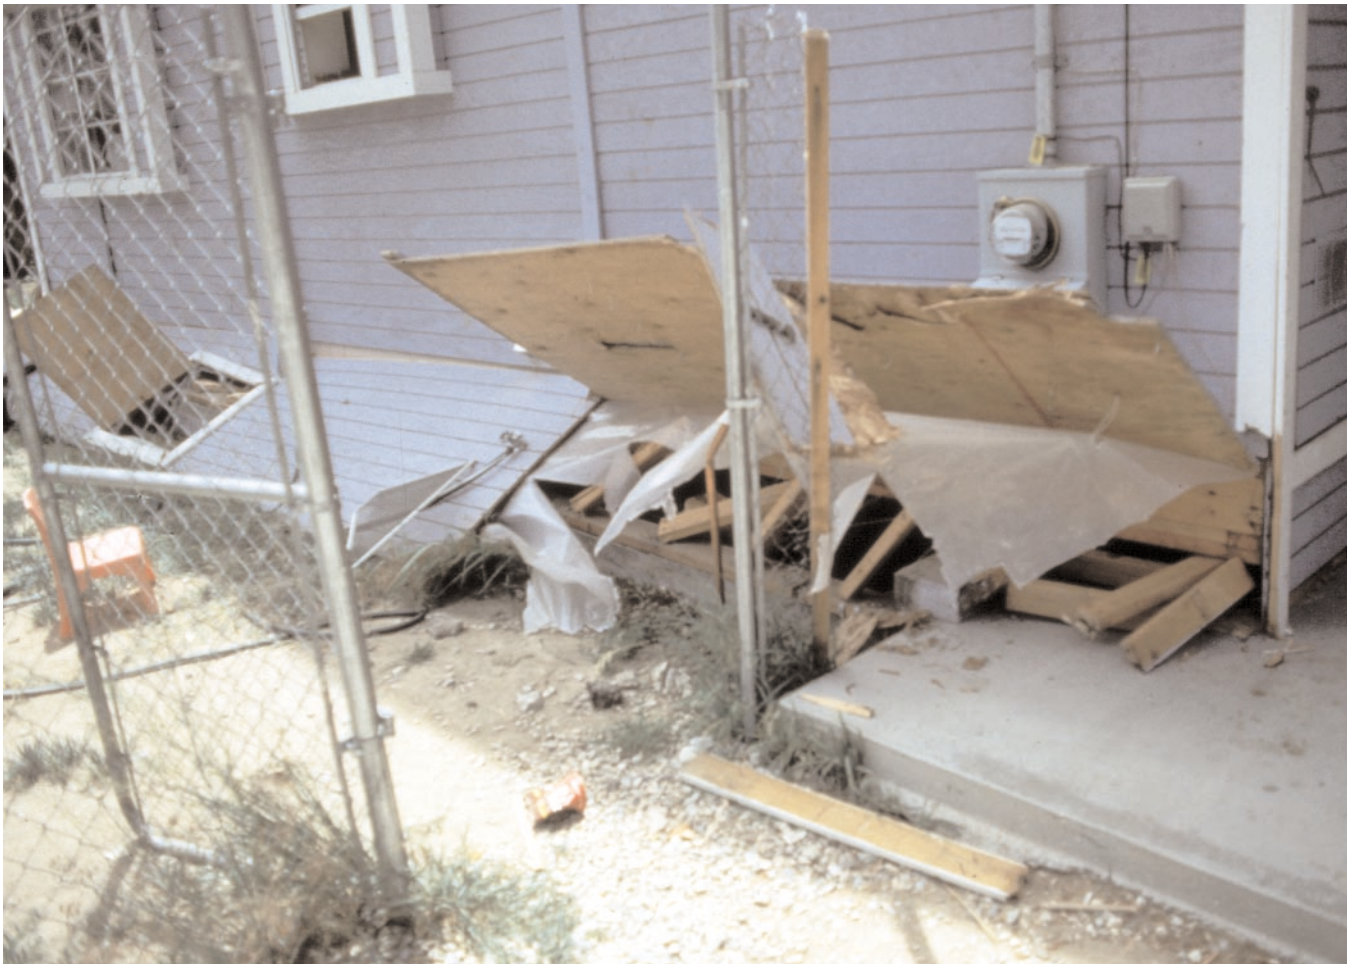
Slide #35

In this house, wood panels serve both as the structural sheathing and as siding. Carpenters had not properly nailed the wood siding panels on the cripple wall. So here, while the load path appears to be more complete than in the previous example, incomplete nailing of the edges of the siding resulted in this damage.

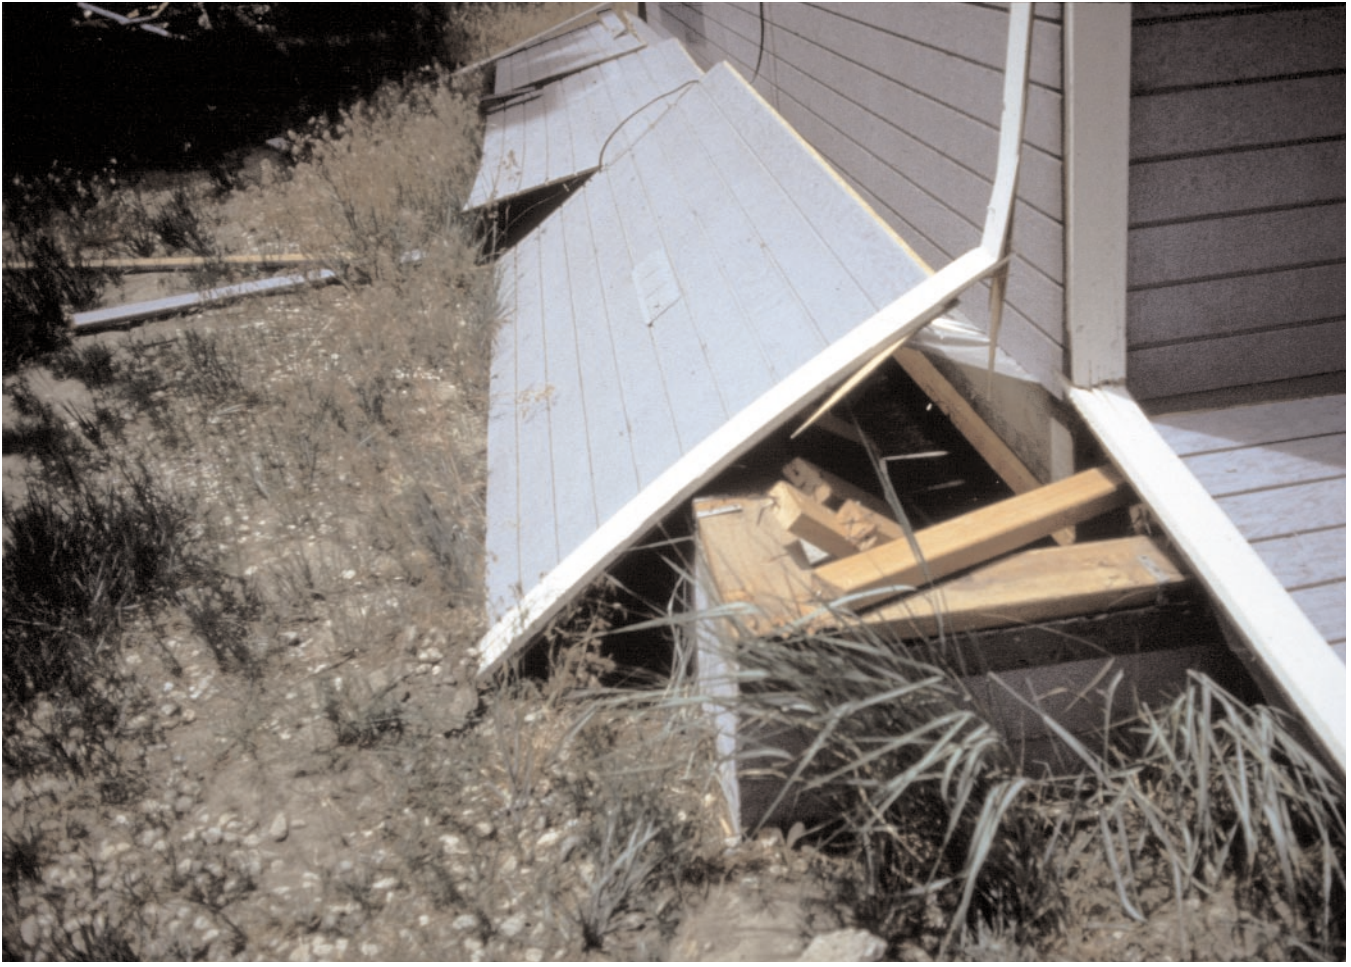
Slide #36

Without this nailing, the load cannot be transferred from the building down into the ground.

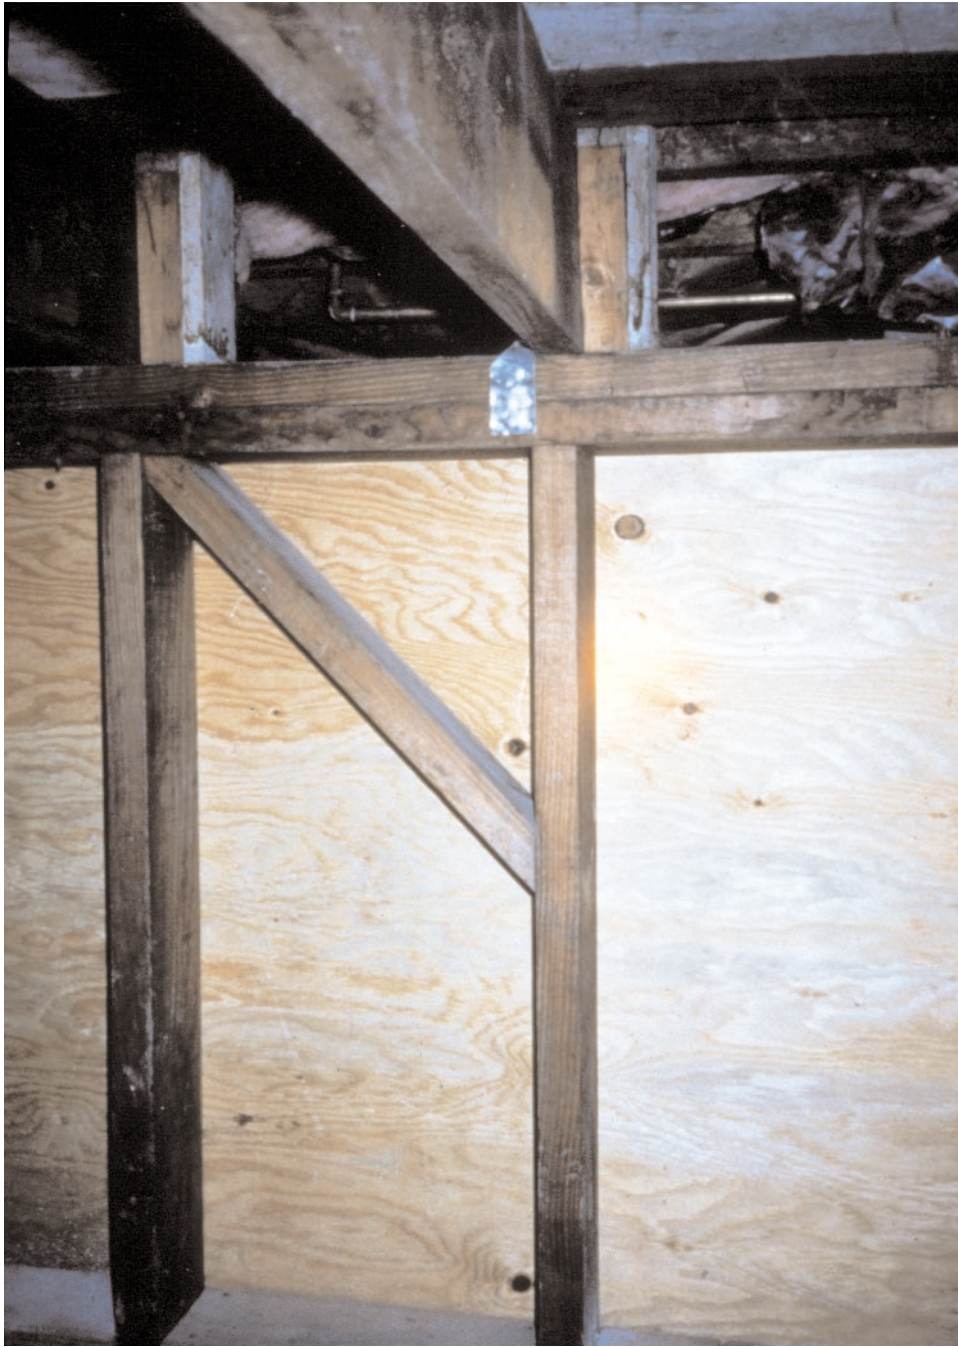
Slide #37

In a retrofit situation, as in new construction, all the parts are important to the good performance of the building. Here a homeowner hired a contractor to retrofit a wood frame home. But the contractor clearly didn't understand force transfer. The contractor installed a beautiful plywood wall, but in order to complete the load path and transfer the force to the shear wall from the floor above you need blocking in each space between the floor joists. The blocking provides a nailing surface for nails from the floor and for sheet metal clips needed to connect the wall top plate to the blocking.

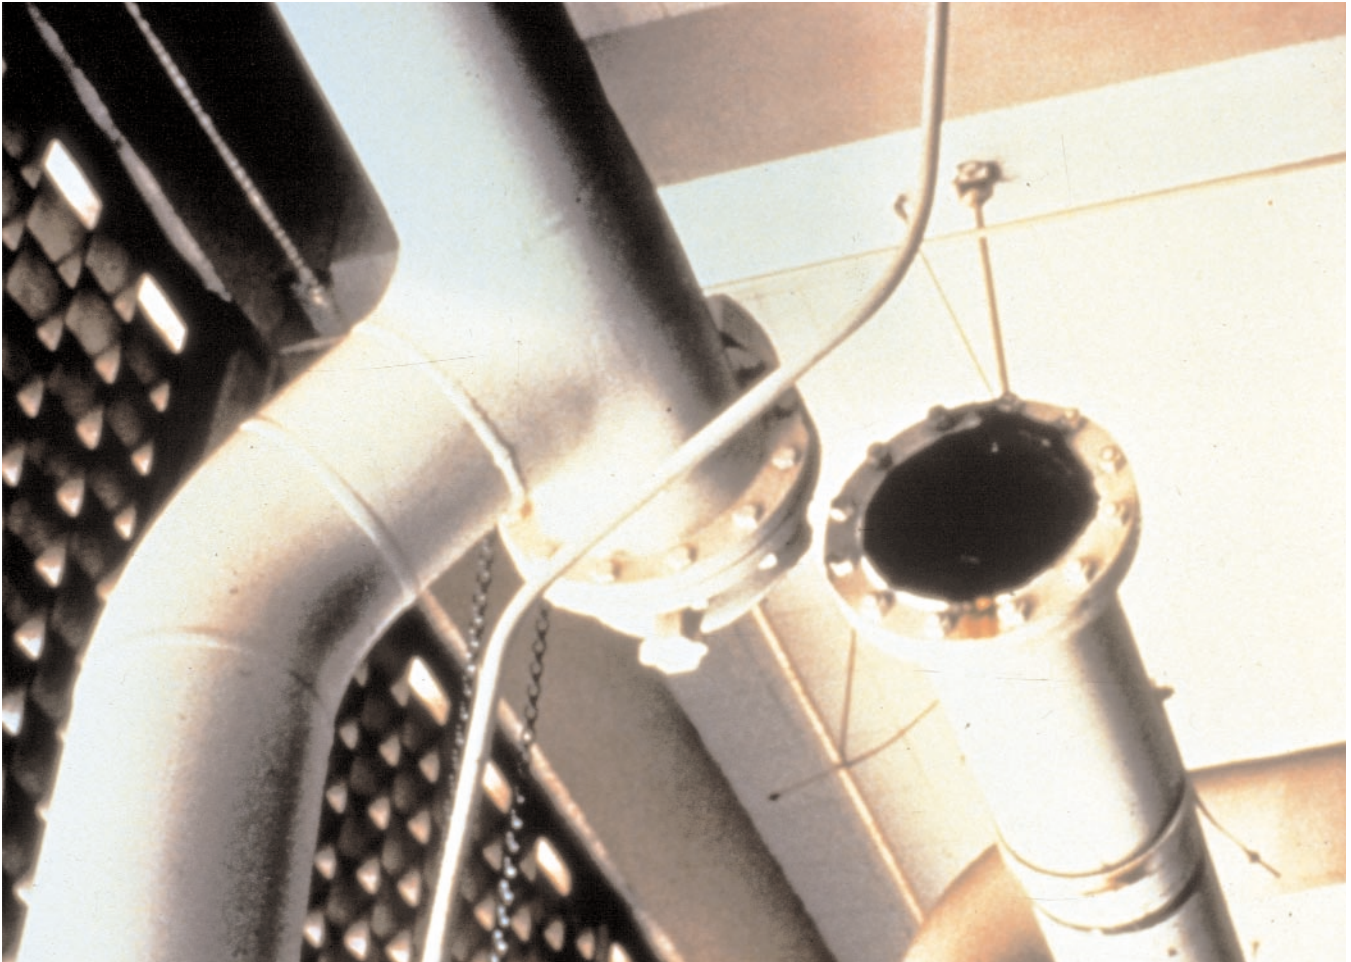
Slide #40

Breaks or leaks in water pipes cause some of the most devastating damage that we see. These pipes need to be properly braced to limit their movement or isolate them from earthquake forces.

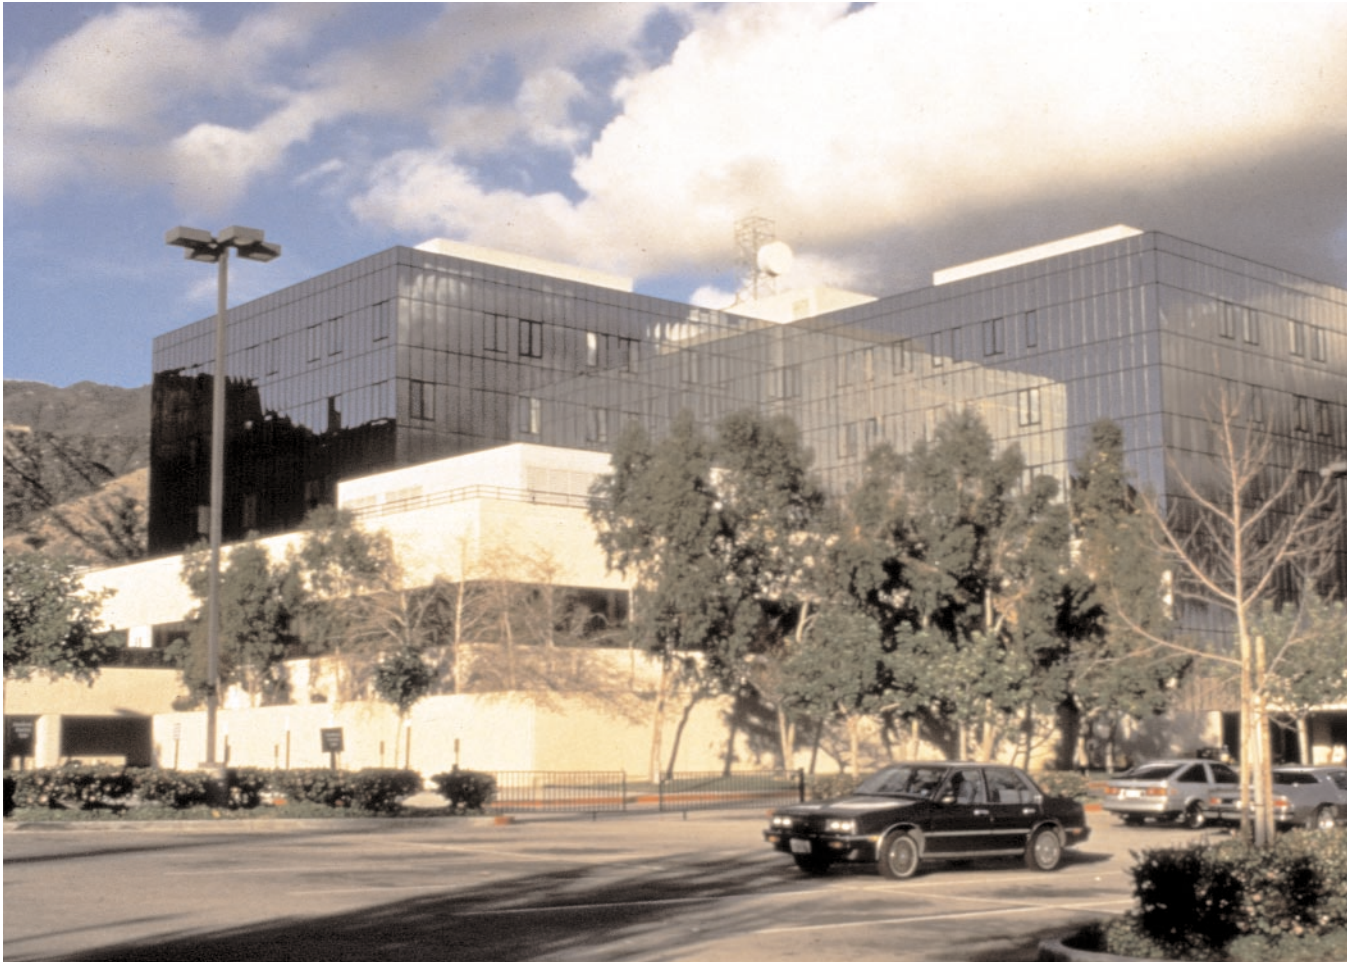
Slide #41

After the Northridge earthquake this brand new hospital was closed and evacuated, with millions of dollars in non-structural damage. These hospitals are supposed to be designed, inspected and built according to the highest standards, but even in a brand new hospital you can find flagrant violations in terms of the protection of non-structural systems.

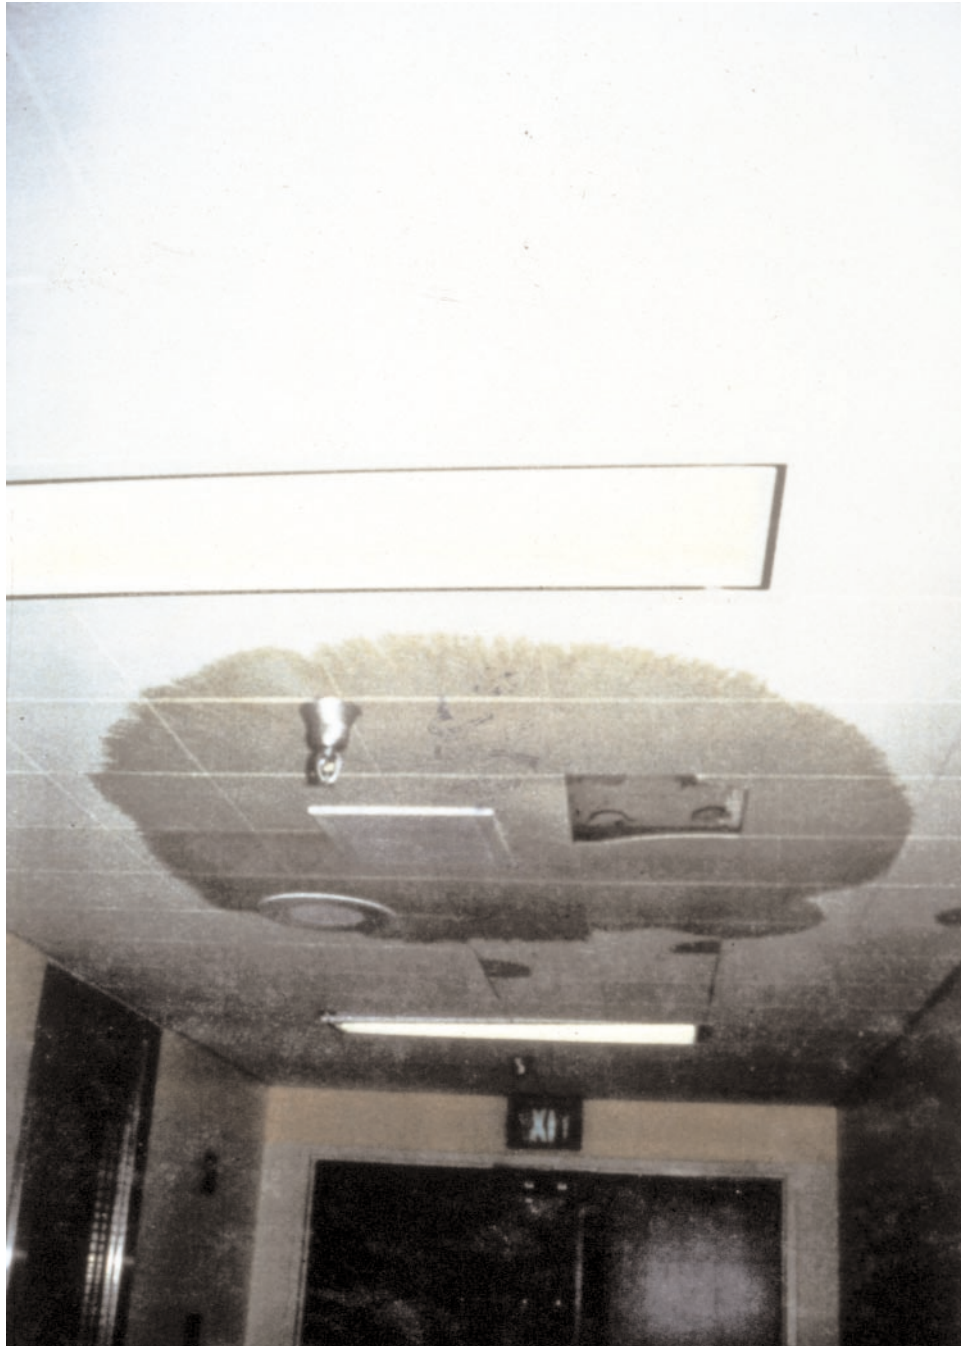
Slide #42

There were many leaks caused by breaks of the reheat coils—to limit the release of water they need flexible couplings where the waterlines connect. Imagine what happens to the furnishings and equipment below this leak.
