REDUCING EARTHQUAKE DAMAGE THROUGH QUALITY CONSTRUCTION

CREATED BY **MARYANN PHIPPS**

This presentation was created and originally presented by Maryann Phipps, formerly Principal, *Degenkolb Engineers*, at the EERI Workshop on Construction Quality and Seismic Education, April 1997.

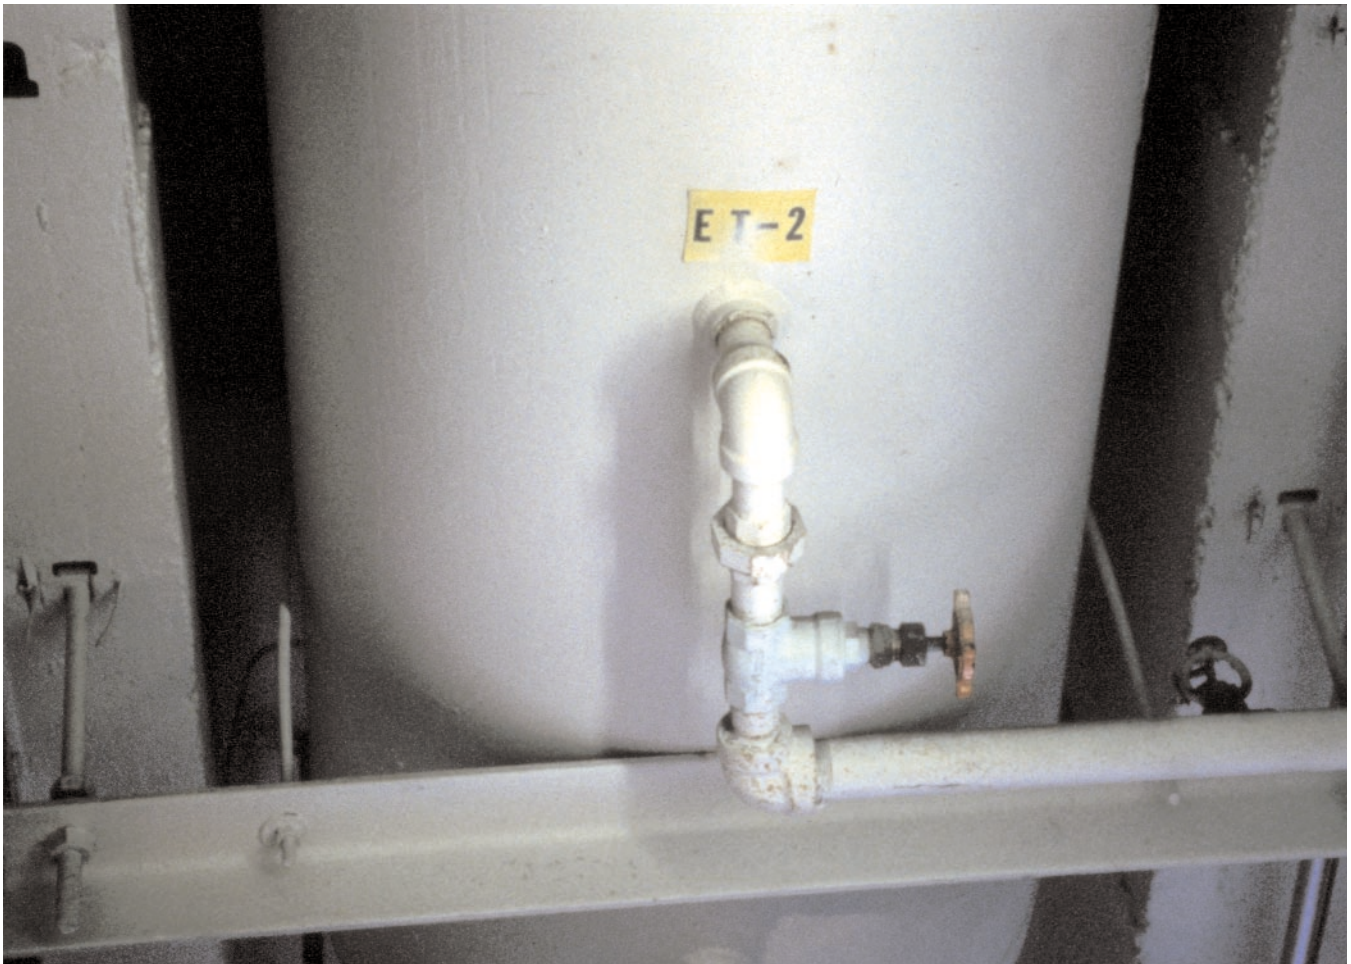
Slide #43

Here we see an overhead tank on a trapeze suspended from the structure above. The piping coming out of the tank feeds a piece of equipment below. Neither the tank nor its trapeze is braced, so in an earthquake it will swing. This motion will cause the piping or its connectors to break. In this case, the installer and inspector both should have known better.

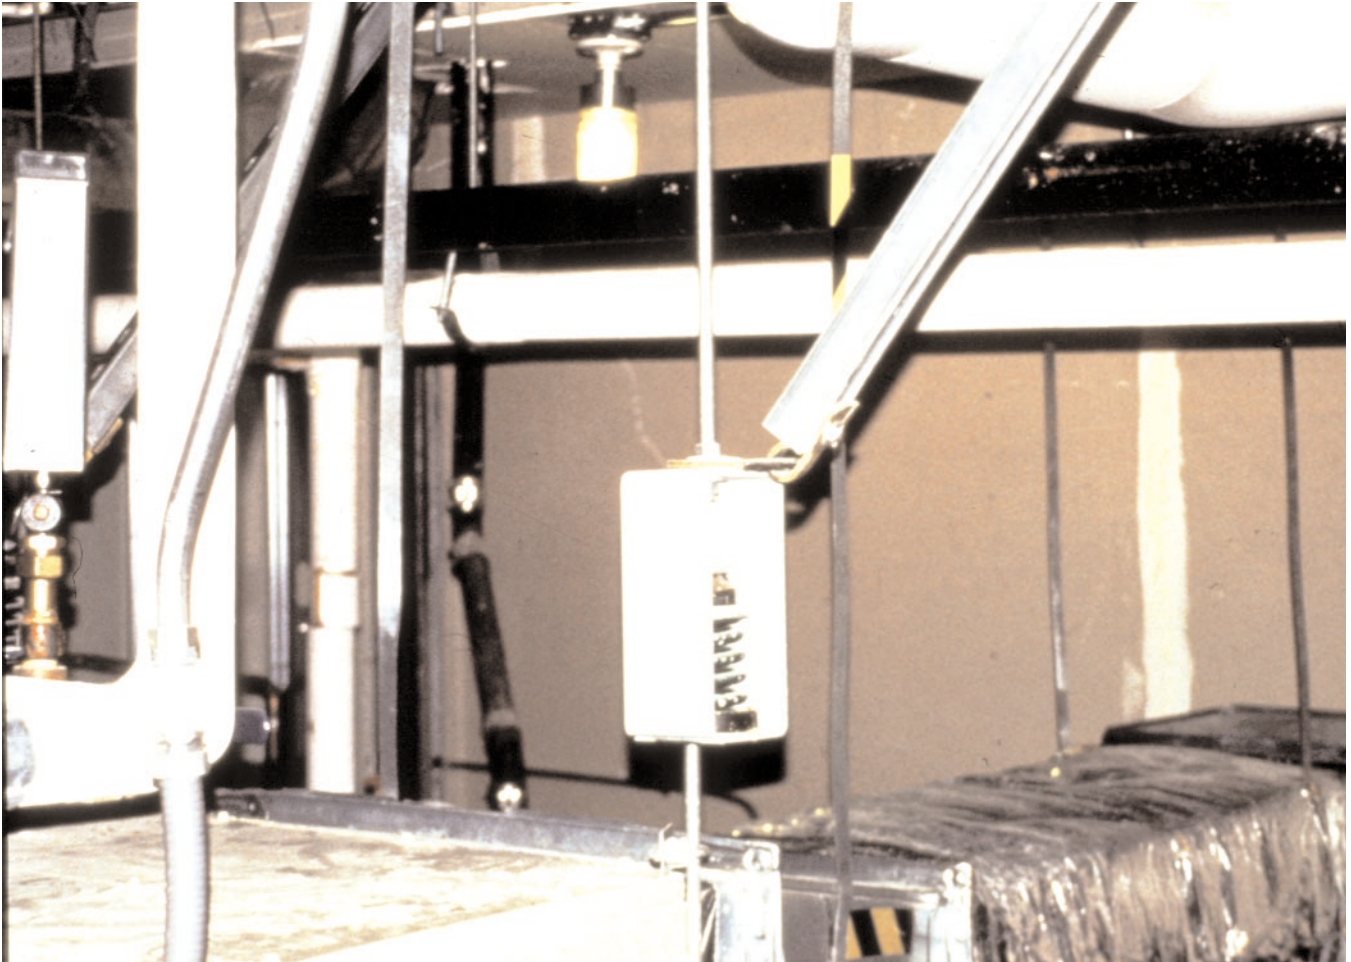
Slide #44

This box with the black spring in it is an isolator for a fan that is located in a duct. The isolator has a diagonal brace, which must have been intended for the fan itself. The isolator does not need bracing, but the in-line fan certainly does. Whoever installed and inspected the unit had no clue about the importance of bracing and its role in promoting proper performance in an earthquake.

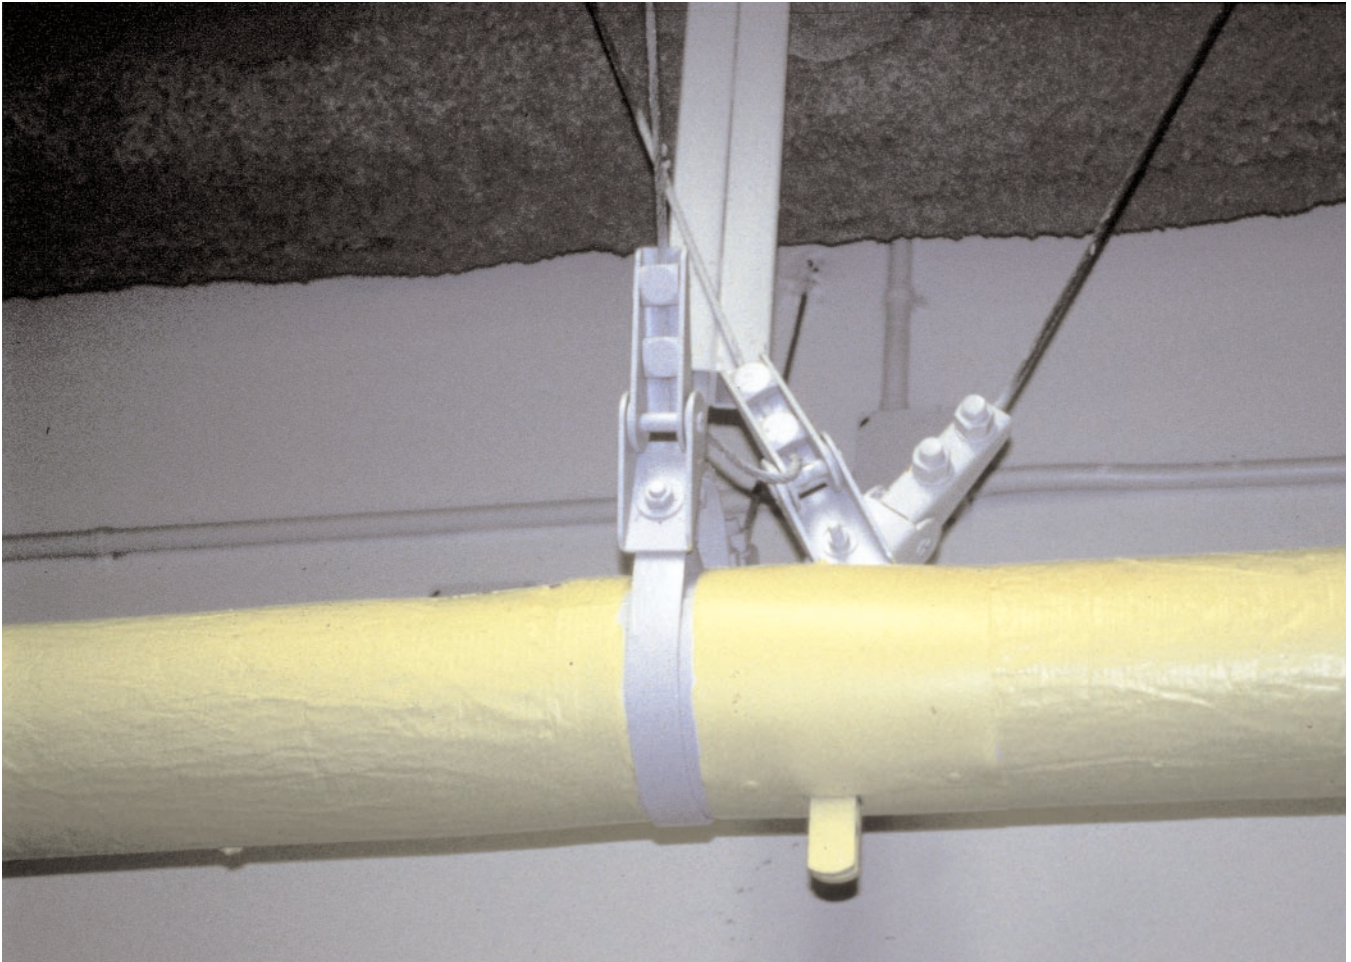
Slide #45

This slide shows wires providing longitudinal bracing for a pipe. The wires are connected to a ring clamp that is inside the insulation connected directly to the pipe, and should prevent longitudinal movement of the pipe.

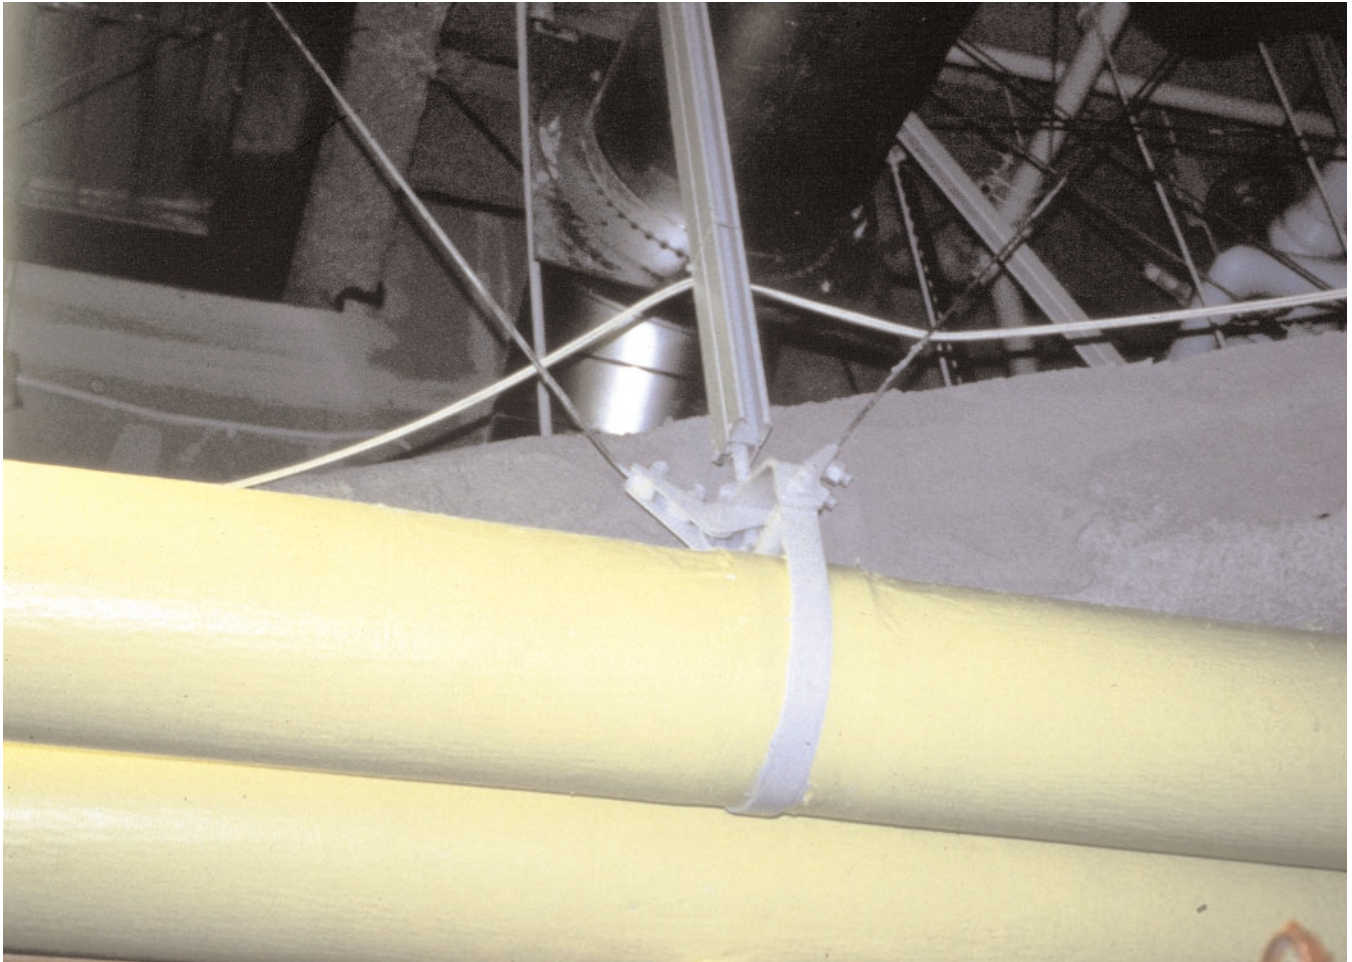
Slide #46

Here is a pipe where the longitudinal bracing is attached to only the hanger. The pipe can slide within the hanger because there is no direct connection between the bracing and the pipe. Unless the piping has flexible joint fittings, movement can cause breakage and leaking.

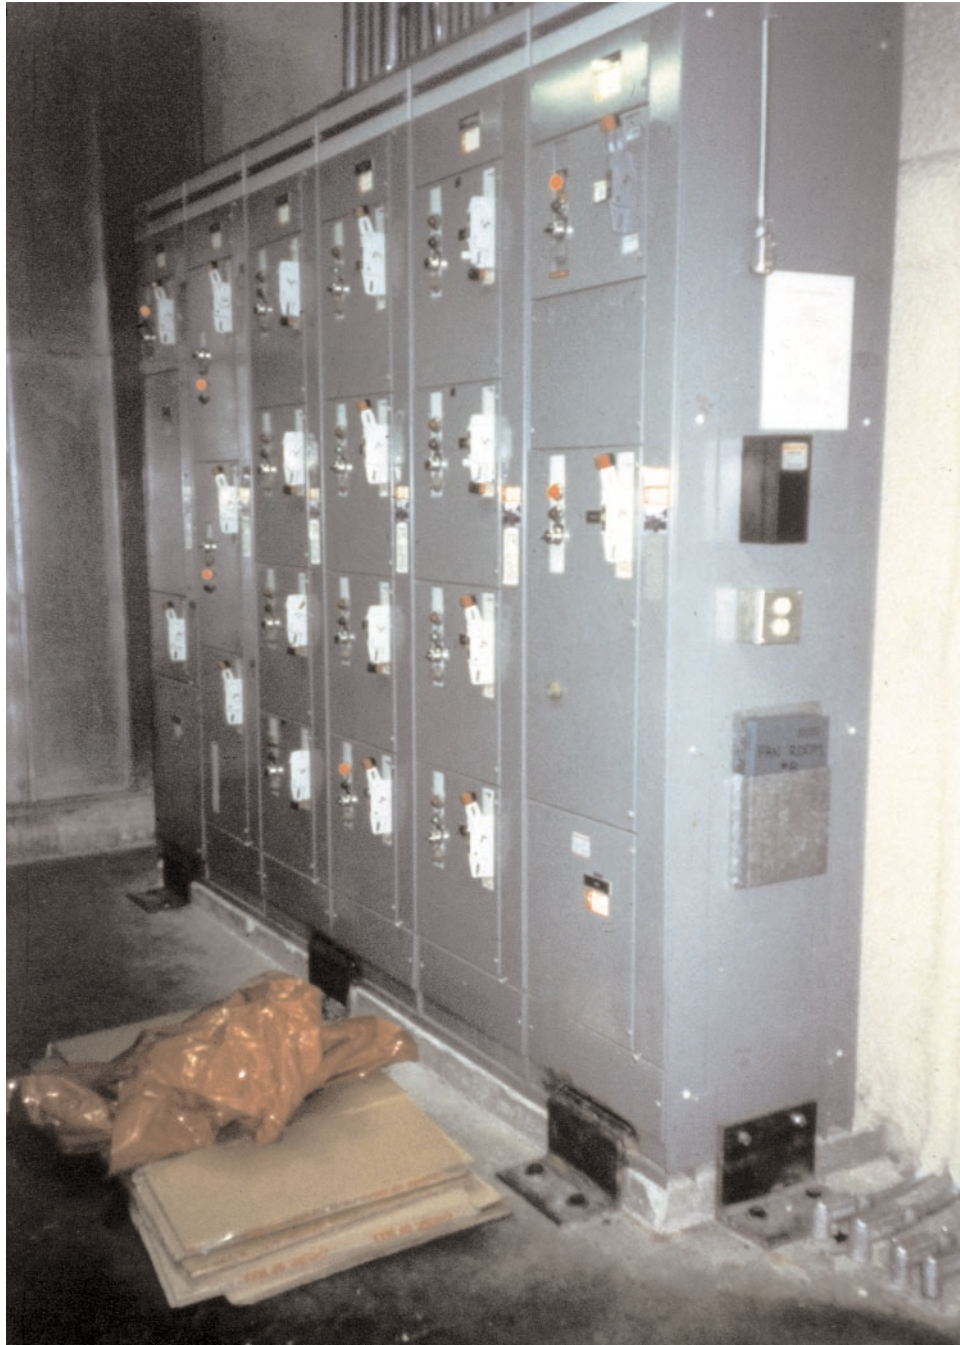
Slide #47

This is a motor control center in a hospital mechanical room. It is a narrow, top heavy piece of equipment. It is anchored at the bottom, but also needs to be anchored at the top so that it will not tip over. If it tips or shifts too much, the equipment it controls will fail, possibly making the building uninhabitable.
