# A SURVEY OF SERIOUS AIRCRAFT ACCIDENTS INVOLVING FATIGUE FRACTURE

## VOL. 2 ROTARY-WING AIRCRAFT

by  
Glen S. Campbell, R.T.C. Lahey  
National Aeronautical Establishment

AERONAUTICAL NOTE  
NAE-AN-8  
NRC NO. 21277

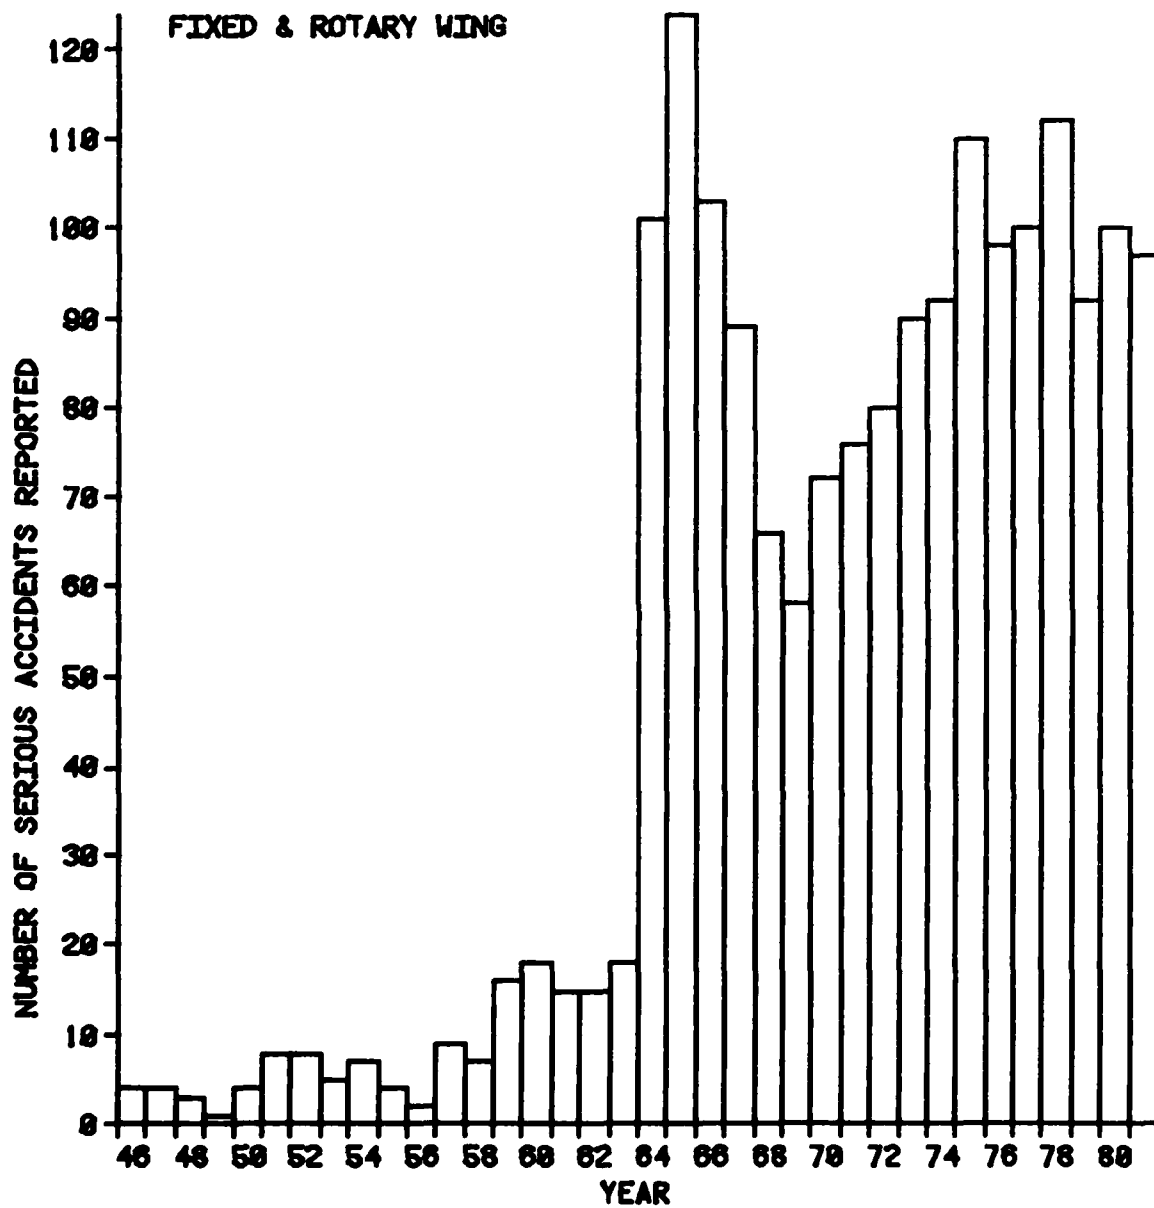
FIG. 1 NUMBER OF SERIOUS FATIGUE ACCIDENTS  
- FIXED-WING & ROTARY-WING

The total number of reported fixed-wing plus rotary-wing accidents occurring in each year is plotted in Figure 1. The big increase in the mid-1960s is the result of improved availability of accident information with the introduction of computer-based information systems in a number of countries (particularly the introduction of the US National Transportation Safety Board system in 1964). Over the last five years there has been an average of 100 fatal accidents (fixed-wing plus rotary-wing) per year resulting from metal fatigue.

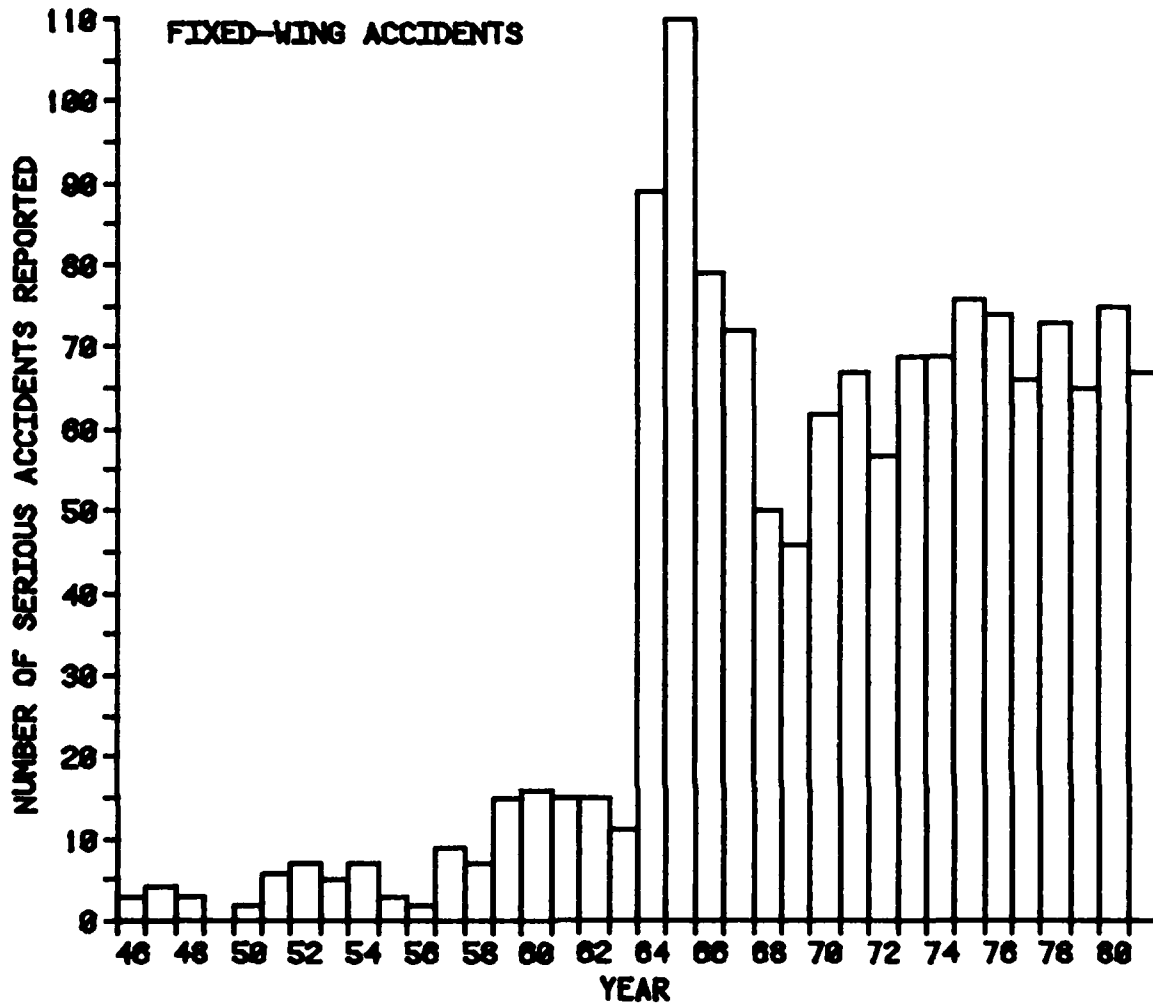
FIG. 2 NUMBER OF SERIOUS AIRCRAFT ACCIDENTS  
- FIXED-WING

The number of fixed-wing accidents for each year is plotted in Figure 2, while the number of rotary-wing accidents is shown in Figure 3. Averaged over the past five years, rotary-wing aircraft have had 31 serious accidents per year.

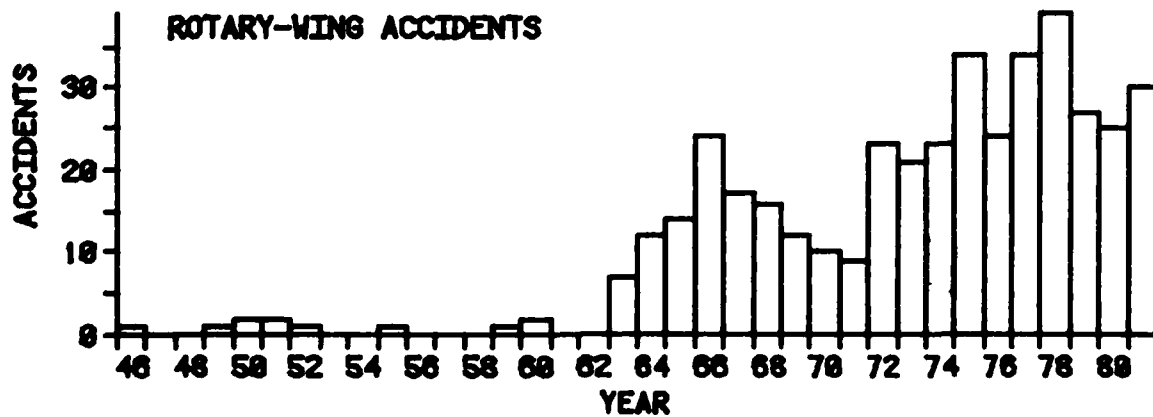
FIG. 3 NUMBER OF SERIOUS AIRCRAFT ACCIDENTS  
- ROTARY-WING

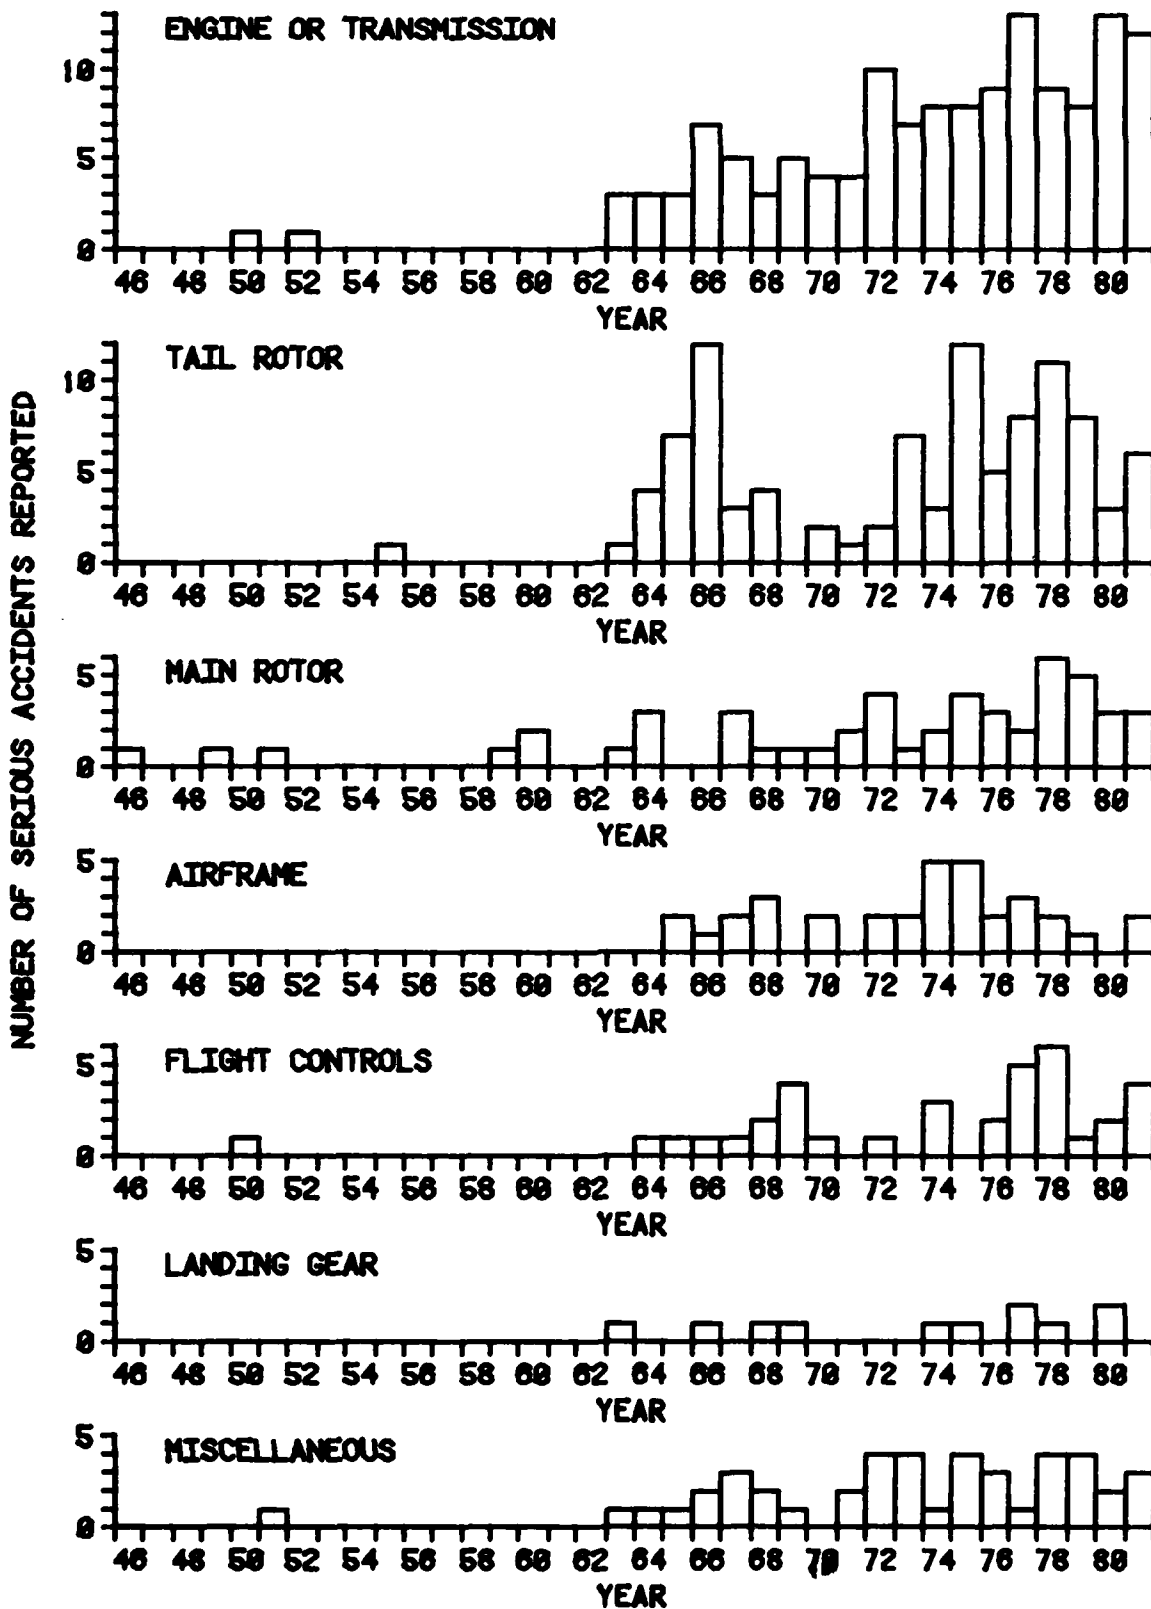
FIG. 4 CAUSES OF FATIGUE FAILURES - ROTARY-WING AIRCRAFT

Figure 4 shows the breakdown of rotary-wing accidents by failure type. Since 1976, engine/transmission fatigue failures have been the most common accident cause, with 11 accidents per year on average, followed by tail rotor problems (7 per year), and failures in the main rotor system (4 per year).
