# Medtronic

MRI guidelines for Medtronic  
implantable infusion systems

Instructions for use

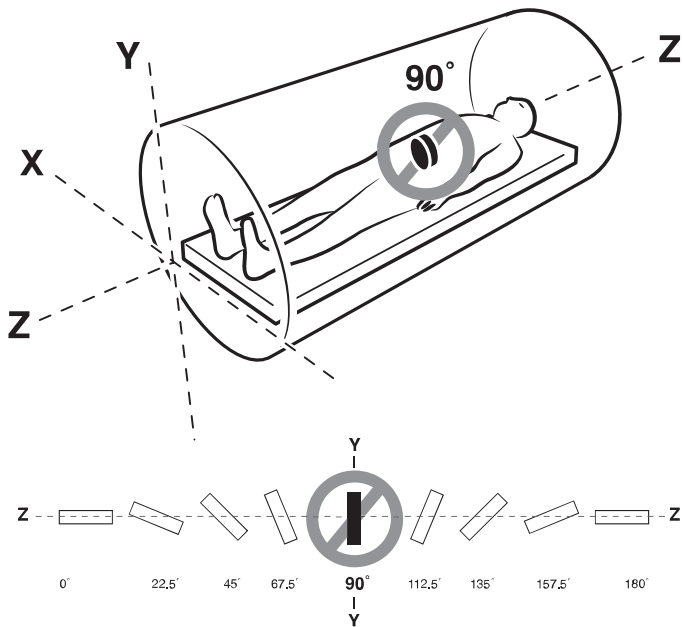
**Figure 1.** Pump positions in relation to z-axis MRI orientations

**Note:** If the pump face is oriented at 90° to the z axis, the refill port would be facing towards the patient's feet or head.

90° alignment of an implanted pump with the z axis (Figure 1) of 1.5-T and 3-T horizontal, closed-bore magnetic resonance imaging (MRI) scanners can cause MRI-induced demagnetization of the internal pump motor magnets, which can result in permanent, nonrecoverable stoppage of the pump. This is due to the orientation of the pump with respect to the magnetic field of a horizontal, closed-bore MRI system. SynchroMed II pump performance has not been established using other types of MRI scanners such as open-sided or standing MRI.

Prior to MRI, confirm the pump is not oriented 90° with respect to the z axis of the MRI scanner (see Figure 1). Palpate the pump to determine the orientation. The pump diameter is about 87.5 mm (3.4 inches) including the catheter access port. If the pump face is oriented at 90° to the z axis, do not initiate the MRI scan. Also, determine if the patient implanted with a SynchroMed II pump can safely be deprived of drug delivery. If the patient cannot be safely deprived of drug delivery, alternative delivery methods for the drug can be used during the time required for the MRI scan. If there is concern that depriving the patient of drug delivery may be unsafe for the patient during the MRI procedure, medical supervision should be provided while the MRI is conducted.
