Owner's Manual

IT3000-AB

1/4" Ultra-Lok Tool

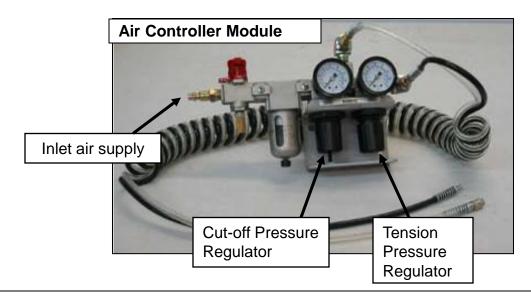
Item	Min	Max
Inlet Supply Pressure (PSI)	100	140
Inlet Supply Air Flow (SCFM)	1.5	
Particle Size In Air Supply (microns)		5
Air Moisture Content		20% RH
Tension Pressure Settings (PSI)	60	80
Cut-off Pressure Setting (PSI)	105	110

Caution – Do not exceed a Tension pressure of 80 PSI. Pressures above 80 PSI may cause premature clamp failure.

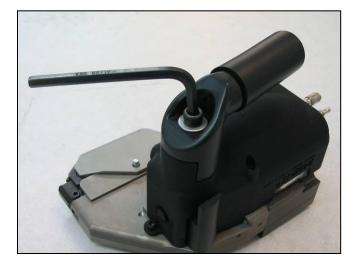
Handle adjustment:

- Using 1/4" hex key (supplied), adjust the Support Arm/Handle to ergonomically match the operators hand.
- Be sure not to adjust the Handle too far outward (beyond interlocking legs) or the handle will not function properly or provide support to the operator.

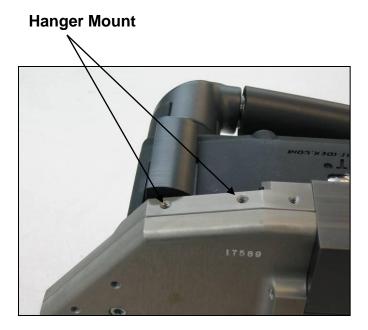
Hanger Support Instructions:

- An aluminum hanger (accessory) can be utilized for supporting the tool.
- 2. The hanger can be installed (as shown) into one of the two threaded holes.
- 3. Secure the hanger against the tool body with the two supplied screws.
- 4. A light application of vibratite is already included on the screw's thread.

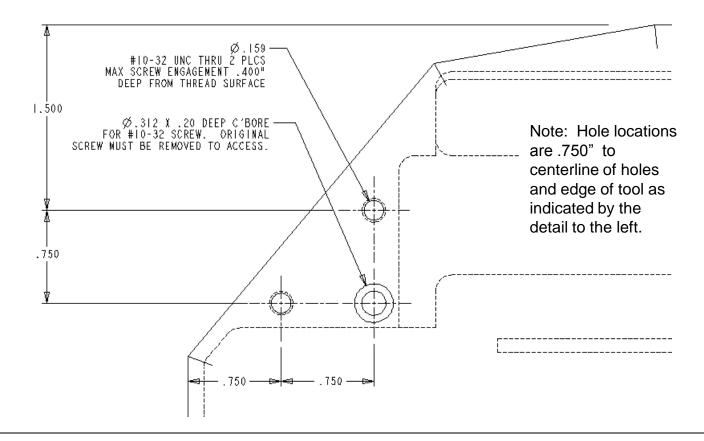
Fixture Mounting Locations

Three additional fixture mounting holes are available to assist with mounting the IT3000. Thread size is #10-32 for each of the holes. Usable thread depth is .400" for two of the three fixture holes. One hole is utilized to attach and lock the tool body halves together. This hole may also be used for fixturing, provided the #10-32 cap screw is replaced with a similar threaded screw with appropriate thread length secure the two halves together in addition to fixturing.

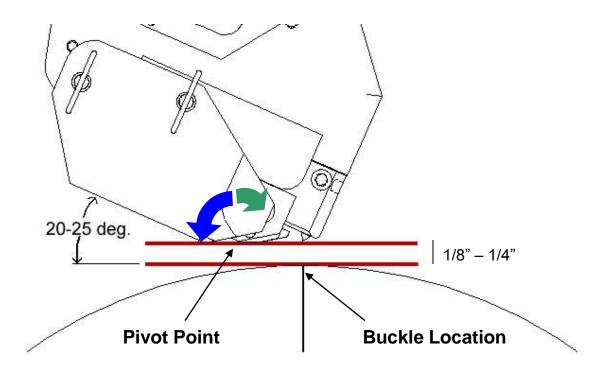
Part of insuring that the tool is producing a strong lock is making sure that it approaches the application correctly and is fixtured to allow repeatability of application. The tool should approach the surface tangent to where the buckle of the band is to be applied. The tool should be allowed to float $1/8^{\circ} - 1/4^{\circ}$ above the surface to allow the buckle to move to the proper position for cut-off. Once the tool begins tensioning, the band will pull the tool down to the surface.

As the band is tensioning, the tool may rotate clockwise up to 5 degrees about the pivot point (Green Arrow). During the cut-off cycle, the tool must be allowed to rotate counterclockwise up to 35 degrees (Blue Arrow). Because of this movement, **BAND-IT recommends that the tool be mounted in a fixture that will provide adequate rotation during both cycles.**

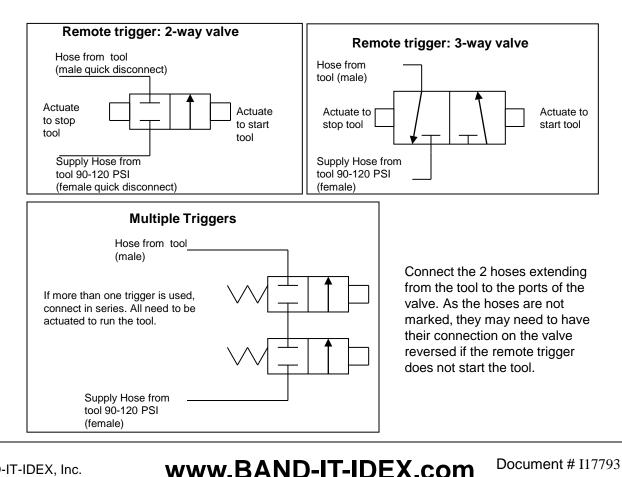
- The modification consists of deactivating the thumb lever actuation switch and installing two 6-ft X 1/8" O.D. hoses to accomplish the same task via the use of a remote actuation device such as a palm button or other device that can provide a pneumatic signal to pilot the tension control valve.
- Various actuation devices can be incorporated based upon end user requirements. Basic schematic for 2way & 3-way valves included below. The valve should be set up in the normally closed mode and upon opening the circuit a supply of air is provided.
- The customer is responsible for incorporating this tool into their process, BAND-IT is available to provide advice and recommendations.

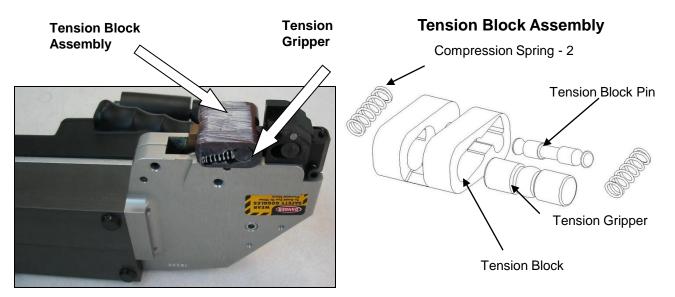
Tension Block Assembly Maintenance:

Remove the Maintenance Flip Cover by loosening the Maintenance Cover Tightening Screw and Flip Cover Head Screw on the Maintenance Flip Cover and removing both Quick Release Pins as shown on **page 17**.

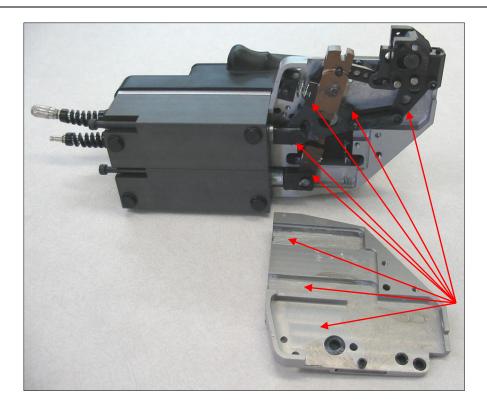
- 4) Lubricate the removed cover as shown with red arrows above. Also, lubricate the tool body, linkage and Tension Block Assembly as shown on **page 27**.
- 5) Inspect all mechanical linkage for lubrication, proper placement and refit cover.
- 6) Secure the tool side cover by inserting and tightening (2) #10 32 X 4" length cap screws through the Cylinder Housing and into the Cover. Apply a light dab of Blue Loctite to one or two threads to prevent loosening during operation.

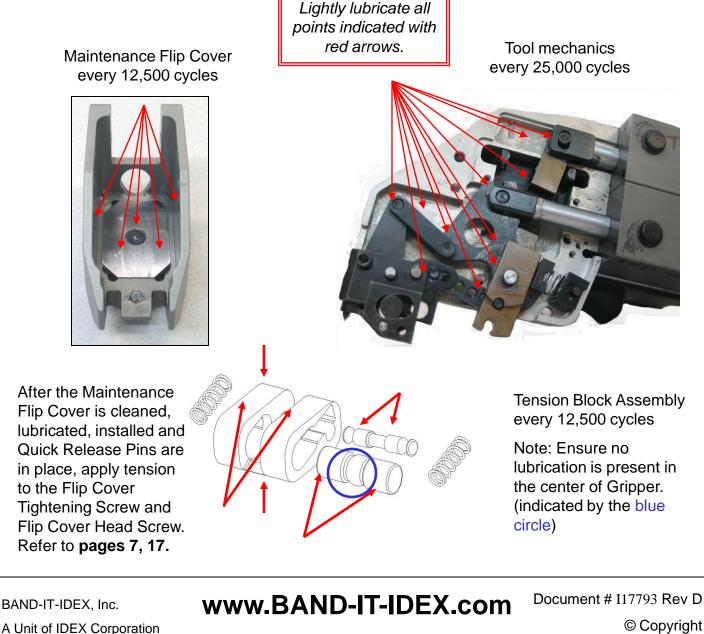
Lubrication – Follow recommended intervals – Use a synthetic gel lubricant containing Teflon for the internal parts as shown and described. Lubricate all pivot points and internal surfaces of maintenance flip cover with a light coating of the lubricant.

Caution – Excessive amounts of lubricant may result in gripper slippage, requiring a full repeat of cleaning process.

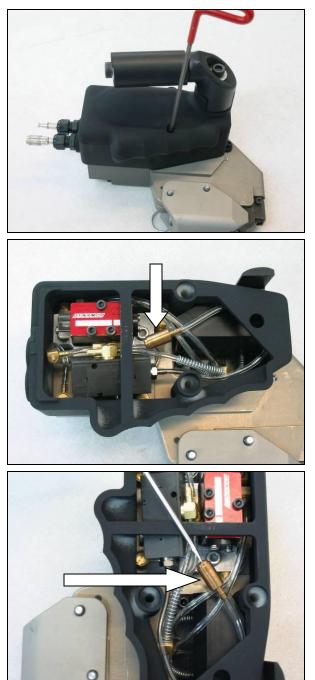
Procedure to adjust the timing of the clamp tail cut-off:

The Timing Valve will be affected over time by contaminants in the air system. Moisture, dirt particles, oil and solvents can cause blockage or fluctuations in the tool performance.

Cycle should be .5 - 1.0 seconds.

Tool cutting before full tension applied.	Verify cut-off timing. If required, remove right side body and adjust timing valve. Replace if damaged.	28
Tool will not cut off clamp	Premature release of trigger	Hold trigger down until tool completes cut off cycle	15
tail	Fluctuating facility air pressure	Verify if facility air pressure meets tool set up requirements (see manual). Air booster system may be	4-8
	Worn knife/blade	Remove and replace knife and blade. Refer to maintenance schedule.	21,22
	Timing valve adjustment	Verify timing. If required, remove right side body and adjust timing valve. Replace if damaged.	28
	Rear tension block slipping, therefore tool does not reach cut off tension.	Remove and inspect gripper block assembly. Replace as required.	24
	Coiled hose line has air leak	Verify no air leaks in coiled hose assembly. Remove and replace as required.	4-8
	Front gripper slipping	Remove and inspect front gripper and gripper guide arm. Replace if worn.	*
