Protein purification troubleshooting guide

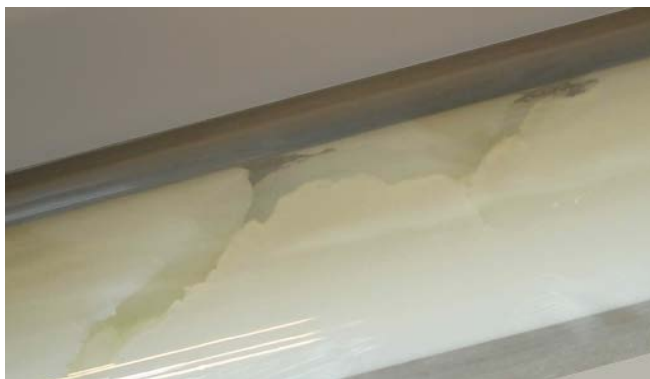
Air in the column

Possible cause	Remedy
Back pressure increase or bed insufficiently packed	<ul style="list-style-type: none"> Turn down adapter to resin surface. Do a column performance test. Repack if needed
Column packing not performed according to instructions	<ul style="list-style-type: none"> Repack according to recommended protocol
Flow rate too high	<ul style="list-style-type: none"> Do not exceed maximum flow rate for resin or prepacked column
Resin bed compressed	<ul style="list-style-type: none"> Repack using lower flow rate Use prepacked columns Check that system back pressure is not too high. Are there any restrictions in system?
Column operated at too high pressure	<ul style="list-style-type: none"> If using recommended flow rates, clean column according to instructions Do not exceed recommended operating pressure for resin or prepacked column For self-packed columns, use "Column handling" functionality in UNICORN™ system control software to save a defined column with its pressure data. Then select this method to protect this column type from too high pressure

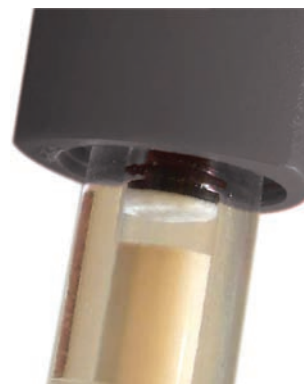
Compressed bed
