# Safety Review

## Beechcraft Baron

Models 55, 58, & 58

AOPA Air Safety Foundation

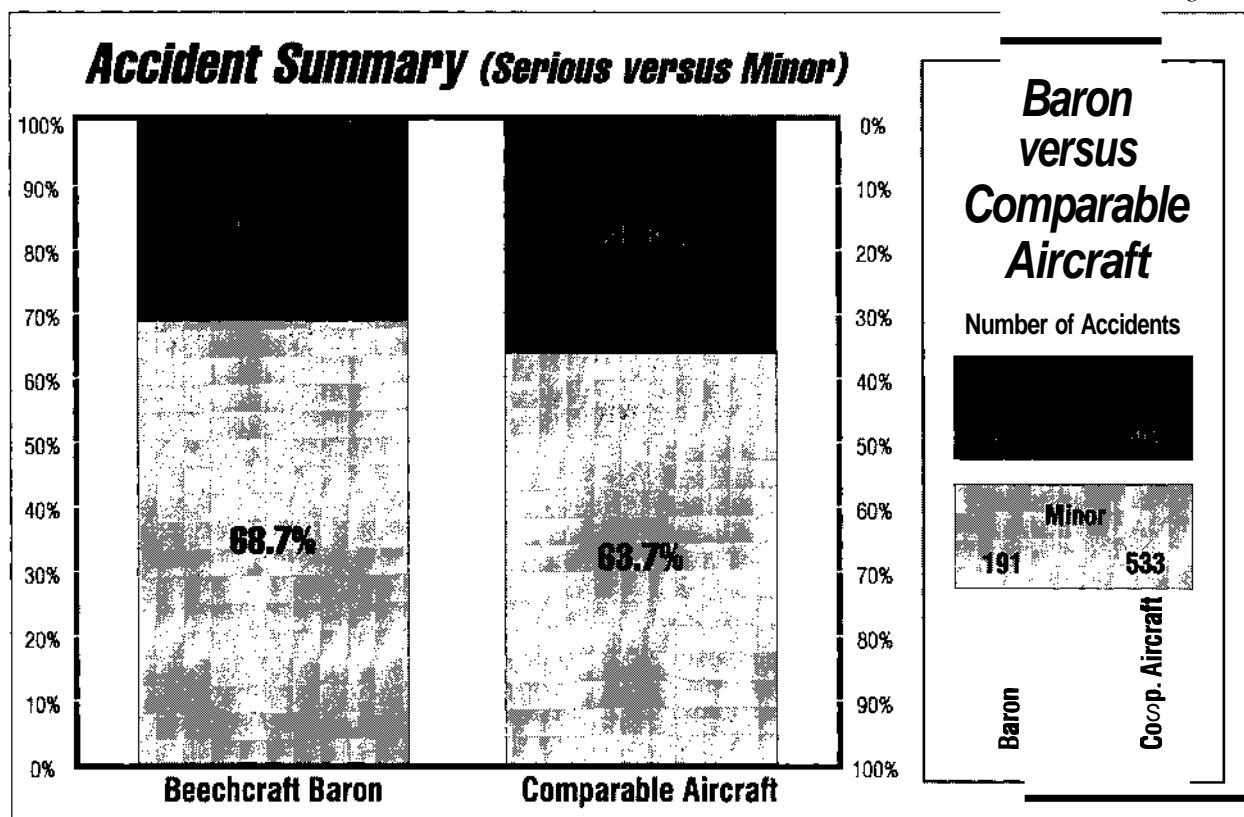
Figure 1 is the overall, serious and minor accident percentage rates and actual numbers of accidents. Serious accidents are defined as those which result in serious or fatal injuries in accordance with NTSB Part 830 definitions. Although many minor accidents, including gear-up landings and *lor* premature landing gear retractions, result in costly damages, they are not classified as serious unless serious or fatal injuries have occurred. The differences between the Baron and comparison aircraft do not appear significant with the exception that the minor accident rate for the Baron reflects a greater number of gear-up accidents and premature gear retraction accidents on landing roll. These will be covered in greater detail in the section entitled *Landing Gear Extension/Retraction Accidents-A Commentary*, found on page 1-23.

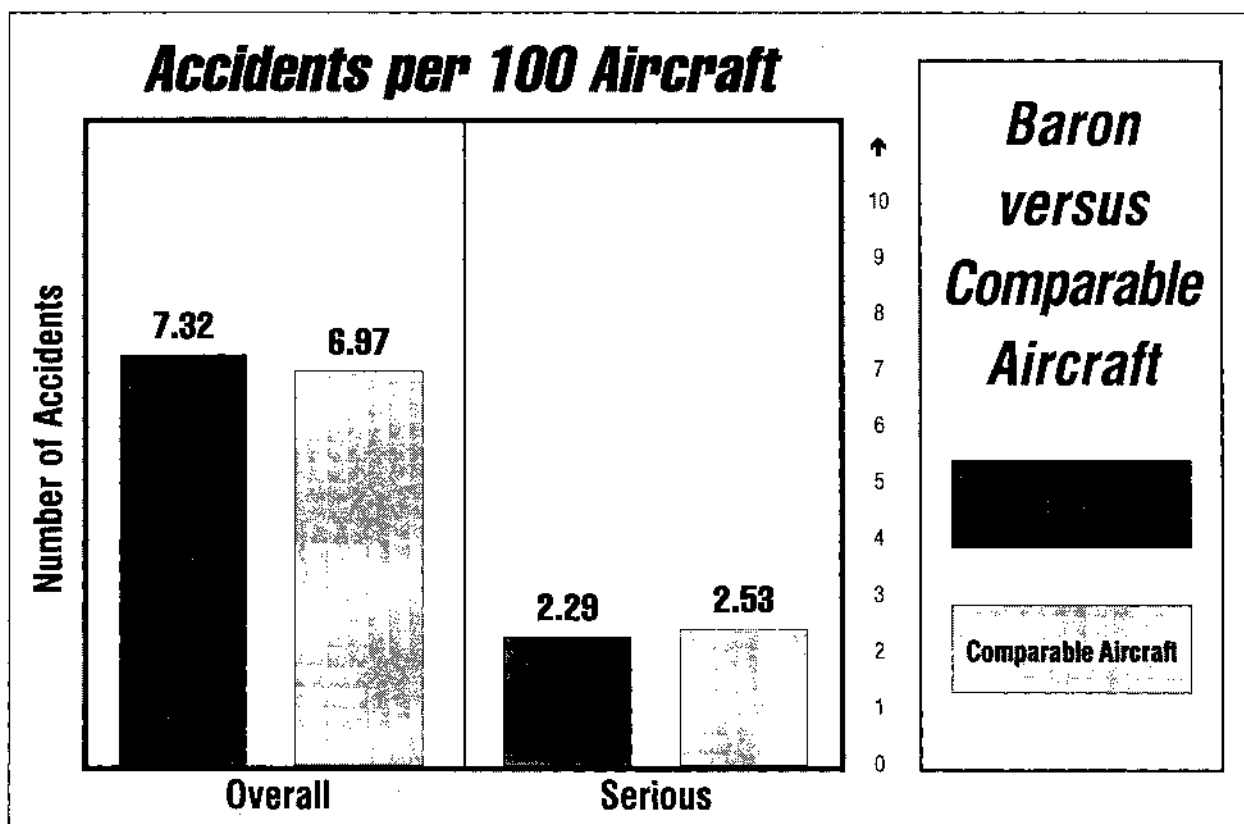
Figure 2

In accidents per 100 aircraft, Figure 2, the Baron has a slightly higher *overall* rate than comparison aircraft. This higher percentage could be attributed to the large number, 49% (see figure 12, page 1-15) of Baron landing accidents. Comparison aircraft landing accidents were just 33% of the total pilot-related accidents. Examples of specific Baron landing accidents can be found in part 2, pages 2-40 to 2-47.

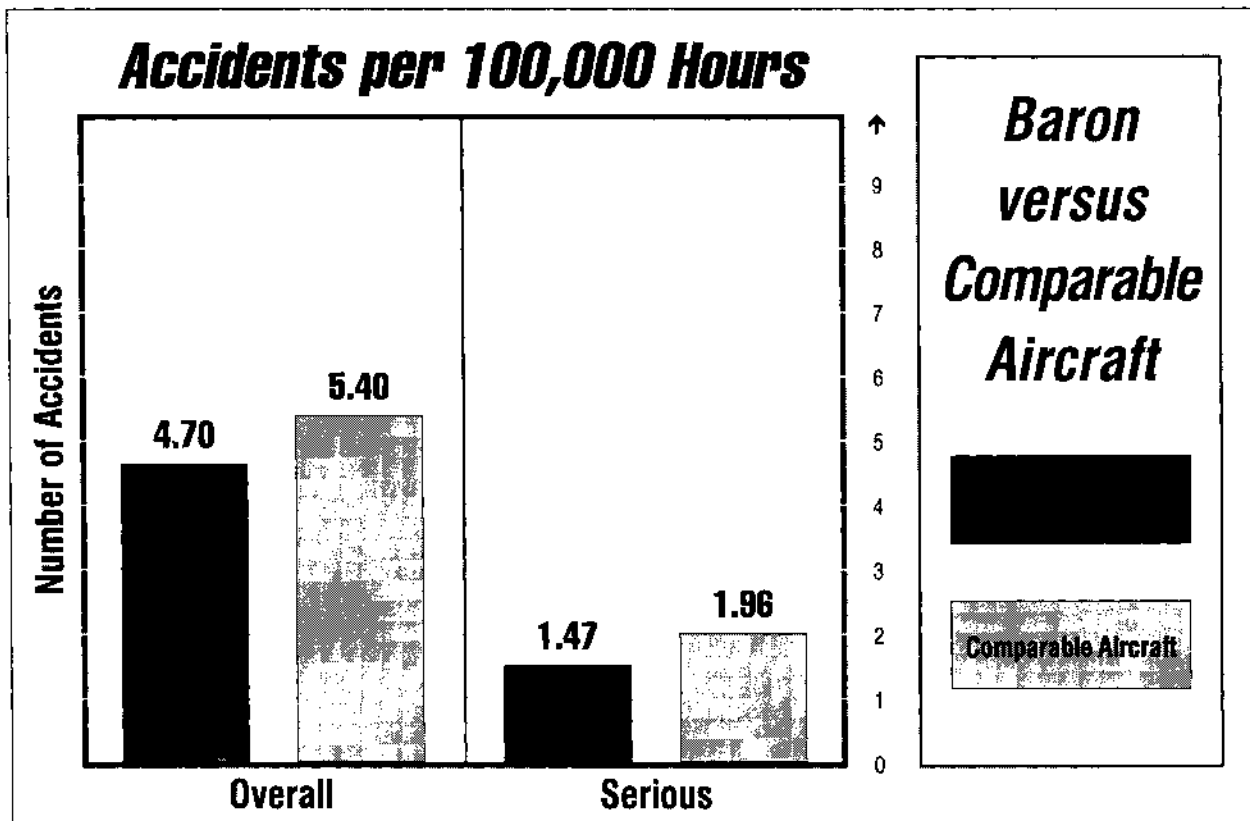
Another method of measuring accidents rates is to use the FAA 100,000 hour standard of measure. This is depicted in Figure 3 and indicates the overall accident rate for the comparison aircraft is slightly higher than the Baron. This reflects higher annual flying hours per aircraft for the Baron (173 hours) compared to 143 hours for the comparison aircraft.

Compare figures 10 and 11 to figure 3 on page 1-4. Note that the *total*/night accident rate is nearly 30% higher than the overall Baron accident rate. However, the night IFR in IMC rate (1.29 per 100,000 hours) is the lowest depicted. This indicates that on the whole, Baron instrument pilots flying IFR at night are doing a reasonably good job. In Part 2 of this report there are some unfortunate exceptions.

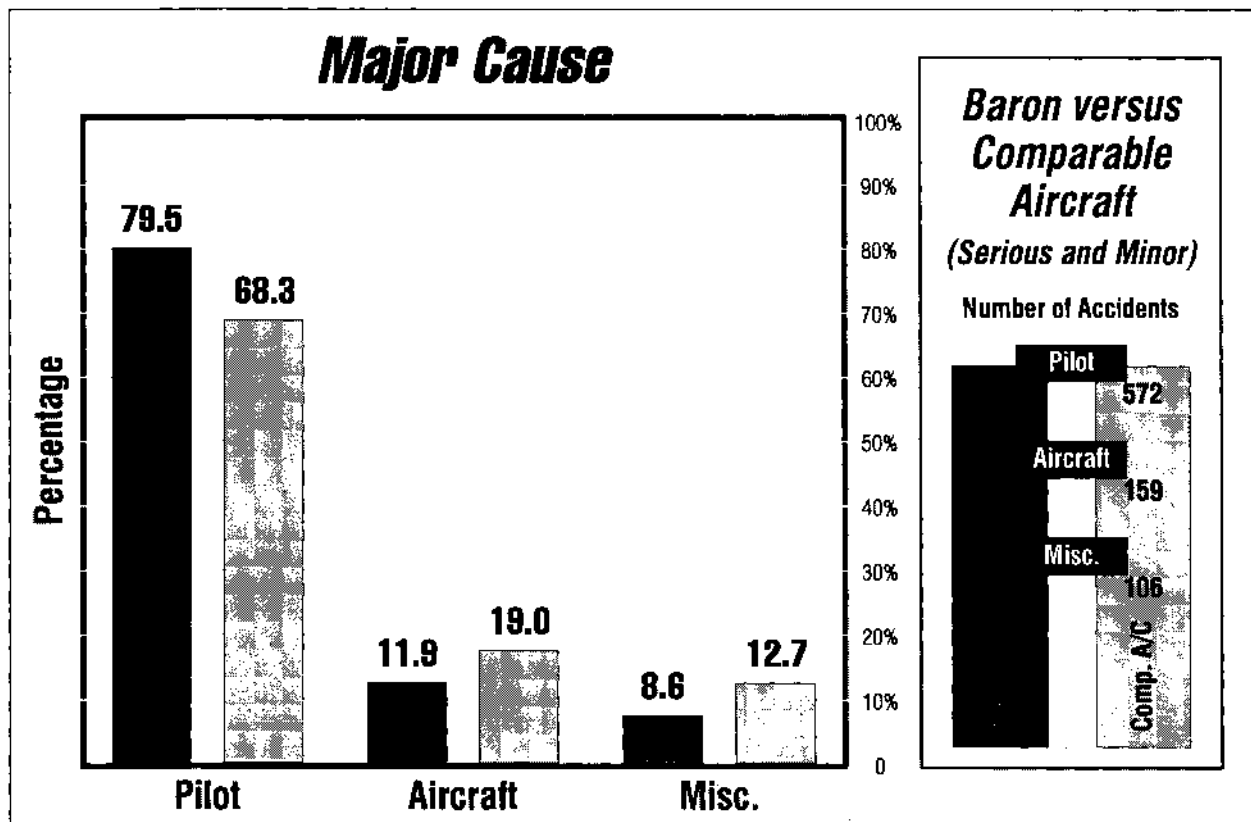
Pilot related accidents of the Baron are consistent with general aviation historical accident data (70 to 80 percent). Figure 4 indicates the major cause percentage attributed to the pilot is higher for the Baron than comparison aircraft. As will be seen later in this study, this could be due to the higher numbers of Baron landing accidents than those experienced by comparison aircraft.

Baron landing accidents, in the subcategory Gear Retraction/Extension, (page 1-22, figure 17) shows a major disparity: 29.4% versus 6.3%, when compared to comparable aircraft. This is a major reason for the poor showing attributed to Baron pilots in figure 4.

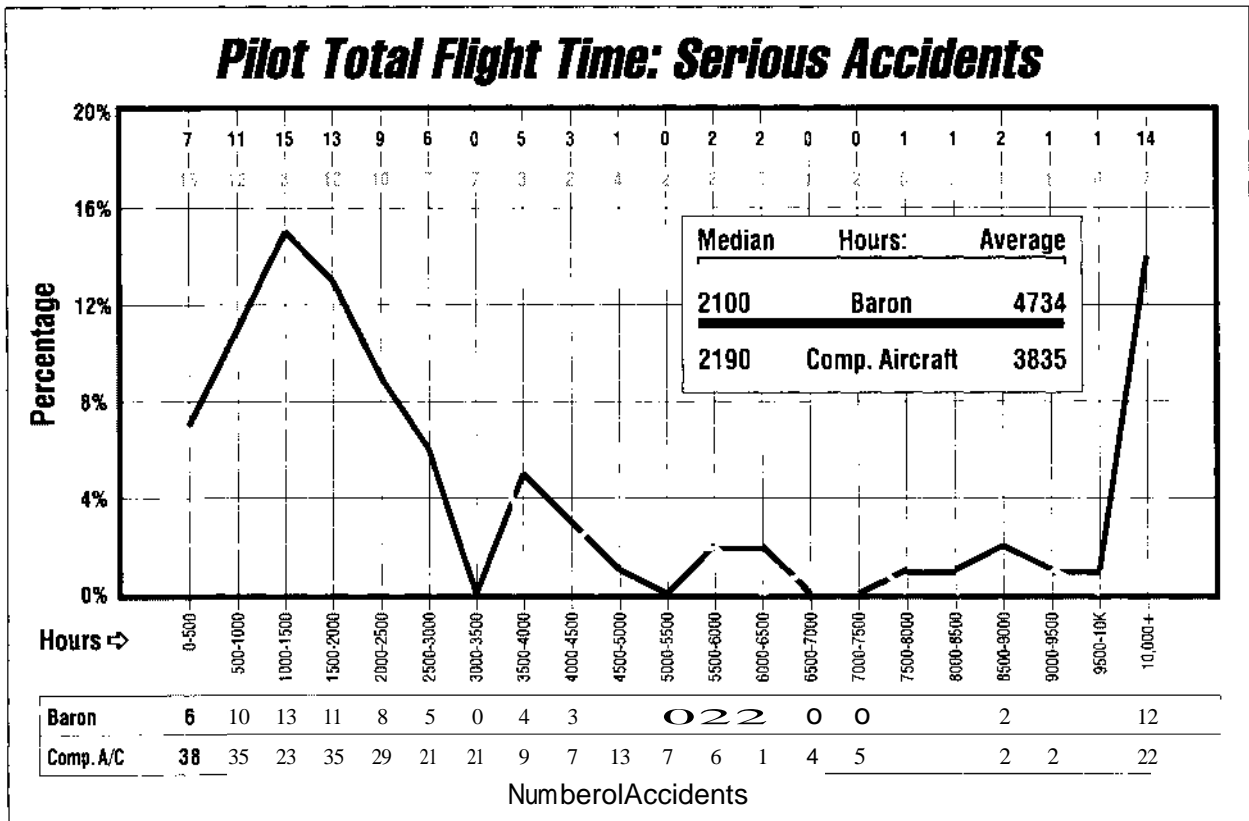
Figure 5

Figures 5, 6, 7, and 8 display the pilot level of total experience and pilot time in type for both serious and minor accidents. Please note that we have included the percentage numbers at the top of each graph.

From the data it appears that pilots with 400 hours or more time-in-type experienced fewer accidents. However, before pilots take comfort based on flight experience, remember that 26% of serious accidents and 29% of minor accidents happened to pilots with more than 5,000 hours total time. Pilots must maintain proficiency, vigilance, and pay the strictest attention to weather forecasts, endurance, preflight planning, and the use of checklists regardless of total time and/or time-in-type.

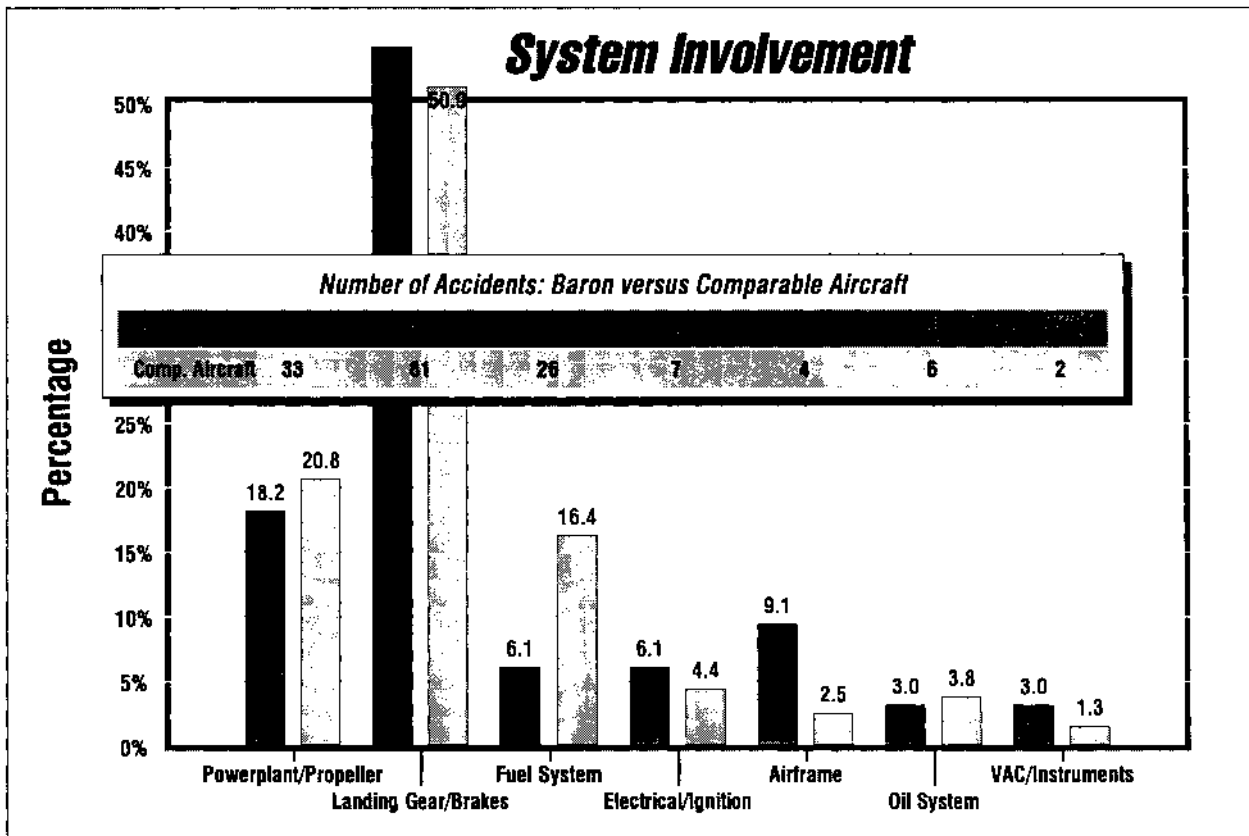
Figure 9

System involvement accident rates for the Baron and comparison aircraft are relatively comparable. In Figure 9, note that landing gear/brakes accidents are the highest for all systems. Although these numbers are mechanical/maintenance related, pilots can assist by reporting hard landings and other adverse situations affecting the landing gear to maintenance personnel for special inspections. Damage and/or wear and tear problems could thus be repaired to prevent more serious complications in the future. For more details, see SDR highlights on page 1-10 and 1-11 in this review.

The high involvement of gear and brakes for both Baron and comparable aircraft suggest that more attention be paid to these critical systems. This is especially true for owner/operators who know the maintenance history of the aircraft.

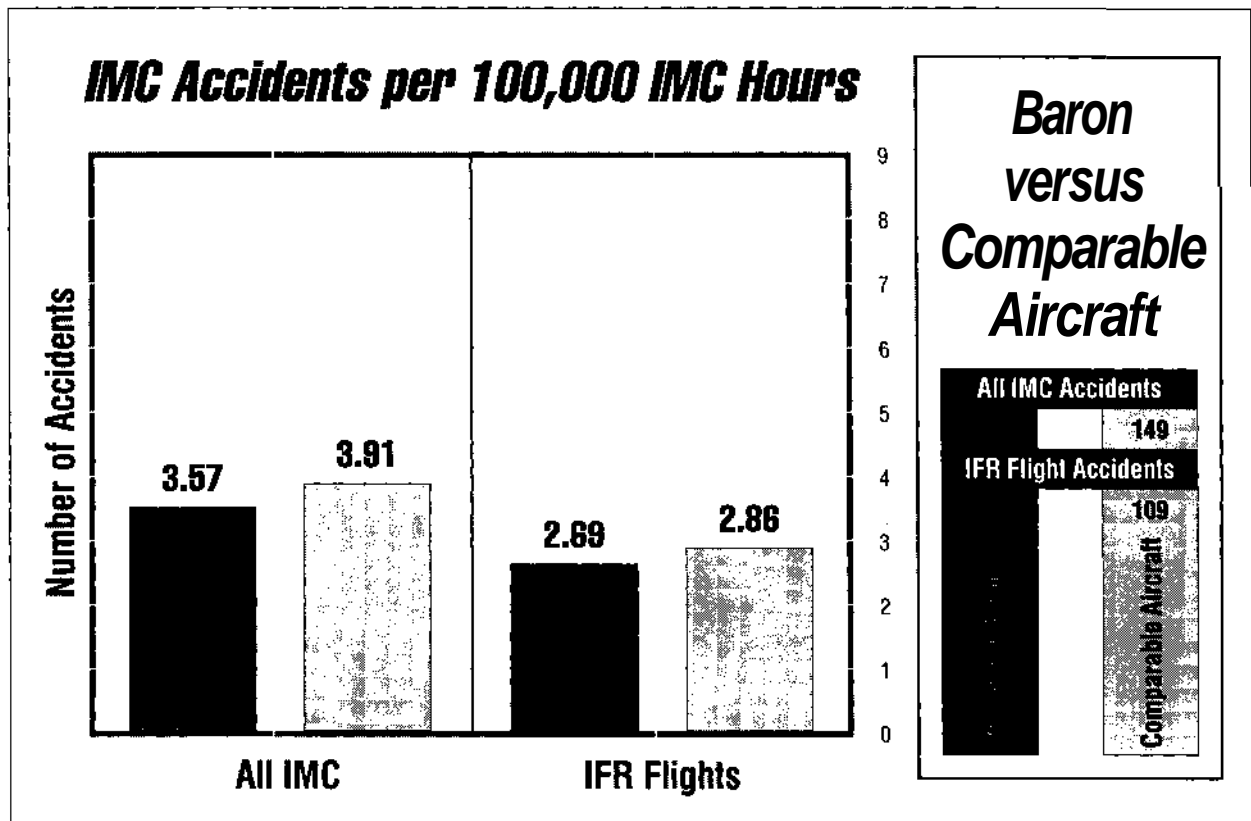
Figure 10 shows serious and minor Baron accidents that occurred in instrument meteorological conditions (IMC). Both the Baron and comparison aircraft rates are about the same. The **ALL IMC** bar includes all accidents under IMC. This includes 49 Baron accidents of which 12 accidents were caused by non-instrument-rated pilots or instrument-rated pilots who continued VFR flight into instrument conditions without instrument flight plans or clearances. Forty comparison aircraft accidents occurred under the same circumstances. *The IFR FLIGHTS bar shows instrument-rated pilots on IFR flight plans.*

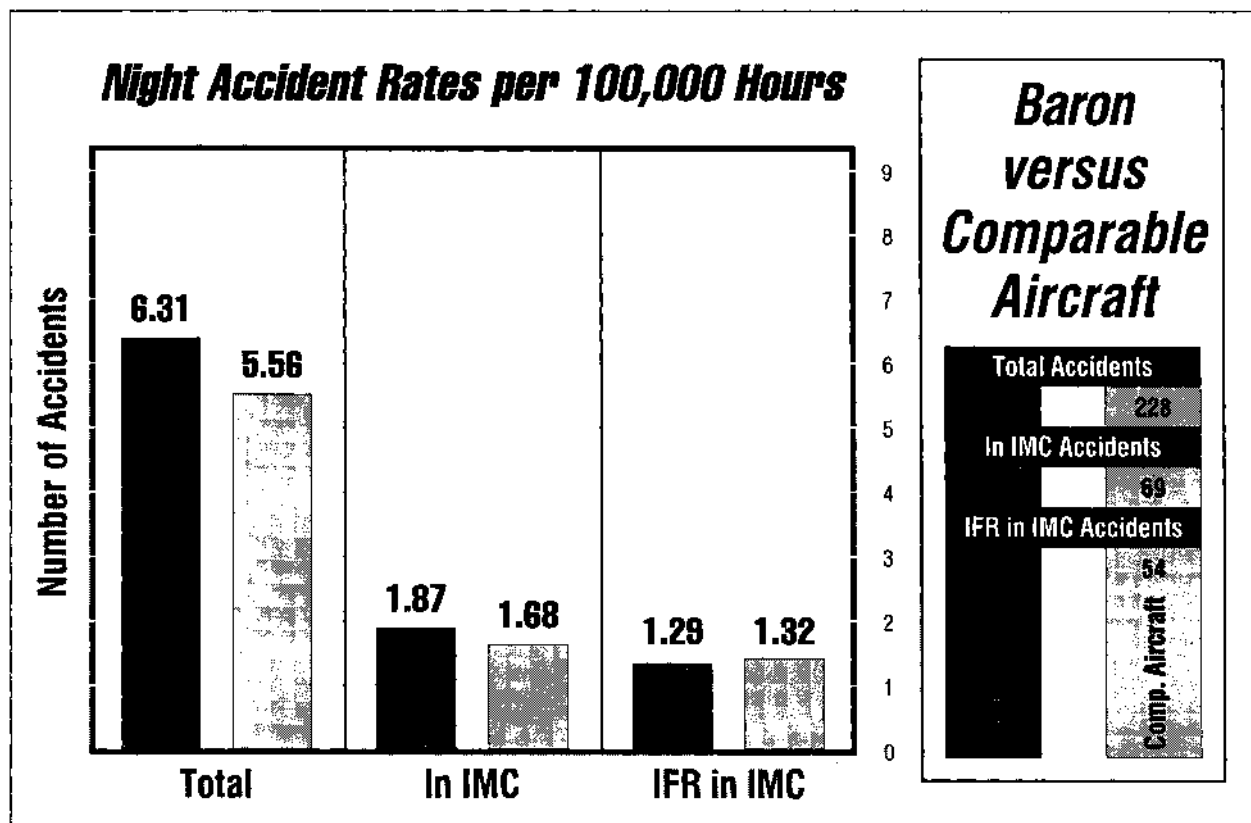
Figure 11 shows serious and minor night accident rates to include those which occurred under IMC. Fifty-four Baron accidents occurred at night of which 27 were in VFR conditions. These rates were nearly twice the **ALL IMC** accidents indicated in Figure 10. Some pilots were involved in night IMC (five Baron and 15 comparable aircraft) not under IFR flight plans. Clearly, night operations accident data confirms that instrument training and currency is essential for safe night operations because of reduced visibility and fewer visual cues. The use of published instrument departures and approaches at night, where possible, ensures terrain and obstruction avoidance. This is good practice for both instrument-rated and non-instrument-rated pilots. Pilots entering IMC without instrument flight plans and ATC clearances, whether instrument rated or not, do so at great risk to themselves and others.

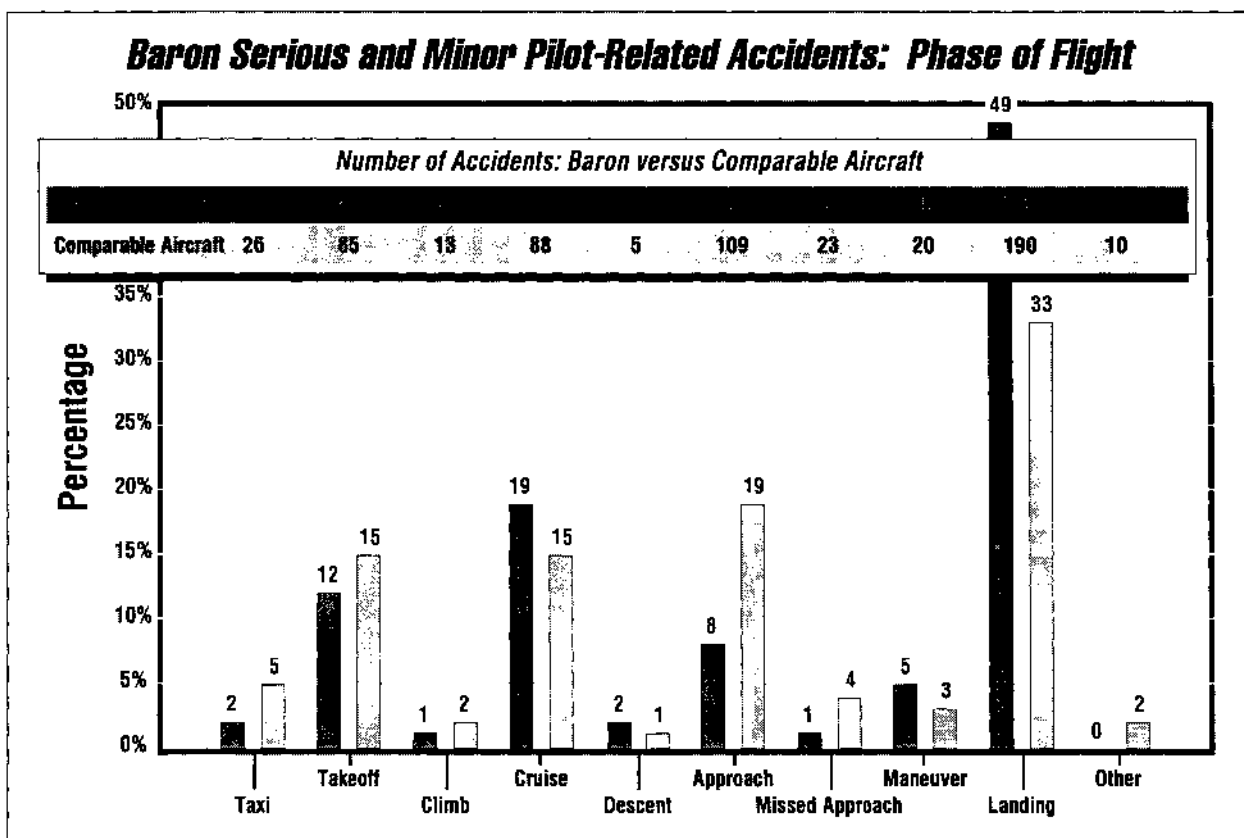
Figure 12

Further study focused on the phase of flight which the accidents occurred. (Figure 12) Both serious and minor accidents were considered. There were 278 accidents of which 221, or 79.4 percent, were pilot related. The majority, or 88.2 percent, of these accidents were in the following phases of flight categories:

➤ Failed to extend or check gear down and locked	39
➤ Delayed gear extension, collapsed during landing	4
➤ Inadvertent gear retraction during landing roll	15
➤ Improper emergency gear extension, failed to use system	6
➤ Overload, swerve, skid, gear collapse	1
➤ Hard landing, improper flare, high sink rate, gusts, stall/mush	12
➤ Landing long, high, fast, delayed go around, overshoot	14
➤ Landing, other	18
<b>Total</b>	<b>109</b>

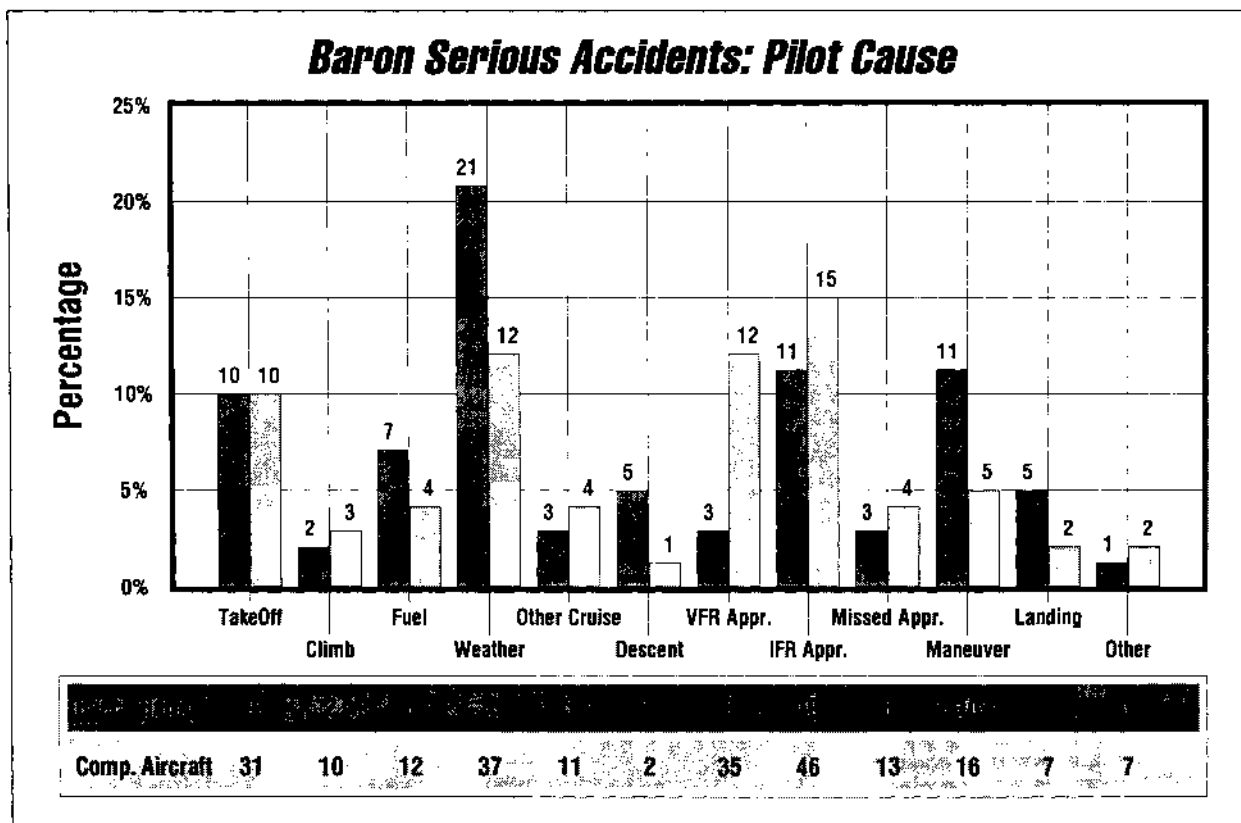
There were 87 serious accidents of which 73 had pilot-related causes. Five were mechanical/machine related and nine were undetermined. Figure 13 is the distribution of the Baron pilot-related causes, serious accidents. The following are the numbers and percent by primary cause category.

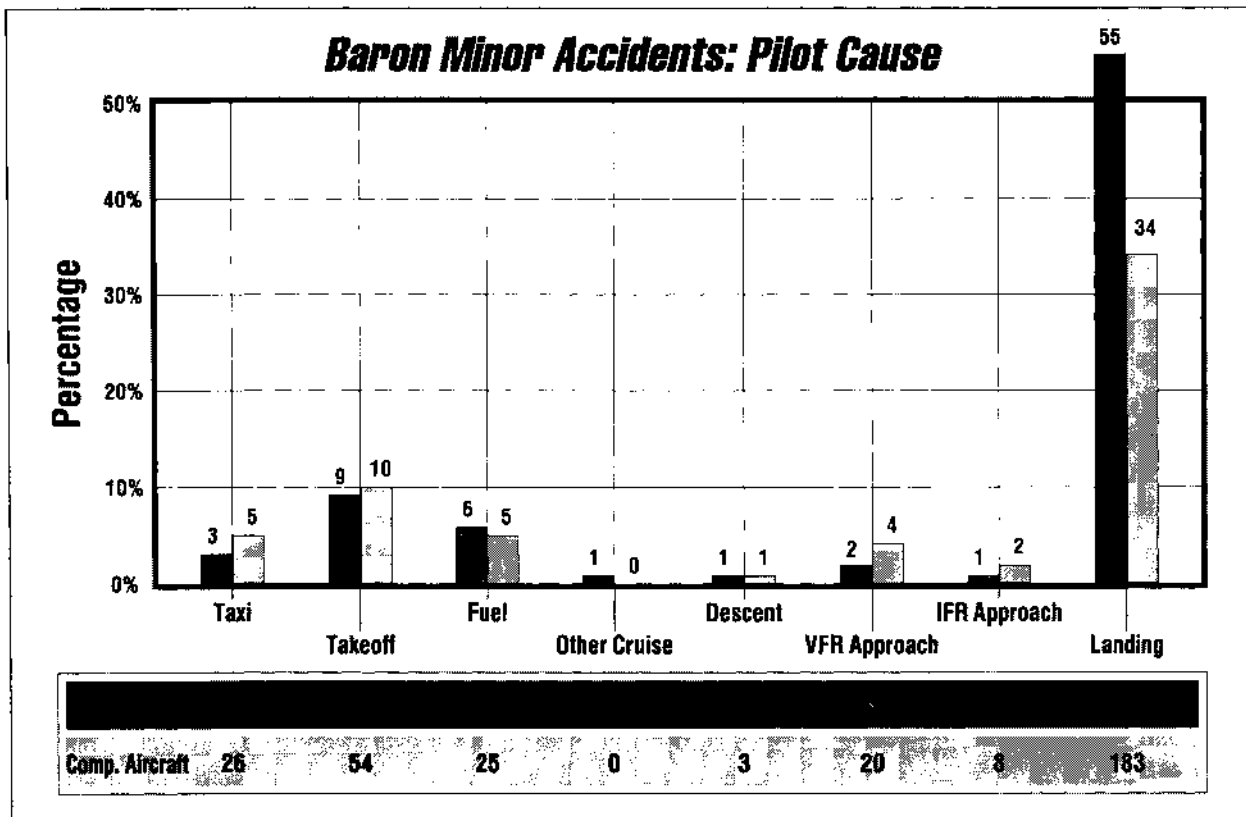
During the reporting period, there were 191 minor accidents of which 148 had pilot-related causes. Twenty-eight were mechanical/machine related and 15 were miscellaneous, other, or unknown. Figure 14 is the distribution of the Baron pilot-related causes, minor accidents.

Number	Percent
Pilot:	148	77.5%
Mech/Maint:	28	14.7%
Miscellaneous:	15	7.9%
<b>Total:</b>	<b>191</b>	<b>100 %</b>

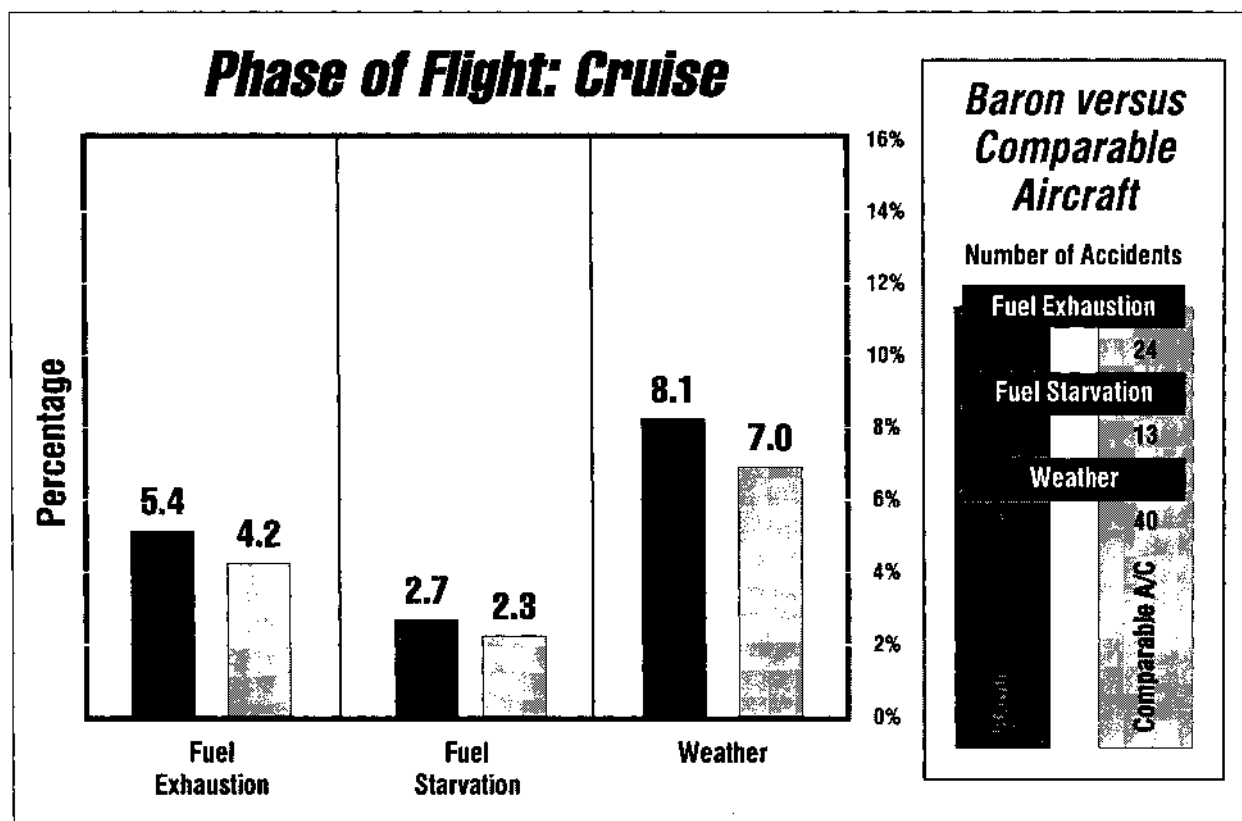
Figure 15 depicts the percentage of Baron and comparison aircraft pilot-related accidents that occurred during the cruise phase of flight.

Weather accidents for both the Baron and comparison aircraft are high. This is probably caused by inadequate preflight planning and the disregard of potential adverse weather. Pilots must make sure adequate planning is done for alternative courses of action when the possibility of adverse weather may affect the plan. A way to escape trouble should be available and the pilot must be willing to use it. From the accident data it is impossible to know if these pilots had encountered dangerous weather before. It's probable that many of them made poor decisions before and were able to escape unharmed but apparently no wiser.

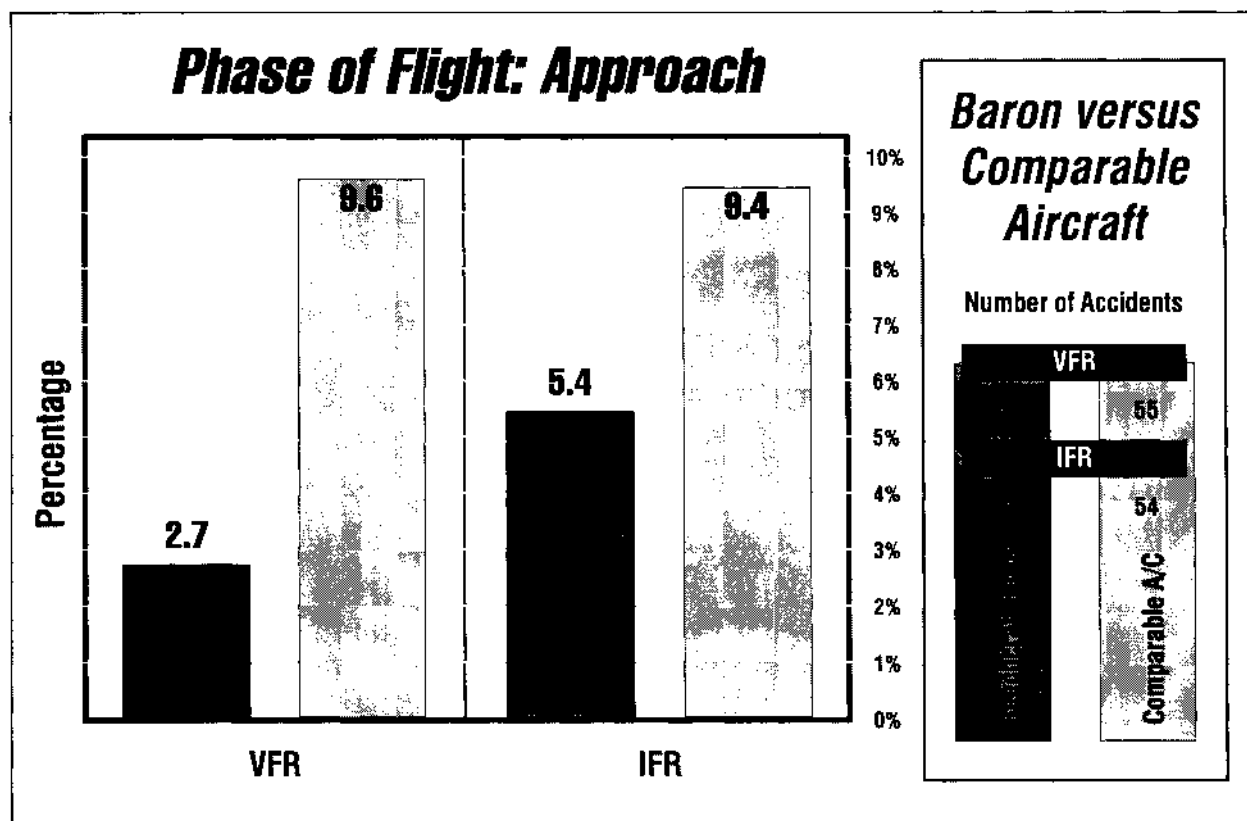
Figure 16 reflects the percentage of Baron and comparison aircraft pilot-related accidents that occurred during the approach phase of flight. The higher comparison aircraft VFR rate could be caused by the higher rates of attempted VFR approaches in IMe, descending into terrain during night landing patterns/approach, and fuel exhaustion during approaches.

Improper IFR procedures and descending below approach minimums during instrument approaches are the basis for the comparison aircraft higher IFR accident approach rate.

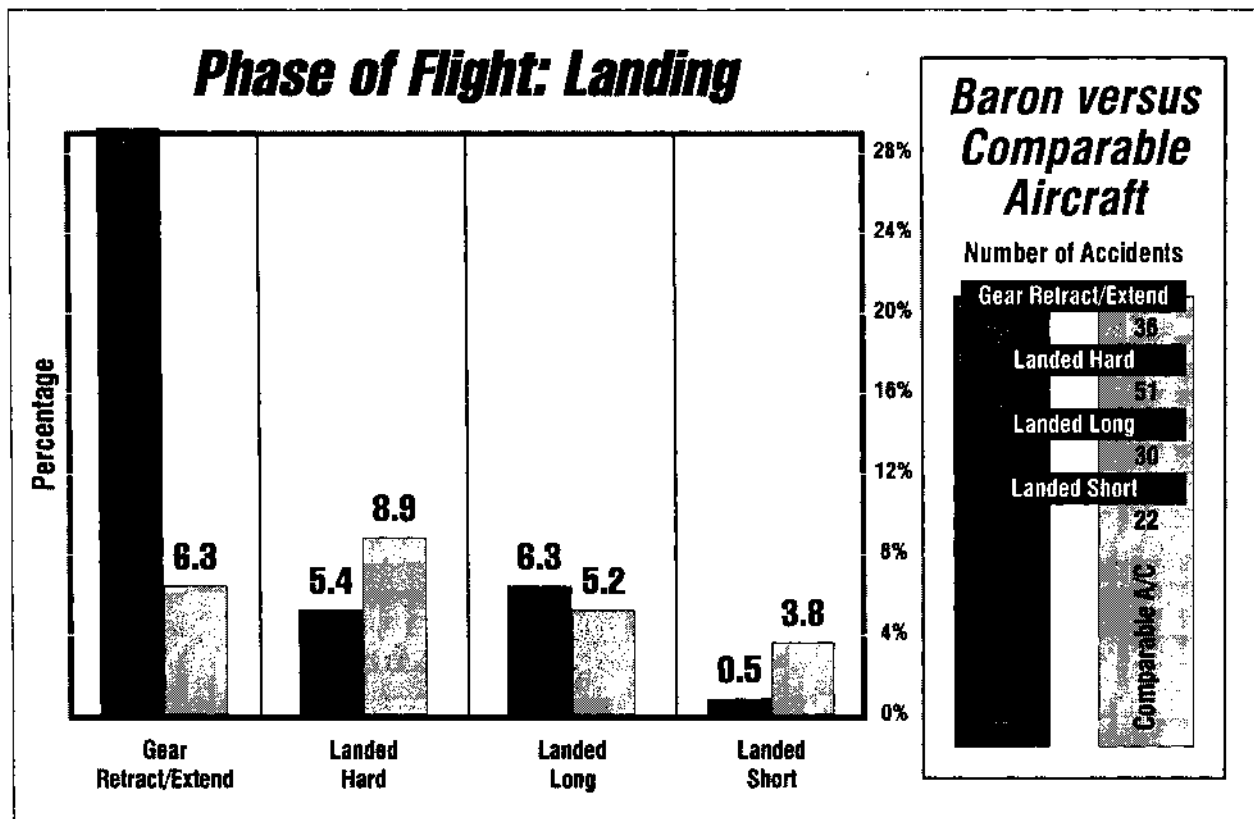
Figure 17 displays the percent of Baron and comparison aircraft pilot-related accidents which occurred during landing. The Baron 29.4 percent rate compared to the 6.3 percent comparison aircraft rate relates to the large number of gear-up Baron landings and the premature retraction of the landing gear on the landing roll. (See next page.) This is discussed together with reference to a special NTSB study which was conducted in 1980 entitled "Design-Induced Landing Gear Retraction Accidents in Various Beechcraft Aircraft." The NTSB report is appended to this study in Part 4.

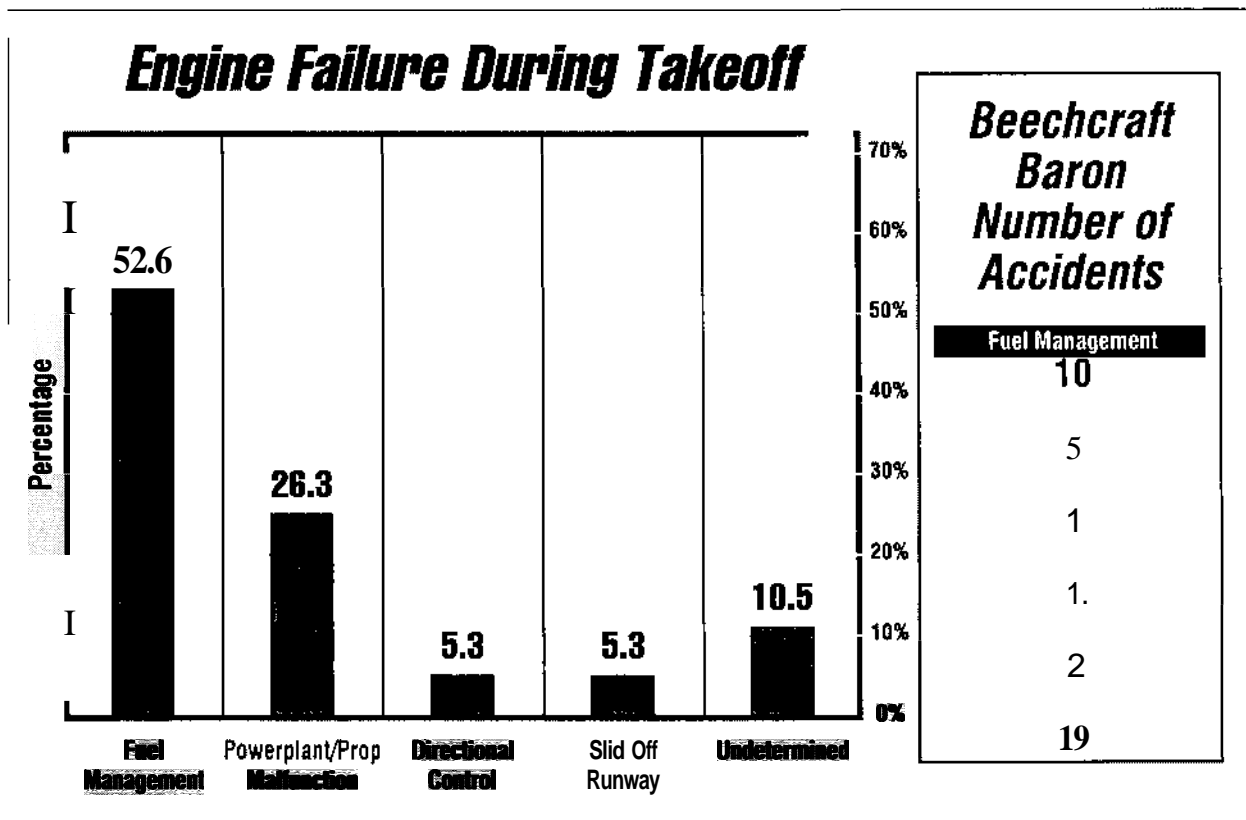
Figure 18

Engine failure on takeoff is a major concern to all pilots flying piston twins. As shown in figure 18 fuel mismanagement is the leading cause of most of the emergencies. Climb capability decreases by approximately 80% when an engine fails and directional control can be challenging. The proper handling of flight controls with accurate decision making is essential.

\* One of the two aircraft departed the runway due to loss of directional control. The other slid off the end of the runway when it was unable to stop.

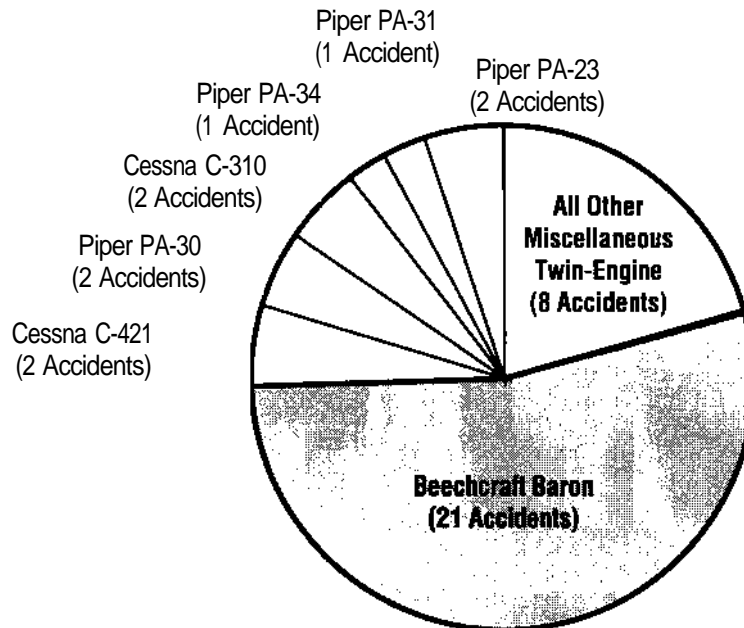
# *Number of Inadvertent Gear Retraction Accidents (1975 through 1978) in Population of Light Twin-Engine Aircraft*

Therefore, the Bonanza and Baron aircraft have inadvertent gear retraction accident rates that are between two to four times the average rate for aircraft in their respective categories. In fact, they were involved in over 61 percent of all these accidents from 1975 to 1978, while constituting only 25 percent of the active fleet of light aircraft having retractable landing gear. These results are similar to those reported in an earlier Safety Board Special Study, published in 1967, concerning design-induced pilot errors. That report concluded that the early Bonanzas, while comprising only 22 percent of the fleet with retractable landing gear, accounted for 48 percent of the inadvertent gear retraction accidents. The number of such accidents involving the Bonanzas and Barons, and their individual accident rates, are several times as great as those of most other similar contemporary light aircraft. Figure 1 graphically illustrates these facts. For instance, the significant differences in the rates of occurrence of inadvertent landing gear retraction accidents can be seen by comparing the Bonanza with a similar aircraft, the Cessna 210. The 4,741 Cessna 210s, which comprised 15 percent of the single-engine, retractable gear fleet in 1978, only had four percent (1 accident) of the inadvertent landing gear retraction accidents occurring to single engine aircraft during the 1975 to 1978

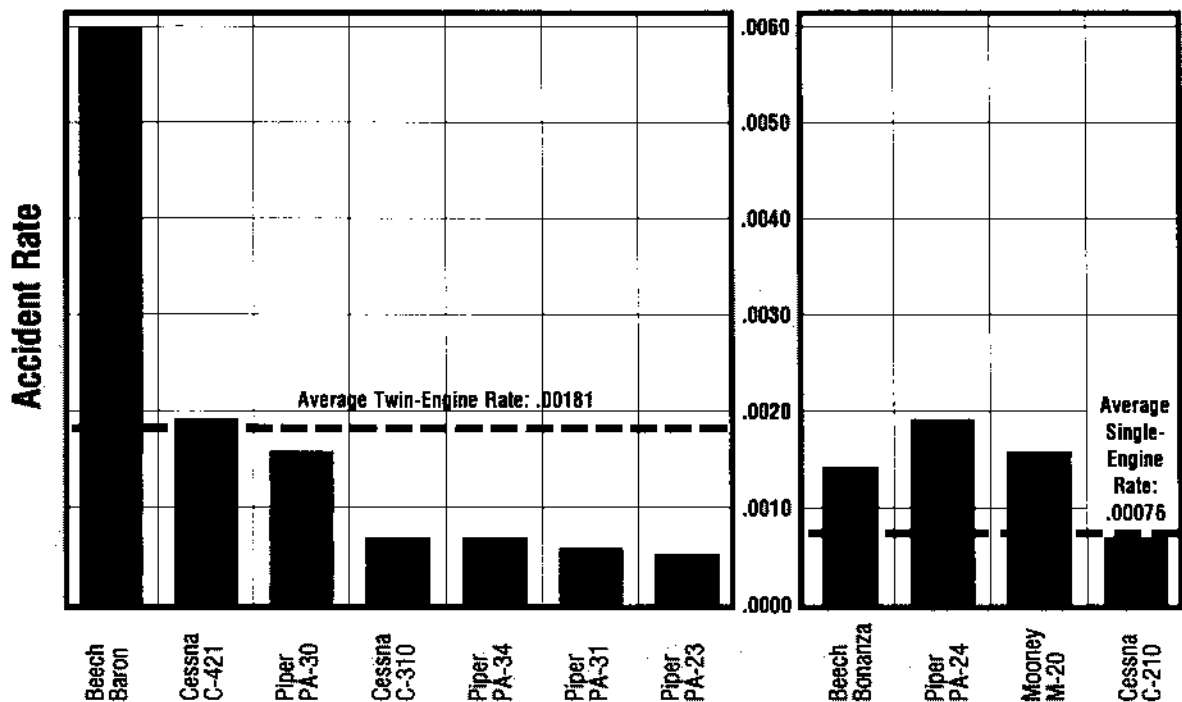
## *Inadvertent Gear Retraction Accident Rate (1975 Through 1978)*

period. In contrast, the Bonanzas, comprising about 30 percent of the fleet, experienced 67 percent of these accidents (21 accidents)-an accident rate about 10 times as high as that of the Cessna 210.

Similarly, the accident rate of the Baron can be compared to the Piper PA-23 Aztec, a similar light twin. The 3,459 active PA-23s comprised about 16 percent of the 1978 light-twin fleet, but suffered only eight percent (2 accidents) of the inadvertent landing gear retraction accidents occurring to light twins from 1975 to 1978. In contrast, the Baron, also comprising 16 percent of the twin fleet, experienced 67 percent of such mishaps (16 accidents)-an accident rate of about 8 times that of the PA-23.
