SANtricity Storage Manager 11.30 Product Release Notes

StorNext QD7000

Firmware 8.30.xx.xx

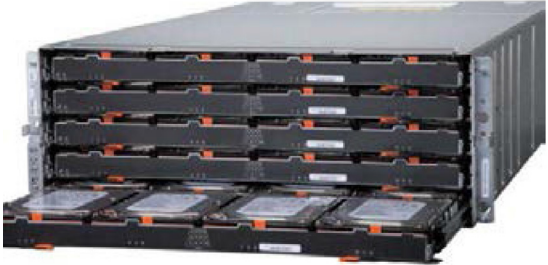
E-Series NetApp Product	Quantum-Storage	Description
<p>E5560 or E5660 (DE6600 4U drive enclosure with E5500 or E5600 RAID controllers)</p>	<p>Quantum StorNext QD7000</p>

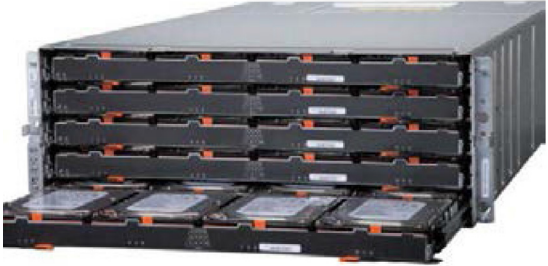
<p>E5460 (DE6600 4U drive enclosure with E5400 RAID controllers)</p>	<p>Quantum StorNext QD6000</p>

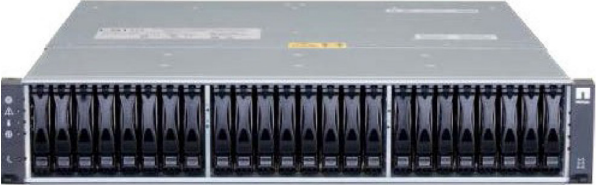
<p>E5424 (DE5600 24-drive 2U drive enclosure (Code Name: Camden with E5400 RAID controllers)</p>	<p>Quantum StorNext QS2400</p>
