TECHNICAL INSTRUCTIONS
FOR
SAFETY RECALL E0E
SOFTWARE UPDATE FOR MOTOR GENERATOR ECU AND POWER
MANAGEMENT ECU
CERTAIN 2010-2014 MODEL YEAR PRIUS

UPDATED August 22, 2014

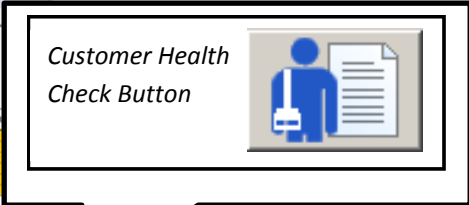
8. PRINT CUSTOMER HEALTH CHECK REPORT

- a) From the Health Check Results screen select the Customer Health Check Report button (TIS will launch when button is pressed).

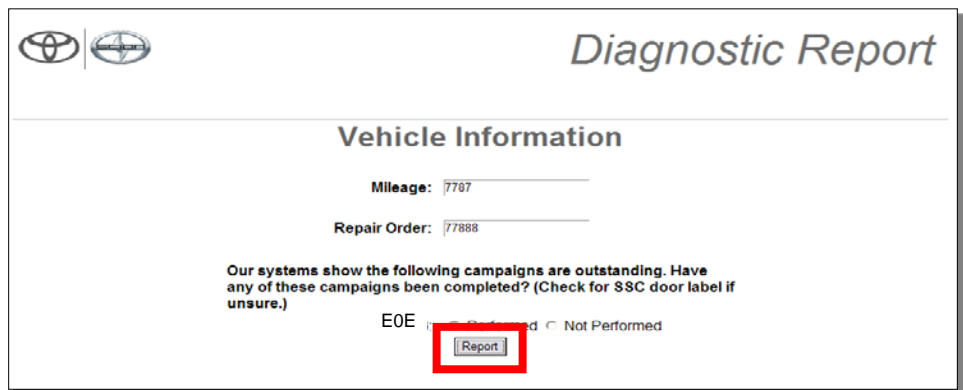
- b) Log in to TIS.
- c) Input Vehicle Mileage and Repair Order number.
- d) Check the "Performed" campaign radio button for the applicable campaigns completed during this service event.
- e) Select the Report button.

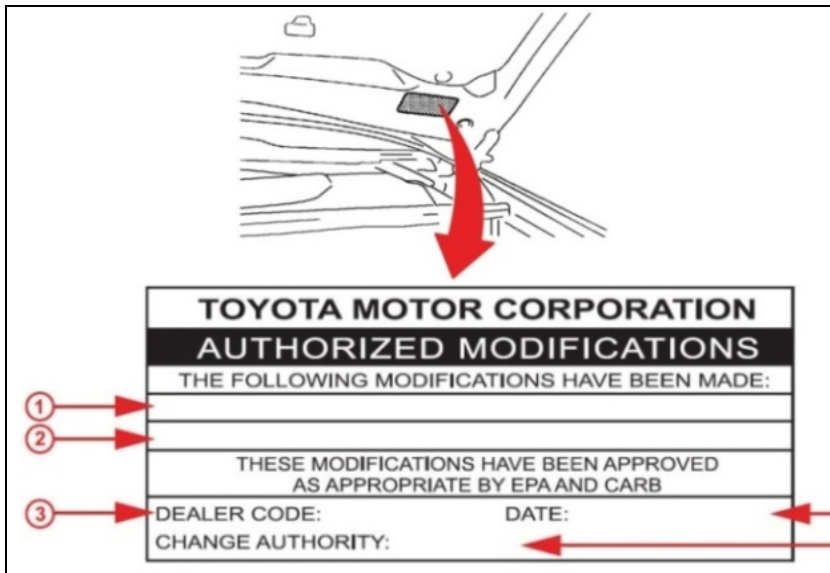
10. Affix the label to the under-side of the hood.

The authorized modification label only needs to have the Power Management ECU Information.

1	Replacement ECU P/N* 89681-47441 89681-47302 89681-47212 89681-47251 89681-47087 <i>Part # varies by model year and production period.</i>
2	New Power Management ECU Calibration IC
3	Dealer Code
4	Date Completed
5	Campaign Code (E0E)

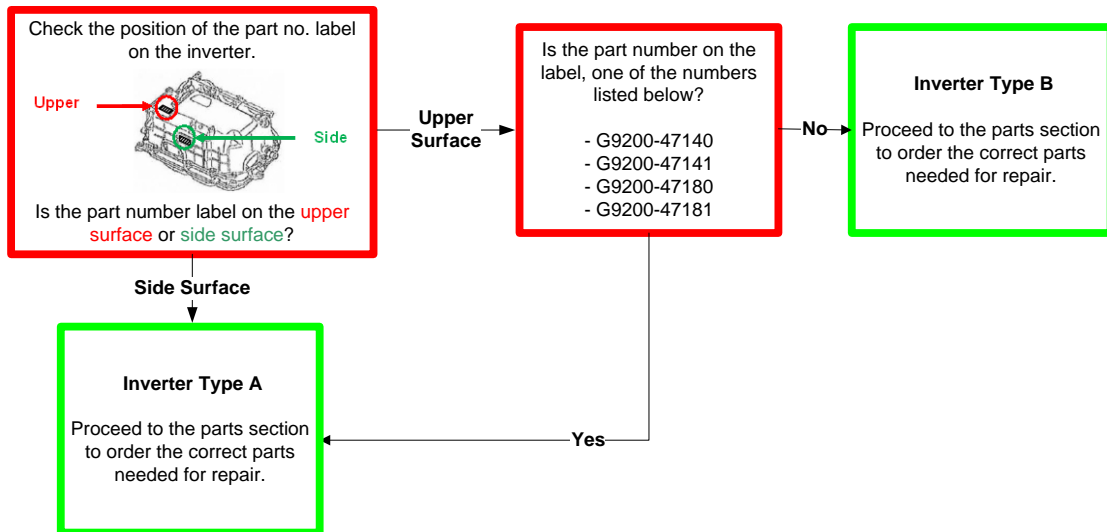
1. DETERMINE INVERTER ASSEMBLY TYPE

a) Using the flowchart below determine the inverter type.
