Windsor Town Centre Traffic Study
prepared by Christopher Hallam &
Associates Pty Ltd (Job 3103)

**WINDSOR TOWN CENTRE
TRAFFIC STUDY**

JULY 2011

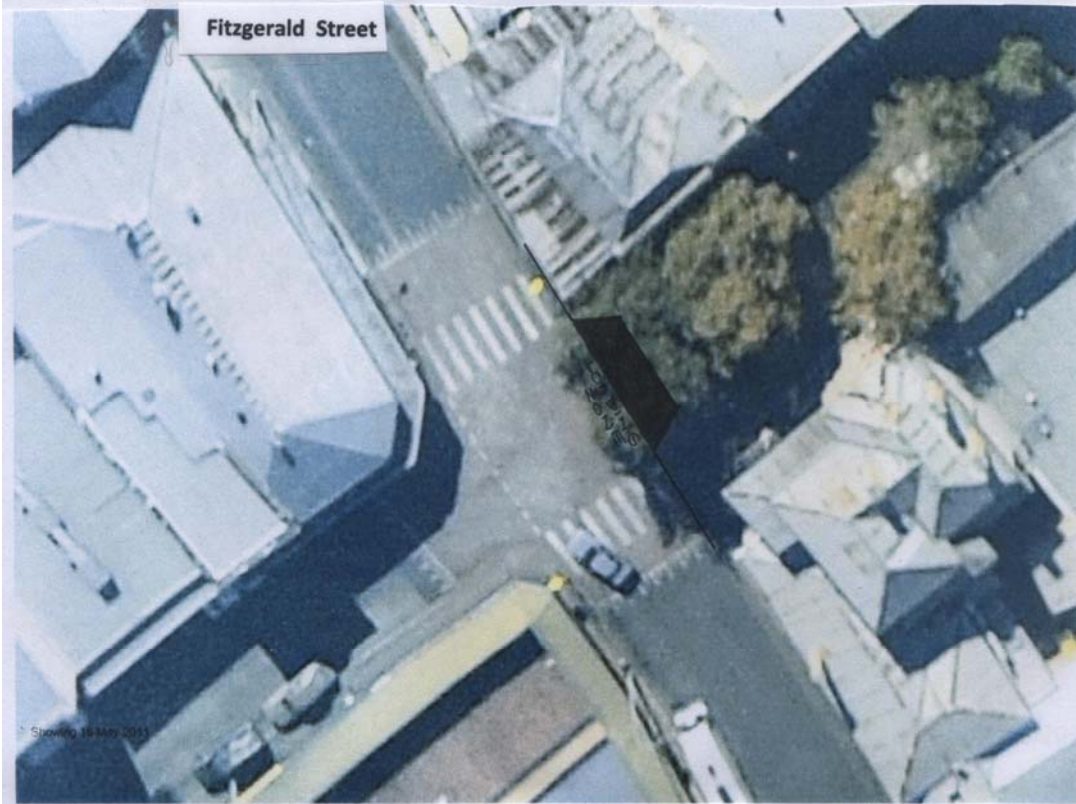
FIGURE 6 PROPOSED LOADING ZONES IN GEORGE STREET MALL

For loading zones and service vehicle access to Windsor Mall, standard practice in pedestrian malls is to restrict access to certain hours of the day, and then without designated loading zones. Consultation with the Windsor Business Group Inc would be appropriate to define appropriate hours. What might apply to the Pitt Street Mall in Sydney, and in other major centres might not necessarily be appropriate in Windsor. Nevertheless, we have identified two opportunities to improve loading areas at the ends of the Mall, with no loss of on-street parking. Figure 6 presents schematic layouts of proposed new loading zones at the Kable Street and at the Fitzgerald Street ends of the Mall. These loading zones would permit small to medium size delivery trucks to stop and unload, stopped parallel to these streets, within the designated Mall areas. At the western end, trucks would approach via Fitzgerald Street North and pull into the zone, leaving in a forwards direction to Fitzgerald Street South. At the eastern end, trucks would approach via Baker Street South, pull into the zone, leaving in a forwards direction
