Cleveland, OH  
September 26-27, 2017

## Process Control for Electrocoat Systems

Jeff Paxon  
Axalta Coating Systems

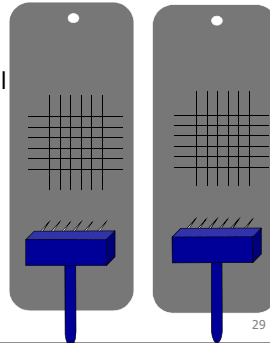
29

### ➤ Adhesion

- **Destructive Adhesion test** will determine how well the paint layer adheres to the metal & phosphate layers.
- The first step is to scribe the panel with an adhesion scribe.

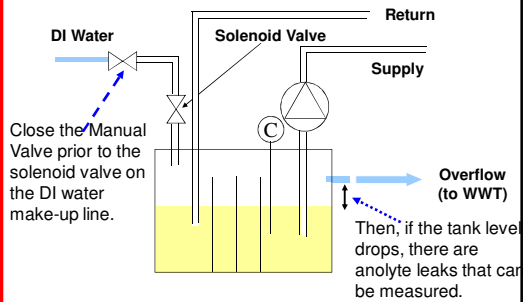
61

## Preventive Maintenance: Anolyte System

### How do you determine if there are anolyte leaks?

- Leaking Anolyte
  - When the E-coat tank is empty, some normal anolyte weeping is expected due to the pressure on the membranes.
  - However, leaks that can be physically identified, such as that above, are unacceptable.

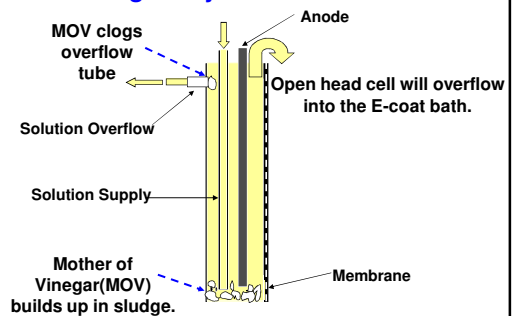
64

### Overflowing Anolyte Cells

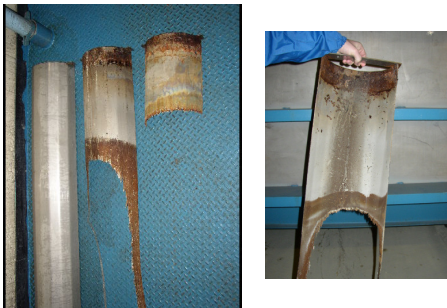
67

#### Anode Erosion - Symptoms

- Anode Erosion - Symptoms
  - Coffee brown anolyte color
  - Brown staining on clear tubing or return piping
  - High iron content in electrocoat bath
  - Rough electrocoat appearance

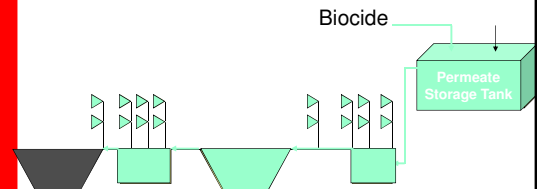
### Full System Biocide Hit

A **full system biocide** hit should be added to the **permeate storage tank**, where it will counterflow to the entire system. If there is no storage tank, it should be made to the final rinse.

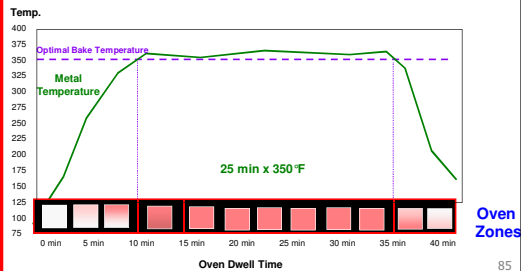
85

Run an **Oven Curve** (Datapaq or Grant Recorder) frequently to confirm metal temperatures and oven performance.

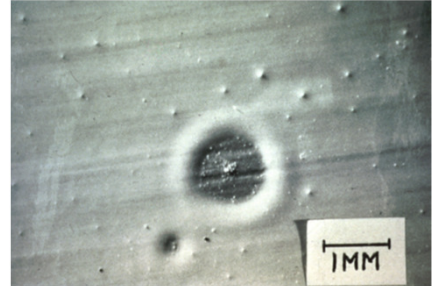
## Craters

➤ Bowl shaped depressions with raised circular edges; can be dimples in a cured electrocoat film or exposed bare substrate in the centers

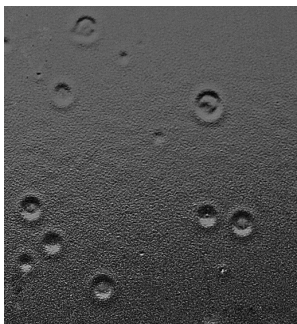
## Craters

- incompatible oils
- lubes, or greases that contaminate the paint bath, post rinses or substrates
- material left on the surface of the substrate

- Craters are caused by contaminants introduced to paint, metal surface before painted, or uncured E-coat film after coating
- Dirt particles, such as the weld ball pictured, need to be identified and categorized before they can be systematically reduced

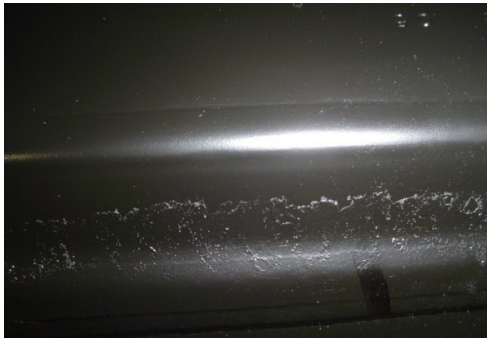
## Pretreatment Mapping

Areas of roughness or the cured electrocoat film mirroring the underlying surface

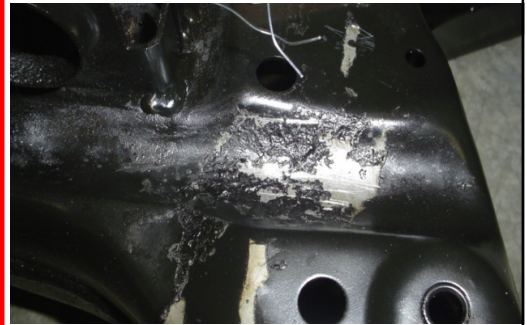
## *Wet Film Adhesion Loss*

Easy removal of the deposited but uncured electrocoat film by touching and/or normal spray rinsing

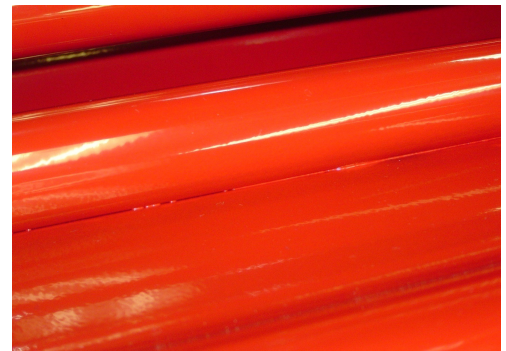
## *Bridging*

Paint build-up that bridges two portions of the part

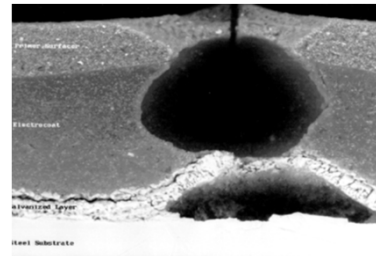
## Blow-out / Gassing

Galvanized gassing, blow-out actually originates in the galvanized layer and blows through phosphate and subsequent layers of paint

Areas of paint blow out, usually exposing bare substrate
