2015 PAVEMENT CONDITION INDEX (PCI) STUDY **EXECUTIVE SUMMARY**

FEDERAL AVIATION ADMINISTRATION
A.I.P. NO. 3-38-0000-013-2015

2015 PAVEMENT
CONDITION INDEX (PCI)
STUDY EXECUTIVE
SUMMARY www.aero.nd.gov

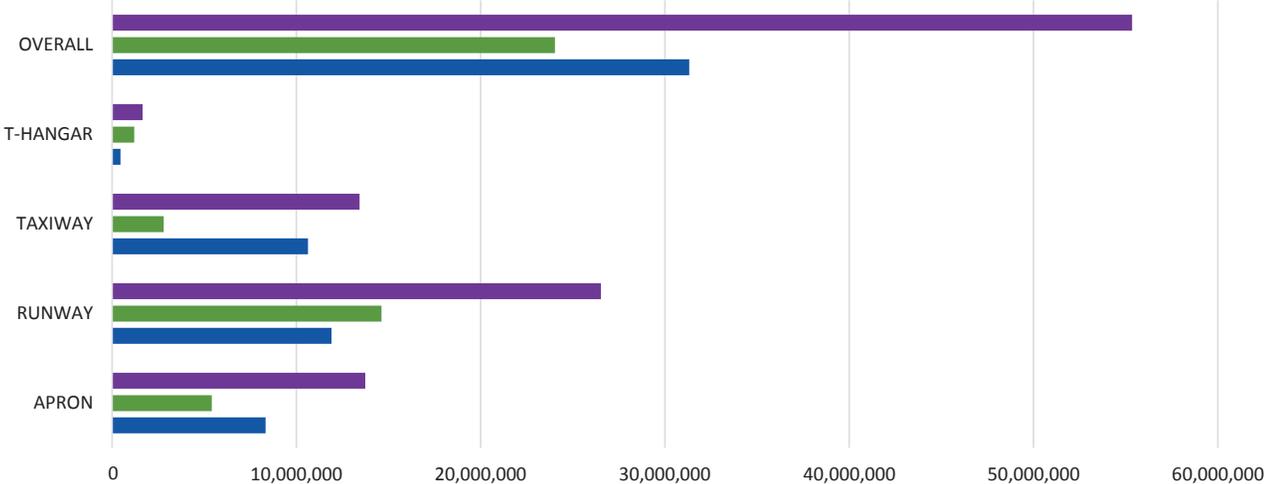
Pavement Area by Surface Type

These airports represent 55.3 million square feet of pavement – 26.5 million square feet of runway pavement, 13.4 million square feet of taxiway pavement, 13.7 million square feet of apron pavement, and 1.7 million square feet of T-hangar pavement, comprised of both concrete and asphalt, as shown in the *Area by Use* and *Area by Surface Type* pie charts below. Pavement at the airports in the state have an average age of 17 years for commercial service airports and 10 years for general aviation airports. Throughout the years, the airports have performed preventive maintenance and carried out a series of rehabilitation/reconstruction projects to sustain and extend the pavement life. The charts shown on the next page, *Pavement Area by Surface Type* and *Area-Weighted Average Age by Surface Type*, summarize the total square footage of pavements found in the state and the average age of those pavements based on use.

IN SQUARE FEET

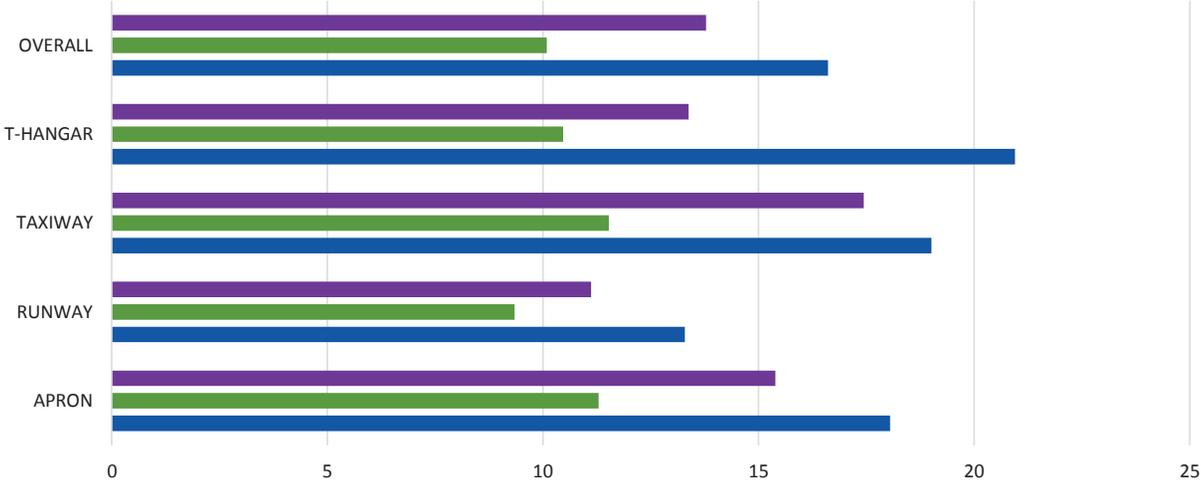
Area-Weighted Average Age by Surface Type

IN YEARS

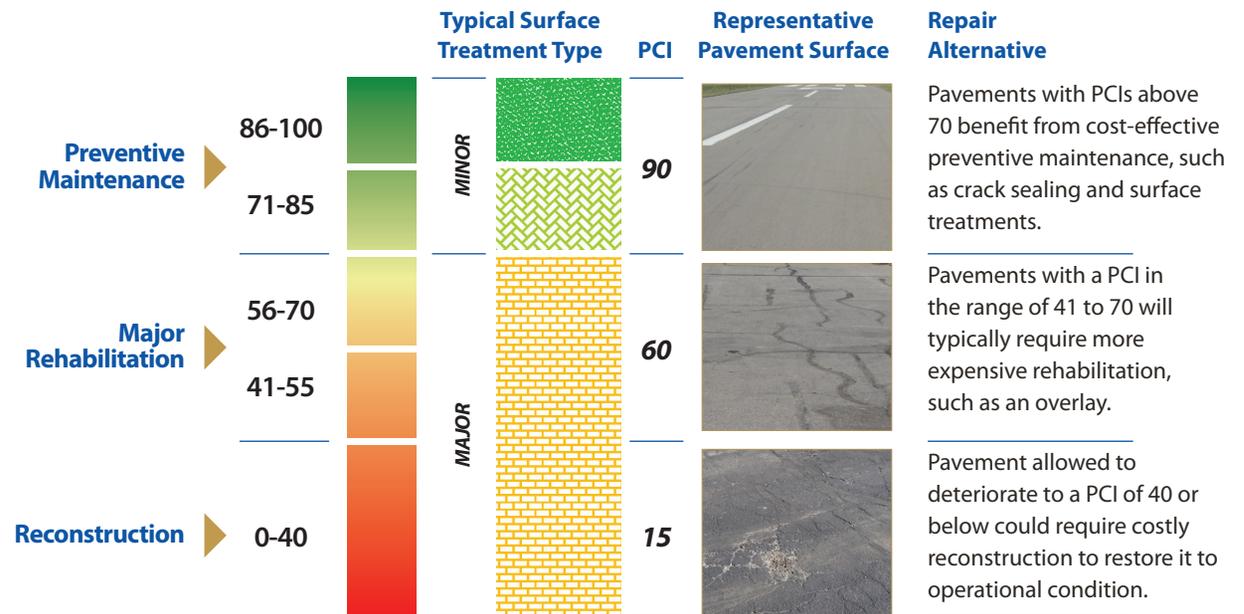
The PCI will also aid in tracking and determining causes of deterioration on a pavement. The correlation between a PCI number and a recommended repair is shown in the illustration to the right. Preventive maintenance consists of patching, crack sealing and joint sealing. Pavement rehabilitation includes surface treatments and thin overlays. Pavement reconstruction refers to full-depth reconstruction and thick overlays. Minor surface treatments are used to address weathering and low-severity raveling. Major surface treatments are used to address medium- and high-severity raveling.

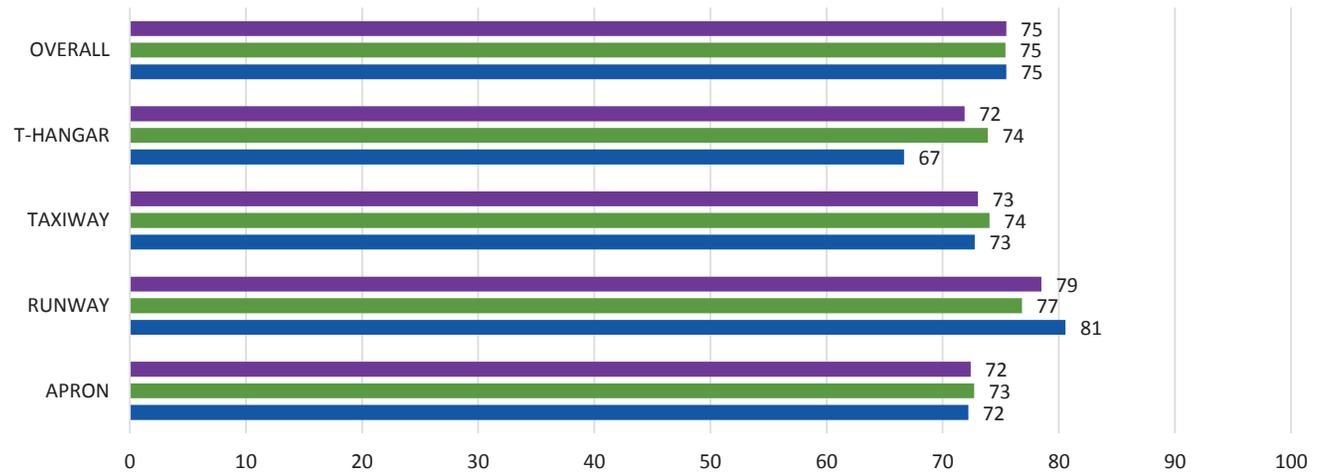
Area-Weighted Average PCI Value by Surface Type

Each airport was inspected and an overall area-weighted pavement condition is assigned to each. The information collected at each airport is used to provide greater detail on the uses of pavements and the correlating PCI value associated with each use. The overall area-weighted PCI of all the airports included in this study is 75. The chart below, *Area-Weighted Average PCI Value by Surface Type*, shows the 2015 condition of the pavement broken out by use and airport classification. The *Overall Area-Weighted PCI* table on the next page provides the overall area-weighted PCI for each airport.

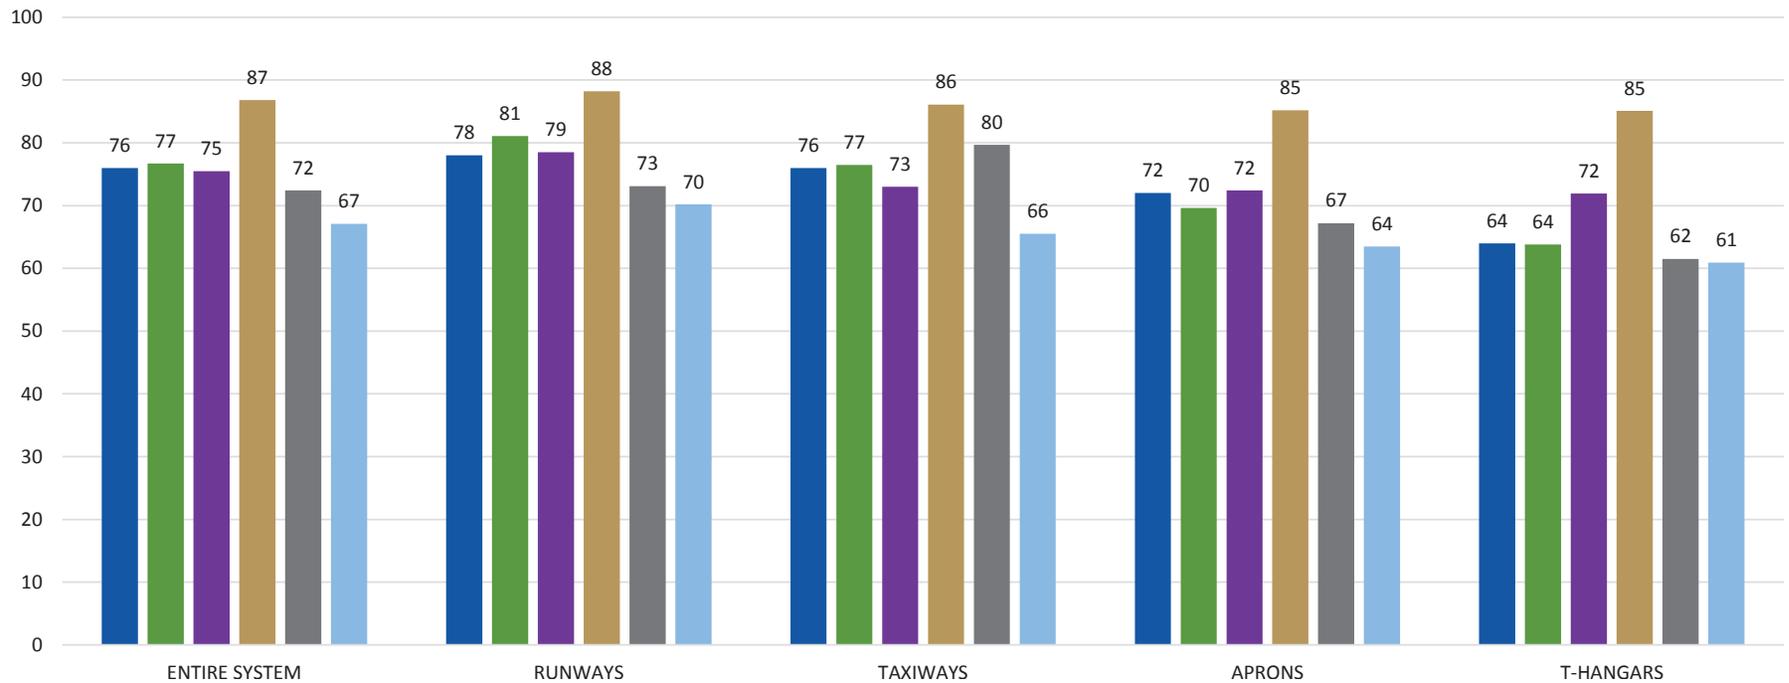
Area-Weighted Average PCI

The APMS is updated every three years and it is important to show how the system as a whole is performing from update to update. The *Area-Weighted Average PCI* chart below provides a summary of the 2009 and 2012 historic PCI values; current 2015 PCI values; projected PCI values in 2020 if unlimited funding were available; projected PCI values in 2020 if only the anticipated state budget funding were available; and the projected PCI values in 2020 if no improvements were completed on the existing system.

- 2009 ■ Unlimited Funding 2020
- 2012 ■ Anticipated Funding 2020
- 2015 ■ No Improvements 2020

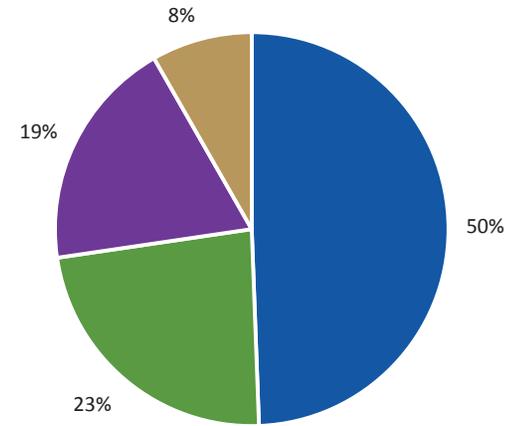
Overall State

Approximately 50 percent of the airports included in the 2015 APMS are at the condition level where they will benefit from preventive maintenance actions, such as crack sealing, joint sealing, and patching. Roughly 23 percent would benefit from applying a surface treatment. Approximately 19 percent of the pavement infrastructure is in need of more extensive rehabilitation, while 8 percent is in need of reconstruction to restore the pavement. The following pie charts show the level of work that is needed in the system.

- Preventative Maintenance
- Surface Treatments
- Major Rehabilitation
- Major Reconstruction

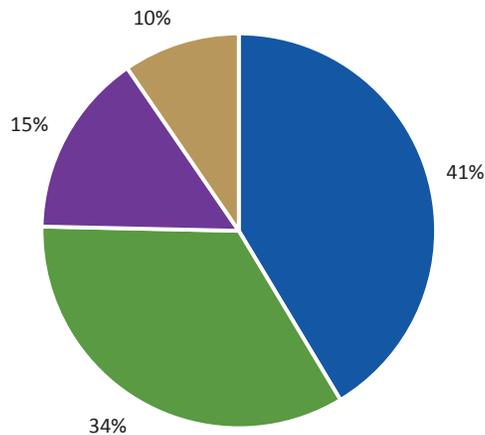
General Aviation

- Preventative Maintenance
- Surface Treatments
- Major Rehabilitation
- Major Reconstruction

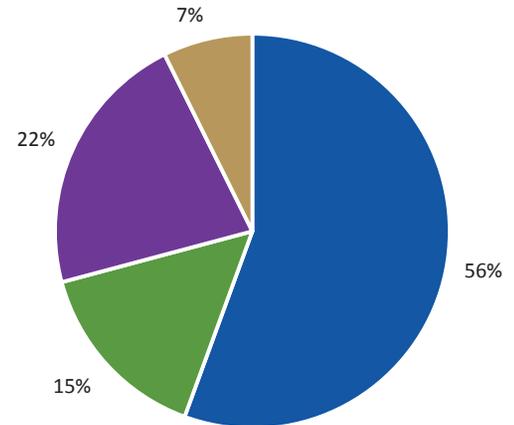
Commercial Service

- Preventative Maintenance
- Surface Treatments
- Major Rehabilitation
- Major Reconstruction
