Examination of Nonchromate  
Conversion Coatings for  
Aluminum Armor From  
Three Final Candidates Using  
Accelerated Corrosion and  
Adhesion Test Methods

ARL-TR-2601

September 2001

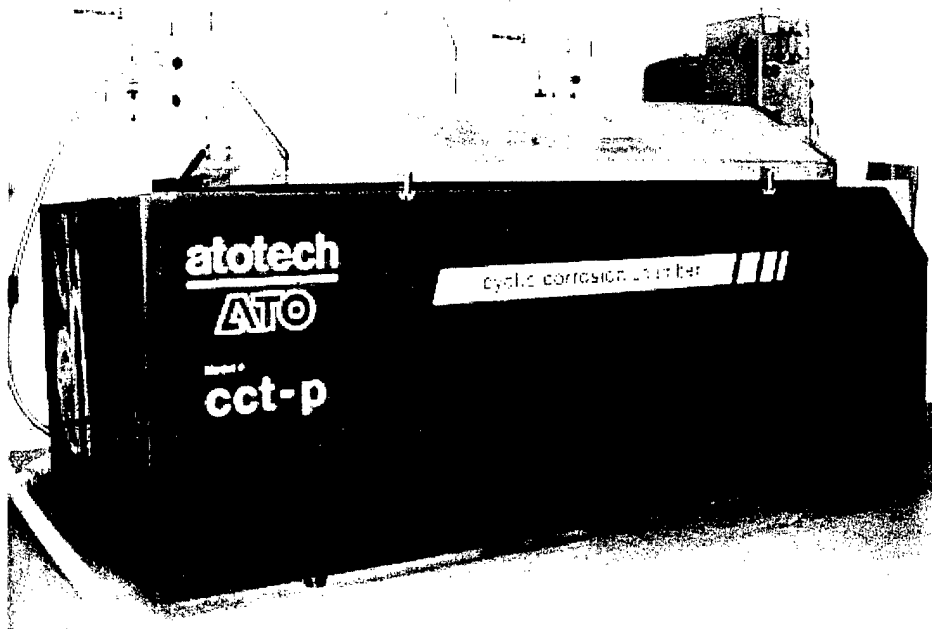
Figure 2. CCTC used for GM 9540P [5].

A cyclic corrosion test chamber (CCTC) was used to evaluate the CARC-coated test panels and Bradley headlight guards. For each conversion coating tested, three primed and topcoated CARC panels were subjected to CCTC testing. As in salt fog, the panels were X scribed. The scribed panels were placed into the chamber (Figure 2) and tested using GM Standard Test 9540P [5], method B, which provides a more realistic accelerated environmental test than conventional salt fog [14]. The standard 0.9% NaCl, 0.1% CaCl<sub>2</sub>, 0.25% NaHCO<sub>3</sub> test solution was used. The 9540P test consists of 18 separate stages that include the following: saltwater spray, humidity, drying, ambient, and heated drying. The environmental conditions and duration of each stage for one complete 9540P [5] cycle are provided in Table 8. In addition, standard plain carbon steel calibration coupons described in 9540P [5] and supplied by GM were initially weighed and subsequently monitored for mass loss at intervals set by the specification. Mass losses measured for steel coupons used for this test were within acceptable parameters stated in the GM specification (Table 9). The panels were photographed or digitally scanned prior to testing, upon significant observations, and at the suspension of the testing (120 cycles). As with B117 [4] salt fog, the extent of damage was assessed using ASTM D1654 [13].

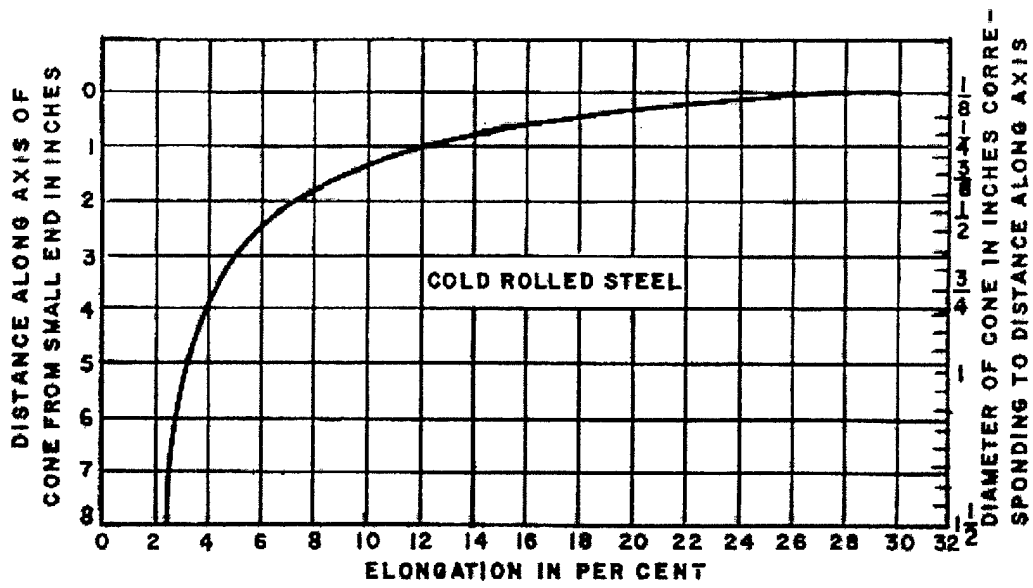
Figure 11. Conical mandrel bend test (ASTM D522 [17]).

(a) Determination of coating elongation.

(b) Correction per mil of coating thickness.

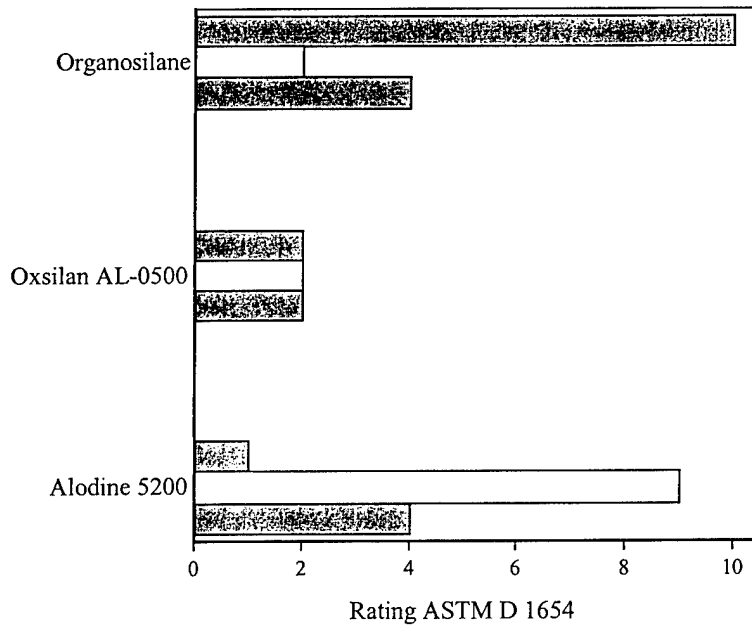
Figure 13. Salt fog performance on scribed CARC-coated Al 7039 panels at 3000 hr (greater is better).

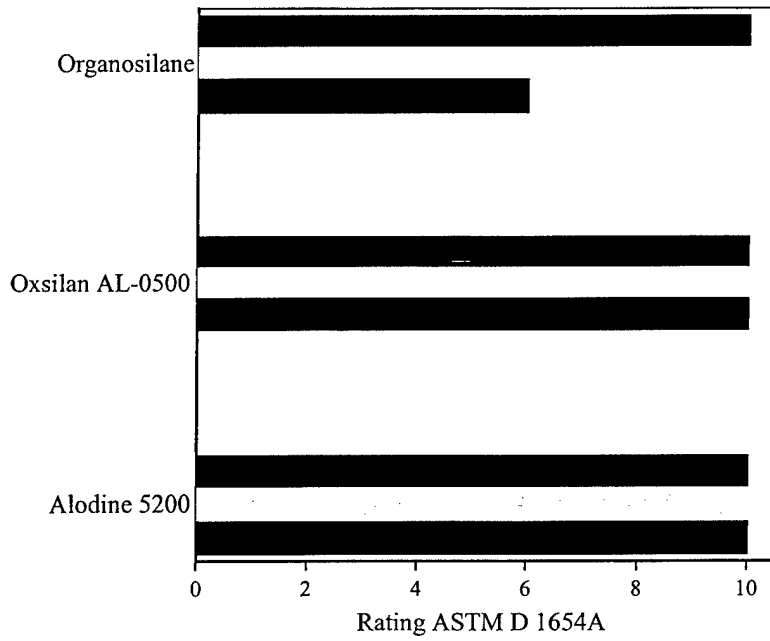
Figure 16. GM 9540P [5] performance on scribed CARC-coated Al 5083 panels at 120 cycles (greater is better).

The painted panels and components were all subjected to 120 cycles of GM 9540P [5]. The assessment used for 9540P is identical to the assessment for ASTM B117 [4] salt fog for painted specimens (Table 7). The creepback ratings at 120 cycles are plotted in Figures 16-19. As in salt fog, the failure mode for the painted

panels was blistering along the scribe. For Al 5083, most panels sustained the full 120-cycle duration without any damage. An exception was one Organosilane panel rated a 6 which had some blistering along the scribe. As in salt fog, the best performing pretreatments for Al 7039 were Organosilane followed closely by Alodine 5200 with much less scatter among the data and, similarly, the Brent pretreated panels had significantly greater damage. For Al 6061, overall damage was less severe than for salt fog and once again the Brent pretreatment excelled for this alloy. Performance for Brent panels ranged from 8 to 10, Organosilane was next best with scattered ratings ranging from 5 to 10, and Alodine 5200 rated poorest with data ranging from 4 to 5. Headlight guards from actual Bradleys, composed of Al 5083, scribed on three flat surfaces each, were also exposed. For these components, all three pretreatments endured the full 120-cycle duration with no corrosion damage. As in salt fog, post-exposure dry- and pull-off-adhesion measurements were performed on the panels and components, and the results are summarized in sections 3.6 and 3.7.

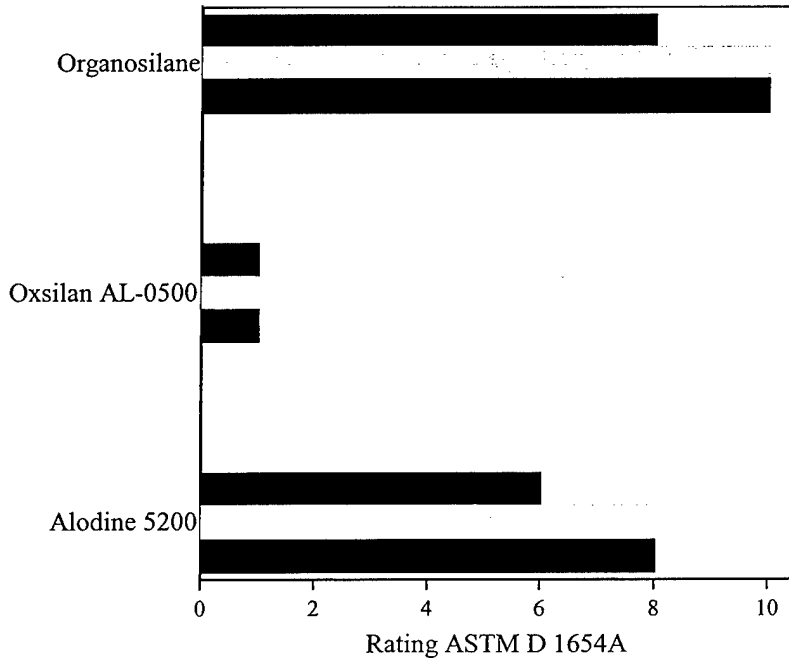
Figure 17. GM 9540P [5] performance on scribed CARC-coated Al 7039 panels at 120 cycles (greater is better).

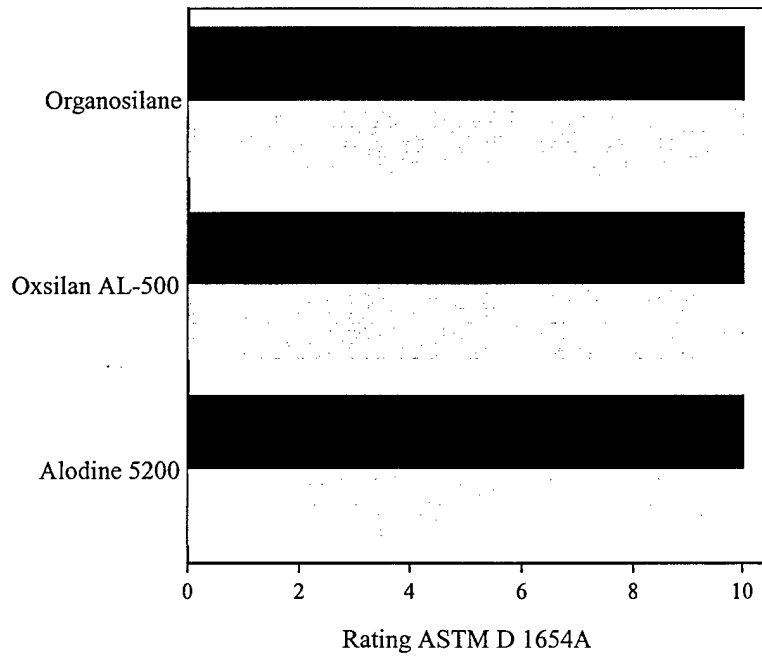
Figure 19. GM 9540P [5] corrosion performance on CARC-coated Al 5083 headlight guards at 120 cycles (greater is better).

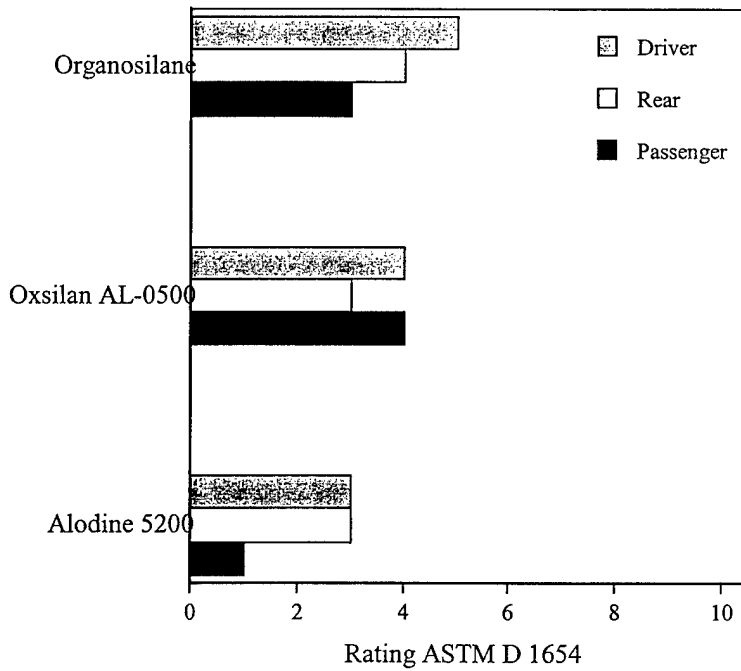
Figure 23. Corrosion/delamination damage on scribed CARC-coated Al 6061 panels at four-phases ATC test track exposure (greater is better).

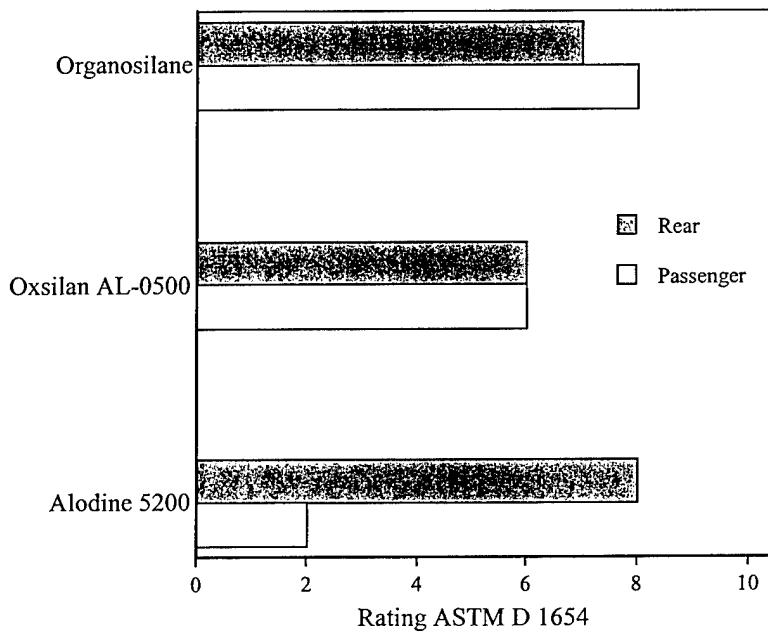
Figure 25. Corrosion/delamination damage on scribed CARC-coated Al 7039 panels at seven-phases ATC test track exposure (greater is better).

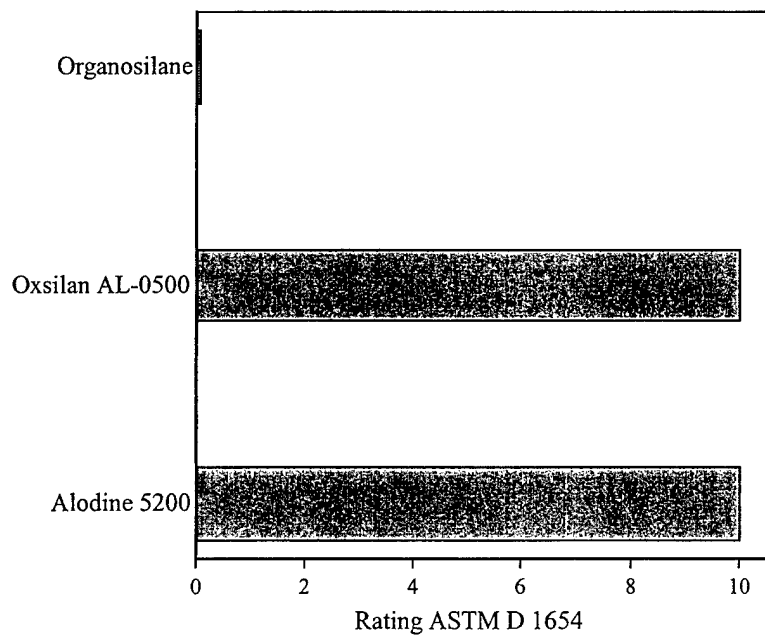
Figure 27. Corrosion/delamination damage on CARC-coated Al 5083 taillight guards at seven-phases ATC test track exposure (greater is better).

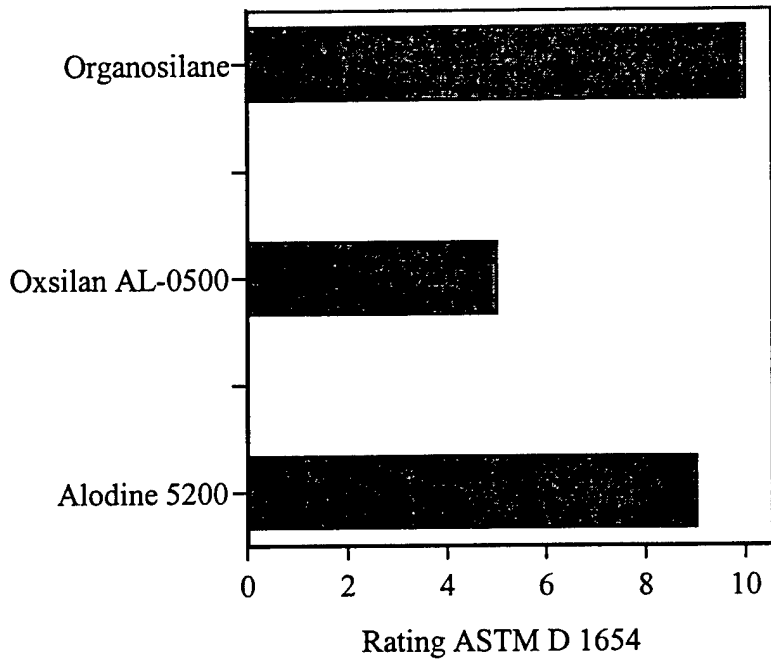
Figure 30. Corrosion/delamination damage on seafoam green-coated Al 5083 bilge cover at seven-phases ATC test track exposure (greater is better).

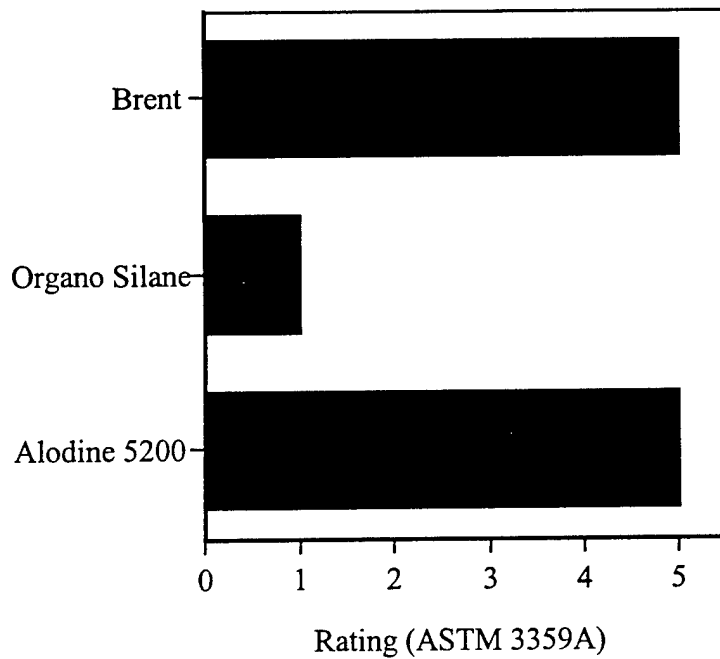
Figure 31. Wet adhesion ratings for aluminum 5083 panels (greater is better).

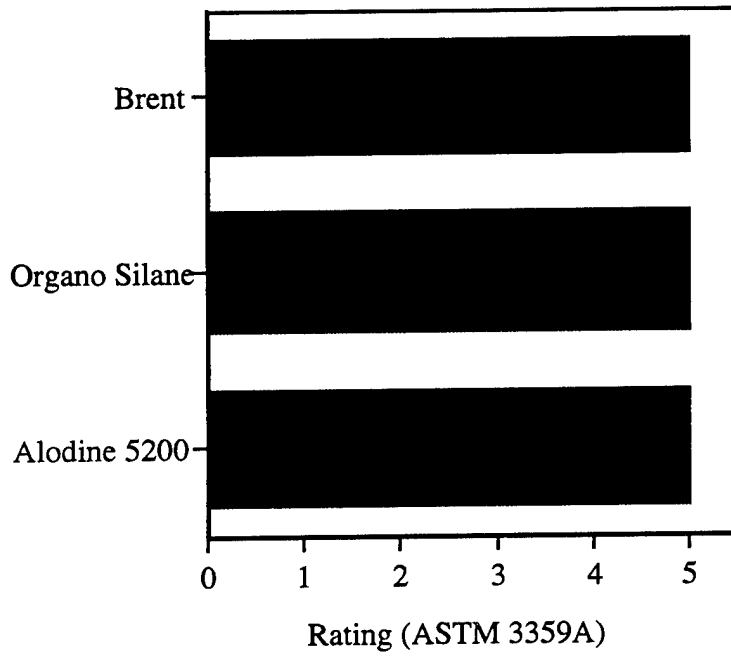
Figure 33. Wet adhesion ratings for aluminum 6061 panels (greater is better).

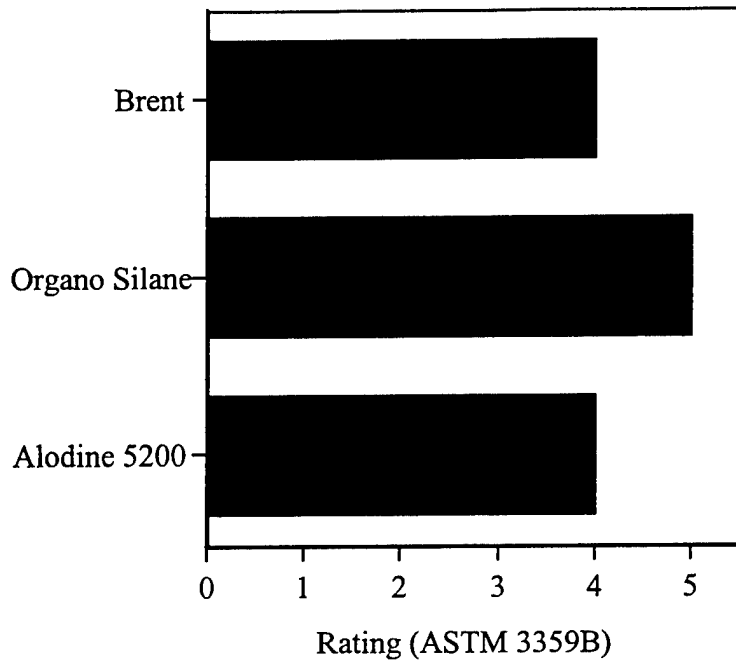
Figure 36. Dry adhesion ratings for unexposed aluminum 6061 panels (greater is better).

For the initial unexposed Al 5083 panels, adhesion was very good with Brent and Organosilane rating a 5 and Alodine 5200 rating a 4. Adhesion problems were found on Al 7039 with Alodine 5200 rating a 0 and Brent rating a 1. However, Organosilane had an excellent rating of a perfect 5. Initial dry adhesion for Al 6061 was good for all three treatments with Alodine 5200 and Brent rating a 4 and Organosilane rating a 5. For the headlight guards, adhesion was good with Organosilane and Brent rating a 4 and Alodine 5200 rating a 5 (Figures 34–37).

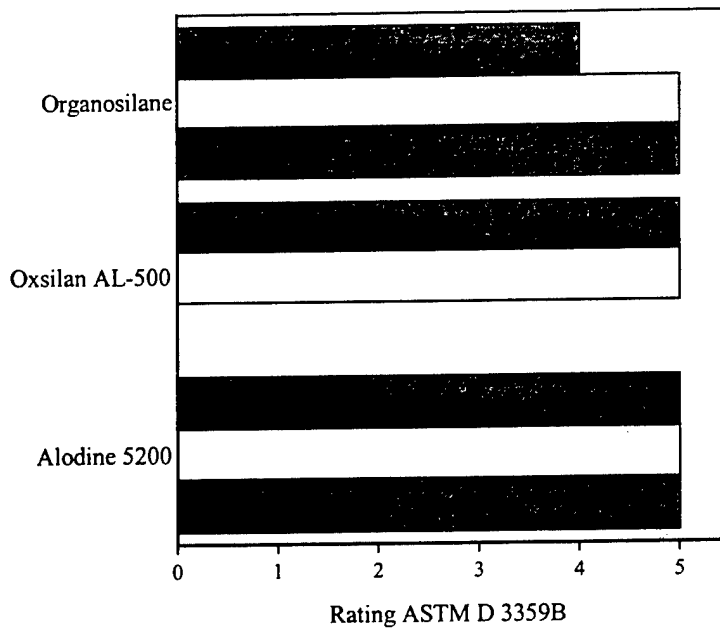
Figure 40. Dry adhesion ratings for salt fog-exposed Al 6061 panels (greater is better).

For post-3000-hr ASTM B117 [4] salt fog, dry adhesion measurements were performed in unaffected zones away from the scribes. As in initial conditions, adhesion for exposed 5083 panels was excellent with multiple Alodine 5200 and Brent panels all rating a 5. Organosilane-treated 5083 panels also were very good rating 4 to 5. Exposed Al 7039 panels performed similarly to the initial state with major loss of adhesion for both Brent, which rated a 0 for all panels, and Alodine 5200, which rated from 1 to 2. Organosilane-treated 7039 was significantly better with ratings ranging from 3 to 5. Adhesion for salt fog-exposed Al 6061 was good with all Brent- and Alodine 5200-treated panels rating a 5. Al 6061 Organosilane panels ranged from 4 to 5 (Figures 38–40).

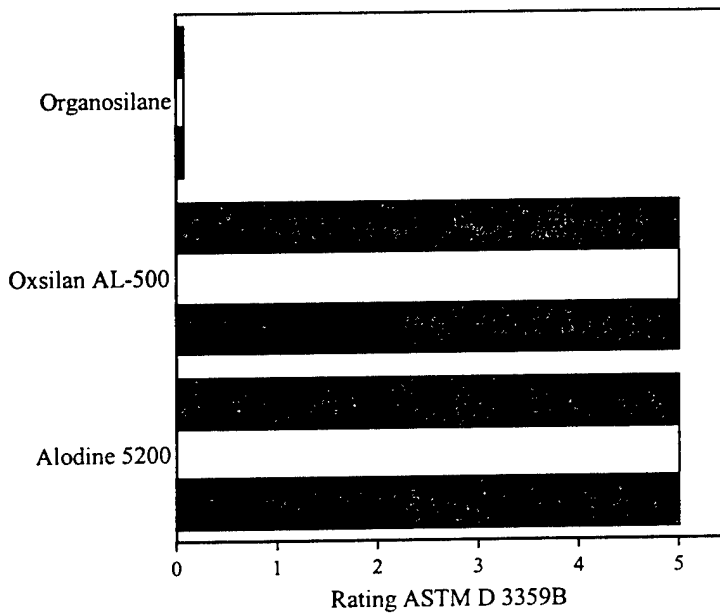
Figure 41. Dry adhesion ratings for GM 9540P [5] exposed Al 5083 panels (greater is better).

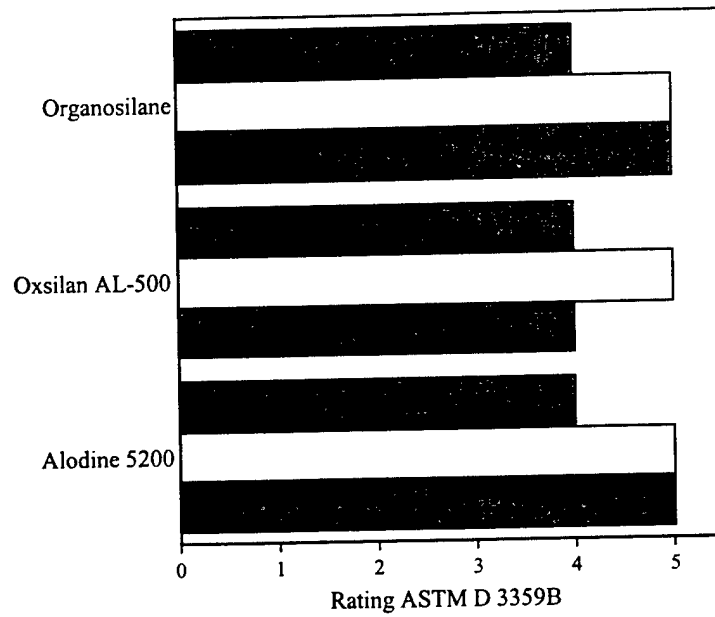
Figure 50. Dry adhesion ratings for Bradley-mounted Al 5083 panels after 4000-mi durability exposure at Camp Roberts, CA (greater is better).

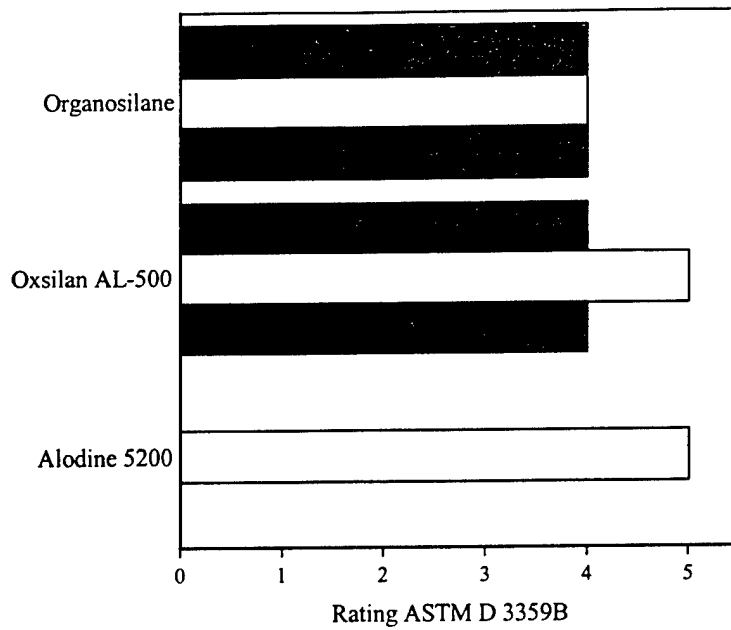
Figure 52. Dry adhesion ratings for Bradley-mounted Al 6061 panels after 4000-mi durability exposure at Camp Roberts, CA (greater is better).
