# Banff Recreation Centre

Canadian  
Wood  
Council

**woodWORKS!**  
Project of the Canadian Wood Council

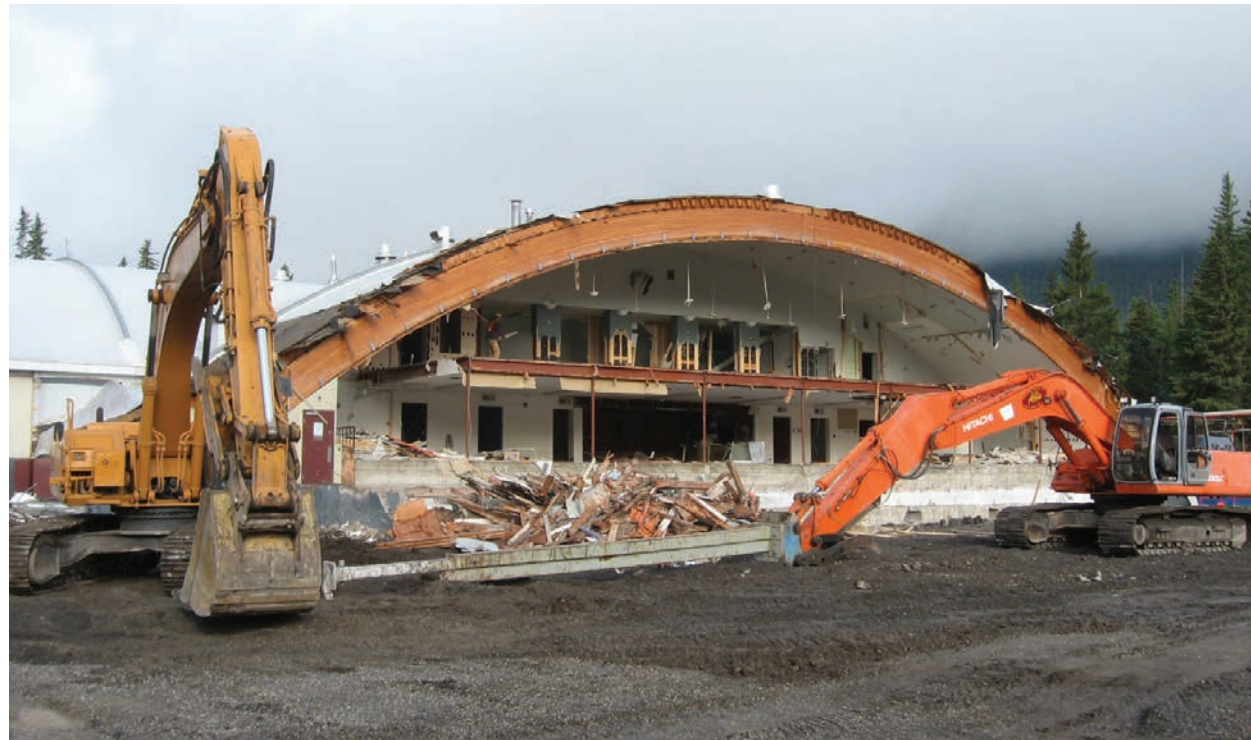
Original glulam beams being salvaged  
from original building  
Photo: GEC Architecture

Beams from the 1958 curling rink and glulam beams from a dismantled school in Canmore were used for the new curling rink. The glulam was sent to the Structurlam plant in Penticton, British Columbia, for inspection, planing, resizing, milling for connections, and refinishing.

Salvaged members were inventoried and inspected. Samples were tested to modern standards at the glulam manufacturing plant to determine the suitability of the members for re-use. Some members were cut to create two smaller members.
