Building my 19ft Barrelback Mahogany Runabout

Gary W. Schoenfeldt

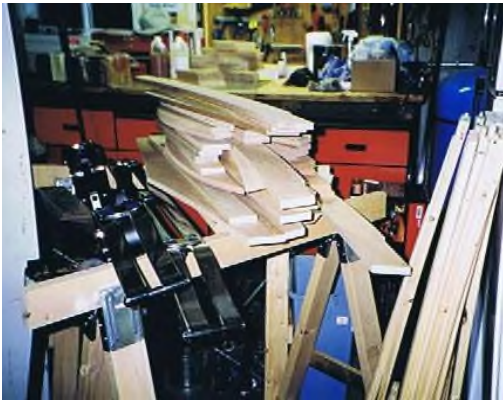
"Cut out frame members"

In February 2001 I bought the plans from Ken Hankinson. I began cutting out framing members and transferring the 1/2 frame full size drawings to a 4' x 8' x 3/4" plywood to use as a layout table to construct the frames on.

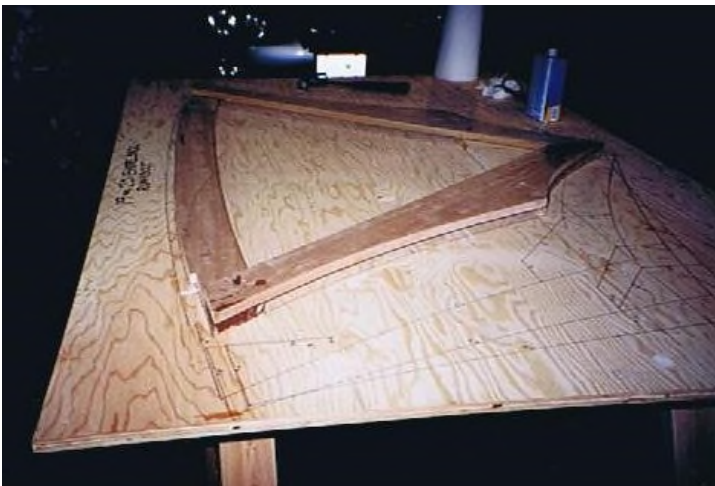
"Constructing frames on the plywood layout table."

When the framing members were all cut out, I began building the seven frames and the bow stem. I also built the jig members needed to support the frames in their order to form the hull shape.

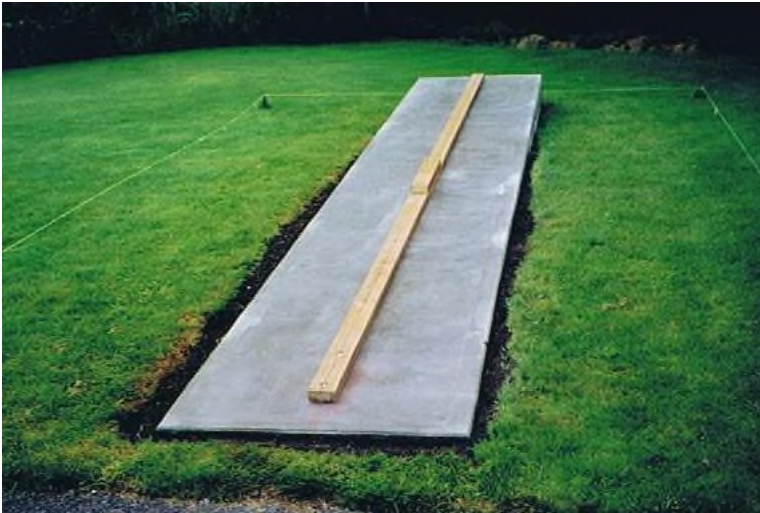
“The concrete slab to build the jig on.”

no level surfaces in the yard so I poured a level 3' wide and 20' long concrete pad in the lawn area for my jig set up location.

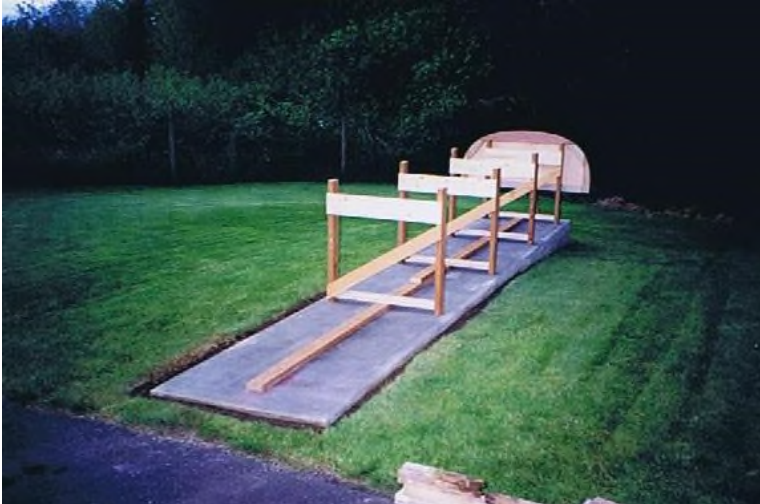
“Beginning to set up frame jig”

The next step was to set up the frame jig so construction could begin. I set the jig up in September 2001.

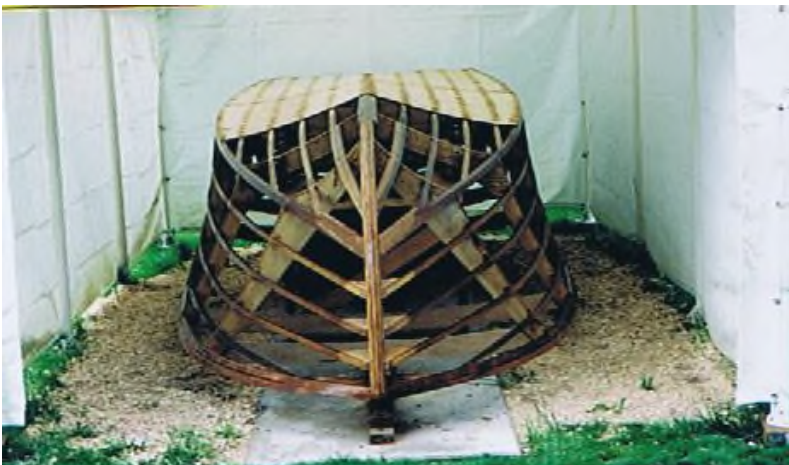
“The frame is complete, faired, and some sheathing is being installed.”

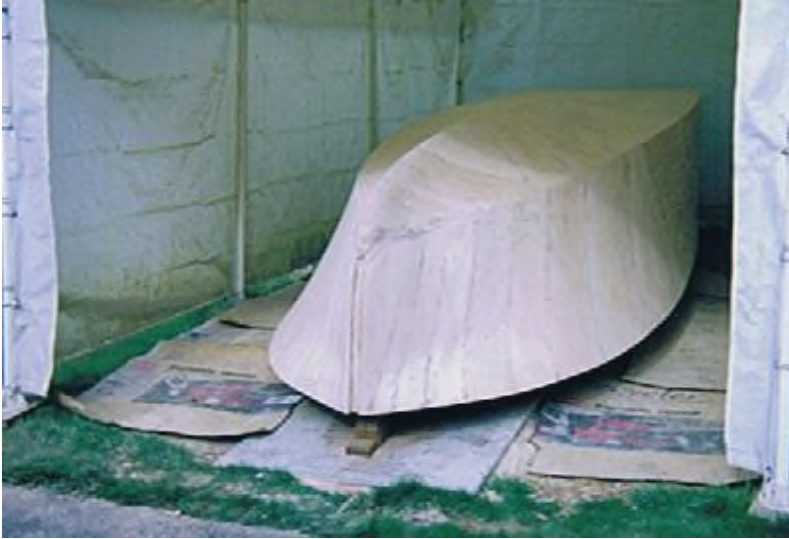
“The hull sub-sheathing is complete and ready for installation of mahogany sheathing.”

The 1/8” thick x 3” wide mahogany strips are laid in a bed of epoxy over the sub-sheathing. The strips of mahogany are temporarily fastened in place with 3/4” long x 18 ga staples. Each staple is shot through a 2” x 2” x 1/4” plywood pad that is wrapped in plastic wrapping tape and placed over the mahogany strips at about 3” oc or less. The tape keeps the plywood pads from sticking to the mahogany where it touches excess epoxy that might be on the surface of the mahogany. Once the epoxy has set up, the pads and staples are removed. There was close to 4 thousand staples used to hold the mahogany strips in place on this boat. That amounted to a whole lot of staple pulling.

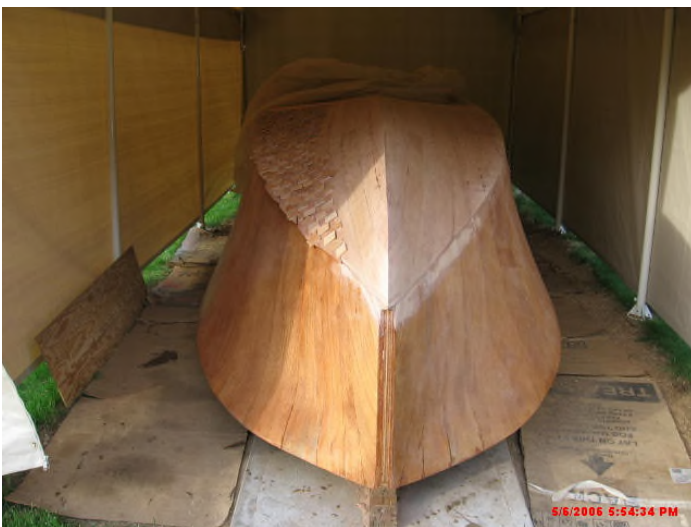
“Mahogany sheathing strips are being installed on the bottom of the hull.”

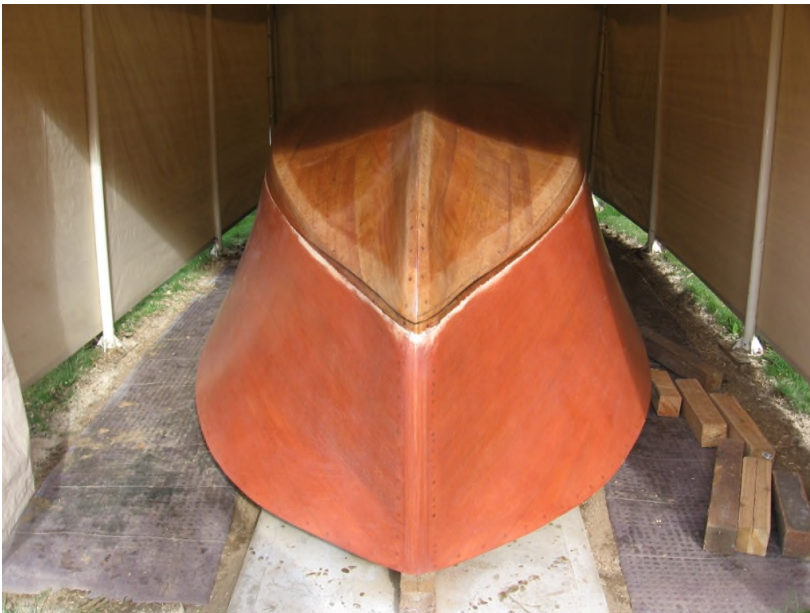
“The bottom has been fiberglassed and the sides of the hull & transom have been stained.”

When the mahogany strips had all been installed, the whole surface was sanded smooth and prepared to receive fiberglass on the bottom of the hull up to the water line. Before fiberglassing, I drilled the holes for the propeller shaft and rudder shaft. The sides of the hull and transom were stained with Chris Craft red/brown stain.

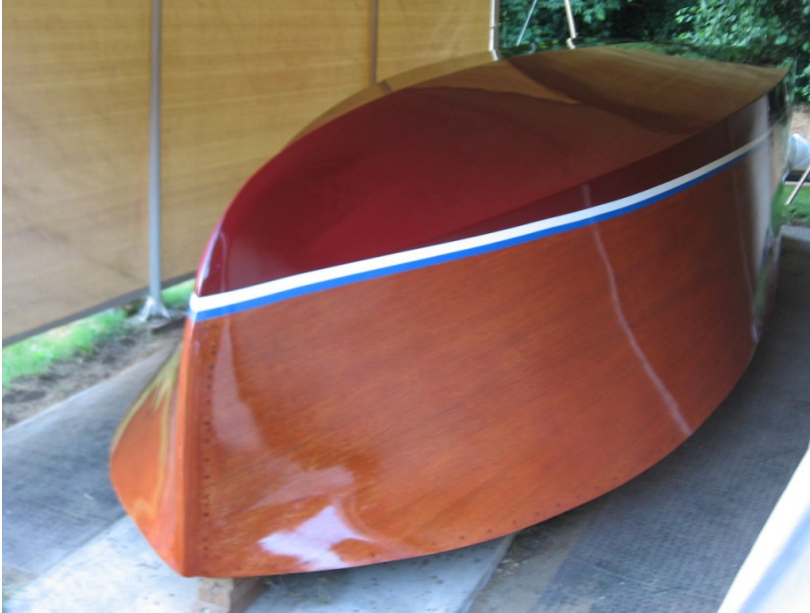
“Bottom has been painted and hull sides and transom stained and varnished.”

With the bottom fiberglassed, it was time to paint the bottom and paint the waterline. The bottom was painted a candyapple red color that was used on Hummer SUV's. The water line was painted in two

colors, a ¾" white strip on the bottom and a ¾" blue strip on the top. This gave the bottom a red, white and blue color scheme for patriotism.

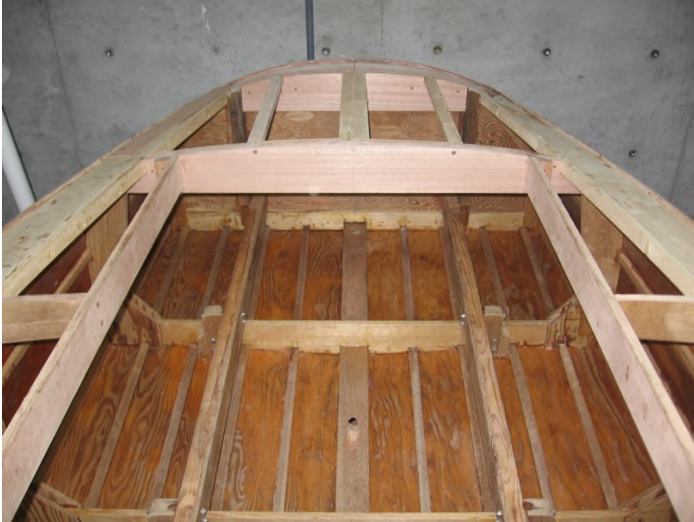
“Deck framing started.”

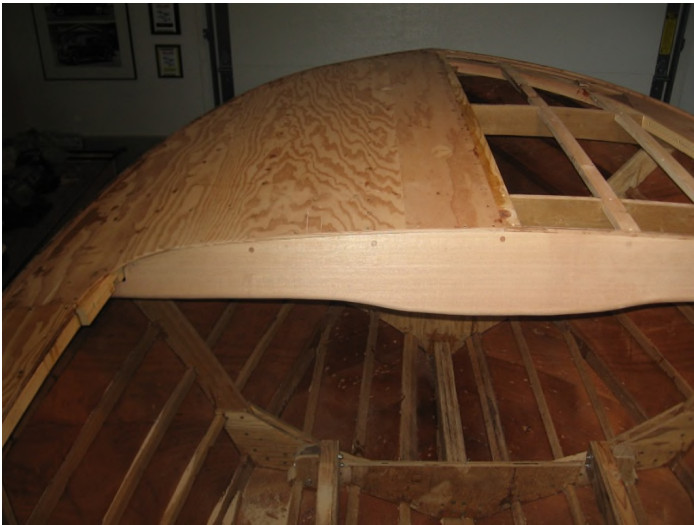
“Sub deck sheathing being installed.”

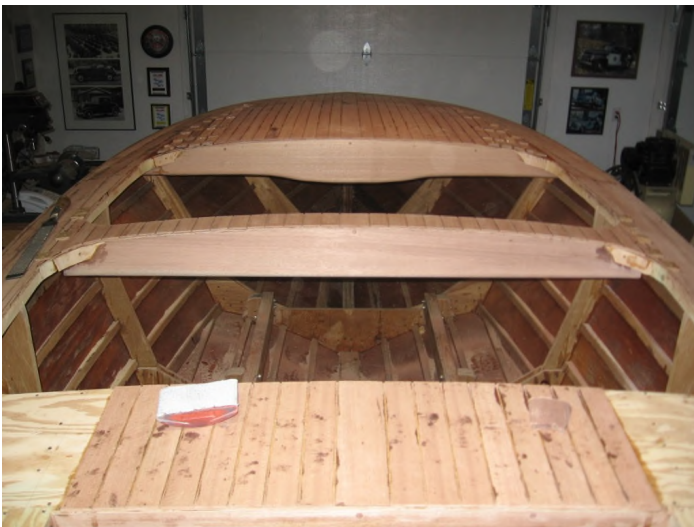
“Mahogany deck surface being installed.”

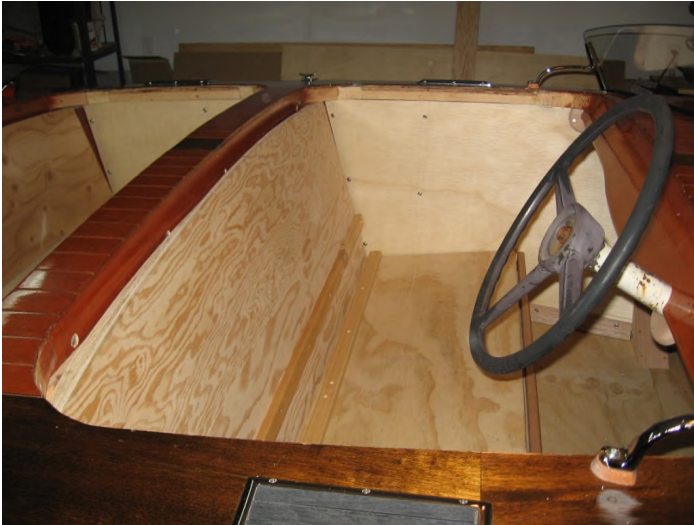
“Interior front seating, side panels and flooring being installed. Beginning installation of Steering box. The steering box is from a 1951 GMC Pickup. The steering column will be shortened and a new steering wheel will be added.”

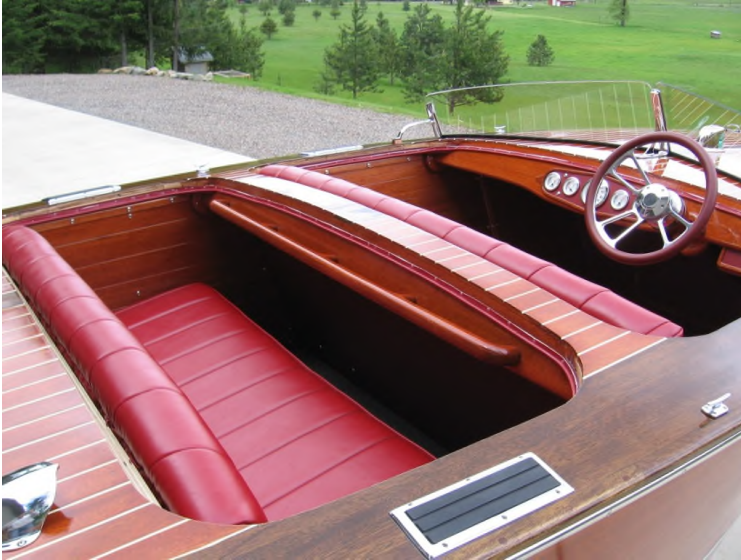
“Seat panels have been upholstered and installed. Interior mahogany paneling has been stained and varnished. Gauge panel has been installed. Electrical wiring started. New steering wheel installed. Bead installed around cockpits for bumper pad around cockpits.”

Installation of steering linkage to rudder, linkage to transmission control, bilge pump, bilge blower and throttle control are underway.

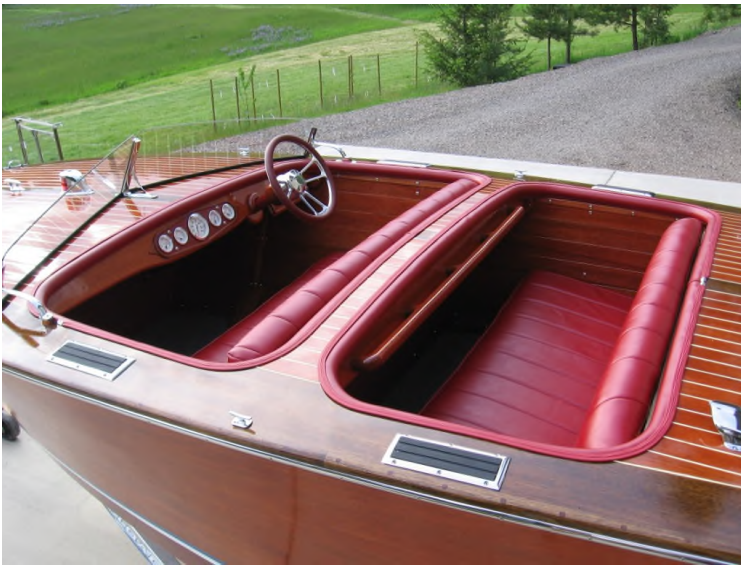
“Cockpit bumper strip installed. Grab bar installed for rear seat passengers. Steering column still needs to be shortened 3 inches.”

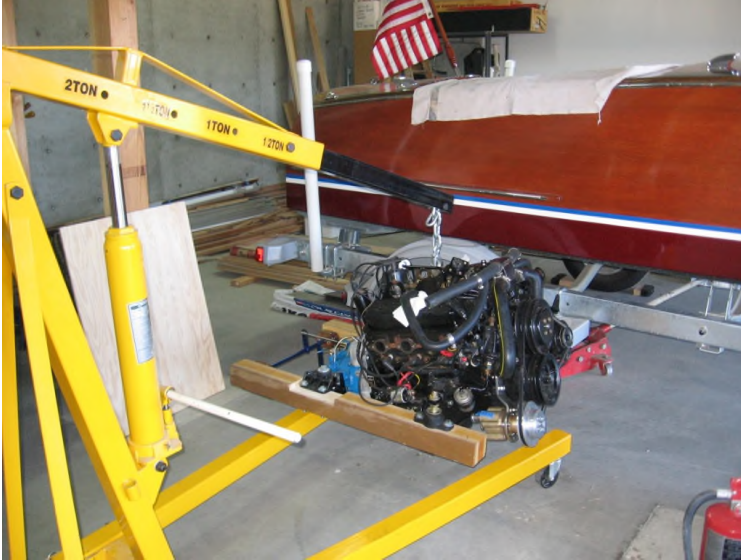
“Engine ready for installation.”

I located an engine in Spokane, WA. The owner of an outdrive boat with a MerCruiser V6, 262 wanted to install a MerCruiser V8 in his boat. I was able to hear the V6 run and it sounded good and had been kept in very good condition. He wanted to sell it at a very reasonable price and it had all the expensive equipment attached that is needed for a marine engine using raw water from the lake for cooling. I had to purchase a new bellhousing and coupler to make it

possible to connect the engine to a Borg Warner Velvet Drive 71C transmission. I bought the new transmission from a company in North Carolina. I ordered new mounts that attached to the front of the engine and to the transmission. The engine and transmission were attached to short runners that were spaced to fit between the main engine stringers that were built into the boat framing during construction.

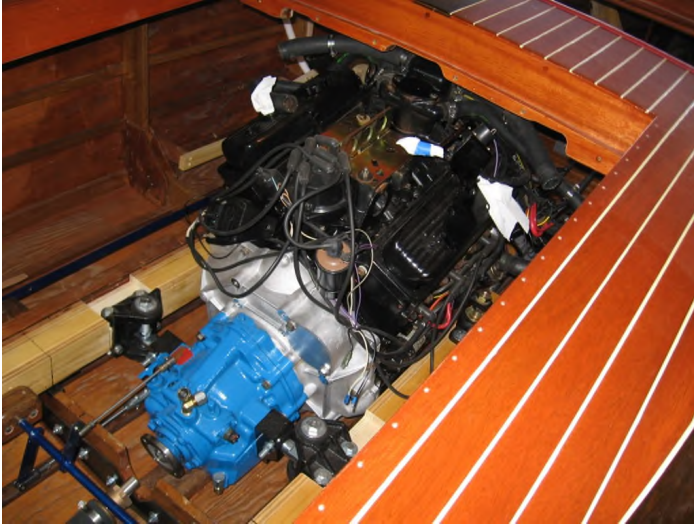
“Engine in place. It’s a tight fit but it works.”

The engine installation went smoothly and took very little adjustment to line the engine up with the propeller shaft and make necessary connections.

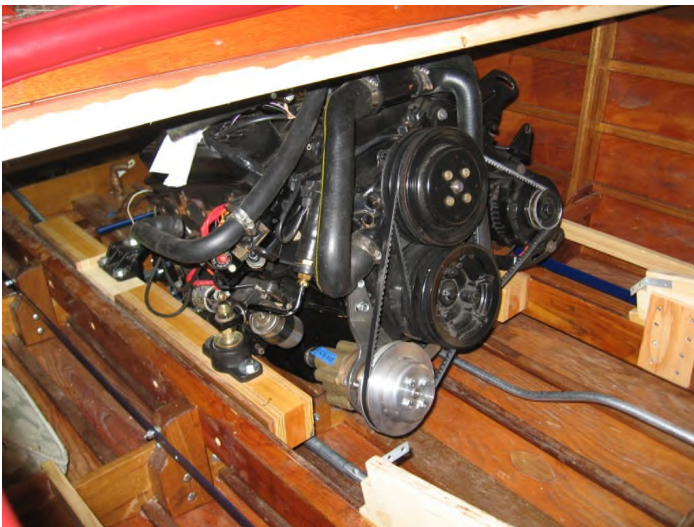
“Engine view with rear seat removed. The rear seat back can be removed to expose opening in rear seat back support that allows access to the front of the engine for maintenance.”

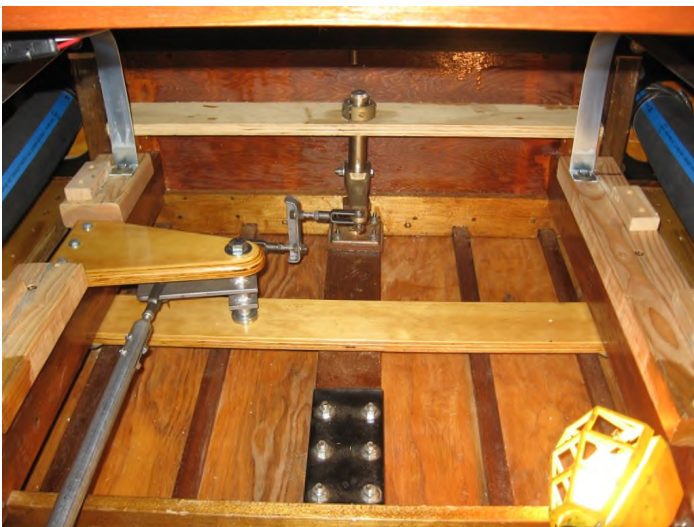
“Rudder control linkage.”

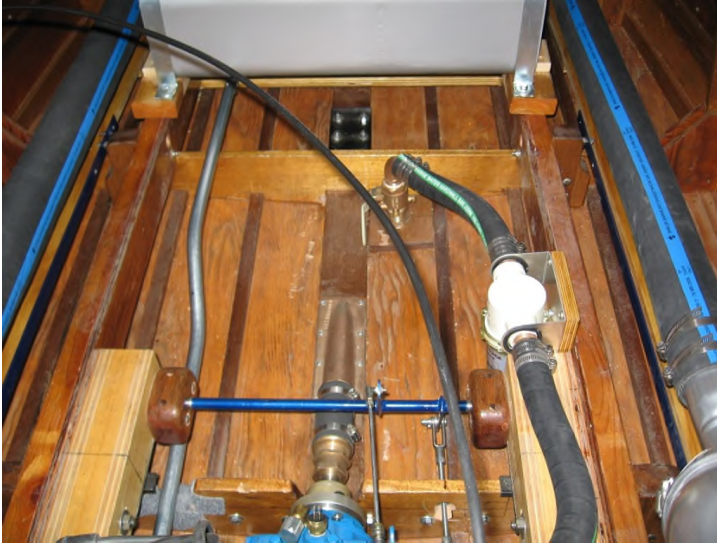
“Raw water pickup and filter.”

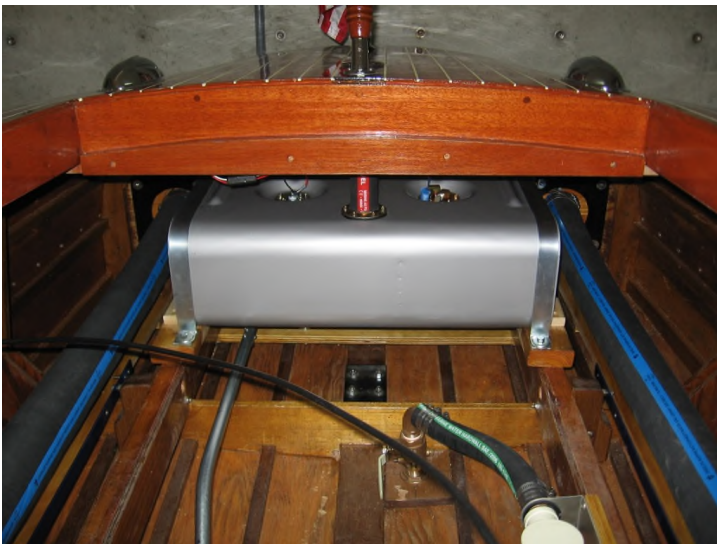
“Fuel tank installed. Exhaust tubing installed and connected to exhaust ports.”

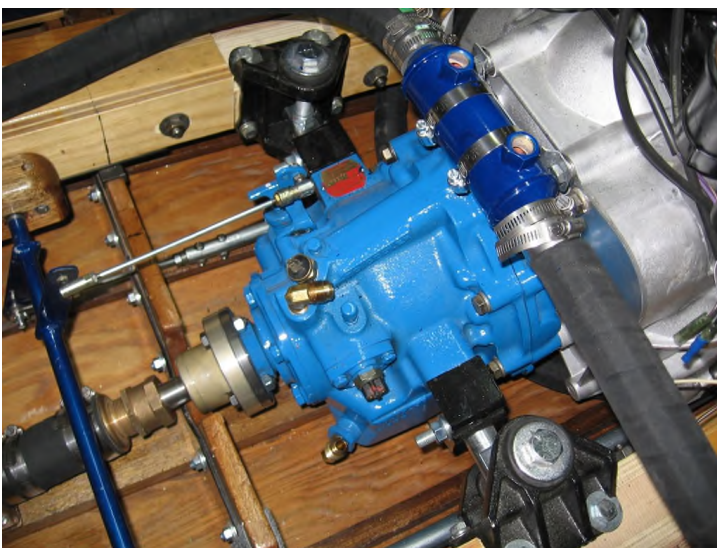
“Transmission linkage and transmission oil cooler in place.”

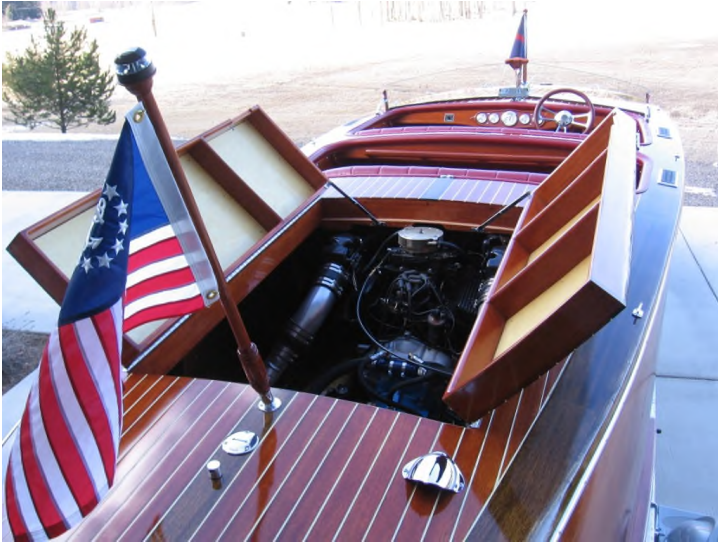
“Engine installation complete with motor hatch doors reinstalled.”
