CONCRETE MASONRY UNIT WALLS RETROFITTED WITH ELASTOMERIC SYSTEMS FOR BLAST LOADS

C.F. Johnson*, T.R. Slawson, Ph.D., P.E., T.K. Cummins, J.L. Davis
U.S. Army Engineer Research and Development Center (ERDC)
Vicksburg, MS 39180

ABSTRACT

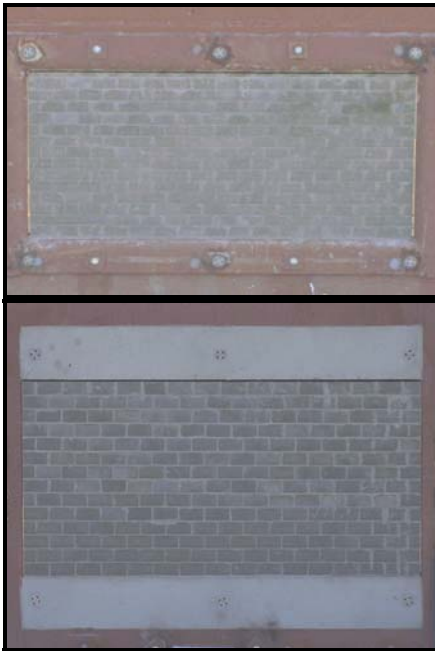
Fig. 1. 1/4-scale CMU wall steel and concrete frame.

The hollow, unreinforced CMU walls used in this study were nominally 64-in. wide by 31-in. tall. The walls were 14-courses tall, and each course was approximately 15.5-blocks wide. The CMU walls were constructed using a 1/4-scale replica of a typical 8-in-thick CMU block. The 1/4-scale CMU blocks were nominally 2-in. x 4-in. x 2-in. thick and have an average weight of 0.57 lbs. All of the walls used in the static test chamber and most of the walls used in the dynamic tests were constructed on a steel frame that was placed in the test structure. Three of the 11 dynamic walls were selected and tested in a concrete frame to investigate the wall response when applied to a conventional foundation constructed of concrete. Figure 1 presents pictures of the steel and concrete frames used during the 1/4-scale experiments.

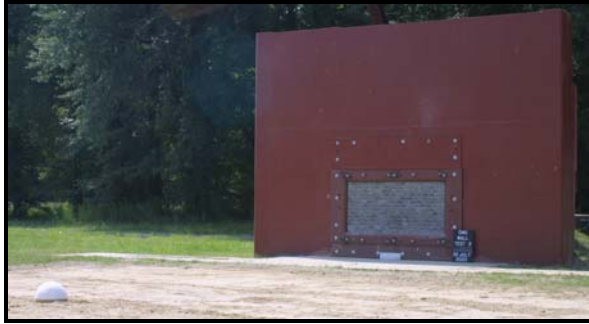
Fig. 5. 1/4-Scale dynamic reaction structure.

The magnitude of the hemispherical charge for each experiment was held constant, and the standoff was selected based upon results obtained from the Wall Analysis Code (WAC) (Slawson, 1995) using the resistance functions obtained in the static experiments. The WAC is a single degree of freedom (SDOF) code used to predict the response of structural elements to blast loads. The final standoff for each dynamic experiment was chosen so that each wall would be subjected to a uniform blast load at a point of imminent failure. The experimental and instrumentation plans used on the 1/4-scale dynamic experiments are shown in Figures 5 and 6.

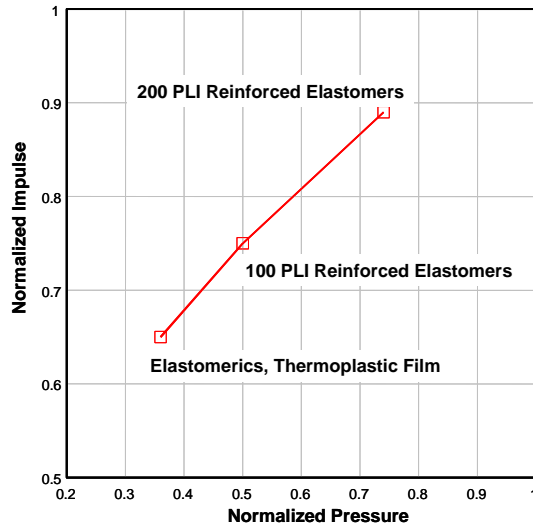
Fig. 7. 1/4-scale CMU retrofit applicable P-I ranges.

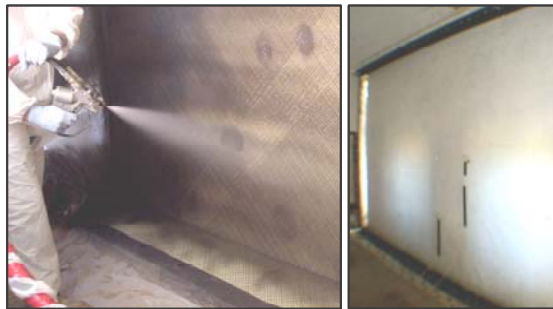
Fig. 8. R8- Polyurea spray 800 pli @ +/-45.

Three of the wall retrofits labeled R8, R9 and R10 in this paper were chosen for full-scale validation. All of the walls were subjected to one standard threat level. The eighth wall (R8) shown in Figure 8 had a spray-on polyurea encompassing an 800-pli scrim applied at a +/- 45 degree orientation. The ninth wall (R9) had a full-scale thickness of trowel-on polyurea. The final wall (R10) was built using the trowel-on polyurea as an adhesive for a thermoplastic film applied in a technique similar to the application of conventional wallpaper. See Figures 9 and 10 to see the application procedures for the trowel-on material and thermoplastic film used on walls R9 and R10 respectively.

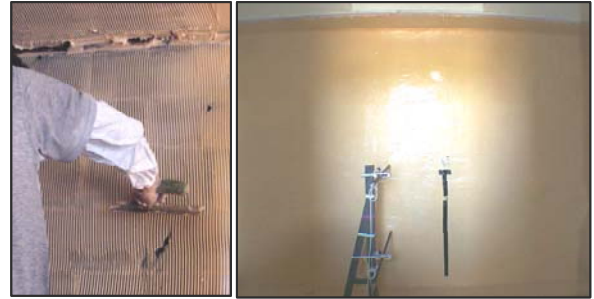
Fig. 9. R9 – Polyurea trowel-on.

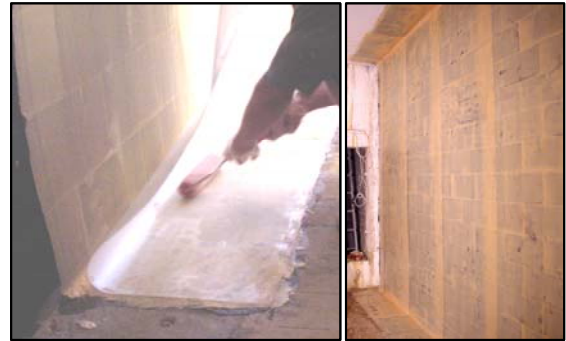
Fig. 10. R10 – Polyurea trowel-on & thermoplastic film.

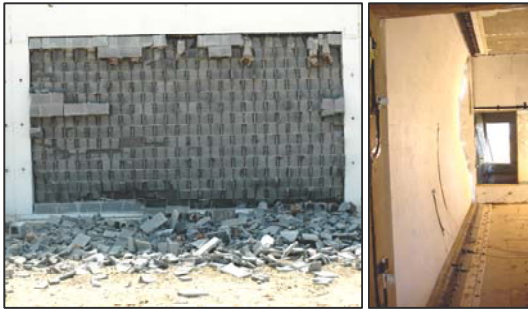
Fig. 12. Post-test view of R8, the spray-on polyurea wall.

R8, R9, and R10 performed very well at the full-scale standard threat level. The face shells of most of the walls were destroyed, but the integrity of the retrofit material remained. No debris was found inside any of the reaction structures, which demonstrates the ability of the retrofit systems to mitigate the hazards associated with hollow unreinforced CMU walls. The results have shown that

both spray-on and trowel-on elastomeric retrofit materials and films are effective. See Figures 12, 13 and 14 for post-test views of the walls.

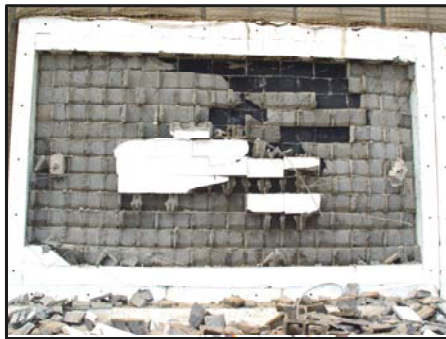
Fig 13. Post-test view of R9, the trowel-on polyurea.

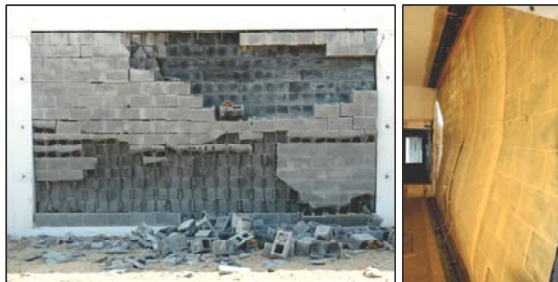
Fig. 14. Post-test view of R10, the trowel-on polyurea and film material.

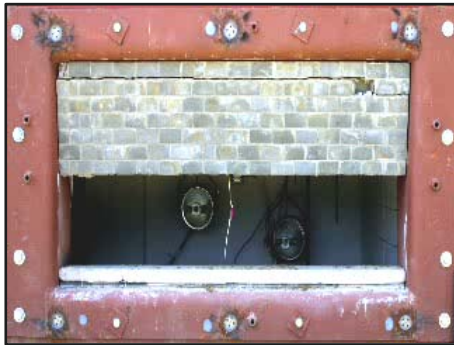
Fig. 16. R2-Polyurea-trowel
($P = 0.36$, $I = 0.65$)

The results from the dynamic experiments resemble the response observed in the static experiments. The unreinforced polyureas did add some additional flexural resistance to the hollow unreinforced CMU wall, but the addition of reinforcement to the polyurea retrofit system increased the flexural resistance of the CMU wall significantly. The increase in flexural resistance was directly related to the strength of the reinforcement as well as the orientation of the fibers in the reinforcement material. The ultimate flexural resistance of the unreinforced polyurea retrofits was increased by a factor of 1.4 using the 100-pli scrim at a +/- 45 bias and was doubled by the 200-pli scrim at a +/- 45 bias. Similar to the static experiments, the orientation of the reinforcement appeared to play a significant role in the wall's response. The reinforced polyurea using the 100-pli scrim at a 0/90 bias was too stiff and resulted in a failure at the support, whereas the wall retrofitted with the reinforced polyurea at a +/- 45 scrim bias survived the same dynamic loading. Results from the static experiments suggested that the trowel-on polyurea material (R2) would be weaker than the spray-on polyurea (R1). This was confirmed in the dynamic experiments. The wall retrofitted with the spray-on polyurea (R1) survived, and the wall retrofitted with the trowel-on polyurea (R2) failed under the same loading conditions. Due to the sensitive nature of the data, the values for pressure and impulse have been normalized. The normalized pressure (reflected and incident) and impulse information for each experiment is listed in Table 2. The experimental results for the reflected pressure, P_r , listed in Table 2 represent the average measurements captured by the six pressure gages located on the face of the structure. Figure 7 graphically demonstrates the applicable pressure and impulse ranges listed in Table 2 for each retrofit system based on the charge size used in the experimental program. The individual response of each wall can be seen in Figures 15-20 at the end of the paper.

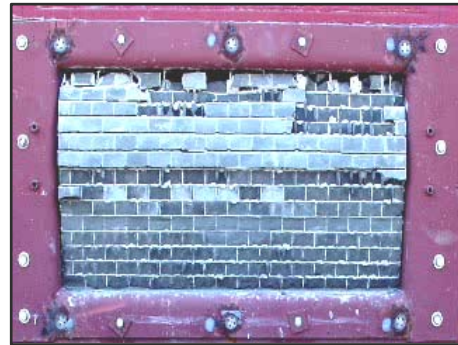
Fig. 19. R5-Polyurea-spray 200 @ +/-45
($P=0.74$, $I=0.89$)

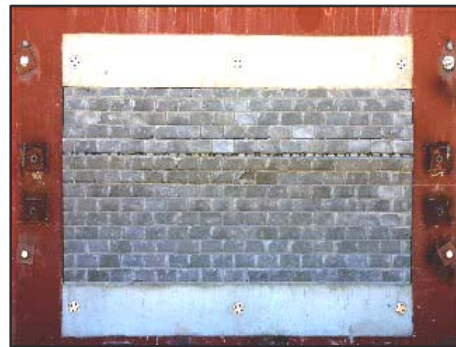
Fig. 20. R6-Thermoplastic film
($P=0.36$, $I=0.6$)
