# DENSO DIGEST

Volume 35, Number 2

# Denso®

LEADERS IN CORROSION PREVENTION  
& SEALING TECHNOLOGY

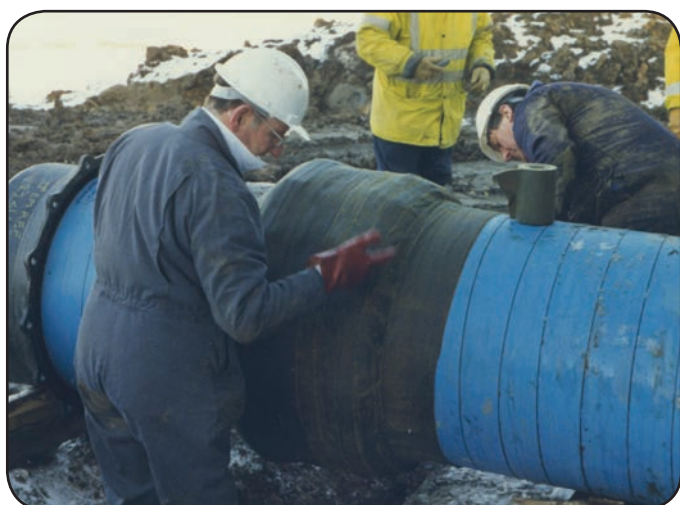
**UK** - Protecting buried Viking Johnson Couplings on water pipework at Whorely Reservoir which supplies Darlington and parts of Teeside.

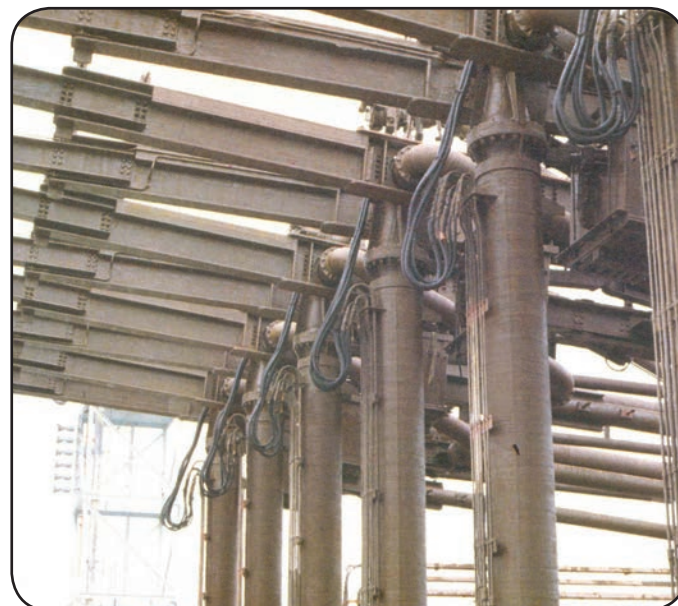
**UK** - Protecting loading booms at the Esso Milford Haven Refinery, using weatherboard and spiral tape wrapping techniques.

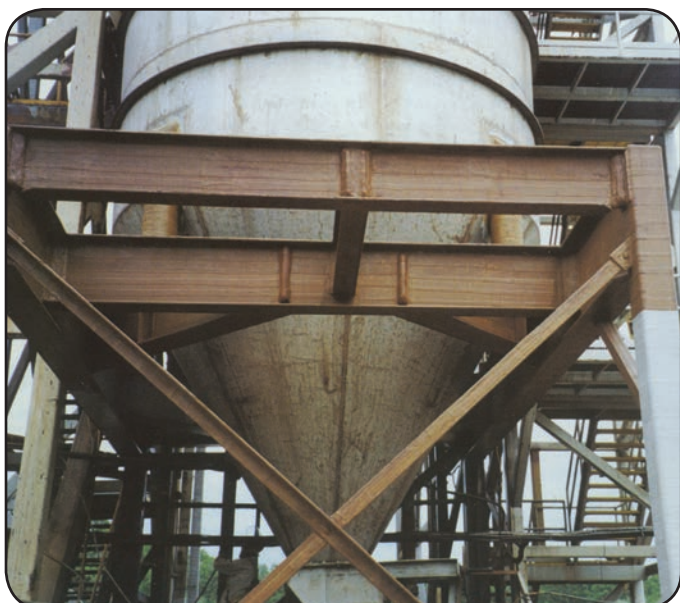
**USA** - Protecting parts of the steel headframe in the severe corrosive environment of a salt mine at the Cargill Salt Facility, Avery Island, Louisiana.

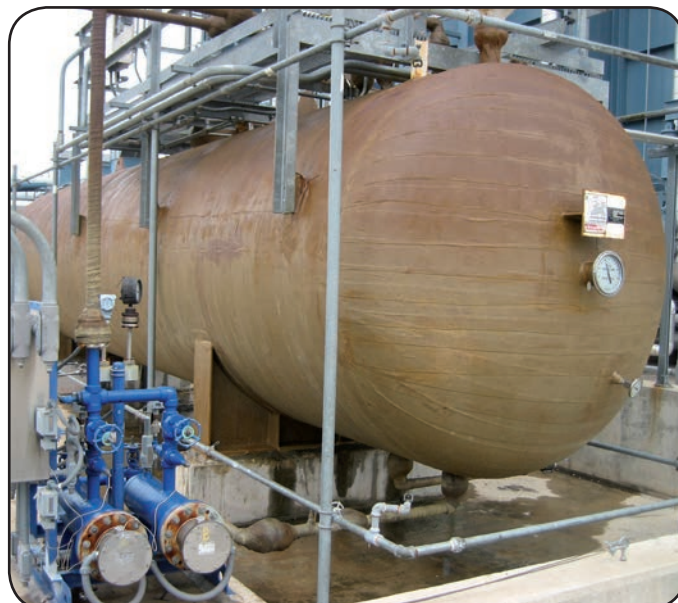
**USA** - Protecting constantly sweating steel ammonia tanks at the Lower Colorado River Authority (LCRA) Bastrop facility, Texas.

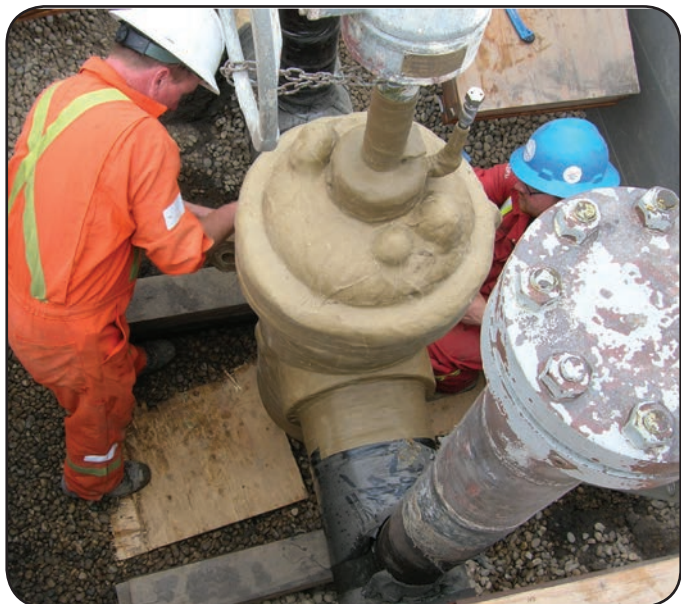
**Canada** - Protecting buried petroleum pipeline valves for the Sun-Canadian joint venture in Southern Ontario.

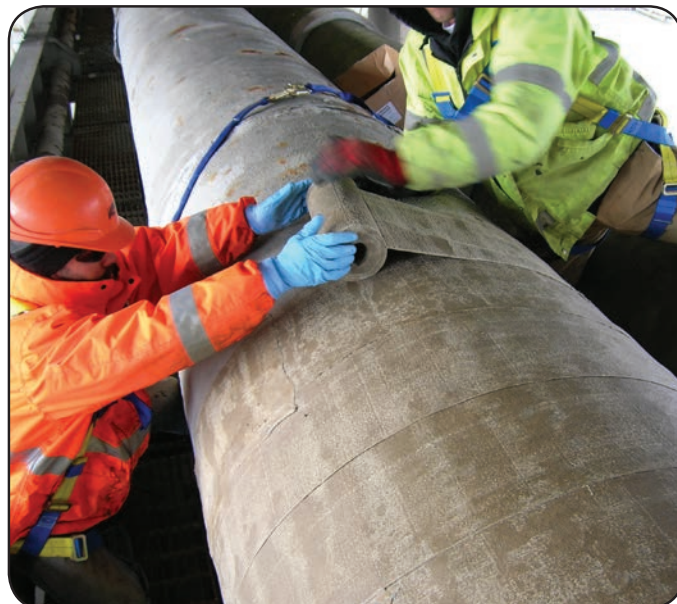
**Canada** - Protecting a sweating concrete water pipeline in sub zero conditions. Halton Region near Toronto.

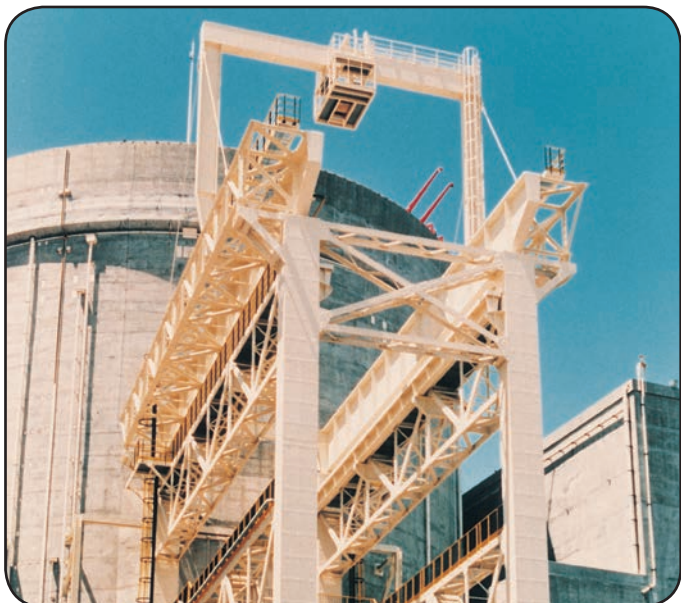
**South Africa** - 30 years of proven, maintenance-free, protection of a huge gantry crane situated in a highly corrosive coastal environment - as part of the Denso Steelcoat™ Systems.

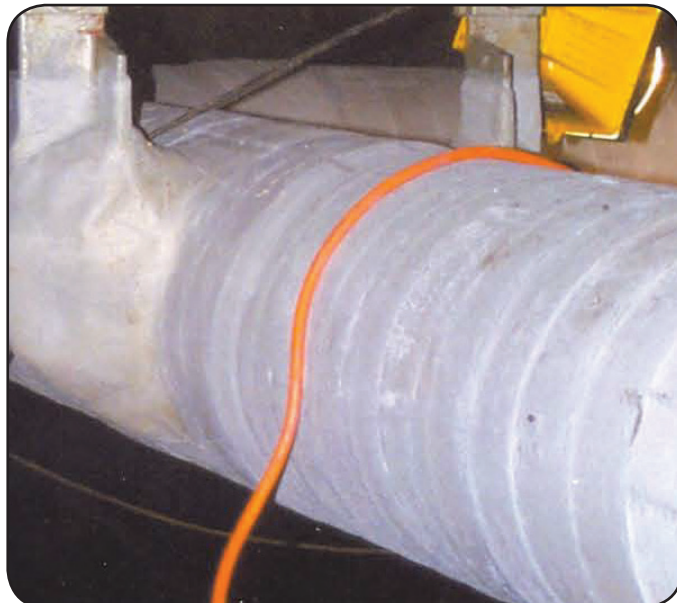
**Australia** - Protecting United Energy gas pipework and fittings in a confined space under the Spencer Street Bridge in downtown Melbourne.

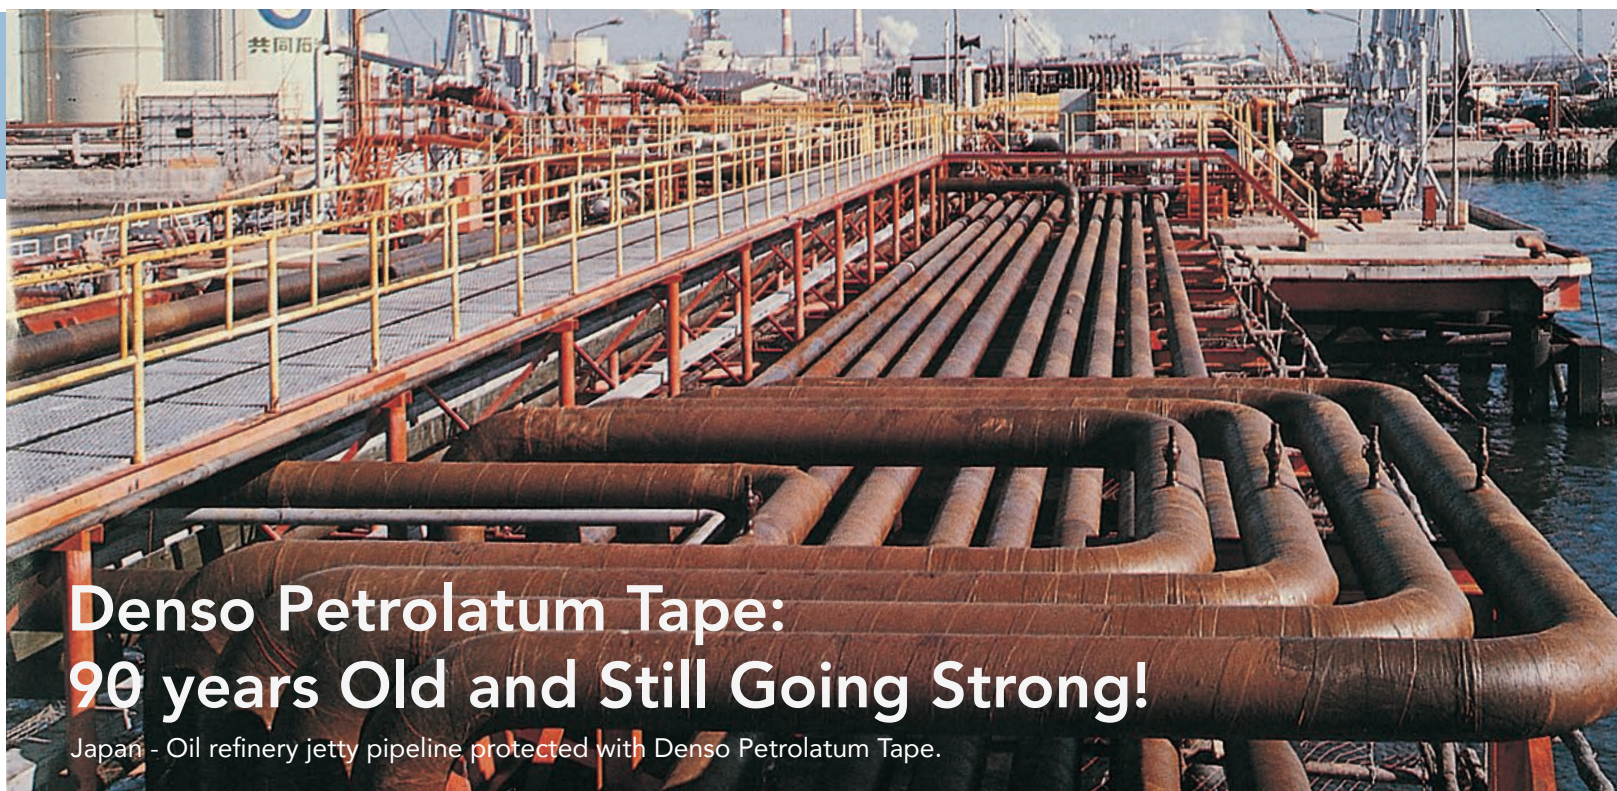
Japan - Oil refinery jetty pipeline protected with Denso Petrolatum Tape.

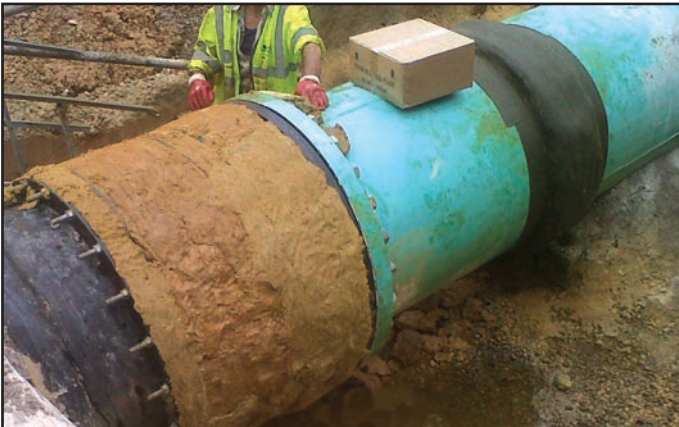
Denso Profiling Mastic™ is used to create a smooth profile prior to tape wrapping.

The Denso™ Petrolatum Tape System was chosen to protect the bolted flanges on the new water main. The system which is applied after cleaning comprises an application of Denso Paste™ followed by Denso Profiling Mastic™ to fill voids and smooth profiles. To complete the system, a spiral wrap of Denso™ Petrolatum Tape using a 55% overlap is applied to give a double layer of protection.

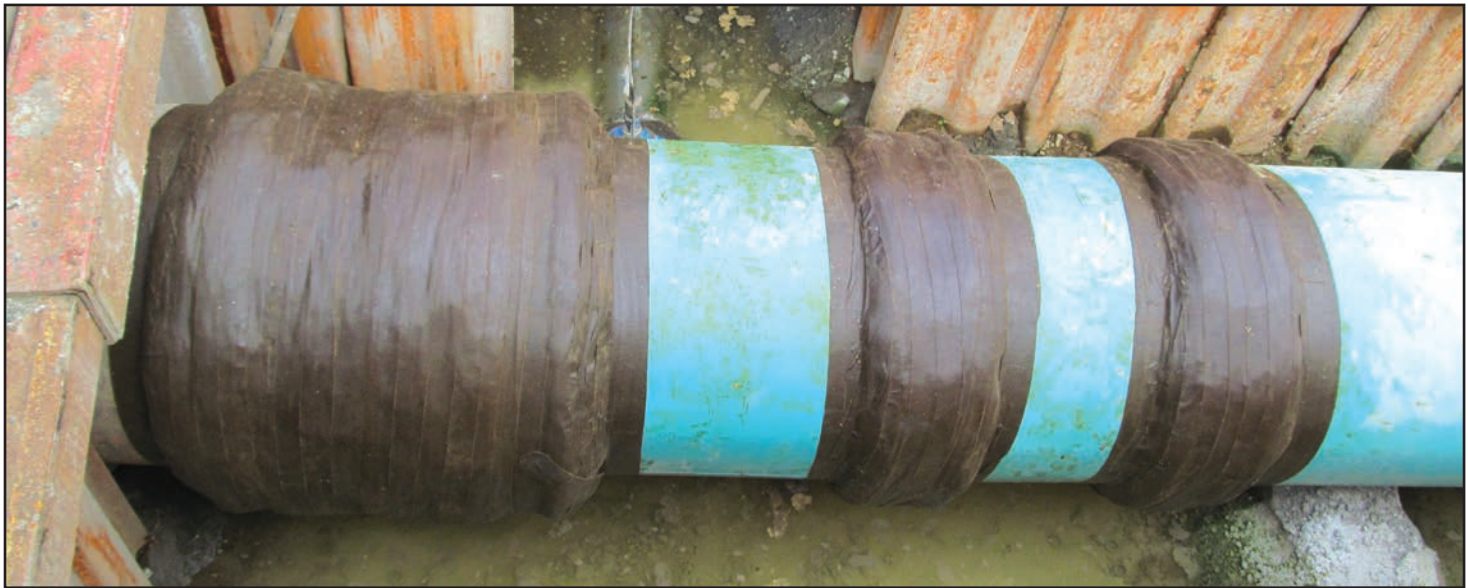
The completed Denso™ Petrolatum Tape System protecting the pipe joints.

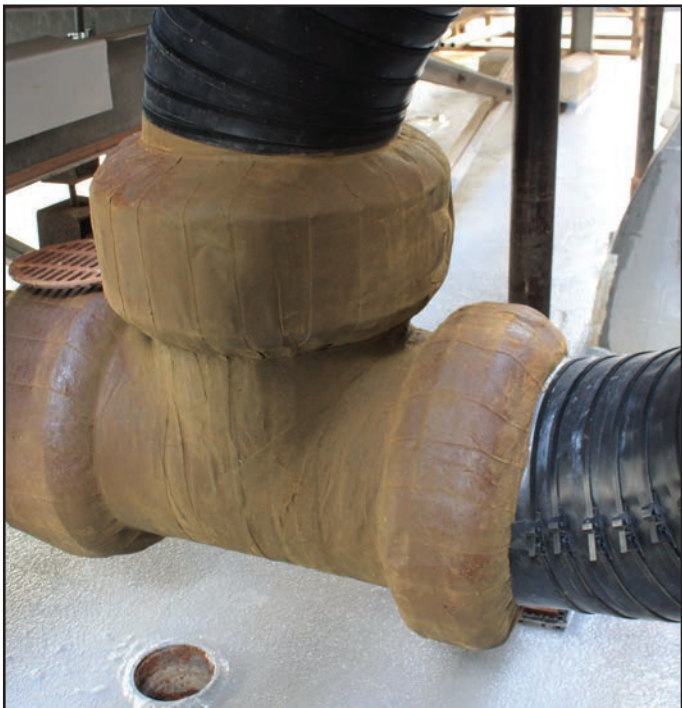
A large pipe tee joint wrapped with Densyl™ Tape prior to the application of Archco 15™ Acrylic Topcoat. The Denso HDPE Outerwrap™ is shown on the connected pipes.

After a short on-site training session with a Denso representative, the contractor MFR Fluid & Air was able to install the Denso™ Petrolatum Tape system quickly and easily much to their satisfaction. The scope of work consisted of minimal surface preparation (SSPC SP-2/SSPC SP-3), followed by the application of a thin layer of Denso Paste S105™, Densyl™ Tape with a 55% overlap, and a protective layer of Denso HDPE Outerwrap™.

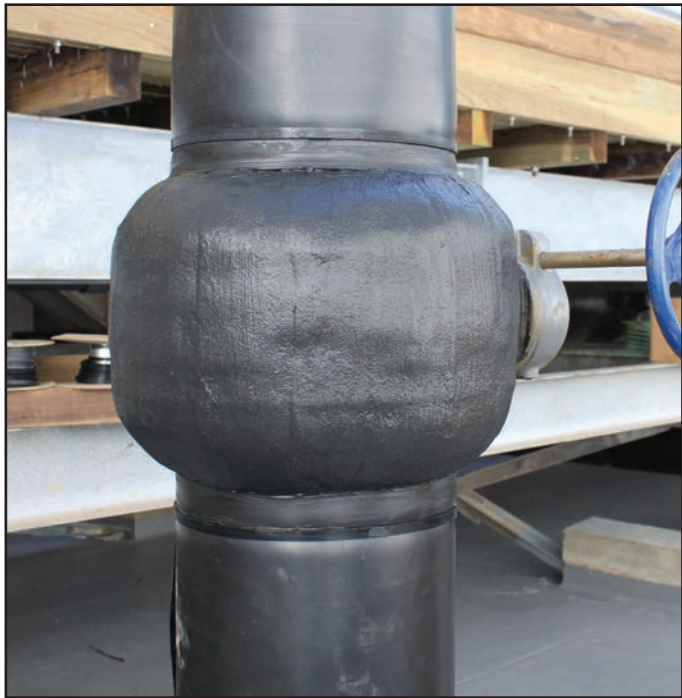
Archco 15™ Acrylic Topcoat is brush applied onto Densyl™ Tape protecting a valve flange as a top coat.

For irregular areas such as flanges and valves, Denso Profiling Mastic™ was also applied to provide a smooth profile to tape over and then top coated with the Archco 15™ Acrylic Topcoat in place of the Denso HDPE Outerwrap™.

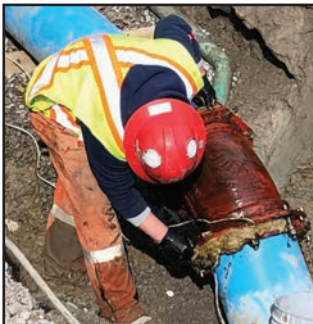
*Applying Denso Profiling Mastic™ to the pipe joints prior to wrapping with Denso LT™ Tape.*

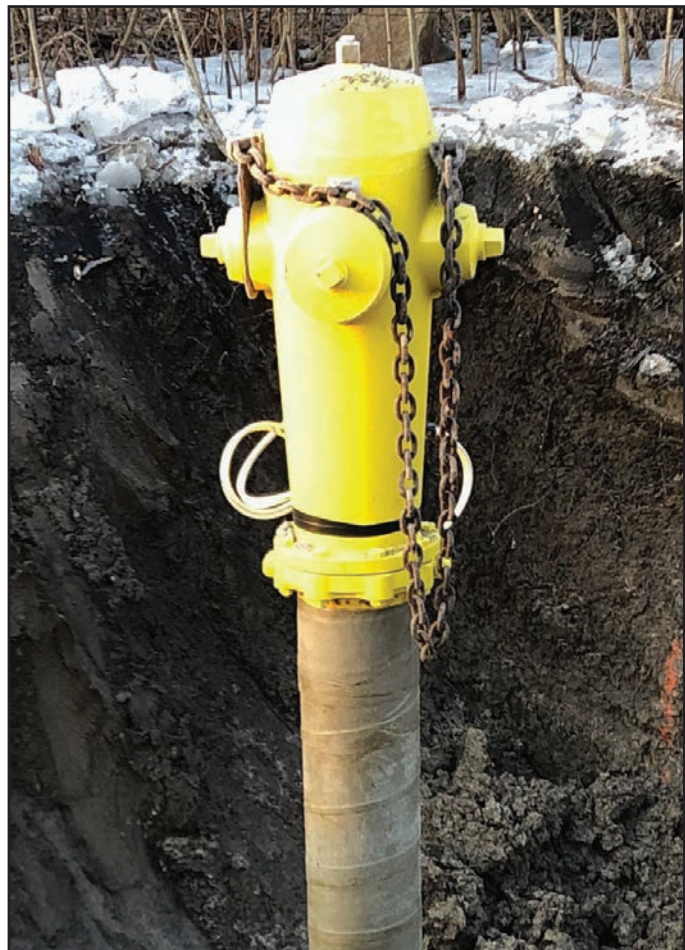
Water hydrant supply pipework protected with the Denso LT™ Petrolatum System.

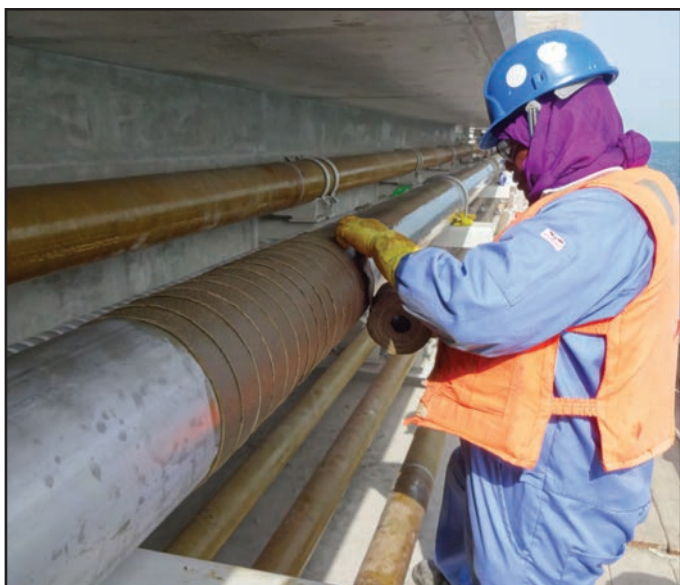
First a coat of Denso Paste™ is followed by a spiral wrap of Densyl™ Petrolatum Tape.

Due to these harsh conditions the project consultant decided that the best solution for the long-term protection of the pipes was a modified Denso Steelcoat™ System. The modified system comprises a coat of Denso Paste™ overwrapped with Densyl™ Tape using a 55% overlap. This was then followed with a wrap of Denso Ultraseal RT™ Tape using a 55% overlap which was then coated with two coats of white Denso Acrylic Topcoat™.

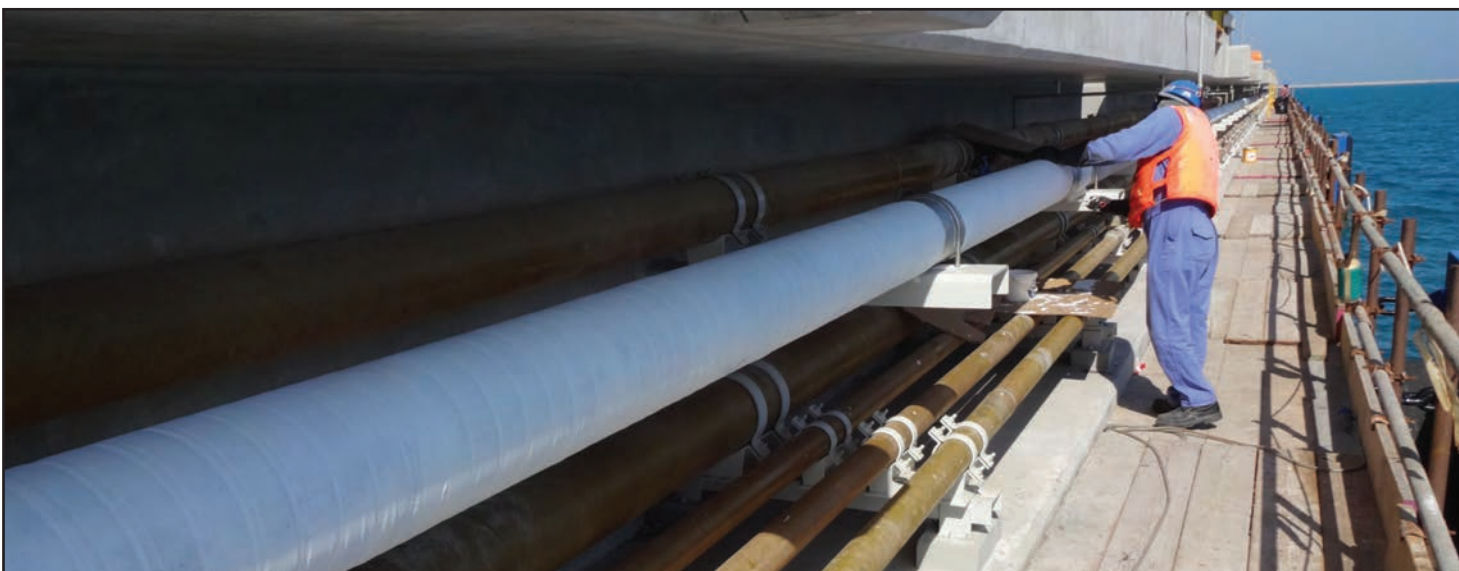
After applying a spiral wrap of Denso Ultraseal RT™ Tape, two coats of Denso Acrylic Topcoat™ completes the pipe protection system.

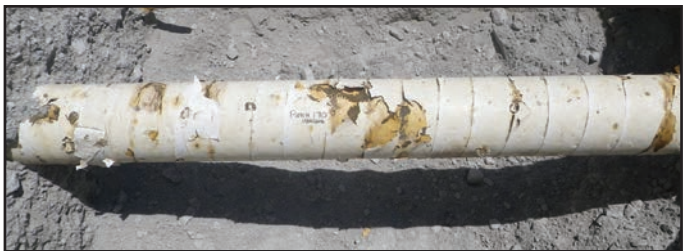
The original Denso™ system had probably been damaged by backfill.

All three excavations found the Denso™ Outerwrap to be slightly damaged which was presumably caused by the backfilling of the trench. No damage was noticed on the Denso™ Petrolatum Tape inner wrap which was still found to be saturated with the petrolatum compound.

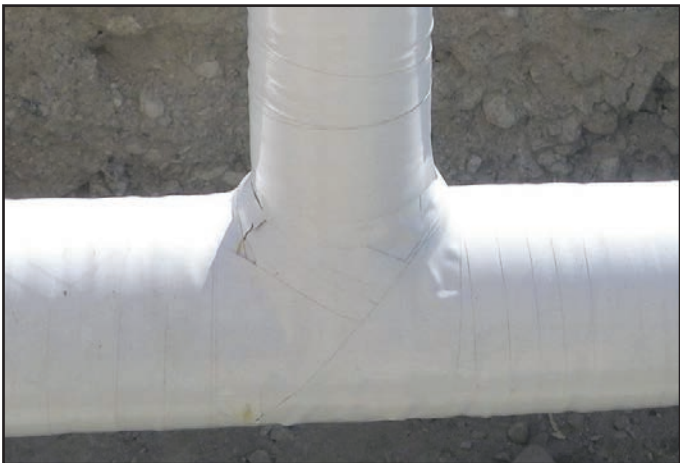
The new tie-in protected with the the Denso™ Petrolatum Tape System.

Recently a 6” tie-in was installed and wrapped for a new fire water system installation at the Main Store using the original system supplied back in 1988!

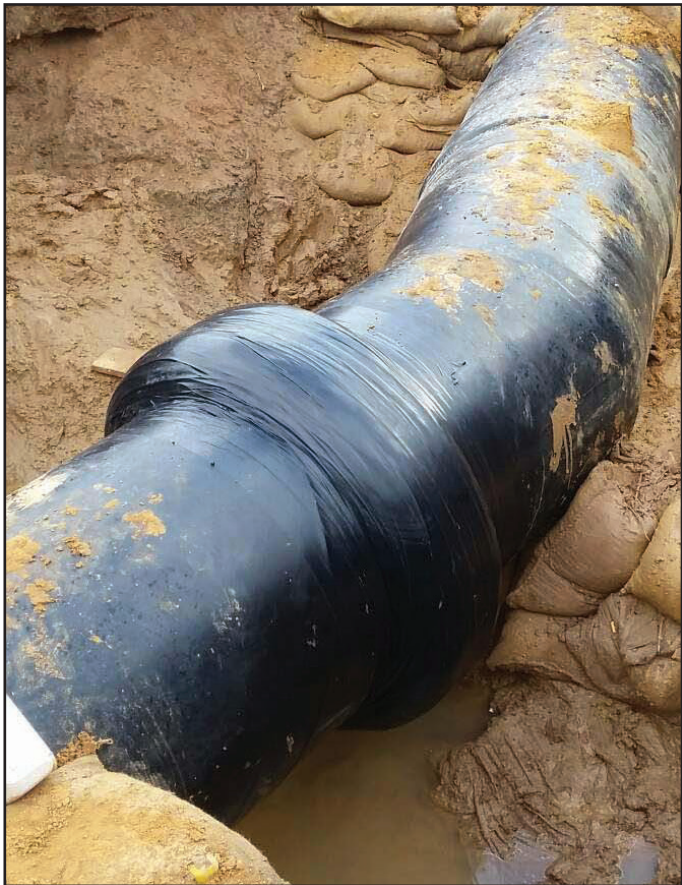
A wrap of Denso PVC SA™ Tape completes the system.

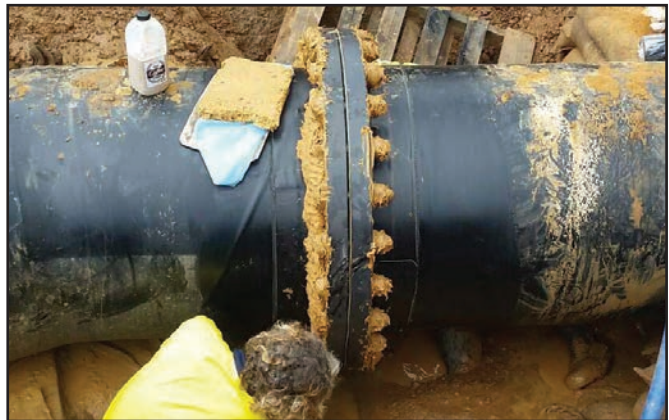
Below: Denso Profiling Mastic™ is used to create a smooth profile for wrapping.

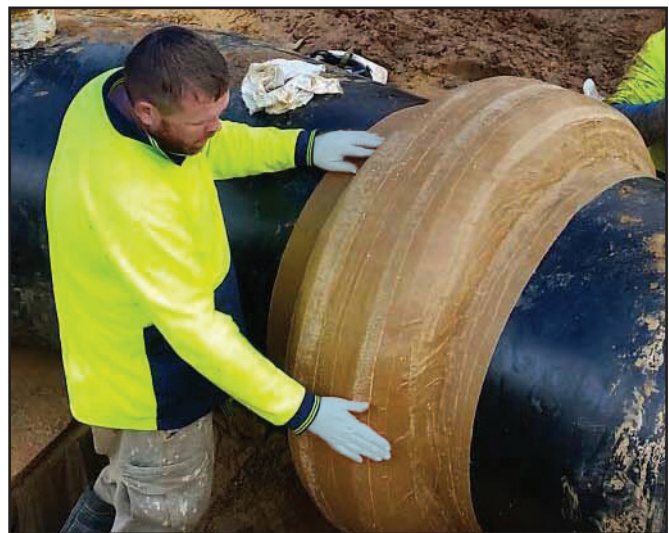
Above: Denso™ Petrolatum Tape is spirally wrapped around the bolted flange.

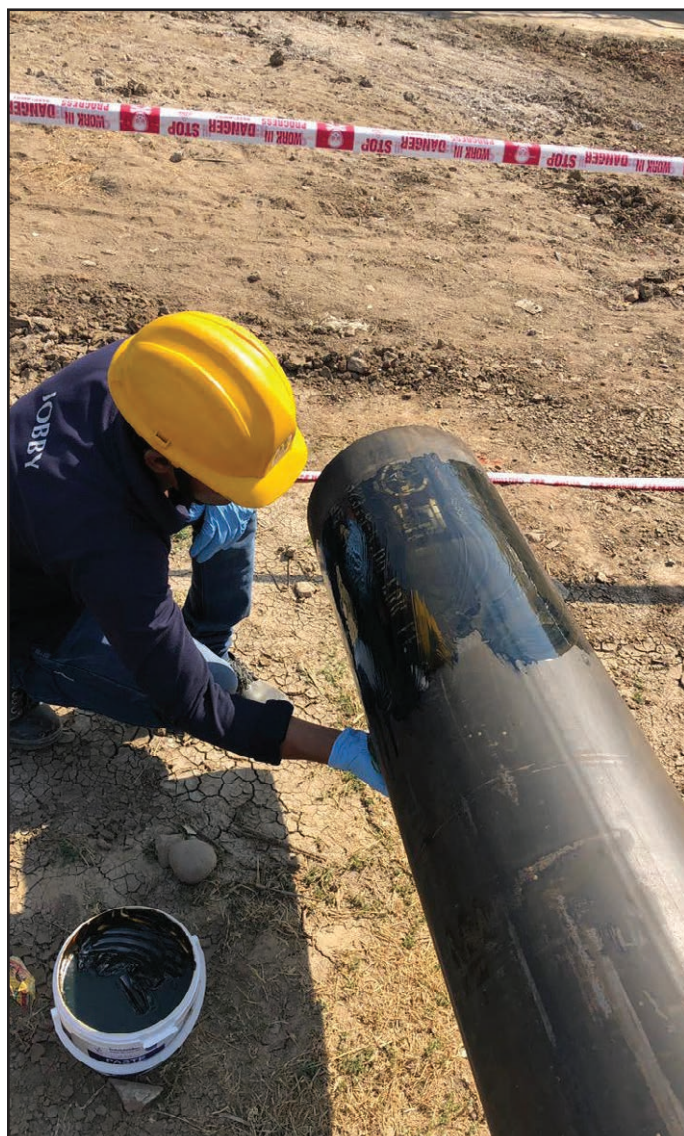
Denso Paste™ is applied to the cleaned pipe surface.

A consultation with the site head and engineering team was organised, where a demo installation was provided along with an overview of our products and services. Once the client could see how easy it was to apply the system, which consisted of Denso Paste™, Densyl™ Tape and Densopol 60HT™ Tape, it was approved for all pipes.

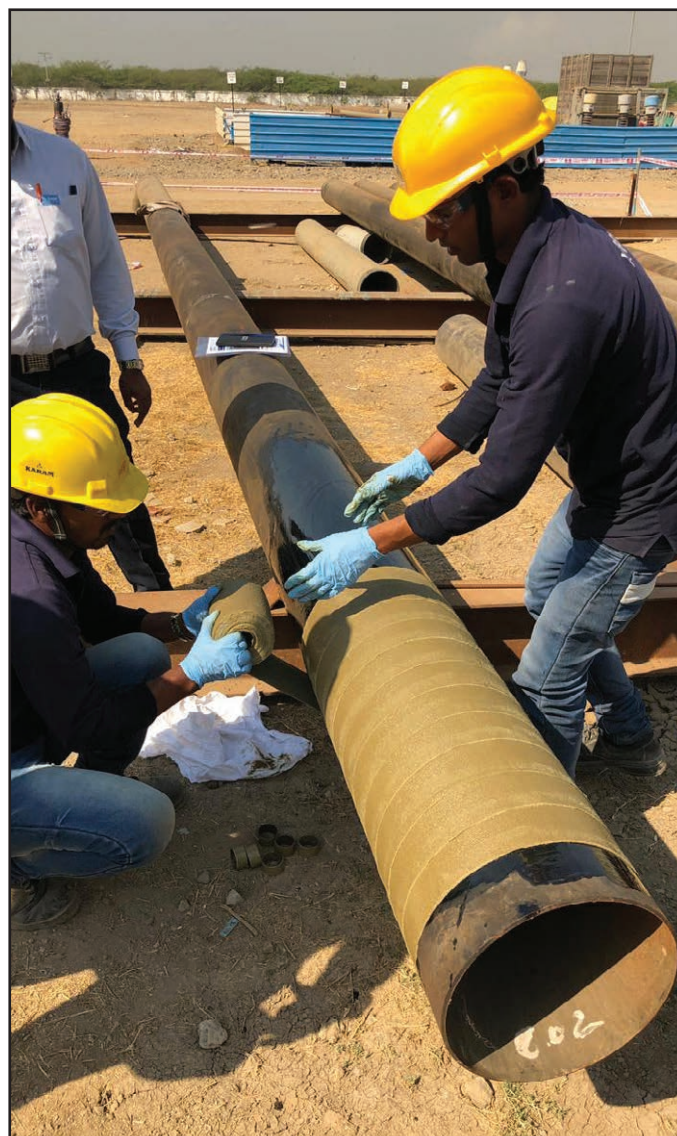
Densyl™ Petrolatum Tape is circumferentially applied over the Denso Paste™.

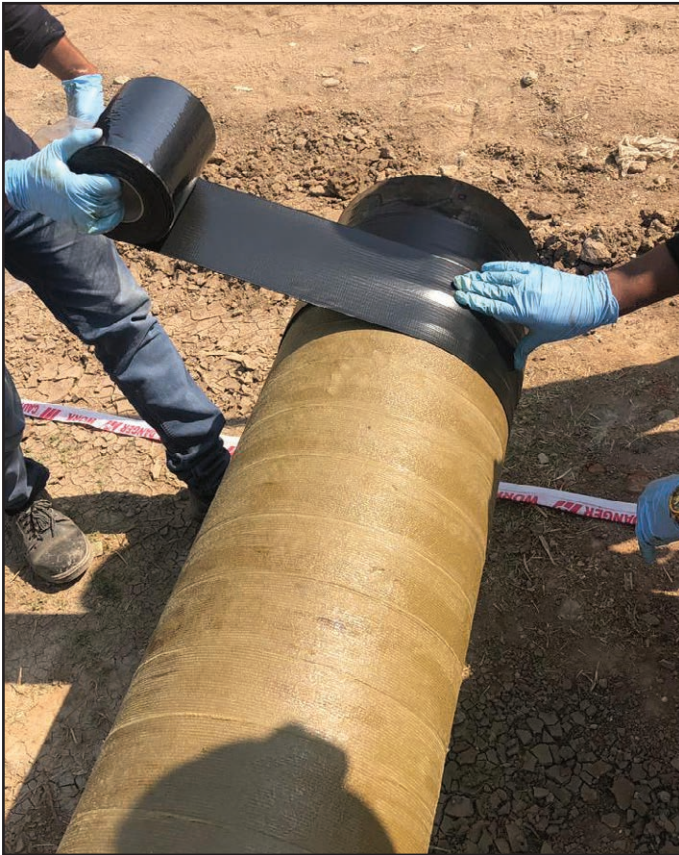
A wrap of Densopol 60HT™ Tape is applied to complete the system.

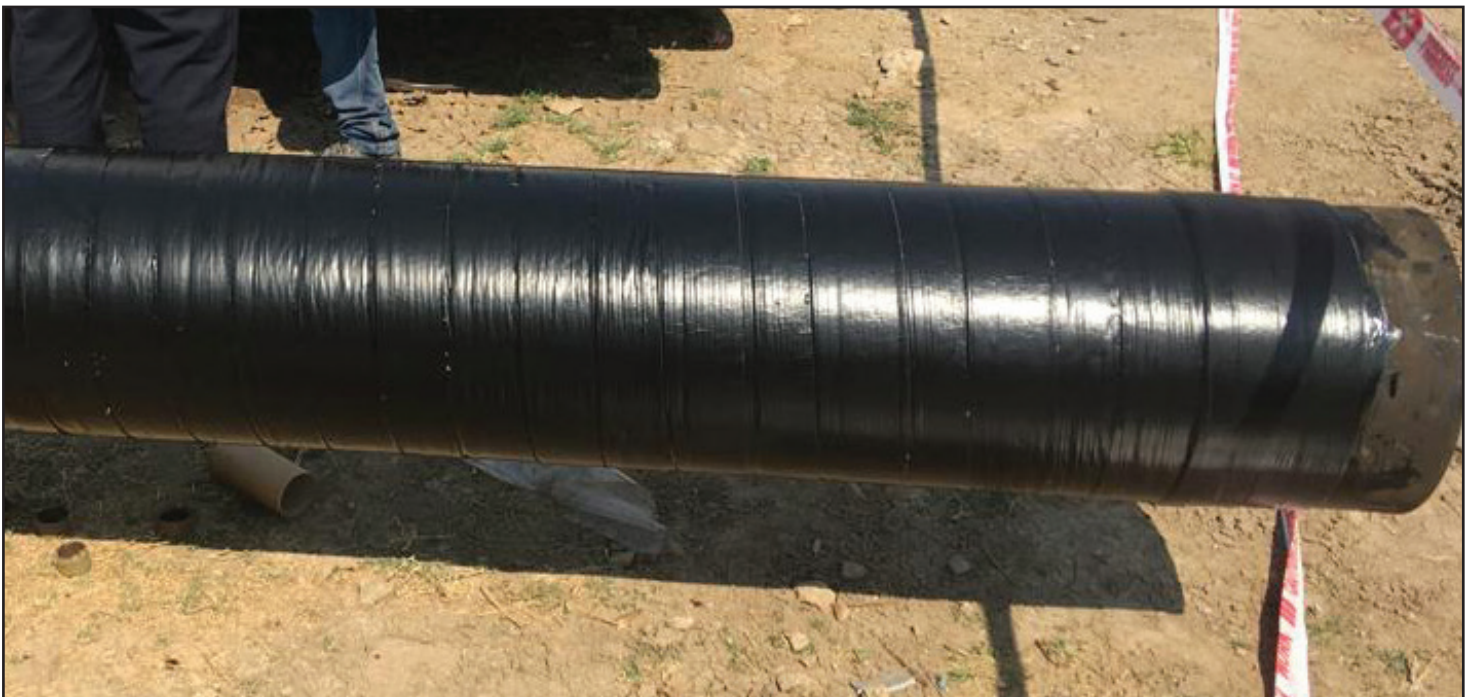
A completed section of pipe.
