Draft
Genesee & Wyoming Counties
Joint Flood Mitigation Plan

Genesee & Wyoming Counties Joint Flood Mitigation Plan

Town of Covington

August 2003

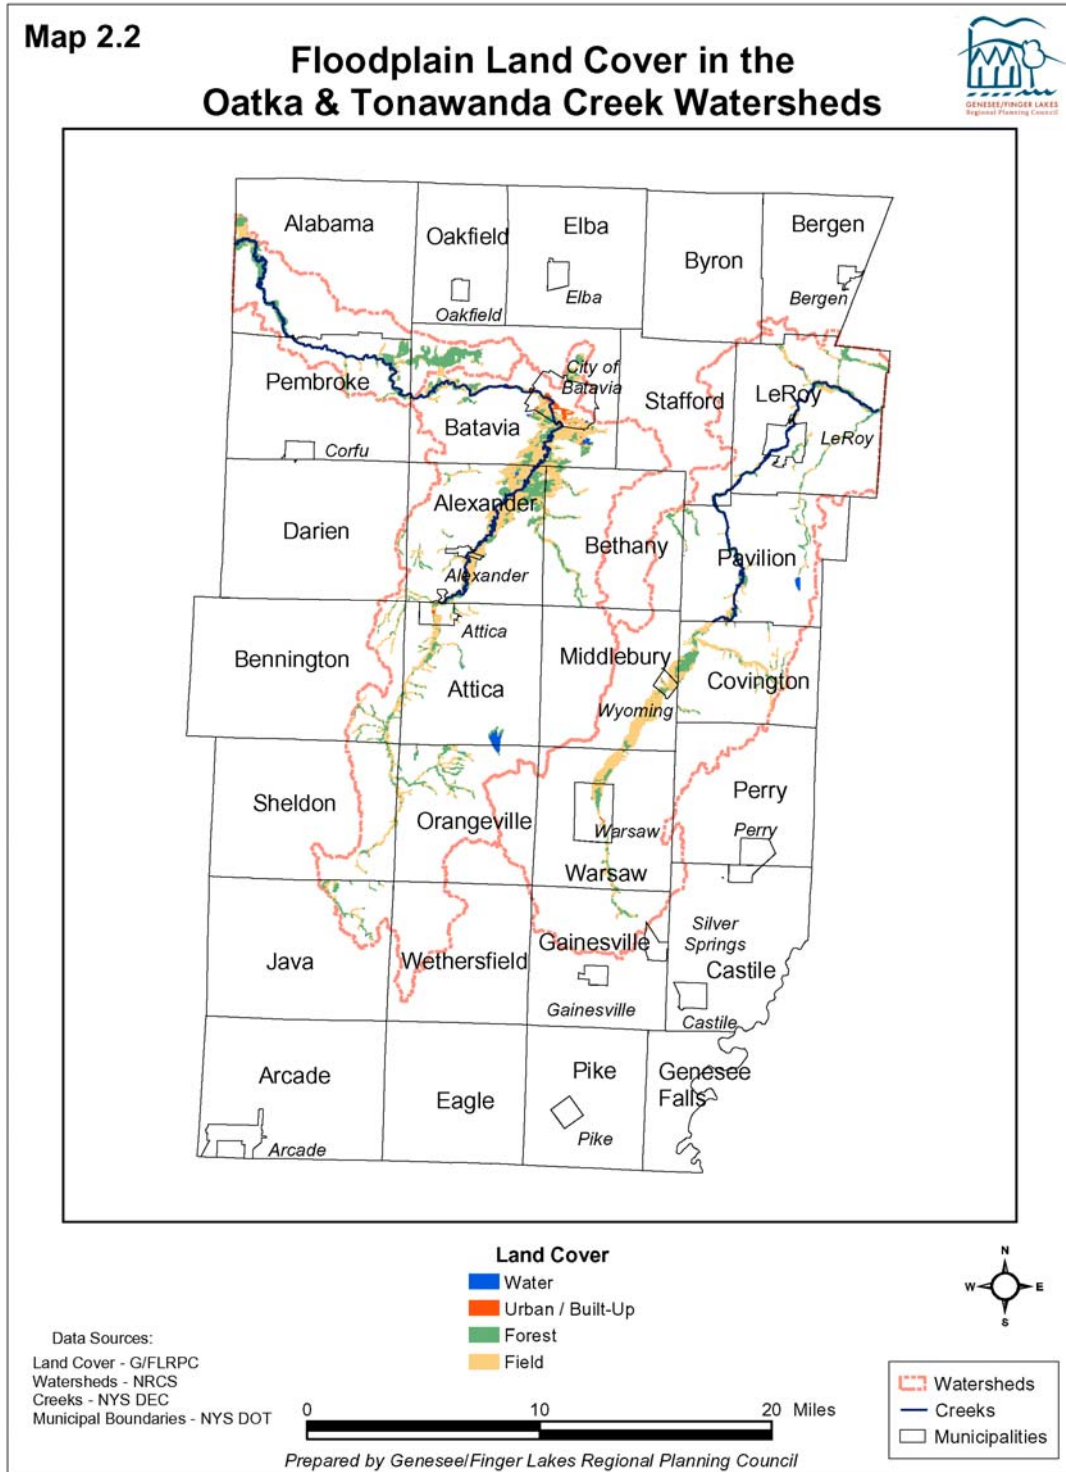
Map 2.2 illustrates the land cover in the Tonawanda and Oatka Creek 100-Year Flood Zones. Land cover in the 100-Year Flood Zone is largely fields and forest with the exception of small urbanized areas in the villages and the large urbanized area surrounding the City of Batavia. The majority of the fields are agricultural.

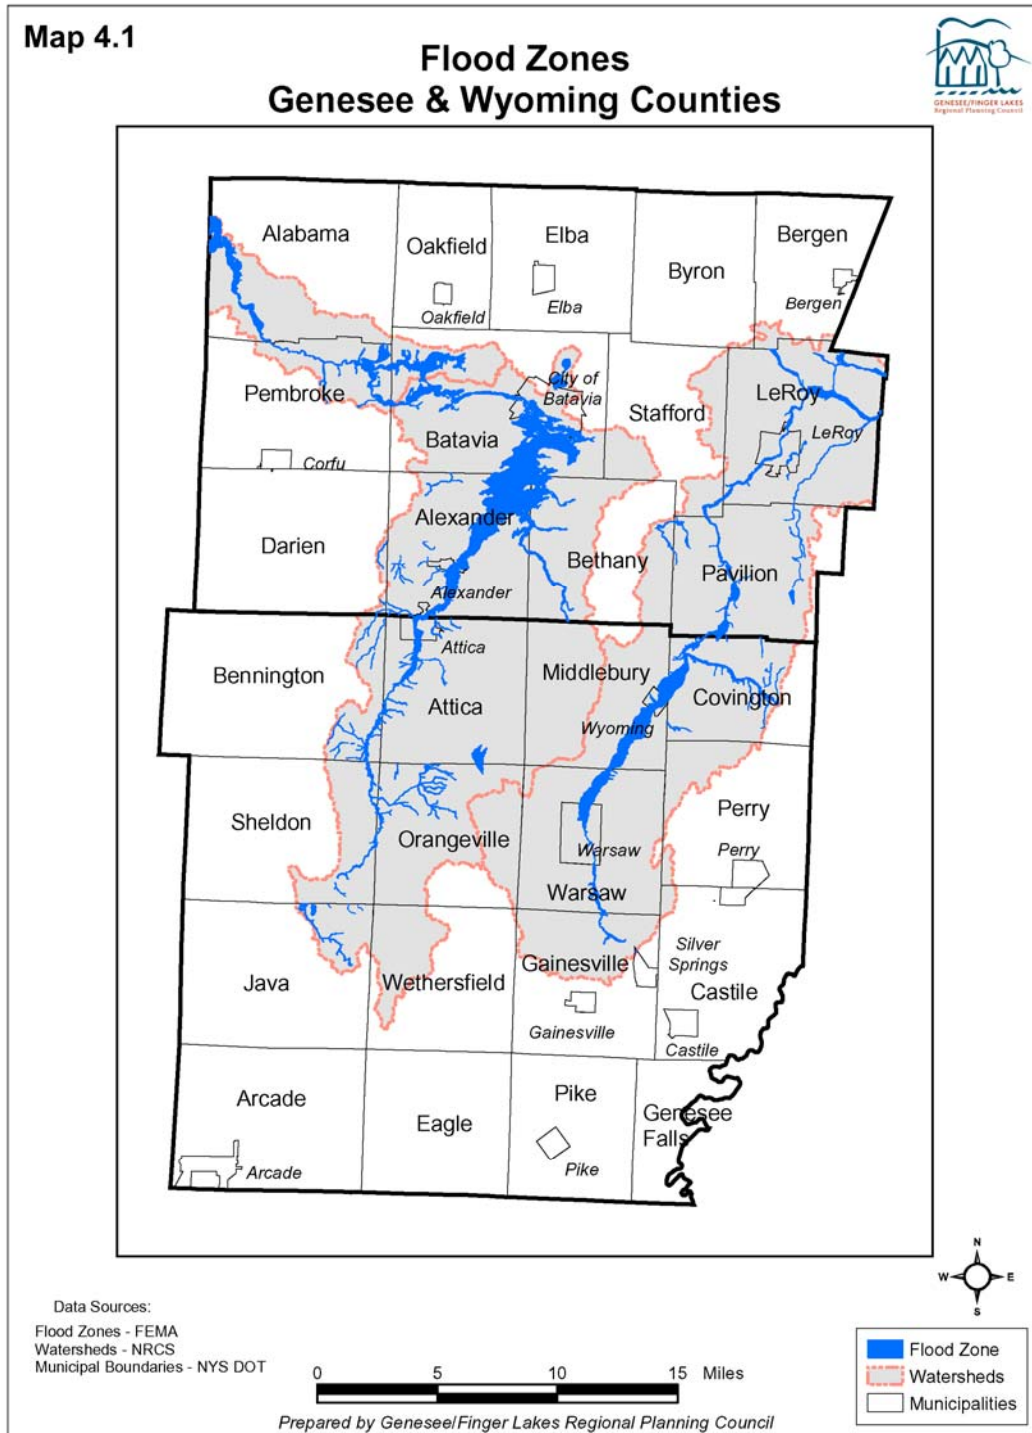
All municipalities in Wyoming County along the Tonawanda and Oatka Creek have FIRM determined base flood elevations with the exception of the Town of Middlebury (see [Map 4.1](#)). It is important to note that FIRM map extent of flooding assumes no stream channel obstructions. This is not the case with Oatka or Tonawanda Creek channels.

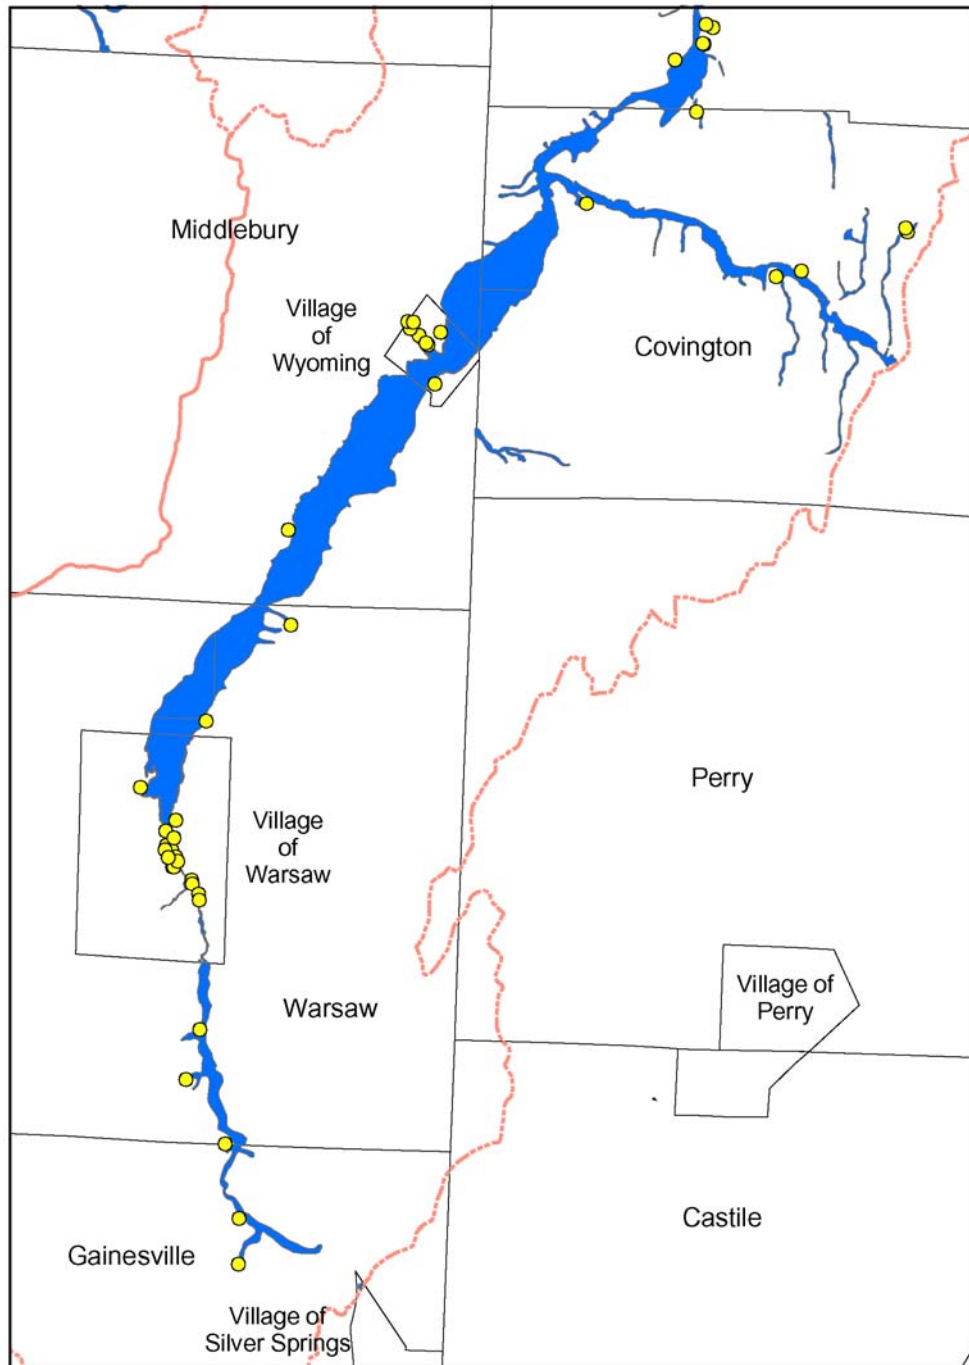
Map 4.2a

The flood hazard areas described below in **Table 4.1 and Maps 4.1**, were determined based on the residential, agricultural and commercial/industrial surveys (see **Section 4.8**), site visits and discussions of the Planning Committee and interviews held with federal, state and county agencies and municipal representatives (see Chapter 3).

Additional Flooded Areas Oatka Creek Watershed, Wyoming County

Table 4.1 - Additional Flooded Areas					
	Total	In Flood Zone	Damage	Out of Flood Zone	Damage
Wyoming County	142	69		73	
Attica	9	5	B,P,C	4	B
Bennington	3	0		3	B
Covington	11	5	B	6	B,1,P
Gainesville	3	1	B	2	B
Java	0	0		0	
Middlebury	2	0		2	B
Orangeville	11	5	B,P	6	B,1
Sheldon	17	9	B,1,P,S	8	B
Warsaw	12	7	B,P	5	B
V. of Attica	49	35	All	14	B,1,P
V. of Warsaw	18	2	B,P,2	16	B
V. of Wyoming	7	0		7	B
B=Basement					
Y=Yard					
S=Structural					
C=Crops					
P=Property					
1= 1st Floor

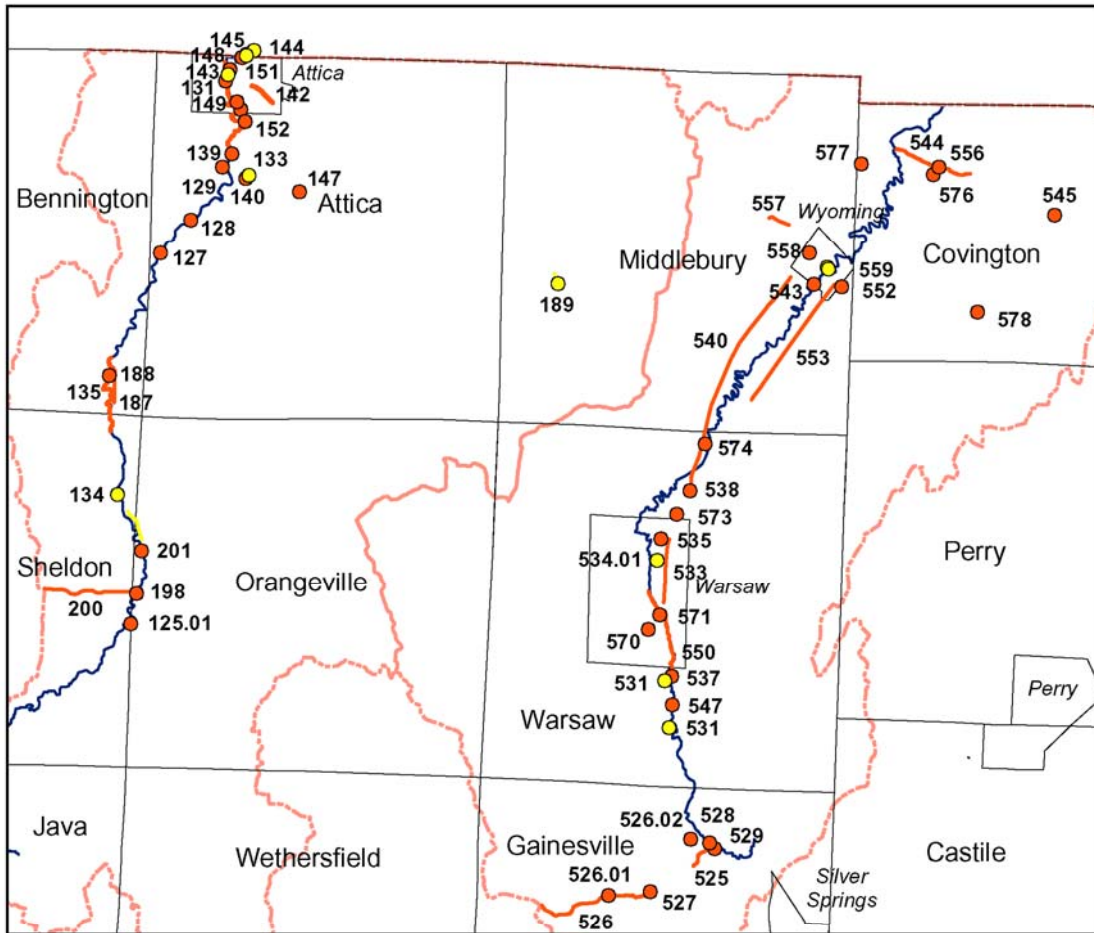
Map 4.4

The following section is meant to give a description of specific flood hazards that have been identified through the hazard assessment process. Site numbers (specific sites or areas) are indicated in parenthesis and are shown on [Map 4.4](#). All sites were ranked based on a priority site evaluation methodology (see [Appendix E](#)).

Specific Flood Issues, Wyoming County
