# **Final Report: Mobile Surveillance and Wireless Communication Systems Field Operational Test; Volume 1: Executive Summary**

**California PATH Research Report  
UCB-ITS-PRR-99-6**

## **Volume 1: Executive Summary**

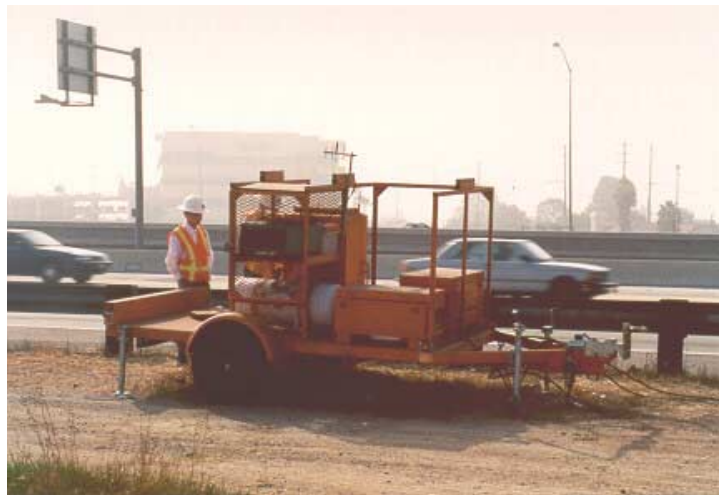
**Figure 1-3. Ramp meter trailer at Grand Avenue alongside I-5 Freeway**

Figure 1-3 shows a ramp meter trailer. Its major components are two traffic signal heads, a ramp meter-on sign, narrow band SSRs for data reception, and solar-powered electrical recharging systems for one of the signal heads and the meter-on sign.

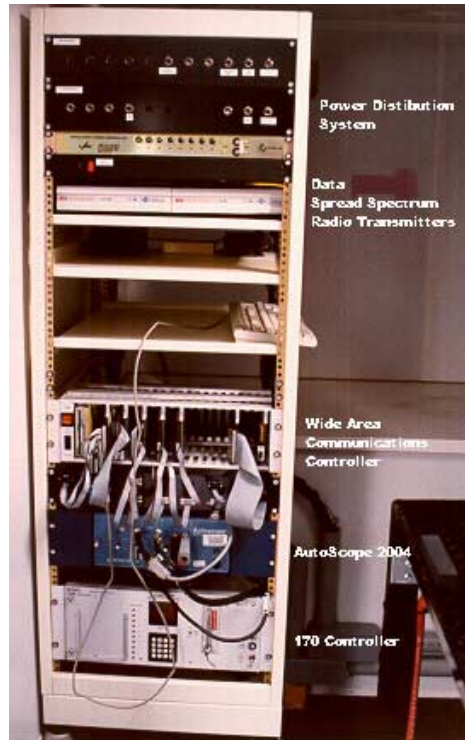
Figure 1-7. Surveillance trailer equipment racks

Figure 1-7 contains photographs of the two racks of equipment found in each of the surveillance trailers. The rack on the left contains the power distribution system, spread spectrum radios that transmit data to the ramp meter trailer and relay site, wide-area communications controller, AutoScope 2004 VIP, and the 170 controller that processes the VIP data. The rack on the right contains a monitor, controls for selectively displaying the imagery from the color surveillance camera or the black and white VIP cameras on the monitor, digital video encoder, spread spectrum radio that transmits compressed video imagery to the relay site, pan-tilt-zoom camera controls, generator auto start/battery recharge system, and the automatic mast retraction circuit.

(a) Left equipment rack

(b) Right equipment rack
