GEOTECHNICAL CONSTRUCTION SOLUTIONS

Everything
FOUNDATION REPAIR

ABOUT L.R.E. GROUND SERVICES

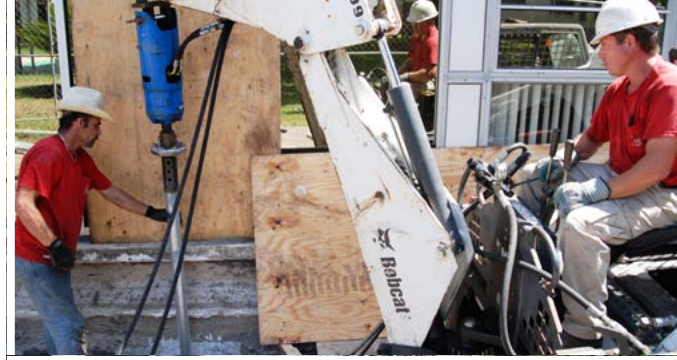
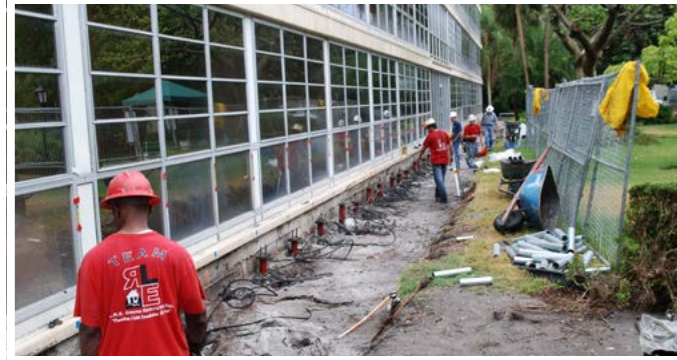
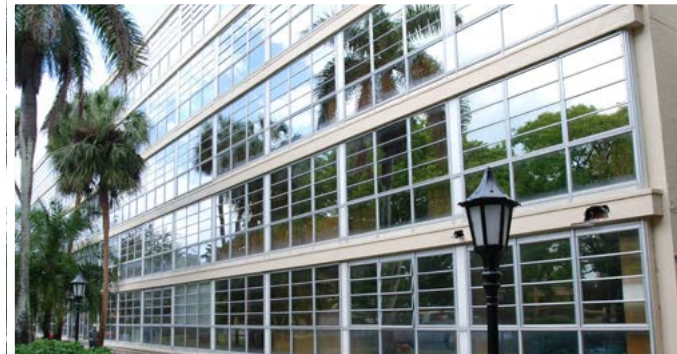
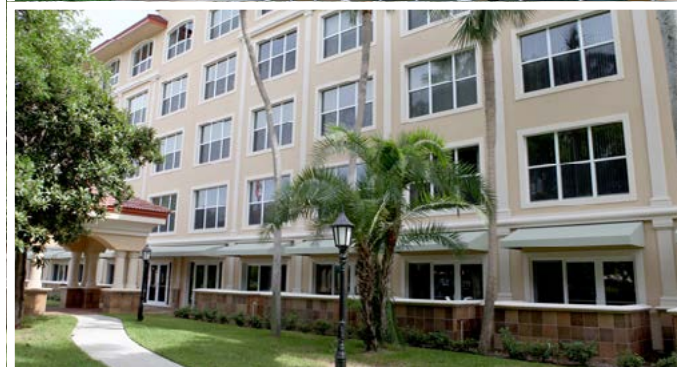
WESTMINSTER BRADENTON MANOR

Built in 1961 the Westminster Bradenton Manor's South Elevation was slated for renovation. It was decided to bring the building up to code by removing the entire facade. Hurricane resistant windows, new stucco with Mediterranean detailing and a new mansard roof were planned. Due to the renovation generating additional loading to the existing wall footing, it was determined that there would be differential settlement between the new footer and existing. A deep foundation was recommended to transfer the load from the new footer to the limestone below. To minimize vibration and possible damage to the existing structure, helical piers were chosen as the deep foundation to support for the new footer.

Helical piers were chosen as the ideal deep foundation system because they can be installed with smaller equipment, with less vibration and disturbance to the existing structure. L.R.E. Ground Services, Inc. was chosen to install the helical pier system for this project. L.R.E. utilized fifty-four (54) Foundation Supportworks, Inc (FSI) 287 helical piers, with 8" - 10" lead sections, installed to 14-foot average depths. The helical piers were installed on 4.5-foot centers to achieve a design working load of 20 kips per pier. Utilizing a FSI retrofit bracket at each location and hydraulic cylinders, L.R.E. uniformly loaded each bracket. Upon completion, the retrofit brackets and tops of the helical piers were encapsulated into the new footer and foundation. The detail of the footer also consisted of doweling into the existing footer and floor slab.

Products Installed: (54) FSI 287 - 8" - 10" helicals to an average depth of 14 feet 4.5 feet on center.

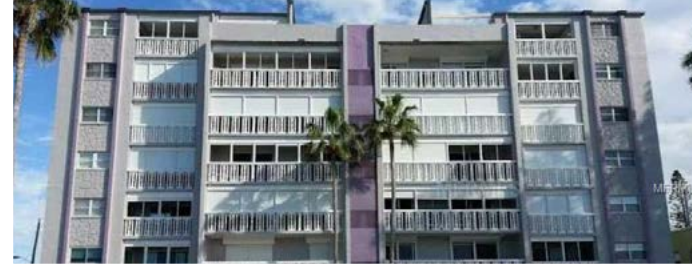
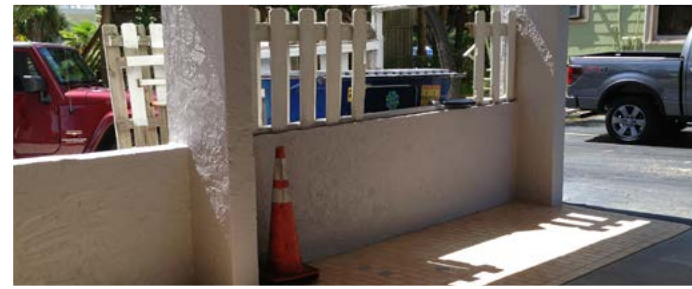
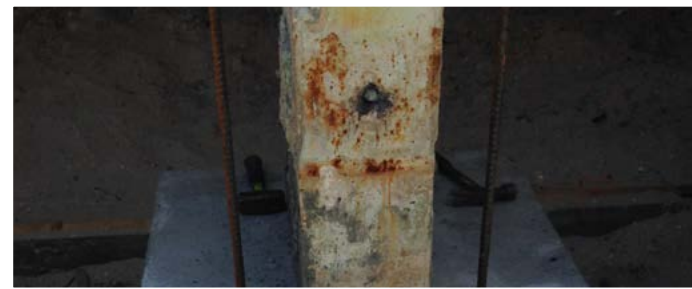
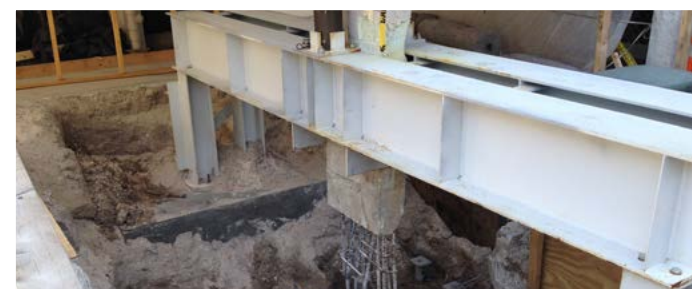
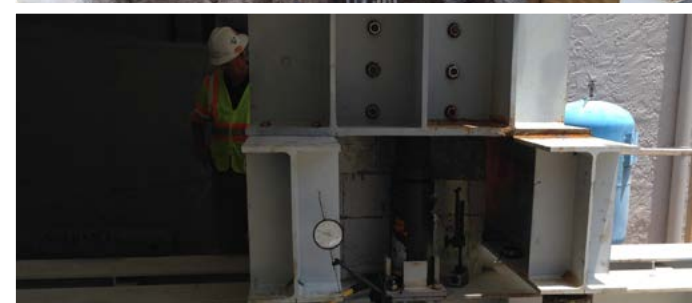
BEACH HOUSE CONDOMINIUM

The project consisted of a seven-story condominium with a ground floor parking garage. Duke Energy had a transformer on grade near one of the columns. At some point the transformer leaked hazardous material into the soil. Duke Energy hired a remediation company to excavate down and remove the hazardous materials. Some of the materials traveled under one of the column pads. Duke Energy hired Master Engineering to provide a comprehensive plan to remediate the remaining hazardous materials.

The comprehensive plan called for removing the concrete slab adjacent to the contaminated column pad, installing two temporary column pads at either side of the column. The plan called for twelve (12) FSI 288 helical piers. Six for each temporary column pad, to support 10 kips of working compression capacity each. Then L.R.E. installed two each W8x40 temporary columns at each side of the existing concrete column, attached to the temporary column pads. Two 18x76 beams were then installed horizontally at either side of the existing concrete column. A custom made bracket was installed atop the support beams and bolted through the existing column. The existing concrete column was loaded onto the support beams utilizing four 100 ton jacks. Once loaded on the existing column pad, a portion of the column and contaminated soils were removed by others. L.R.E. then installed fourteen (14) FSI 288 helical piers, then formed and poured a new permanent column pad. The Phase 2 load transfer of the existing column to the new permanent column pad was completed using four HSS 6x6 temporary columns. Once loaded, the existing column was poured into the new column pad and all temporary steel support was removed. Three load tests were required, one prior to the temporary column pad and one prior to the permanent pads being cast. An additional load test was required due to some of the helical piers spinning out prior to reaching the required torque correlation.

Products Installed: (26) FSI 288 8" - 10" Helix Configuration

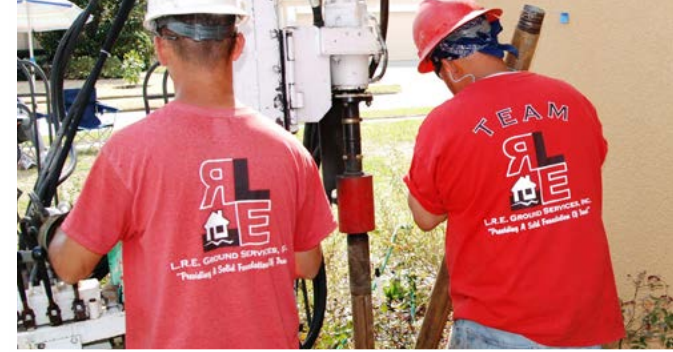
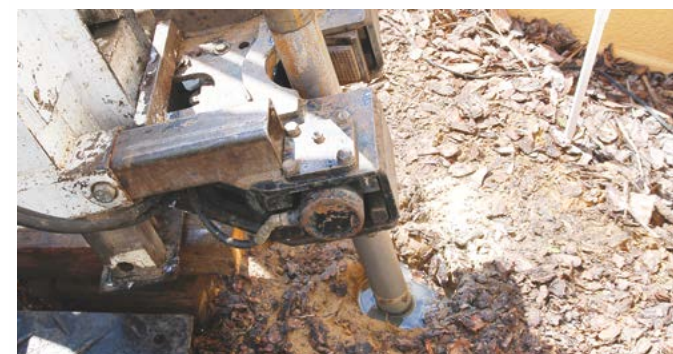
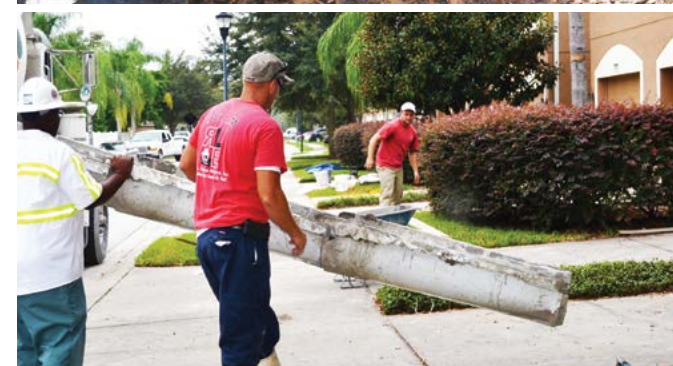
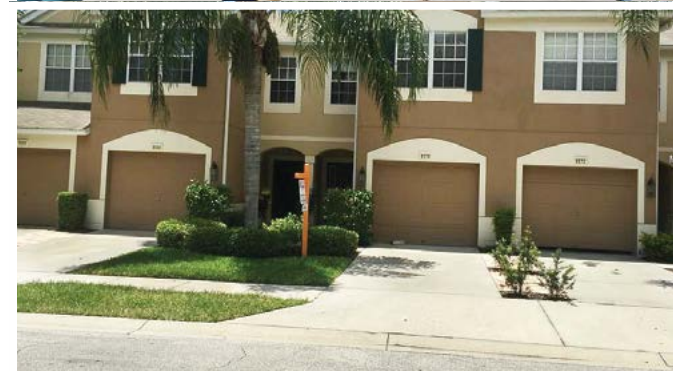
SOLANA BAY CONDOMINIUM

The subject property is comprised of 16 two-story masonry structures and a pool building, with a total of 110 units. Initially one building was tested in September 2010 and found to have sinkhole activity. Several other buildings started to experience settling. The HOA requested all structures be tested. Central Florida Test Laboratories, Inc. was hired to investigate and found sinkhole activity at the entire site.

Central Florida Test Laboratories, Inc. recommended compaction grouting to stabilize the deep subsurface soils. It was recommended that all the structures be remediated. This was accomplished utilizing 1,030 grout points to an average depth of 48 feet. Following the compaction grouting, it was recommended that the upper loose soils needed to be addressed. It was recommended that the perimeter of the structures and interior load bearing walls be stabilized with chemical permeation grout. Upon completion of the compaction grout, chemical grout was installed along the perimeter of the structures and along the interior load bearing walls. This process densifies and tightens the loose upper soils. L.R.E. also removed and replaced all concrete sidewalks and driveways on this project.

Compaction Grout: 49,000 feet of injection pipe and 3,550 CY of compaction grout installed.

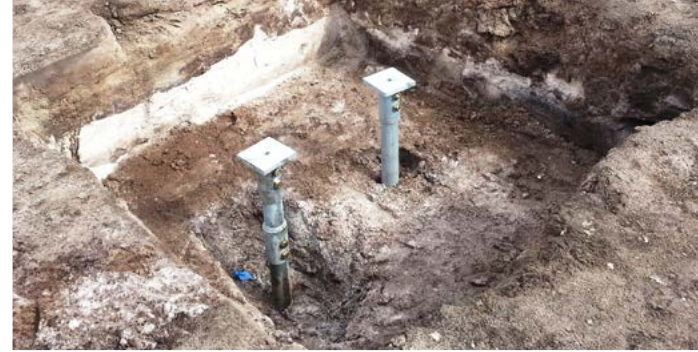
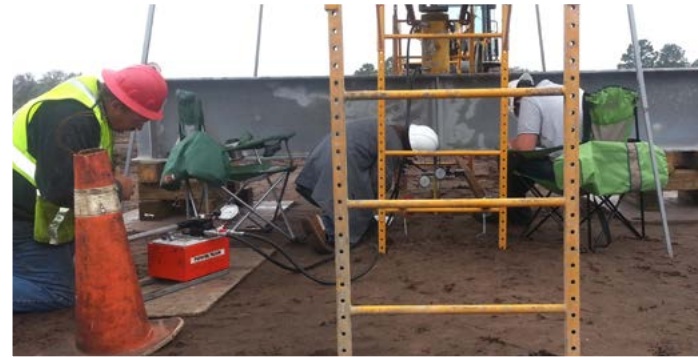
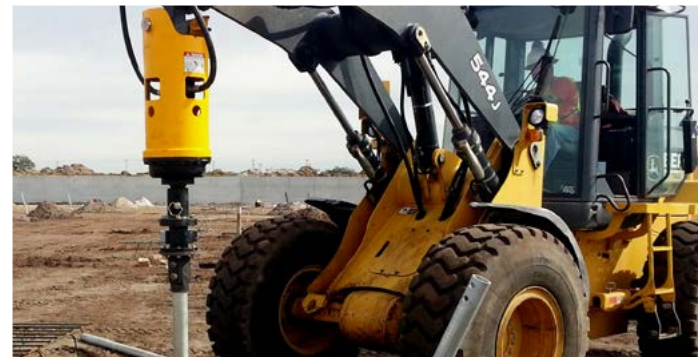
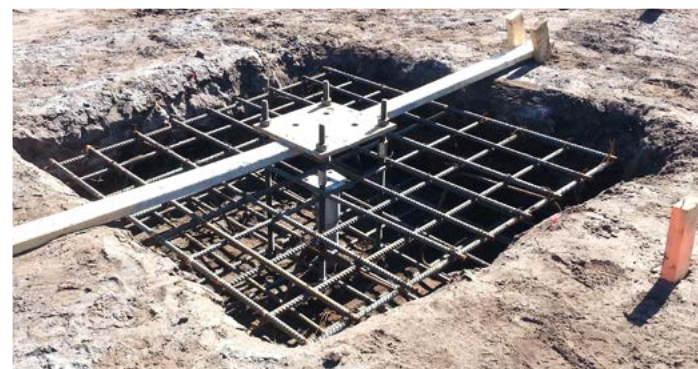
DART CONTAINER

A new 379,800 sq. ft. warehouse was proposed on a site that had been previously used to dispose of mine waste (slimes). A geotechnical investigation discovered fill soils over slimes and waste clays as deep as 40 feet within the proposed building footprint. The surficial fill soils were determined to be competent to support the relatively light design compression loads. However, deep foundations were considered to resist the uplift loads, thereby eliminating the need for massive concrete column pads. The design uplift loads were 58, 64 and 70 kips for the interior column pads, columns along two exterior wall lines and the center column line, respectively. The failure criteria was very stringent. No more than 0.25 inch of movement (uplift) would be allowed at service load conditions.

Helical piles were proposed to be cast into the concrete column pads to support the design tension loads. One or two piles would be used at each column location to reduce individual pile loads to 30.2 to 58 kips. Spacing efficiency modifiers were used to determine capacities of piles in the two-pile caps where pile spacing was less than three times the diameter of the largest helix plate. Thirty-two (32) Model 288 (2.875-inch OD by 0.276 wall) round shaft helical piles with a custom helix plate configuration consisting of either four or five 12" helix plates were installed to resist design working tension loads from 30.2 to 33.3 kips. One-hundred twenty-seven (127) Model 350 (3.50-inch OD by 0.313-inch wall) round shaft helical piles with a helix plate configuration consisting of either 12"-14"-16"-16"-16" or six (6) 12" plates were installed to resist design working tension loads from 36.8 to 58 kips. The helical piles were installed to an average depth of 46 feet below grade to achieve torque-correlated ultimate capacities of at least twice the design working loads ($FOS \geq 2$). Prior to installing the production piles, six tension load tests were performed at the site on sacrificial piles to verify pile capacities and monitor deflections. The pile load tests were planned within days of the test pile installations, which would not allow for full redevelopment of soil strengths around the helix plates and along the pile shafts. The tension piles would also not be pretensioned following installation. Therefore, 3/32-inch shims were added within the extension couplers during installation of both the sacrificial test piles and the production piles to control vertical movements and meet the stringent deflection criteria.

Products Installed: (32) FSI HP288 helical piles, (127) FSI HP350 helical piles, average pile depth of 46 feet, design working tension loads from 30.2 to 58 kips

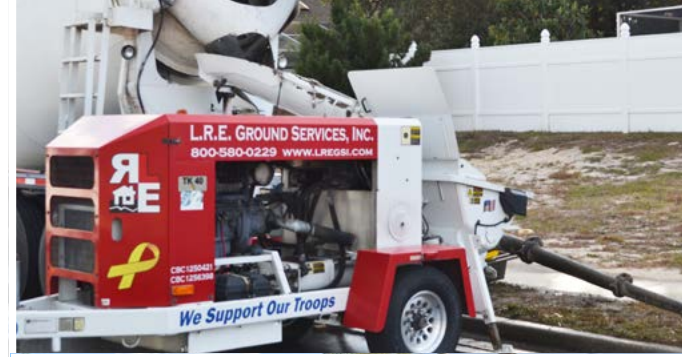
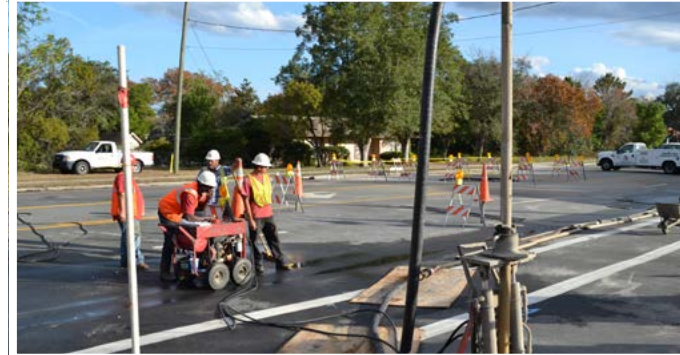
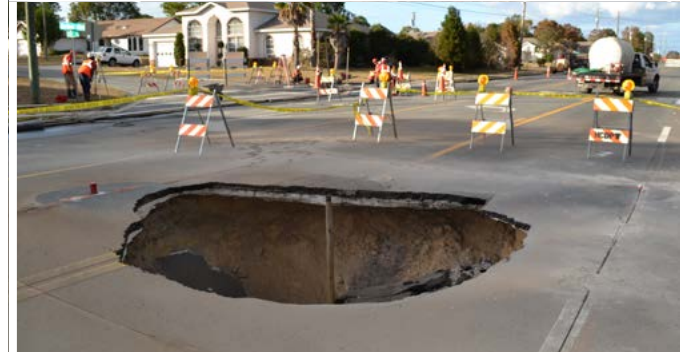
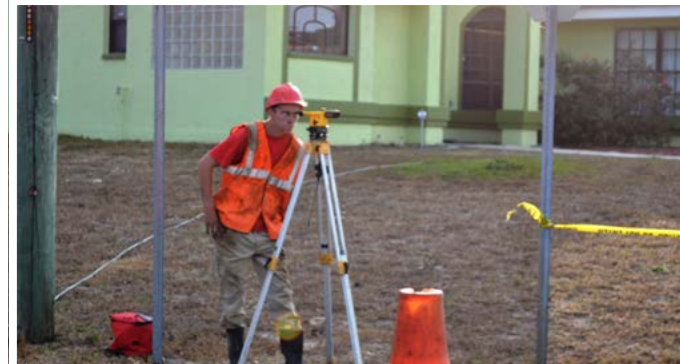
MARINER BOULEVARD

Following Tropical Storm Debby, a portion of Mariner Blvd. between Claymore and Little Streets collapsed. The massive amount of rainfall triggered several sinkholes on Mariner Blvd. near Little St. Hernando County temporarily backfilled the depressions and repaved the areas.

Professional Service Industries, Inc. (PSI) was contracted by Hernando County to determine if the underlying soils were stable. PSI investigated two areas north of Little St. and one area West of Mariner Blvd. on Little St. PSI determined that sinkhole activity was present and formulated a repair program. PSI recommended compaction grouting was needed to stabilize the deep soils at the three areas. L.R.E. Ground Services, Inc. was contracted by Hernando County to remediate the sinkhole activity. Utilizing PSI recommendations and monitoring of the project, L.R.E. performed compaction grouting at the three areas. This was accomplished utilizing 23 grout points to an average depth of 72 feet and 708 cubic yards of grout.

Compaction Grout: 23 points to an average depth of 72 feet with a total of 708 CY of grout.

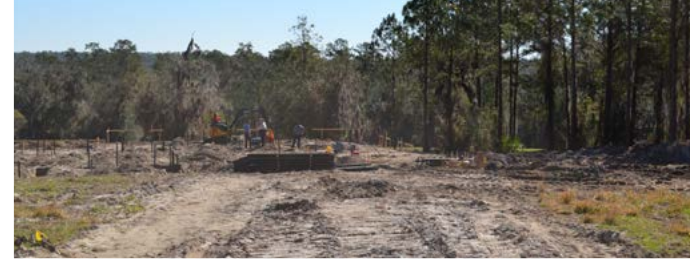
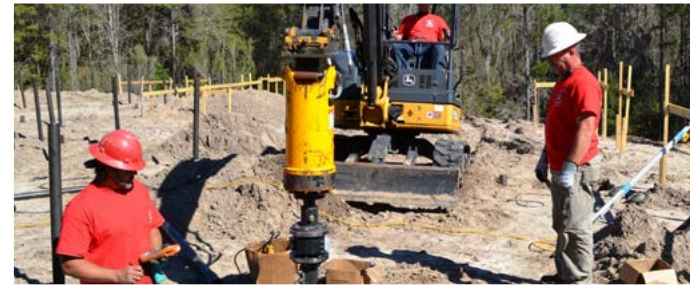
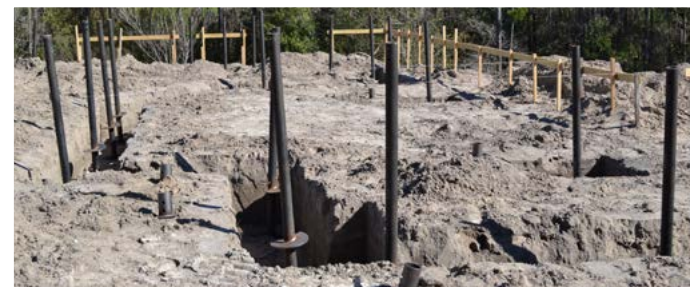
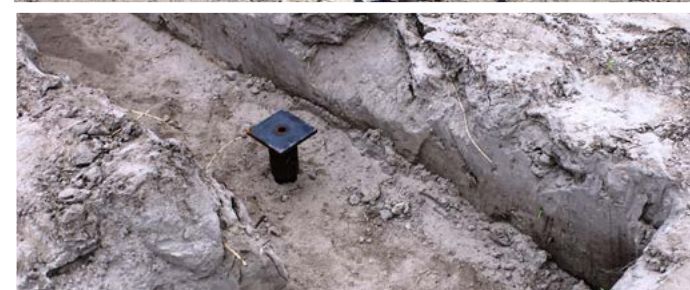
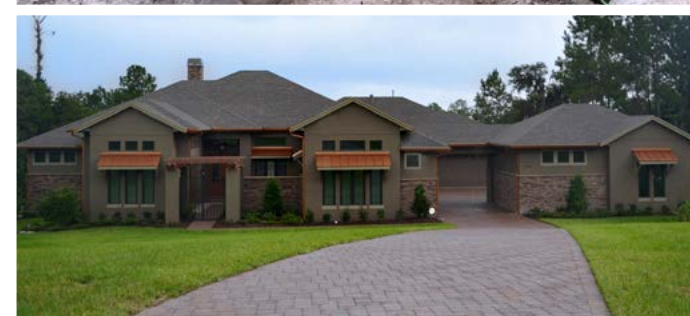
PRE-CONSTRUCTION HELICAL PIERS

This property is located in Central Hernando County, FL. Due to concerns over high clay soils and sinkhole activity in this part of Florida, the owner hired a Geotechnical engineer. SPT and soil borings were completed and soil samples collected. Due to the highly expansive clay soils found during the testing, it was recommended that piers be installed.

Helical piles were recommended for this project. Helical piles install quickly with little to no vibration and there is no waiting period after installation. This allows the contractor to pour the footers and column pads as the pier installation is completed. Using specialized software it was determined that a 10" - 12" Helix configuration would be required for the specified loading. The piles were installed to depths below the clay soils to help isolate the foundation and prevent shrink/swell movement. The final installation depths were determined by the torque correlation method. In order to achieve the desired loading, hydraulic pressure is monitored using specialized equipment. The top of the piles are fitted with a pre-construction cap that is cast into the concrete footers and column pads.

Products Installed: (134) 2.88" helical piles, 10" - 12" helix configuration, average pile depth of 23 feet, design working compression loads of 28.8 kips.

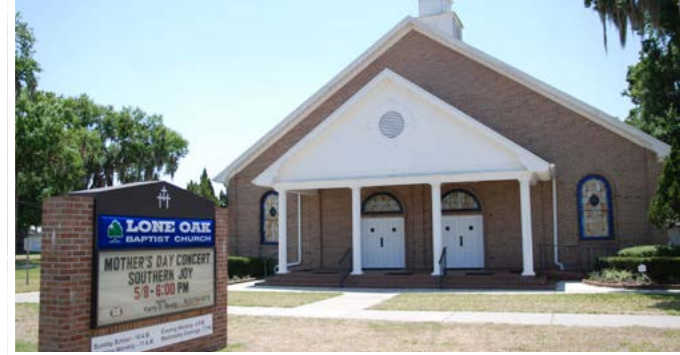
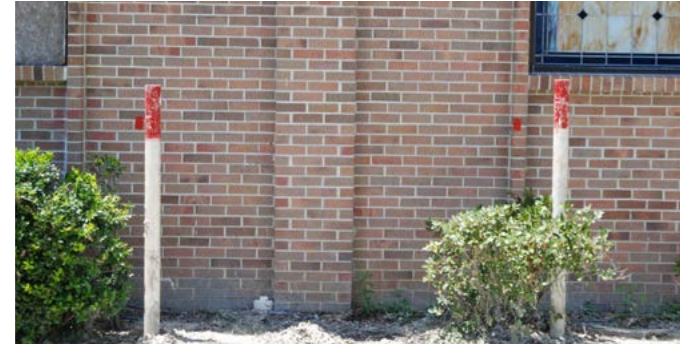
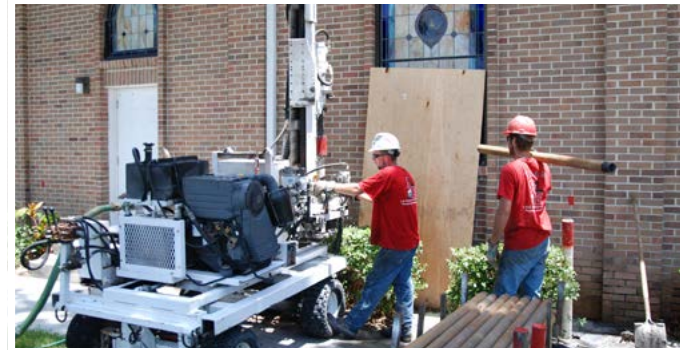
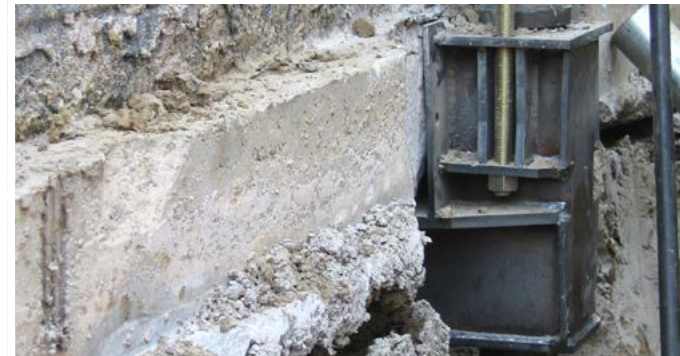
LONE OAK MISSIONARY BAPTIST CHURCH

The Sanctuary building constructed in 1983 experienced settling issues in 2009, mainly at the northeast quadrant of the building. An engineers investigation by another firm and repairs by another contractor were completed in July of 2009. Soon after this work was completed more settling was observed. West Coast Forensics Consulting Group, Inc. was hired to investigate and found the original repair was not adequate.

West Coast Forensics Consulting Group, Inc. recommended additional compaction grouting was needed to stabilize the deep soils. This was accomplished utilizing 50 grout points to an average depth of 85 feet. In addition it was recommended that the perimeter of the structure, the interior slab, load bearing walls and column footers be underpinned. This was accomplished with seventy-six (76) exterior 3" push piers to an average depth of 58 feet around the perimeter of the structure, two interior slab brackets to an average depth of 75 feet, and a total of thirty-four (34) 3" push piers with retrofit brackets at the load bearing walls and interior column footings. Upon completion of the underpinning, 1,000 lbs of polyurethane grout was installed to fill the voids below the slab and the underlying soils.

Products Installed 133 Total Piers: (23) Interior slab brackets and (34) retrofit brackets at the load bearing walls and the interior column footers to an average depth of 75 feet.

Exterior: (76) push piers to an average depth of 58 feet.

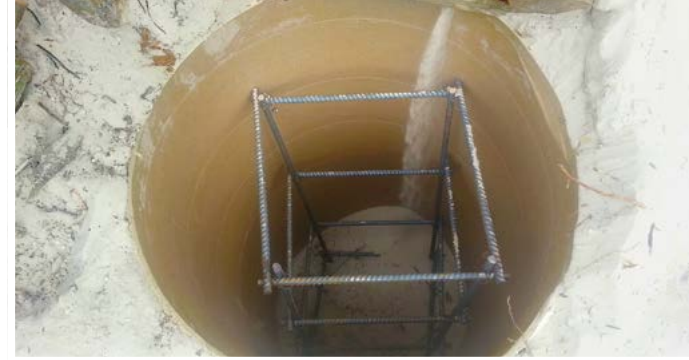
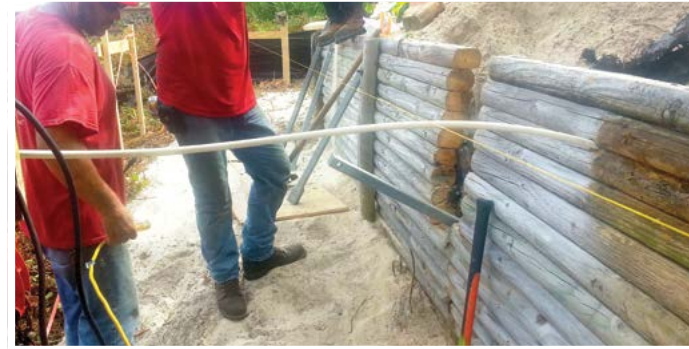
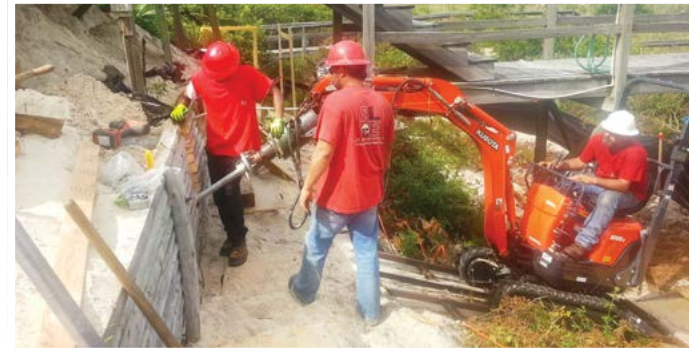
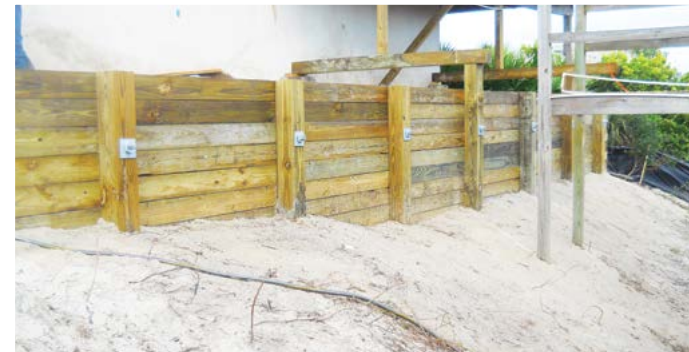
TIEBACK ANCHORS AND RETAINING WALL

A property owner living on the beach in St. Augustine was experiencing pool shell movement due to loose soil conditions. The sandy conditions were causing the pool shell to move towards the water, inflicting damage to the pool shell and putting the entire pool and deck in jeopardy. A retaining wall already existed, but it was not providing adequate support.

The engineering firm that investigated the sliding pool shell determined that the existing retaining wall needed to be replaced and tieback anchors needed to be installed in order to combat the soil instability and loose sands. L.R.E. was hired to install 11 tieback anchors for the project. In addition, L.R.E. poured individual footer columns for footer posts in the sand and constructed a new 75 linear foot retaining wall. These efforts permanently stabilized the pool shell.

Products Installed: Individual footer columns for footer posts in the sand. Eleven (11) FSI 150 Helical Square Bar Tieback Anchors installed. Seventy-five (75) foot retaining wall constructed.

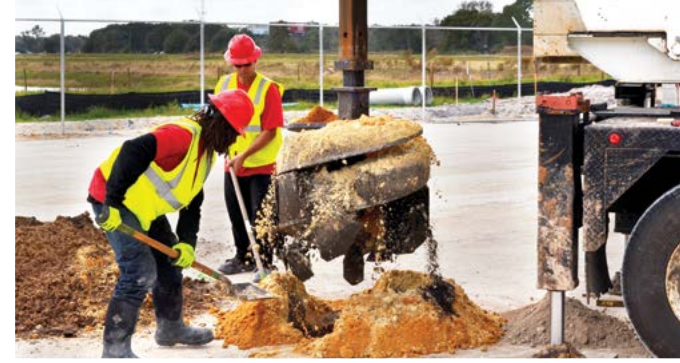
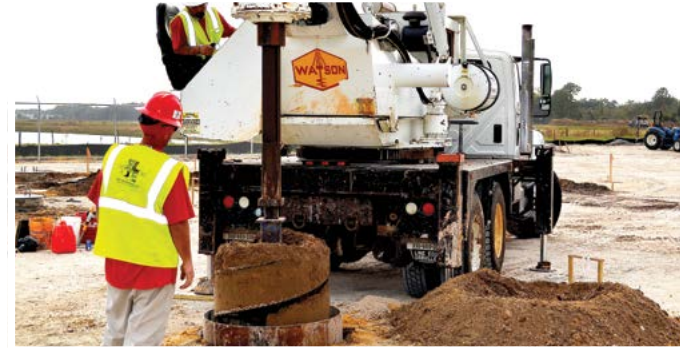
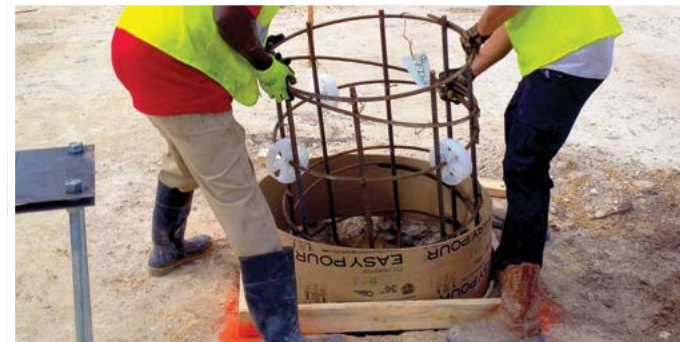
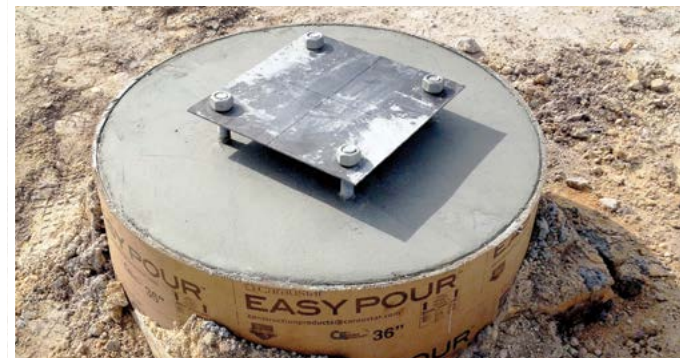
WITHLACOOCHEE RIVER ELECTRIC SUBSTATION

Due to the rapid growth in the Wesley Chapel area, Withlacoochee River Electric Company needed to build a new substation to generate, transmit and distribute additional electric for the larger population. The high water table, poor soil conditions and lateral capacity of the structure required large diameter Drilled Shafts to be installed so the structure could be bolted directly to the piles.

L.R.E. Ground Services, Inc. was called on to install Drilled Shafts. These were used to combat the light compression loads combined with the tension and lateral loads in order to resist wind conditions and add stability to the substation once it was built. It was critical to have an experienced and competent contractor perform the work to ensure that the bolt patterns were to the exact specifications of the engineer as the room for tolerance was less than ¼ inch. L.R.E. installed 36" and 48" diameter Drilled Shafts to depths of up to 12 feet. These bolted the substation directly to the piles. Drilling fluid was used to maintain the holes' stability throughout the process because of the poor soil conditions and high water table. Roughly 40 cubic yards of concrete were pumped into 21 piles to successfully complete the project.

Drilled Shafts: 21 Drilled Shafts that included 36" to 48" diameters. This project also required a total of 21 steel cages and approximately 40 cubic yards of concrete.

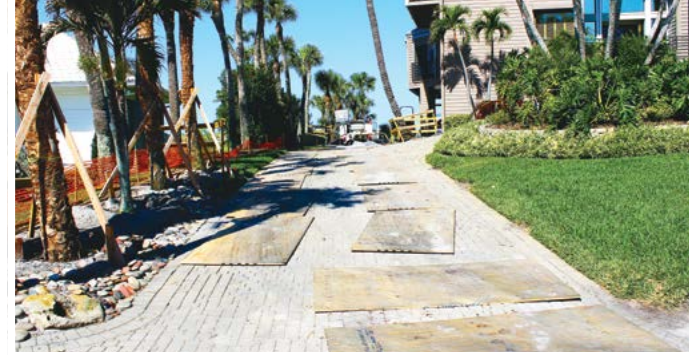
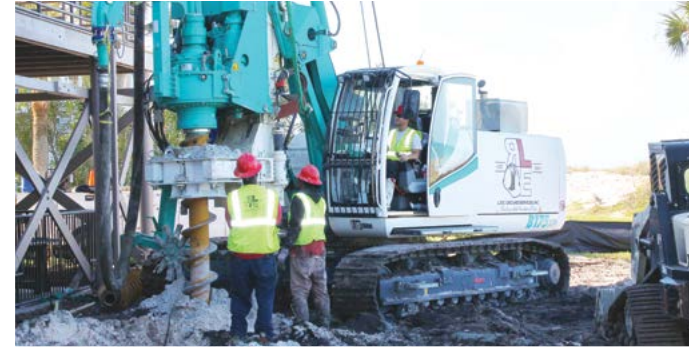
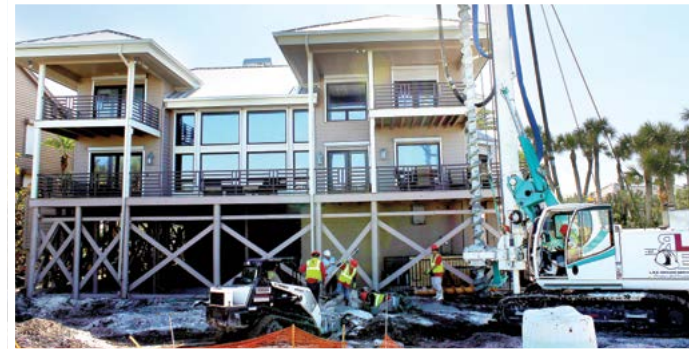
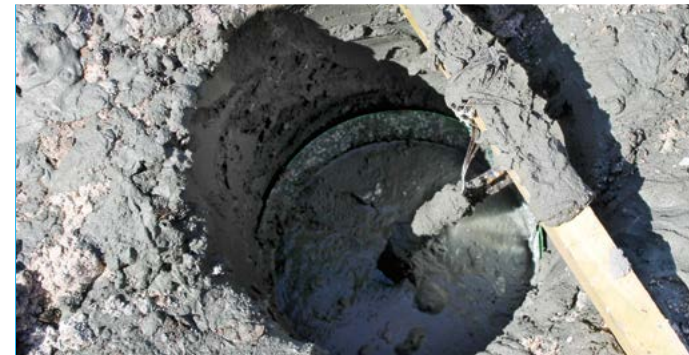
ELEVATED POOL DECK PROJECT

A property owner on Clearwater Beach wanted to build a pool on an elevated pool structure to enjoy the beachfront view and avoid any potential storm surges that could arise from inclement weather. The property owner wished to replicate the elevated pool concept that was inspired by one of the surrounding property owner's structures. L.R.E., which was hired to install Auger Cast Piles, faced the difficult task of combating limited accessibility and constricted work space while installing a total of 21 piles.

L.R.E. mobilized its Casagrande B175XP Auger Cast rig for this particular project. The Auger Cast piles were needed to provide support, withstand scour and endure coastal weather conditions. The B175XP rig proved to be instrumental in overcoming limited and tight access challenges. While the 16-inch, 35-38 foot piles were not a challenge for the rig, L.R.E. still utilized its Jean Lutz Data Acquisition system to provide quality assurance that the perfect pile was installed each time. The final outcome was 21 successful Auger Cast piles with data printouts of each pile and a clean worksite that allowed the general contractor to work on the next phase of the project.

Auger Cast Piles: 21 Auger Cast Piles installed to depths between 35 feet and 38 feet. Each pile was 16 inches in diameter and used pile protection tops and single #9 rebar.

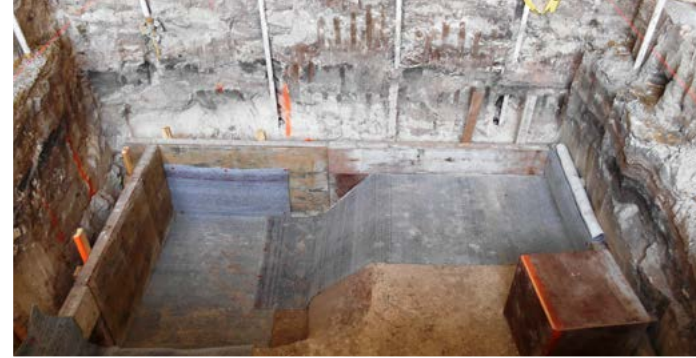
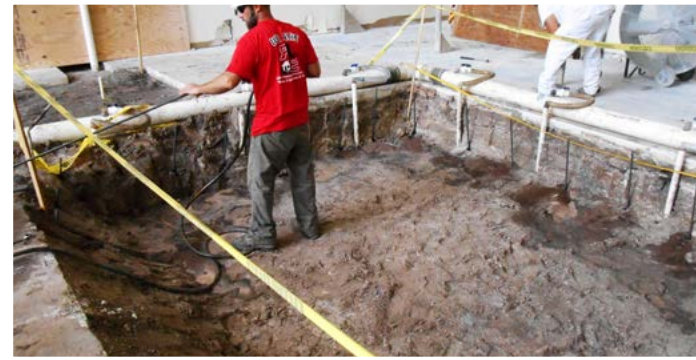
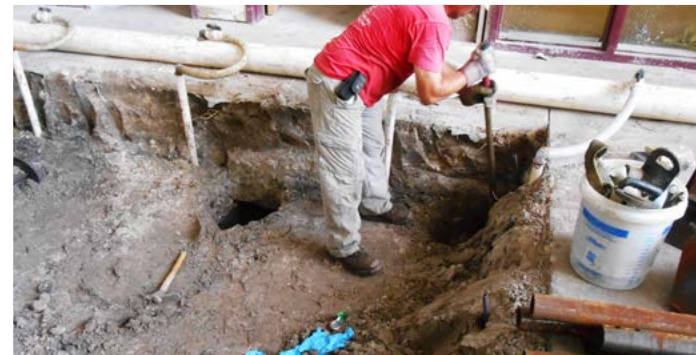
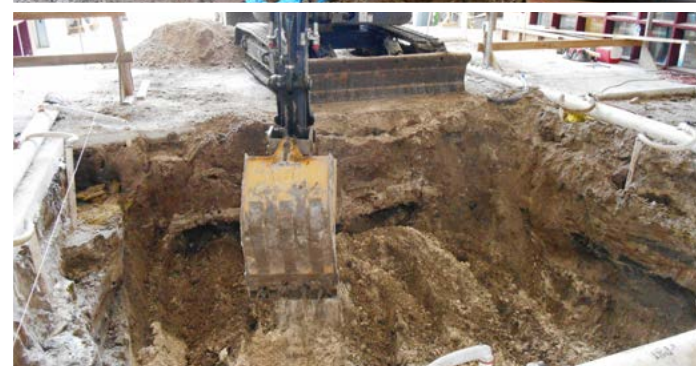
PASCO SCHOOL ADMINISTRATION

Products Installed: FSI permeation grout and (2) FSI-288 helical piers with an 8"-10" helix configuration
