Guidance document on parapet walls

**BD2452 – Safety of Masonry Parapets**

BRE

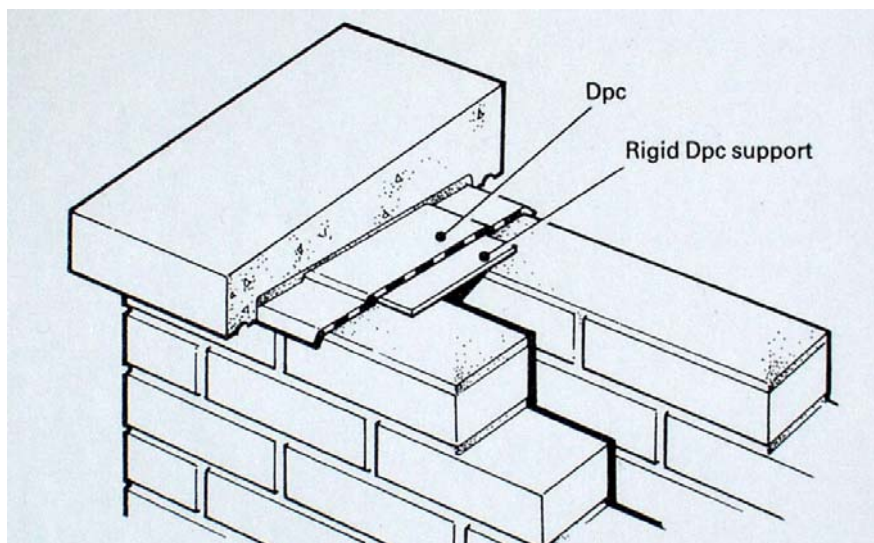
**Figure 2 Damp proof membrane on rigid support**

- A continuous damp proof course should be specified.
- All joints in the damp proof course should be overlapped by a minimum of 150mm and sealed.
- The damp proof course membrane should be supported across the top of the cavity with a rigid support such as slate or a suitably stiff plastic material, see Figure 2.

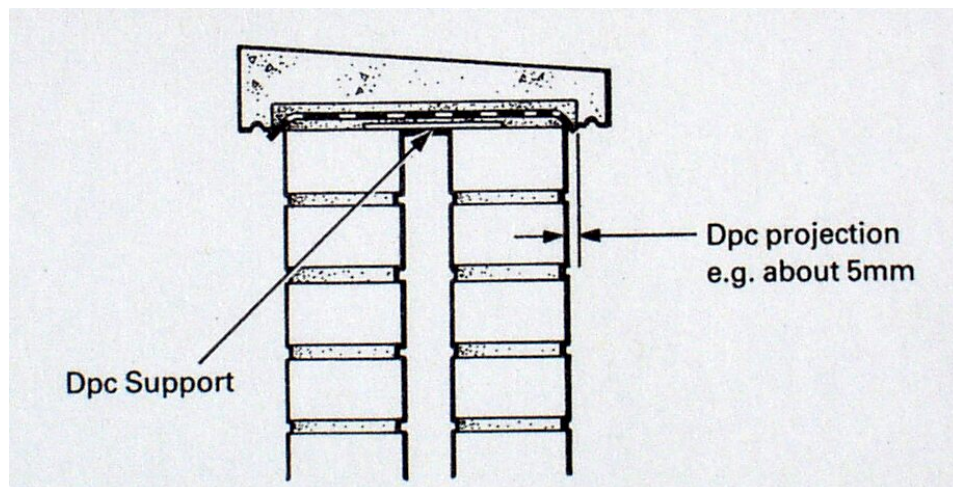
**Figure 3 Damp proof membrane extends beyond the brickwork**

- The damp proof course and its support should be bedded on fresh mortar.
- Damp proof course membrane should extend at least 5mm beyond each face of the parapet wall, see Figure 3.

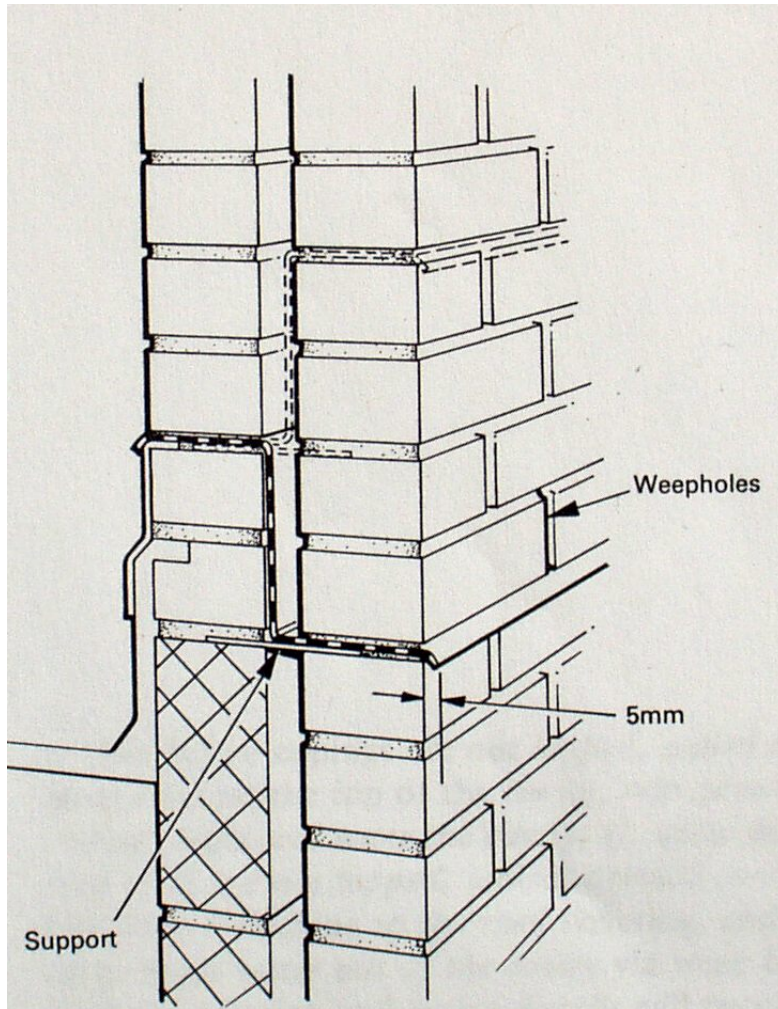
**Figure 4 Cavity tray dressed down and supported across the cavity**

- The step down of the cavity tray at the base of the parapet wall should be at least 150 mm towards the inner or outer face. The cavity tray should project at least 5mm from the finished surface of the wall in order to provide an adequate drip detail. If water is direct across the inner leaf there is an additional risk of water penetration to the roof perimeter junction, and the inner leaf.

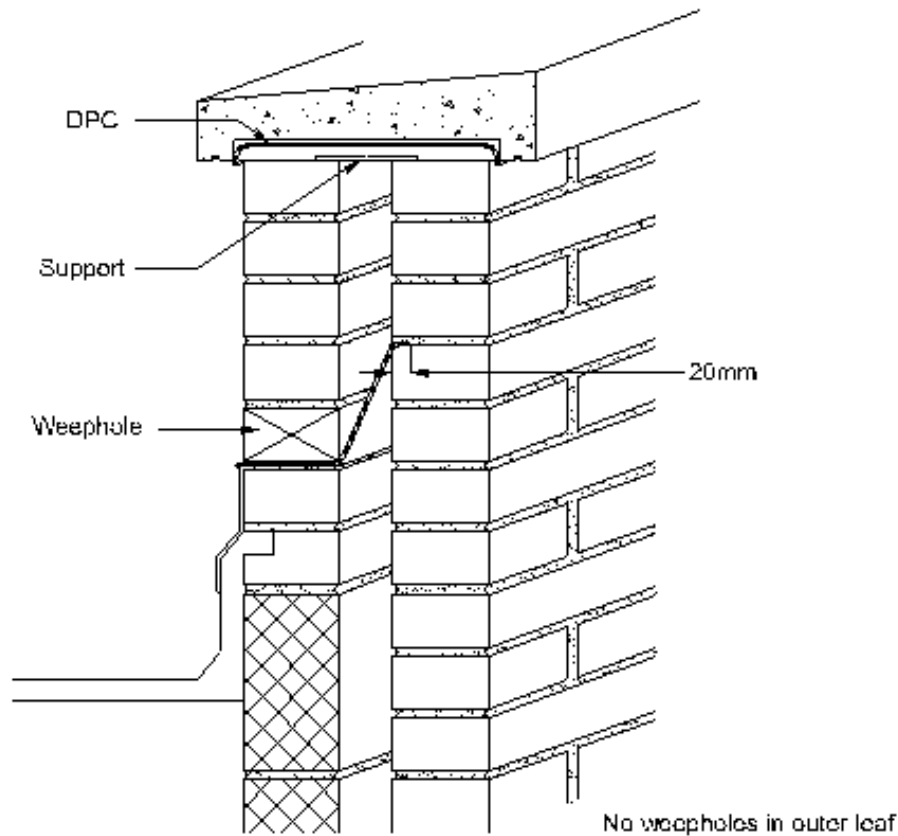
**Figure 5 D.p.m. with limited insertion into the outer leaf dressed down and supported across the cavity**

- The presence of a cavity tray introduces a plane of weakness at the base of the parapet wall. An alternative solution is to use a d.p.m. that is fully bedded in the inner leaf but only embedded to a depth of 20mm in the outer leaf - there may be proprietary cavity tray systems that offer a similar solution. This form of construction can be seen in Figure 5. An advantage this configuration confers is that it allows water to pass down through the outer leaf, eliminating the need for weepholes at this level and reducing the level of dampness in this section of the outer leaf of the parapet - a perennial problem with parapet walls. Although this might, to some extent, be seen as compromising the waterproofing, it would only do so in the outer leaf - a part of the façade which is designed to cope with water draining down its cavity face. If this option is adopted, then F1, S1 or F1, S2 bricks may be used to construct the outer leaf of the parapet.

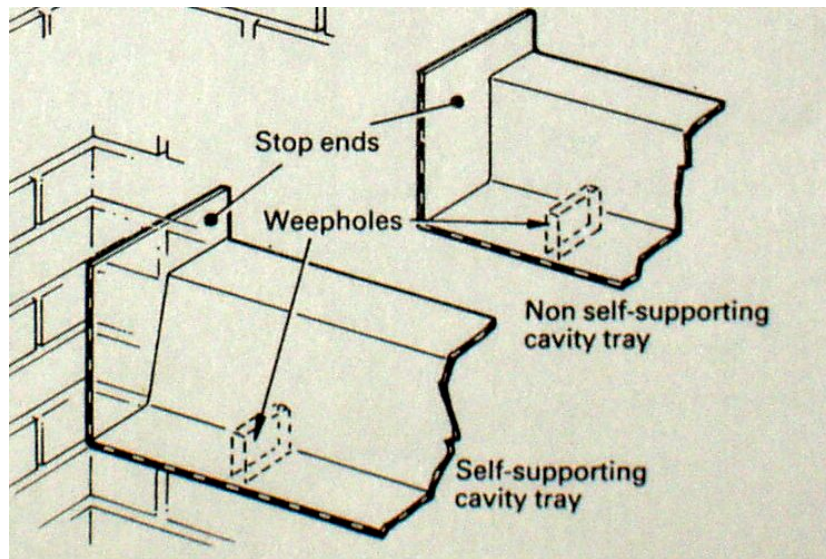
**Figure 6 Cavity tray stop ends at abutments**

- Damp proof membranes used to construct cavity trays should comply with BS 6398 or a material certificated by an acceptable third party should be used. The tray should be dressed down the inner leaf or outer leaf and supported across the cavity horizontally, Figure 4. Purpose made cavity tray units should be used at corners.
- Ensure that the material used to support the cavity tray damp proof membrane support is sufficiently rigid to prevent sagging.
- Ensure that the laps in the cavity tray are at least 150mm in length and sealed and that the cavity tray is fully supported and watertight and that any purpose made corner units are sealed to the tray lengths.
- Where the parapet abuts an adjacent wall a cavity tray with a stop end should be used, Figure 6.

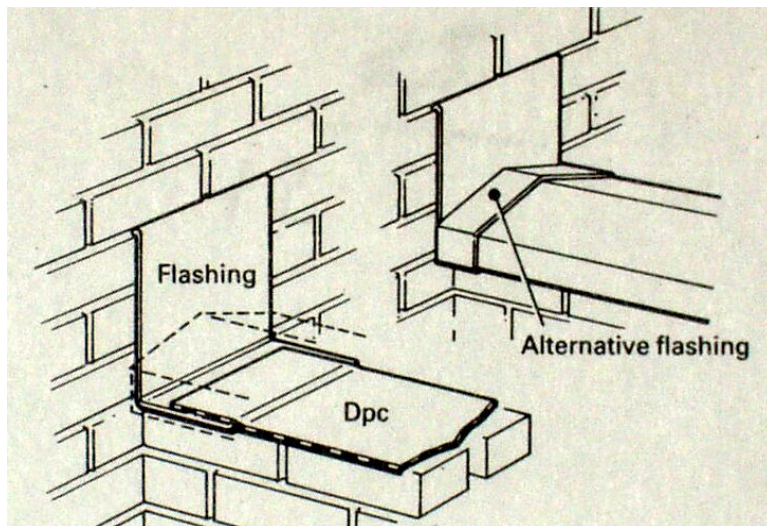
**Figure 7 Abutment flashings for upper damp proof membrane**

If the parapet abuts an adjacent wall a flashing should be installed, Figure 7.

- Alternatively purpose made weep holes or weep slots can be built in as work proceeds, but check what the specification requires.
- Ensure that the damp proof course and cavity tray extend beyond the rear face of the wall, Figure 7.

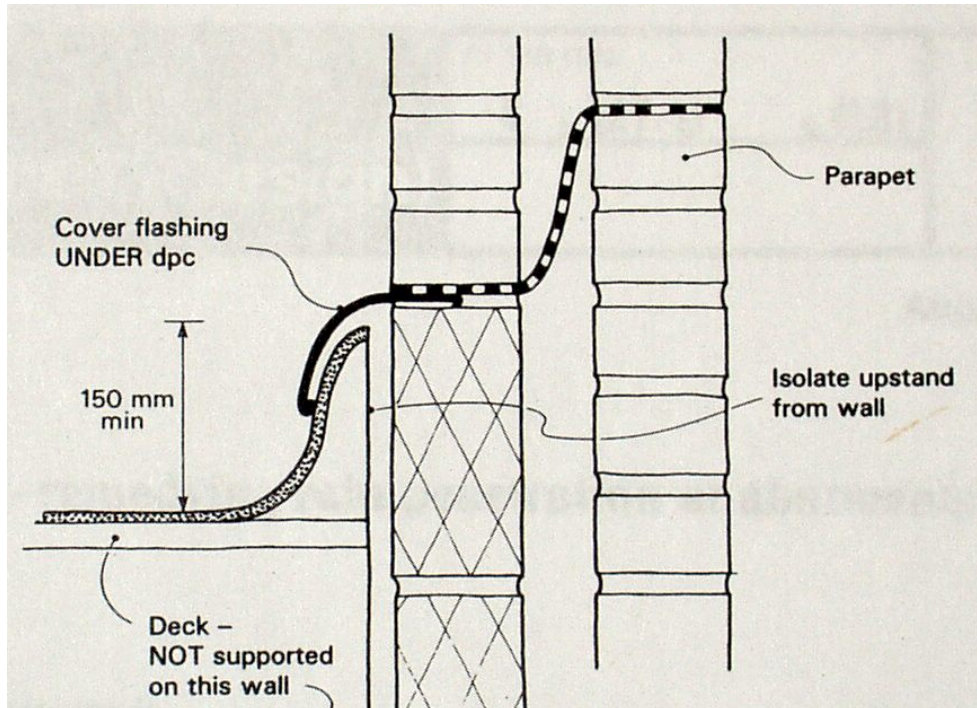
**Figure 8 Roof upstand and parapet wall detail**

- All upstands should be at least 150mm high above the finished roof level and well lapped by secure flashings.
- Flashings associated with the roof should lap under the parapet wall damp proof course. This especially important when the damp proof course forms a cavity tray that drains water towards the roof, Figure 8.

- Roof cover flashing should be well lapped by the cavity tray.
- Flashings associated with adjacent roof coverings should be set under the damp proof membrane.
