**HORIZONTAL DIRECTIONAL DRILL ANALYSIS
LEWISBERRY ROAD CROSSING
PADEP SECTION 105 PERMIT NO.: E67-920
PA-YO-0016.0000-RD-16
(SPLP HDD No. S2-0260-16)**

This reanalysis of the horizontal directional drill (HDD) installation of a 16-inch diameter pipeline that traverses Lewisberry Road in Fairview Township, York County, Pennsylvania, is in accordance with the Stipulated Order issued under Environmental Hearing Board Docket No. 2017-009-L for HDDs listed on Exhibit 3 of the Stipulated Order. This HDD is number 11 on the list of HDDs on Exhibit 3 of the Order.

The 16-inch pipeline HDD is referred to herein as HDD S2-0260-16.

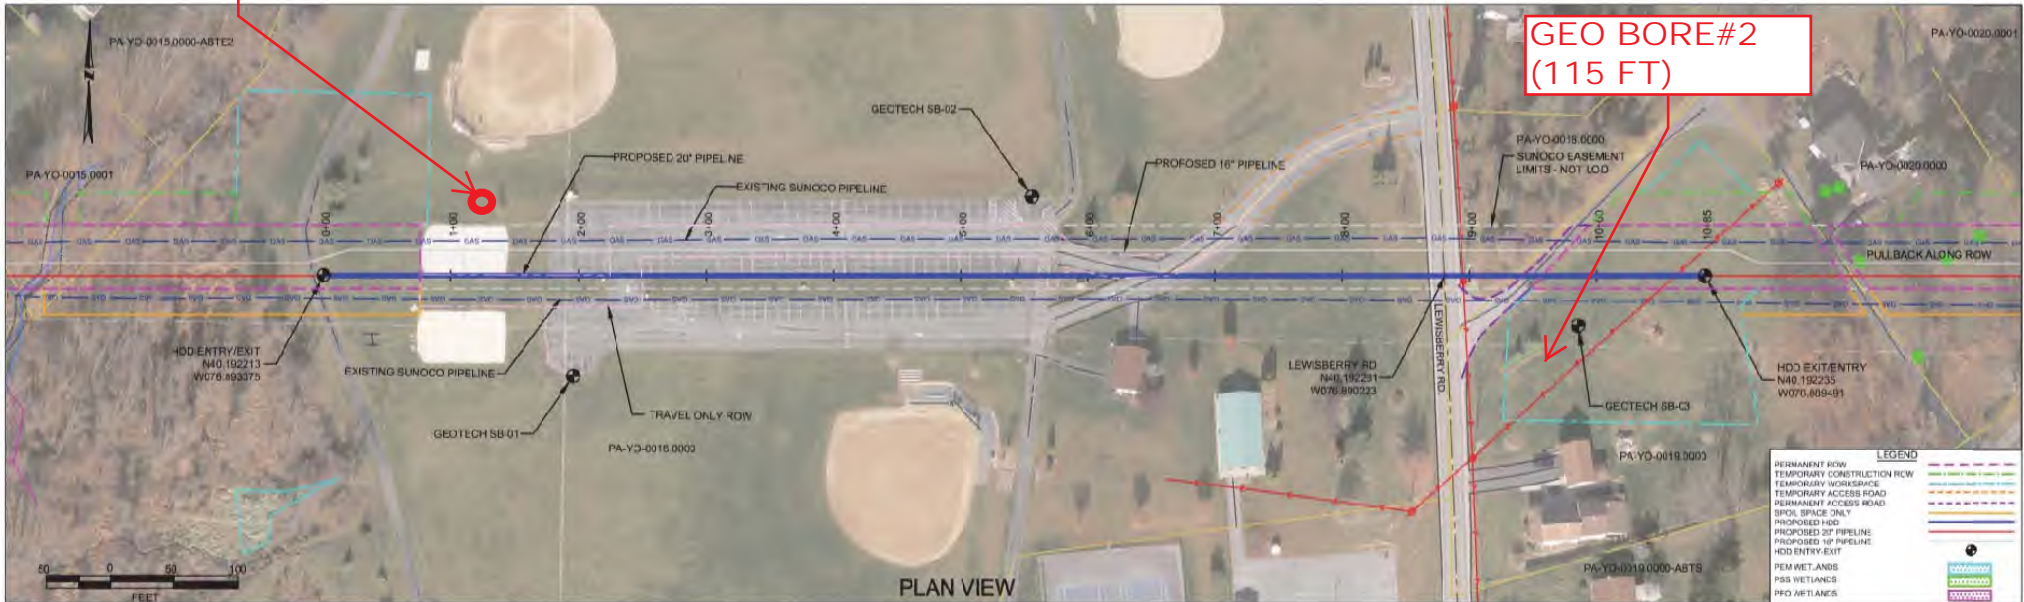
PROFILE VIEW

- GEO BORE#1**
 - NG EL. 523'
 - TOPSOIL (0' - 0.3')
 - ML (0.3' - 11.5')
 - GROUNDWATER (14.2')
 - SM (11.5' - 19.7')
 - ALGIER REFUSAL (19.7')
 - SANDSTONE (19.7' - 20.0')
 - COMPLETION DEPTH EL. 503'
- GEO BORE#2**
 - NG EL. 535'
 - TOPSOIL (0' - 0.5')
 - GROUNDWATER (14.0')
 - SM (0.5' - 25.0')
 - ALGIER REFUSAL (25.0')
 - SANDSTONE (25.0' - 33.0')
 - COMPLETION DEPTH EL. 502'
- GEO BORE#3**
 - NG EL. 557'
 - TOPSOIL (0' - 0.7')
 - SM (0.7' - 8.5')
 - GROUNDWATER (15.5')
 - ALGIER REFUSAL (15.5')
 - SANDSTONE (15.5' - 33.0')
 - COMPLETION DEPTH EL. 541'

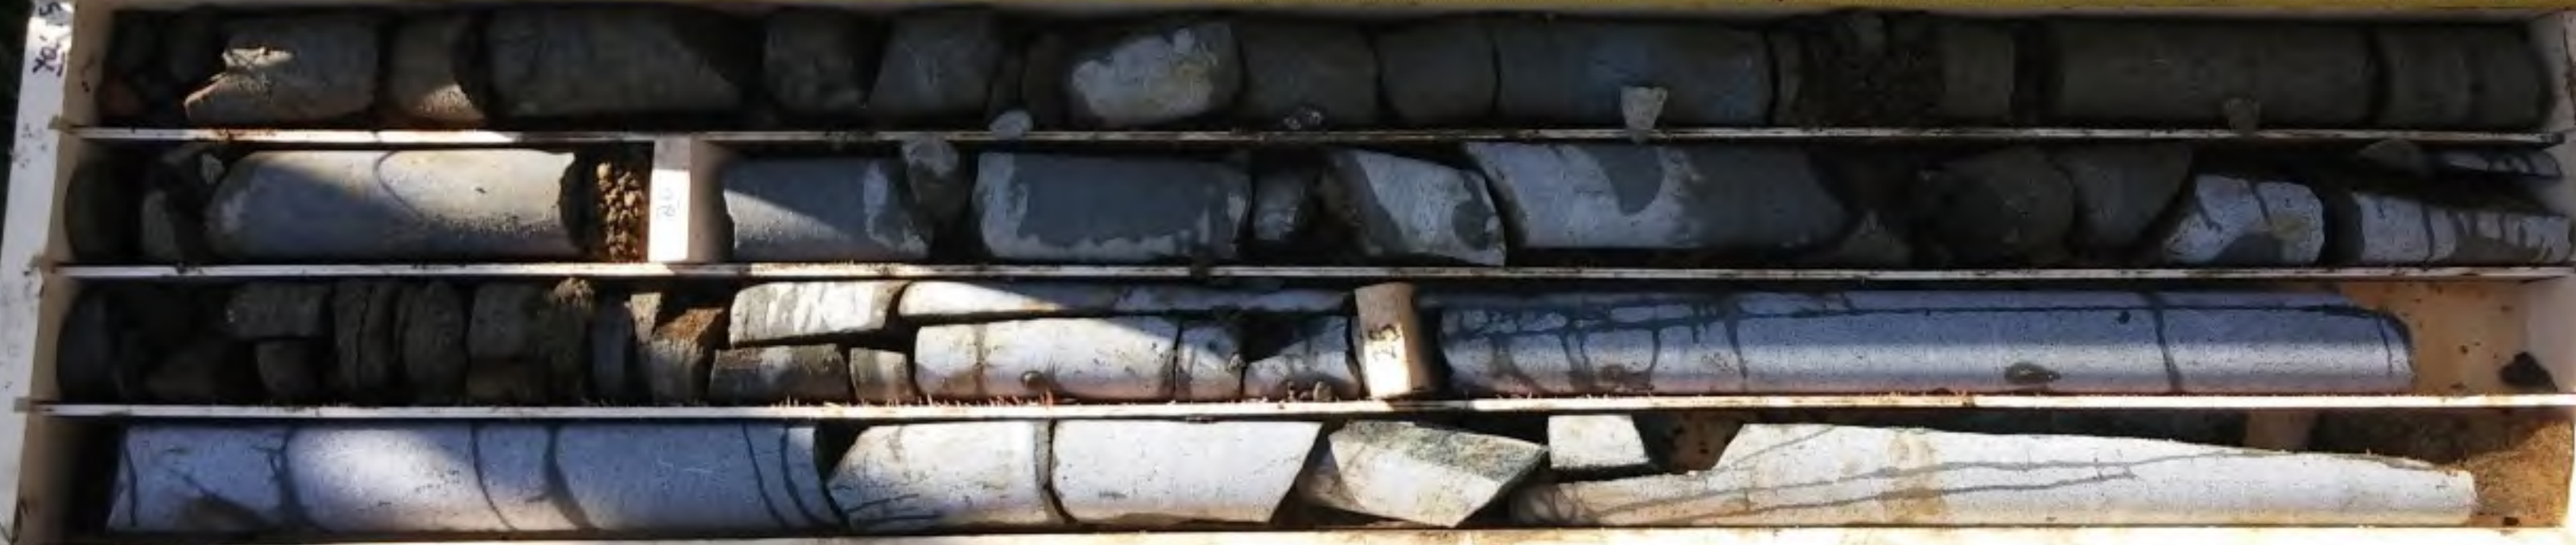
PPP#4
 04911463
 B-2
 9-8-17
 10-30
 Bot luf
 Lewkberry Rd.

Run	Depth(ft.)	Rec(in.)	Re2D(in.)
R-1	10-15	6" (clay)	
R-2	15-20	56	17
R-3	20-25	60	11
R-4	25-30	60	34

The bedrock in both borings was described as ranging from moderately hard to extremely hard, and broken to massive. Photographs of the cores obtained from borings B-1 and B-2 are included in **Attachment 2**.

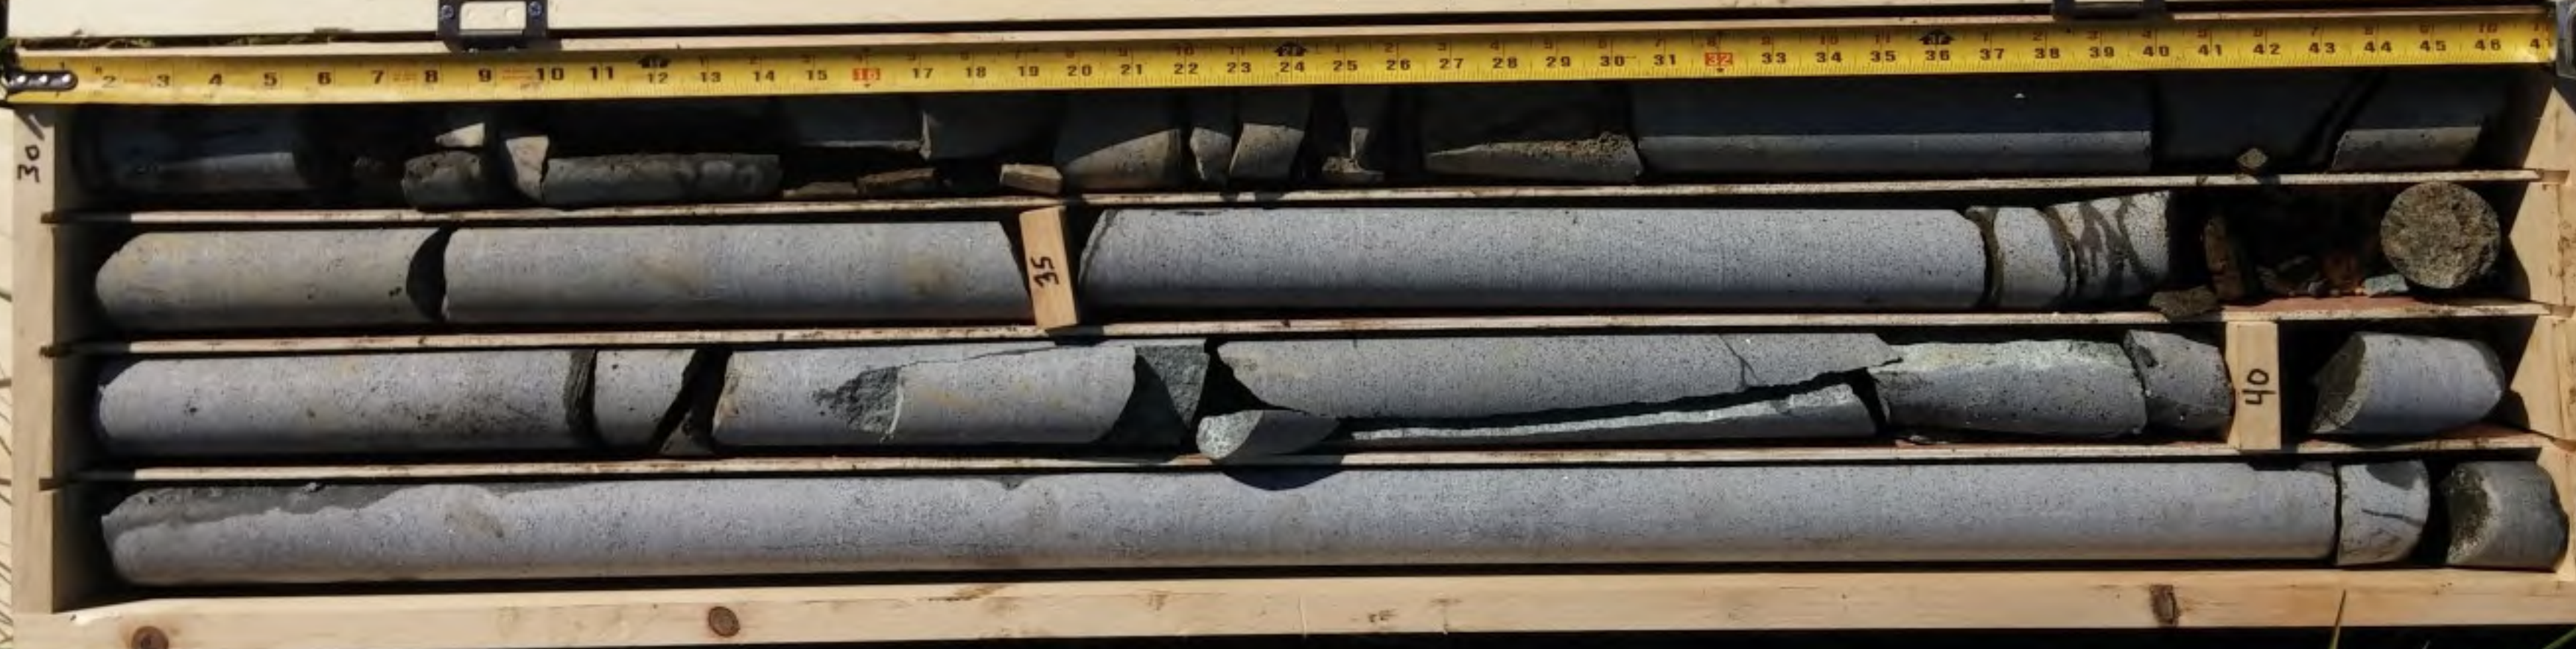
PPP#4
04911463
B-2
9-8-17
30-44.9
Box 2 of
Lewisberry Rd.

RUN	Depth (ft.)	Reccin)	R&D (in.)
R-5	30-35	60	26.5
R-6	35-40	60	25.5
R-7	40-45	60	51.5

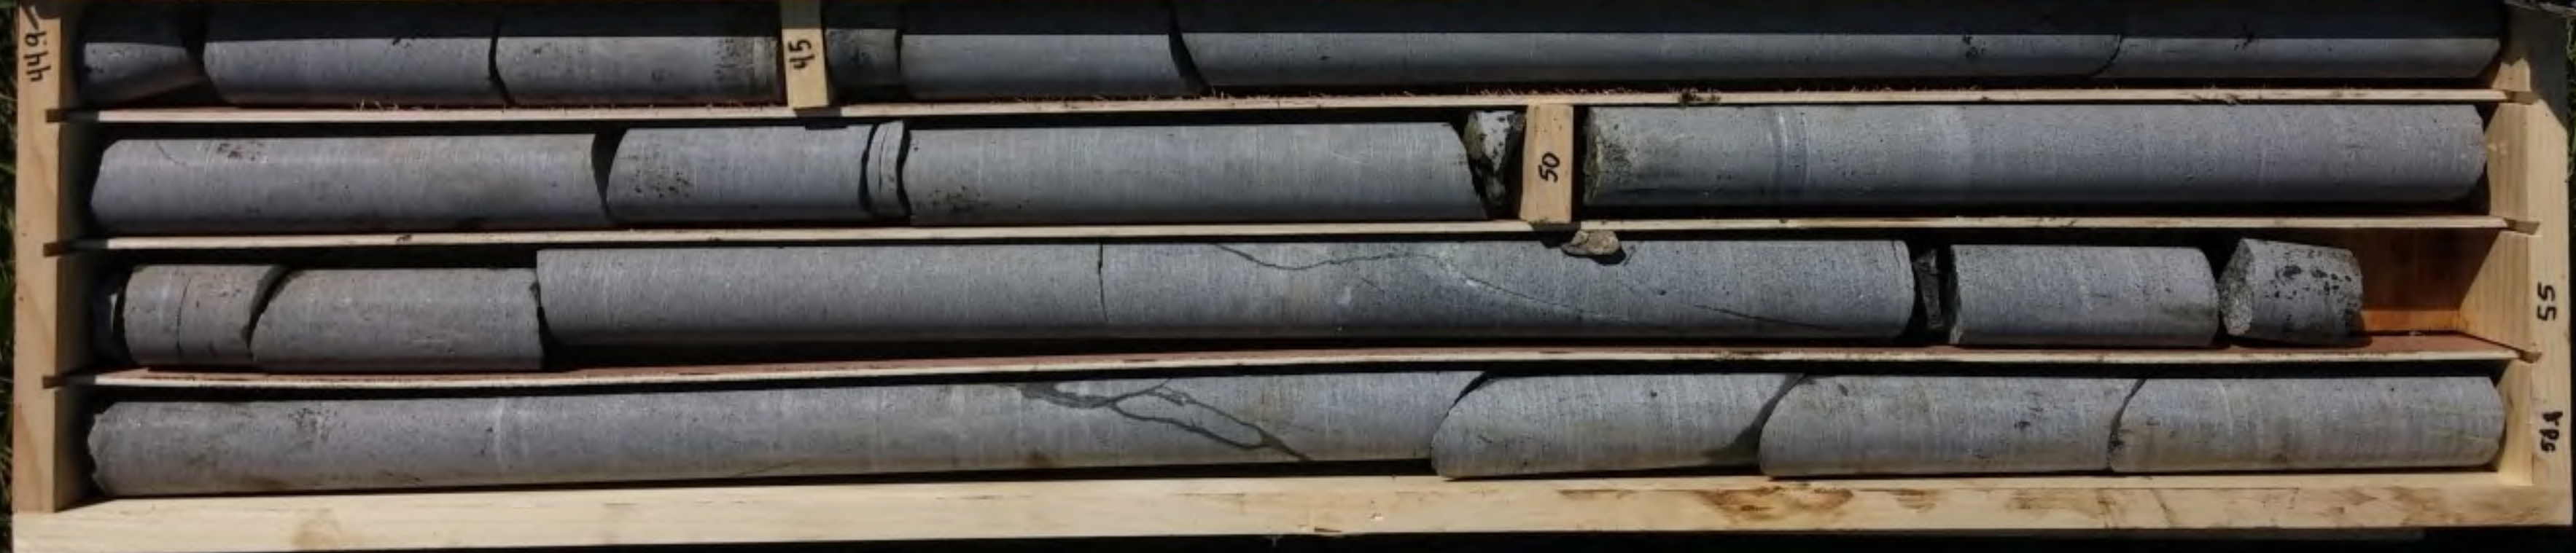
70004
04911463
B-7
9.8.17
449-588
Box 3 of
Lewisberry Rd.

Run	Depth (ft.)	Rec (in.)	R.G.D (in.)
R-8	45-50	60	54
R-9	50-55	60	53
R-10	55-60	60	55.5

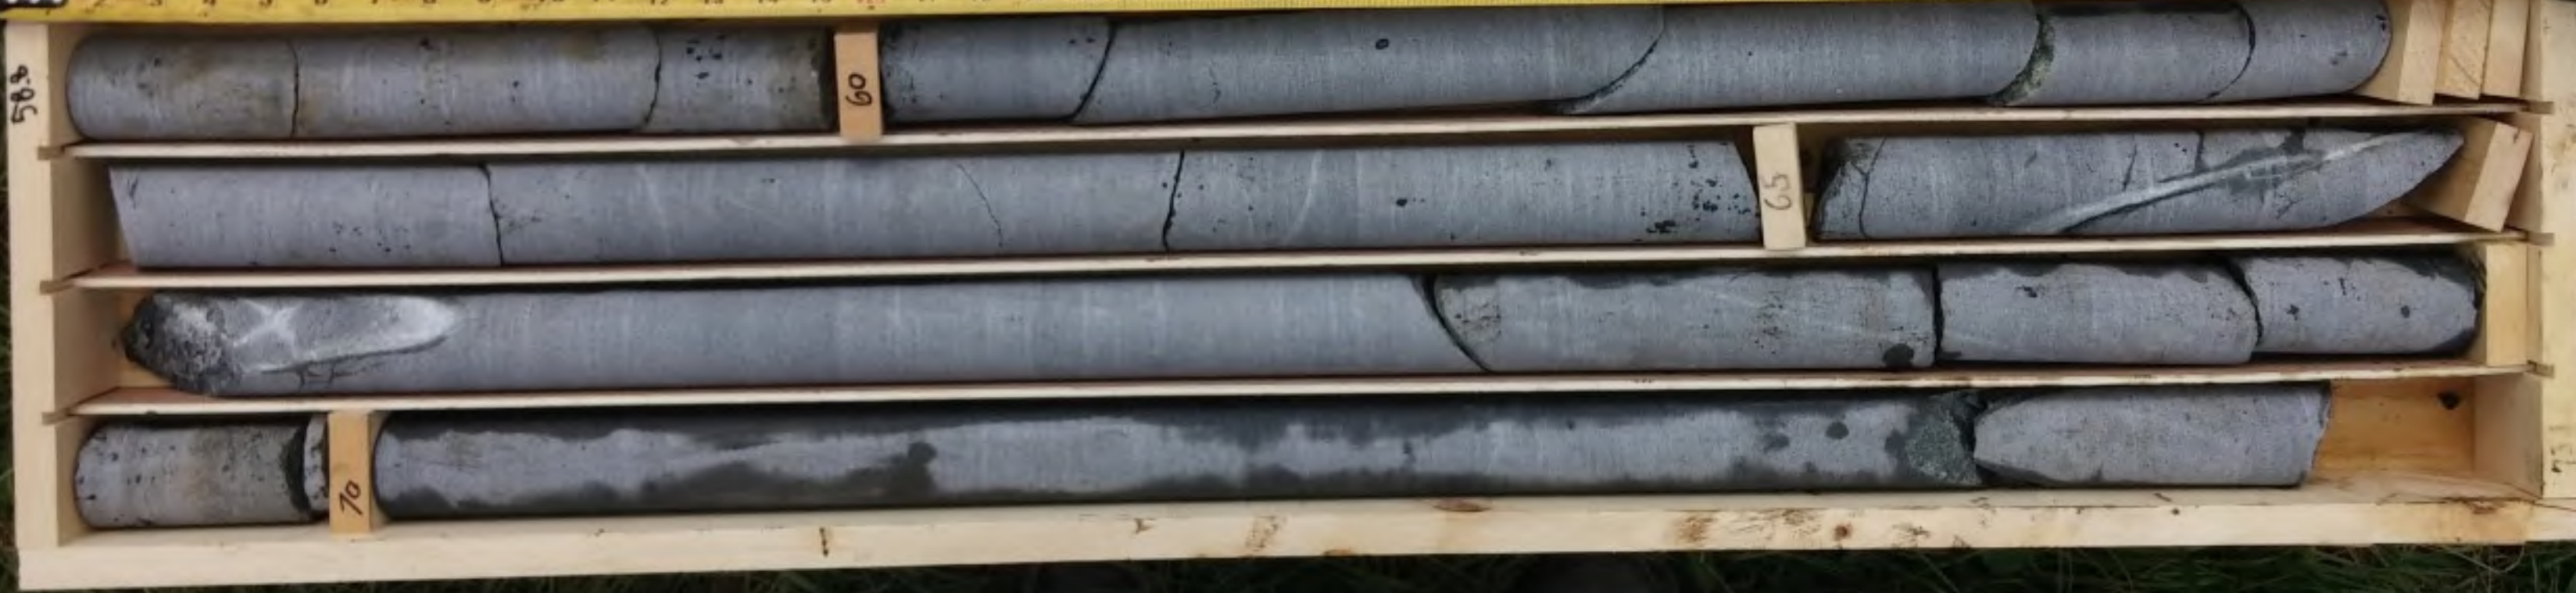
PPP#4
04911463
B2
9.8.17
58.8-73.1
Box 4 of
Lewisberry Rd.

RUN	Depth (ft.)	Rec (in.)	R&D (in.)
R-11	60-65	60	45
R-12	65-70	60	58
R-13	70-75	60	57.5

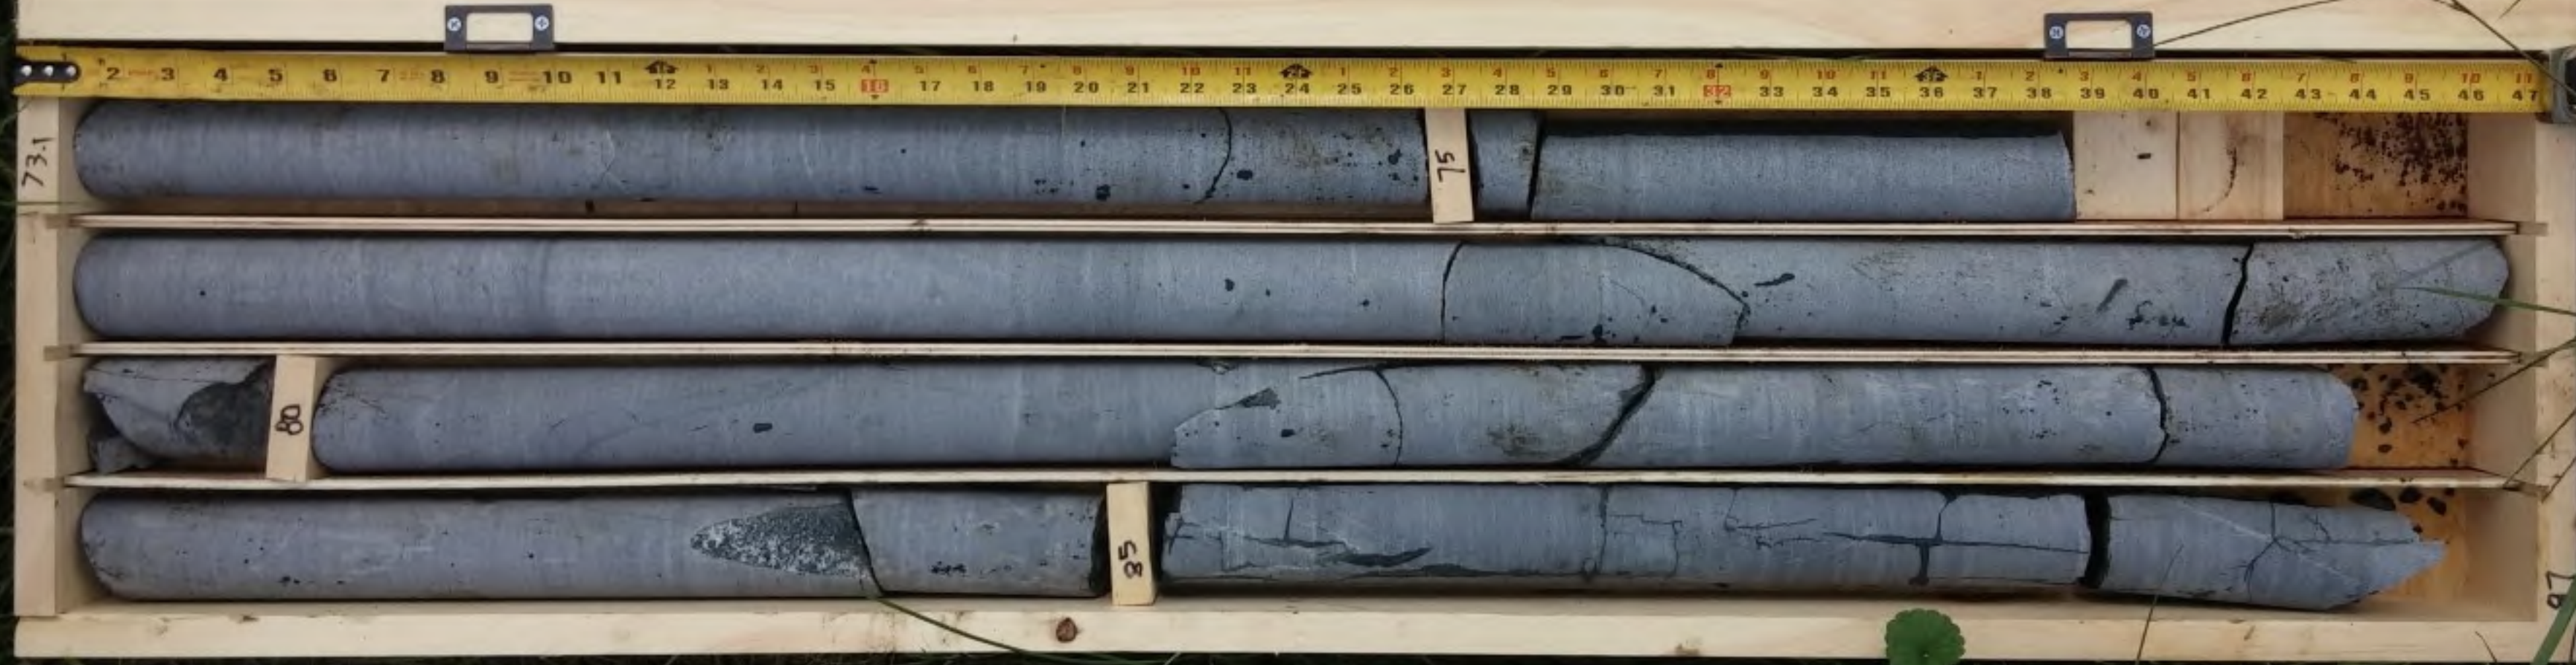
Box 5 of
Lewisberry Rd.

RUN	Depth (ft.)	Rec (in.)	RQD (in.)
R-14	75-80	60	53
R-15	80-85	58	45
R-16	85-90	60	46

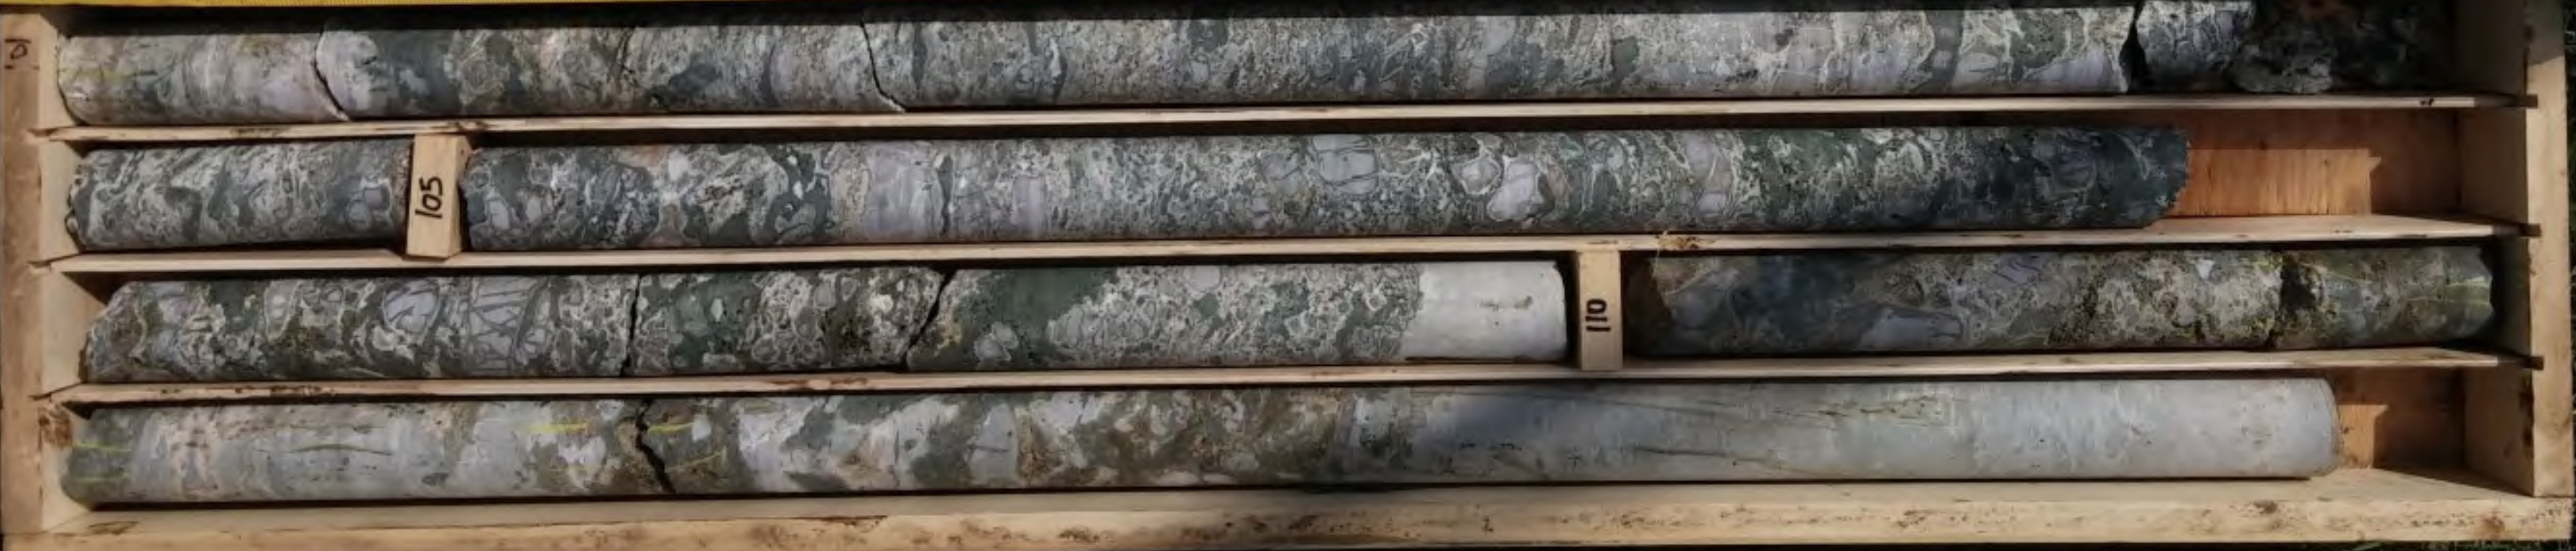
PPP#4
04911463
B-2
9.8.17
101-115
Box Tot
Lewisberry Rd.

RUN	Depth(ft.)	Rec(in.)	R&D(in.)
R-20	105-110	60	59
R-21	110-115	60	60

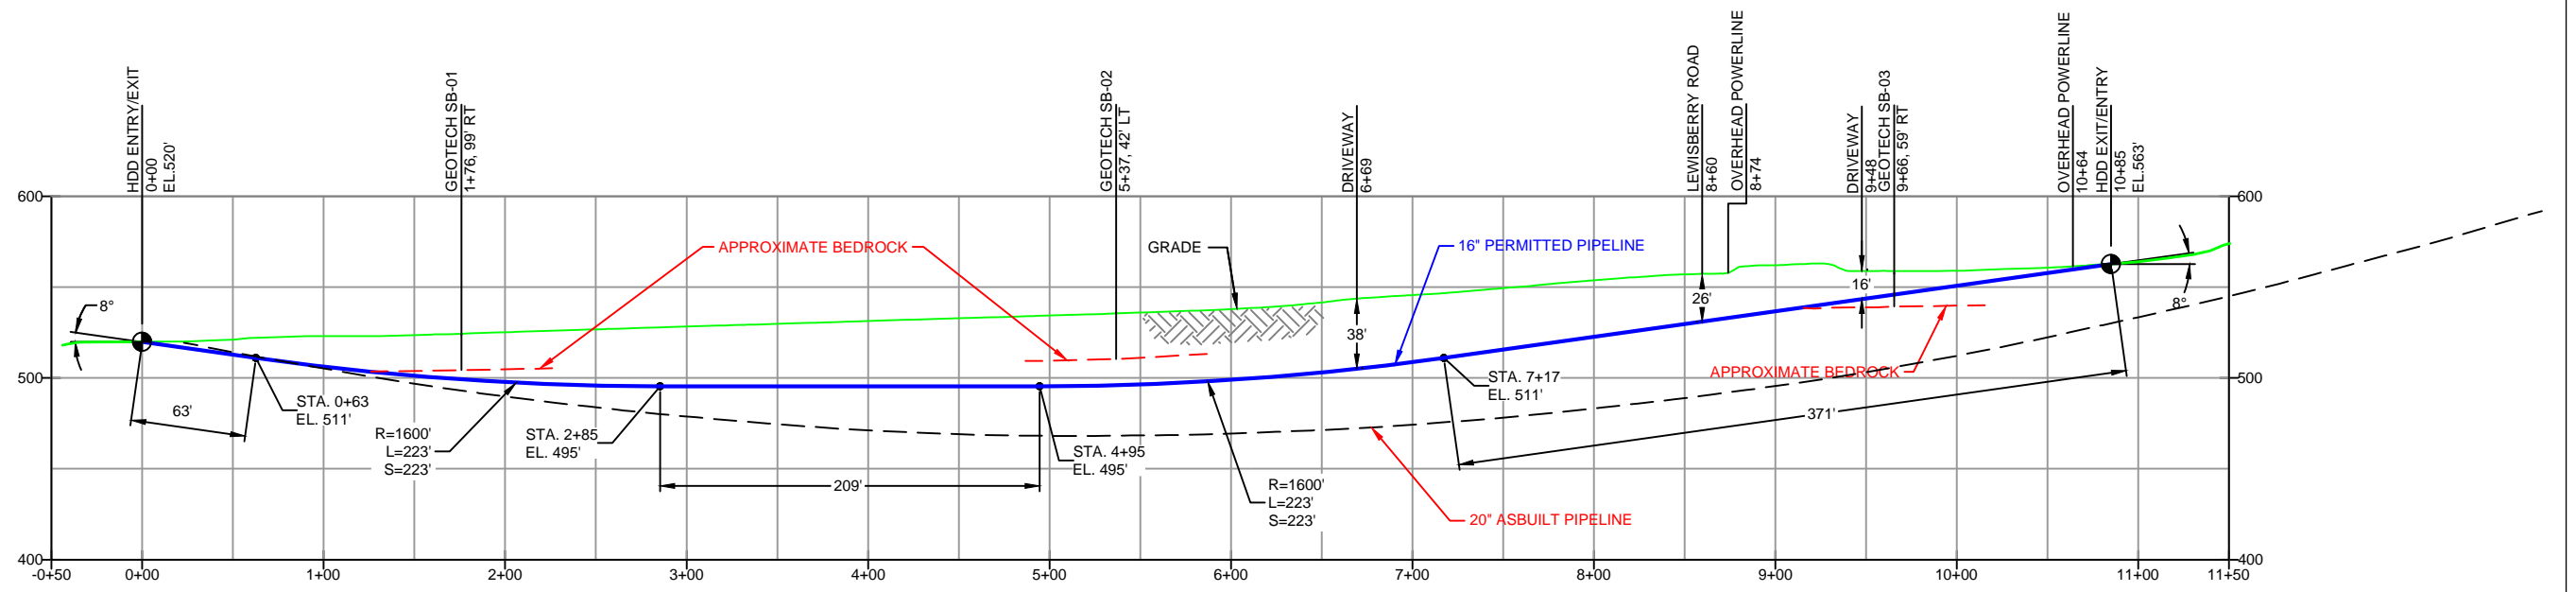
SCALE: 1"=100' DWG. NO. PA-YO-0016.0000-RD-16

PLAN VIEW
PROFILE VIEW

- DESIGNED IN ACCORDANCE WITH CFR 49 195 & ASME B31.4
 - CROSSING PIPE SPECIFICATION:
HDD HORZ. LENGTH (L=): 1085'
HDD PIPE LENGTH (S=): 1089'
16" x 0.438" W.T., X-70, API5L, PSL2, ERW, BFW
COATING: 14-16 MILS FBE WITH 30-35 MIL ARO (POWERCRETE OR ENGINEER APPROVED EQUAL)

- Horizontal length: 1,085 feet (ft)
- Entry/Exit angle: 8 degrees
- Maximum Depth of cover: 38 ft
- Pipe design radius: 1,600 ft

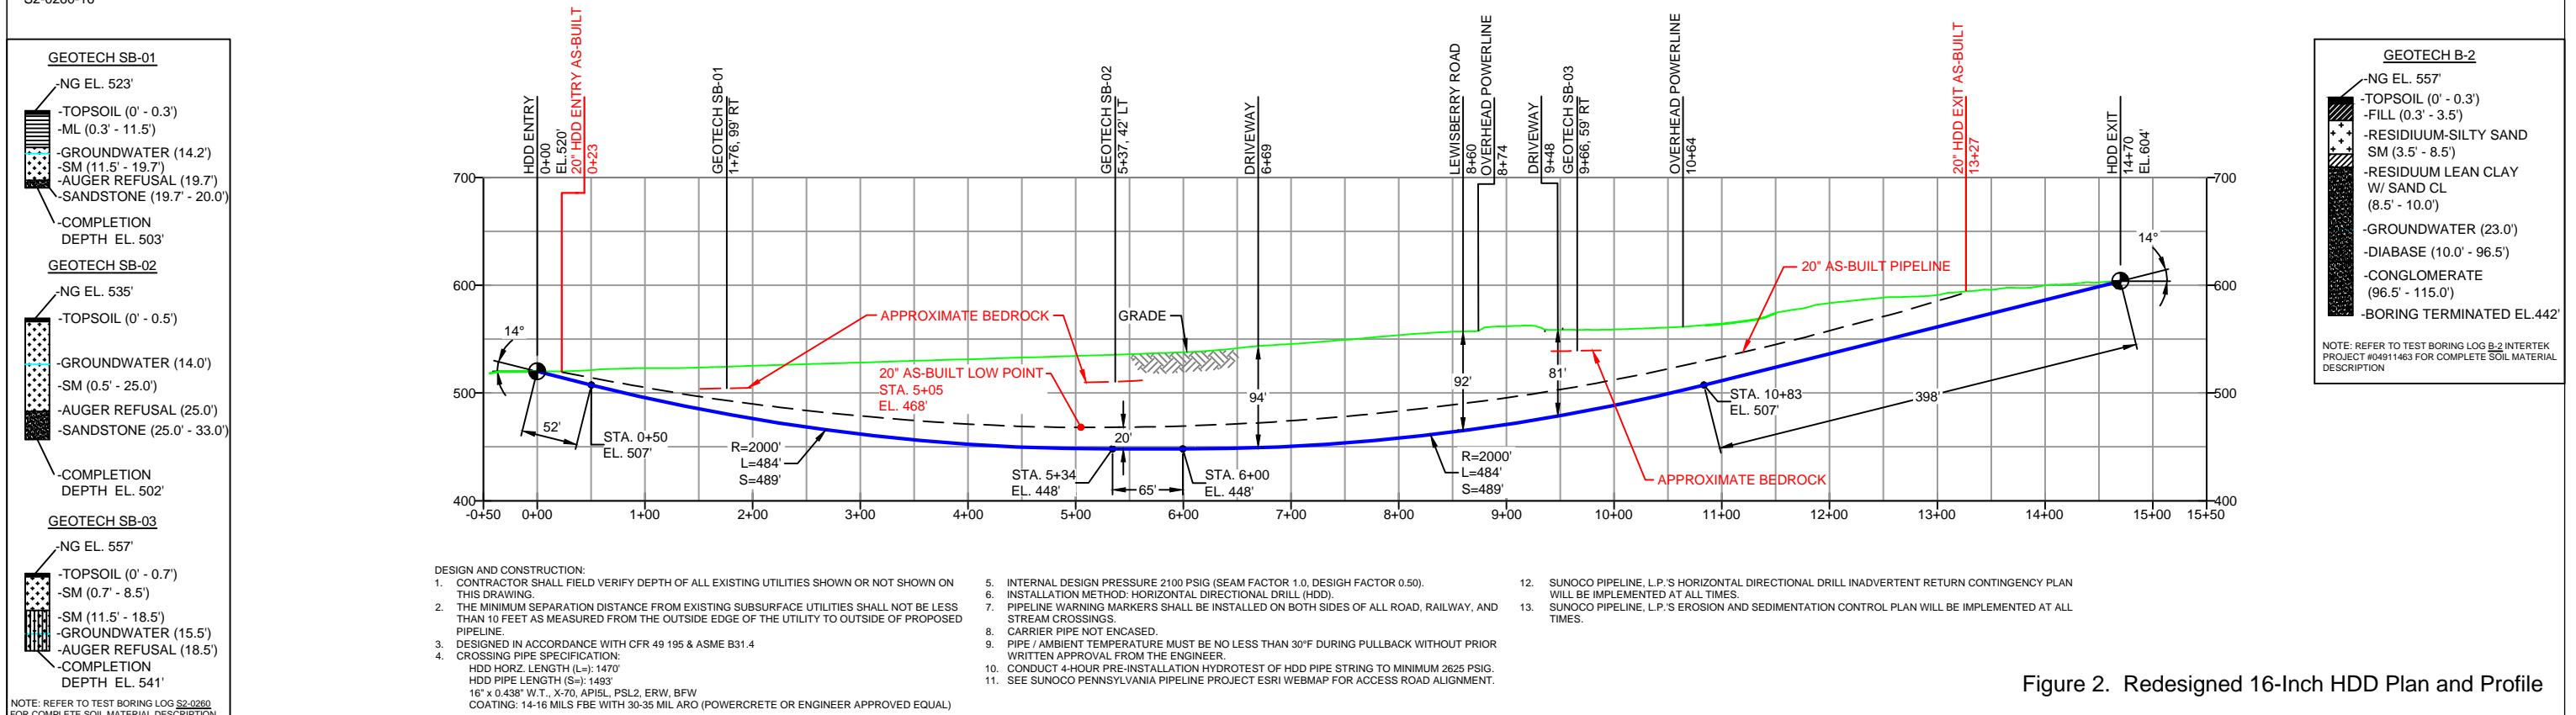
Figure 2. Redesigned 16-Inch HDD Plan and Profile

PROFILE VIEW
