Troubleshooting DTC P1456 and P1457

(Supersedes 99-040, dated August 9, 2013, 1999, to revise the information marked by the black bars)

VEHICLES AFFECTED

- 1997-03 CL
- 1996-01 Integra
- 2001-04 MDX
- 1997-05 NSX
- 1996-04 RL
- 1999-03 TL

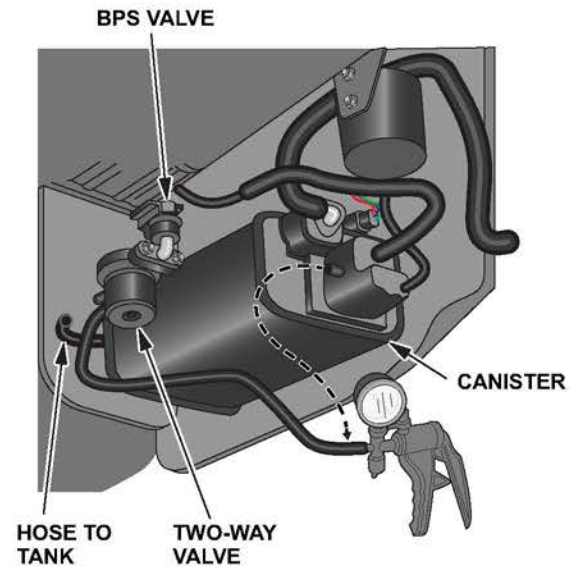
- Connect a vacuum pump to the canister side two-way valve hose.

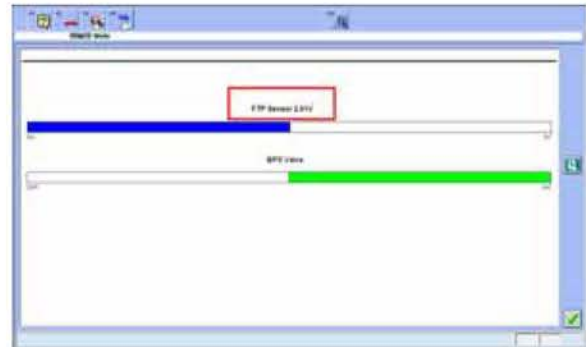
- Apply about 5 in.Hg of vacuum to the system.
- Enter the HDS PGM-FI menu, and select INSPECTION> EVAP TEST> SINGLE SOLENOID> BYPASS SOLENOID. Click the green check box to turn ON the BPS valve.

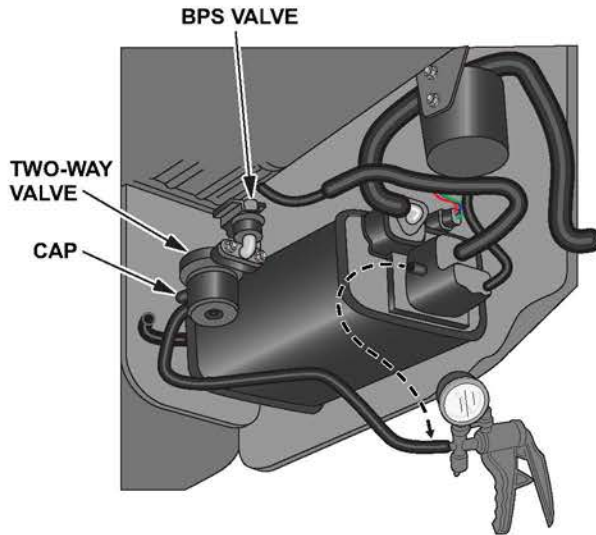
5. Test the EVAP two-way valve.
 - Make sure the BPS valve is still commanded ON with the HDS.
 - Cap the open hose fitting on the two-way valve.

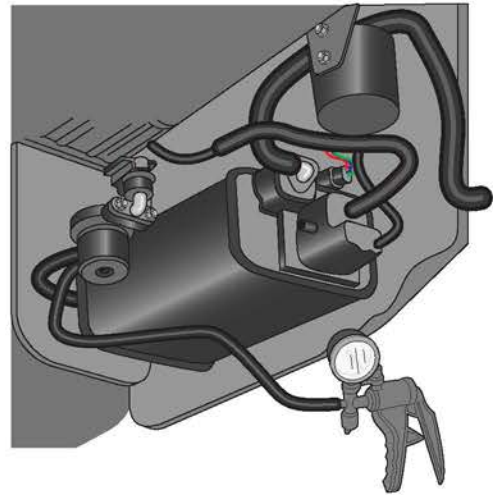
- Reconnect the vacuum pump.

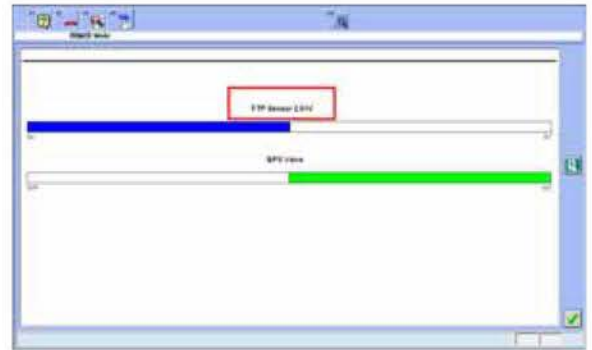
- Enter the HDS PGM-FI menu, and select **INSPECTION> EVAP TEST> SINGLE SOLENOID> BYPASS SOLENOID**. Click the green check box to turn ON the BPS valve.

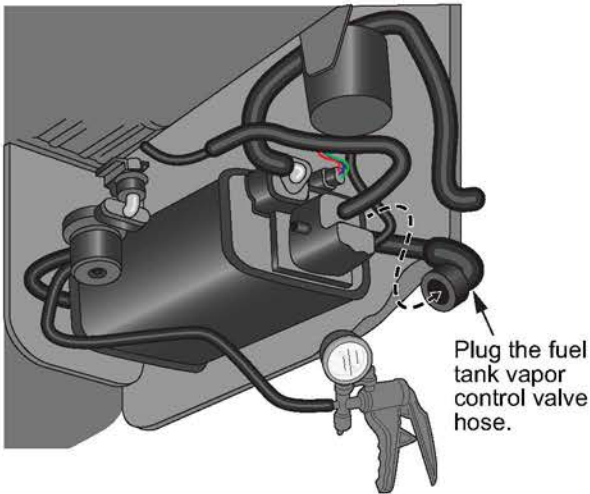
7. Test the fuel tank vapor control valve.
 - Make sure the BPS valve is still commanded ON with the HDS.
 - Disconnect the fuel tank vapor control valve hose from the canister, and plug the opening.

No – The fuel tank vapor control valve is leaking. Replace the fuel tank vapor control valve, then go to step 10.

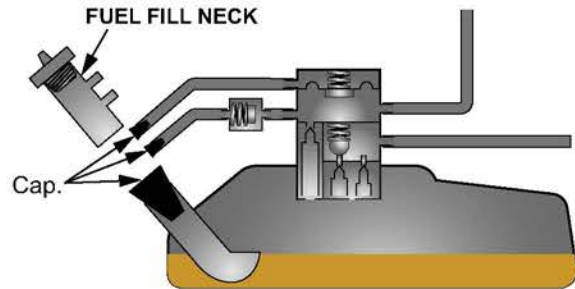
8. Isolate the fuel fill neck and fuel cap.
 - Make sure the BPS valve is still commanded ON with the HDS.
 - Disconnect the three hoses connected to the fuel fill neck and cap the openings. Rubber cones used to plug exhaust systems for leak testing are ideal to plug the large filler neck hose.

No – The fuel fill neck or fuel cap is leaking. Replace the fuel fill neck and fuel cap, then go to step 10.

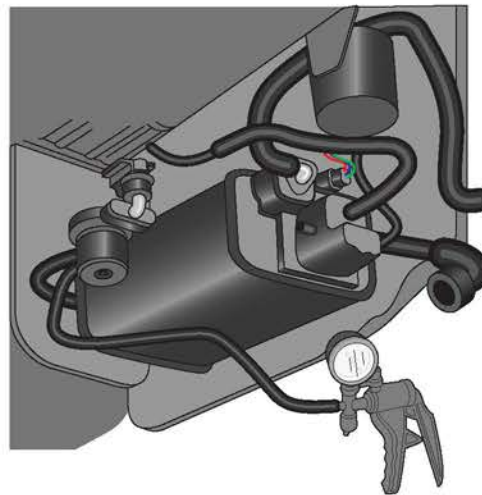
- Watch the FTP sensor value on the HDS, and gently apply vacuum until the value reads approximately **2.10 V**.

Did the value increase more than 0.05 V in 20 seconds?

Yes – The fuel fill neck and fuel cap are not leaking. Go to step 9.

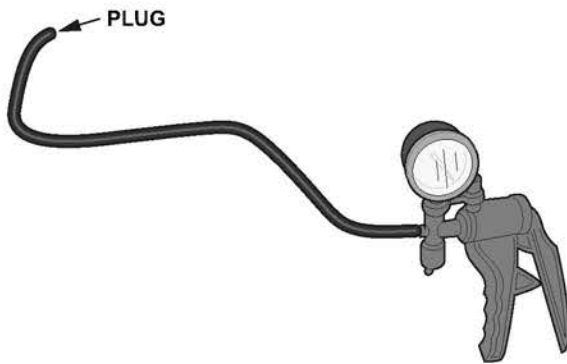
- The leak has been isolated to the tank area. Closely inspect all hoses and connections shown in the picture for signs of any cracks, holes, or other signs of leaks. Use a mirror and shop light to inspect as much of the fuel tank as possible.
- If you are unable to locate a leak with a visual inspection, you will need to remove the fuel tank from the vehicle to continue with the diagnosis. Follow the applicable electronic service manual procedures to remove the fuel tank.
- After the fuel tank is removed, test the hoses connected to the fuel tank for leaks by disconnecting the hoses, plugging one end of the hose and then applying vacuum to the other end. If the hose does not hold steady vacuum for 20 seconds, replace the hose.

- Thoroughly inspect the entire exterior shell of the fuel tank for any signs of damage or leakage. If no damage is found, replace the tank seals for the ORVR (onboard refueling vapor recovery) and fuel pump and re-assemble.

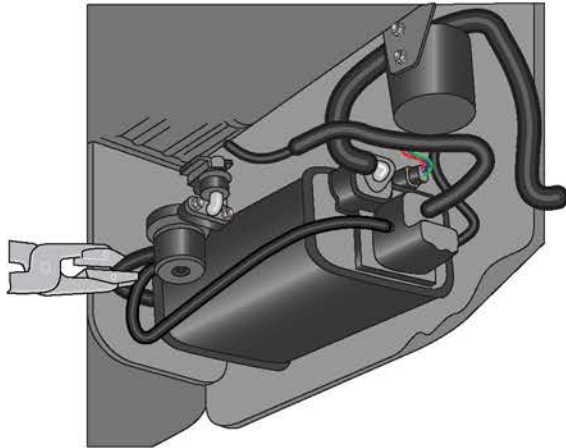
- Leave the fuel cap off.
- Pinch the hose between the two-way valve and the fuel tank.

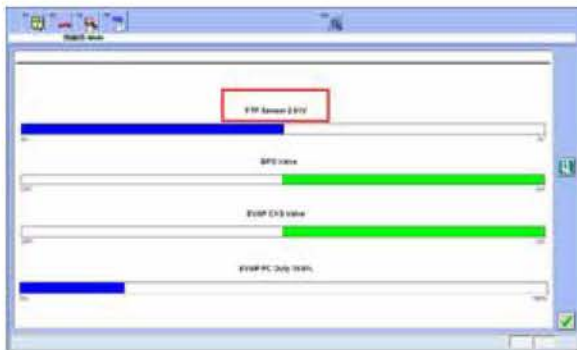
- Enter the HDS PGM-FI menu, and select INSPECTION> EVAP TEST> MULTI SOLENOIDS> PCS ON> CVS ON> BPS ON.

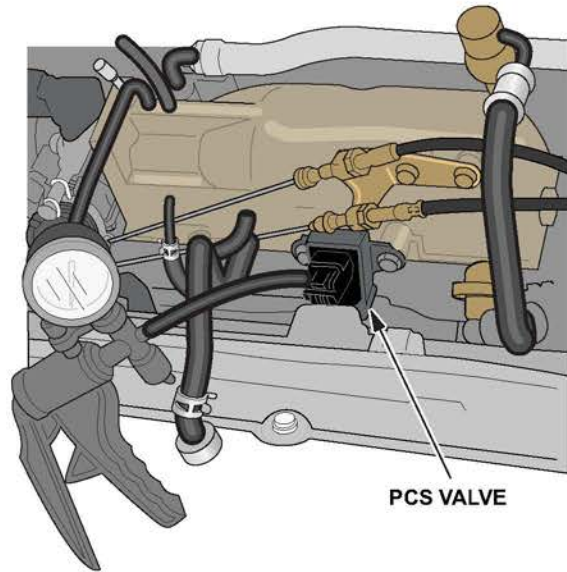
- Attach a vacuum pump to the engine side of the PCS valve.

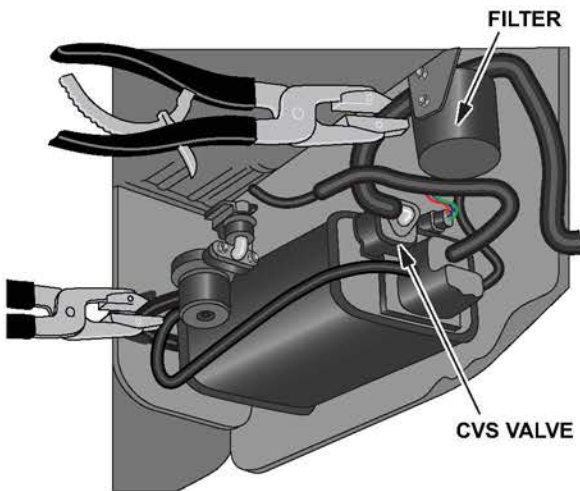
- Pinch the hose between the two-way valve and the fuel tank.
- Pinch the hose between the CVS valve and EVAP filter.

No – The CVS valve is leaking. Inspect the CVS valve O-ring; If damaged, replace the O-ring and retest; otherwise, replace the CVS . Go to step 9.

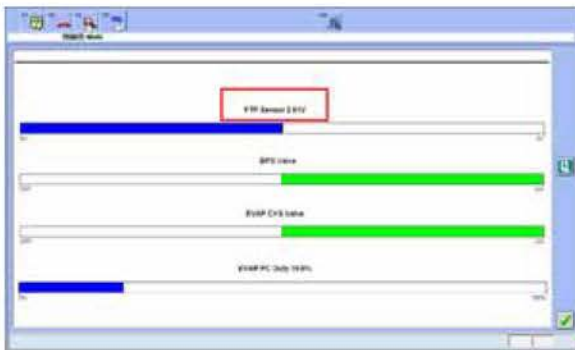
- Enter the HDS PGM-FI menu, and select INSPECTION> EVAP TEST>MULTI SOLENOIDS> PCS ON> CVS ON> BPS ON.

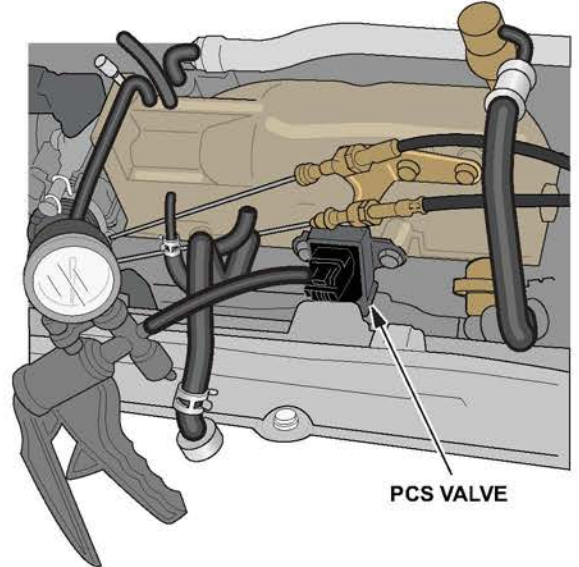
- Apply vacuum to the system while monitoring the FTP sensor value reading on the HDS. Stop when the value reads approximately **1.50 V**.

- Watch the value on the HDS for 20 seconds.

Did the value increase more than 0.05 V in 20 seconds?

Yes – The CVS valve is not leaking. Go to step 4.

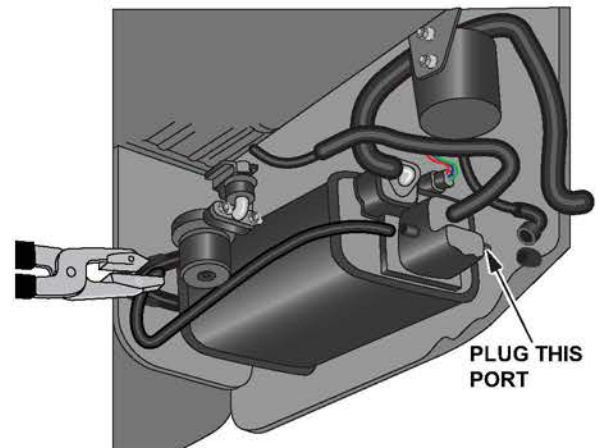
- Disconnect the clamping pliers on the canister vent hose.
- Disconnect the fuel tank vapor control hose from the canister, and plug the fitting on the canister.

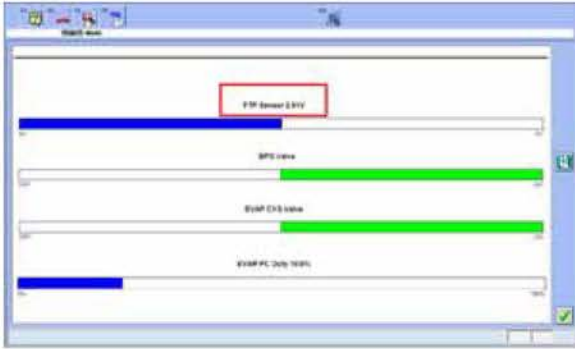
- Enter the HDS PGM-FI menu, select INSPECTION> EVAP TEST> MULTI SOLENOIDS> PCS ON> CVS ON> BPS ON.

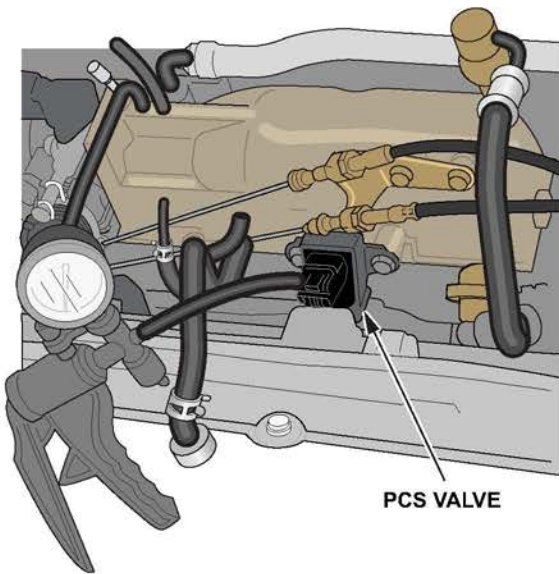
- Apply vacuum to the system while monitoring the FTP sensor value reading on the HDS. Stop when the value reads approximately 1.50 V.

- Watch the value on the HDS for 20 seconds.
Did the value increase more than 0.05 V in 20 seconds?
Yes – The fuel tank vapor control valve is not leaking. Go to step 5.
No – The fuel tank vapor control valve or hose is leaking and needs to be replaced. Once the leaking component has been identified and replaced, go to step 9.

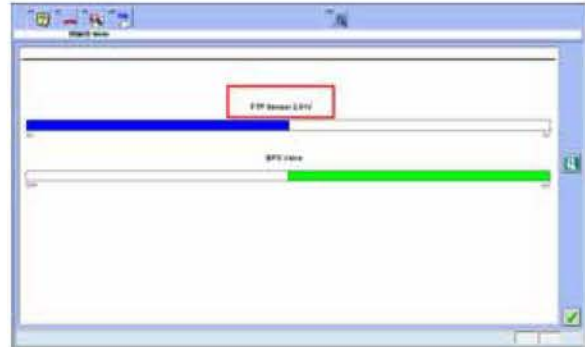
- Remove the vacuum pump, reconnect the hoses, and remove the clamping pliers.
- Enter the HDS PGM-FI menu, and select INSPECTION> EVAP TEST> SINGLE SOLENOID> BYPASS SOLENOID. Click the green check box to turn ON the BPS valve.

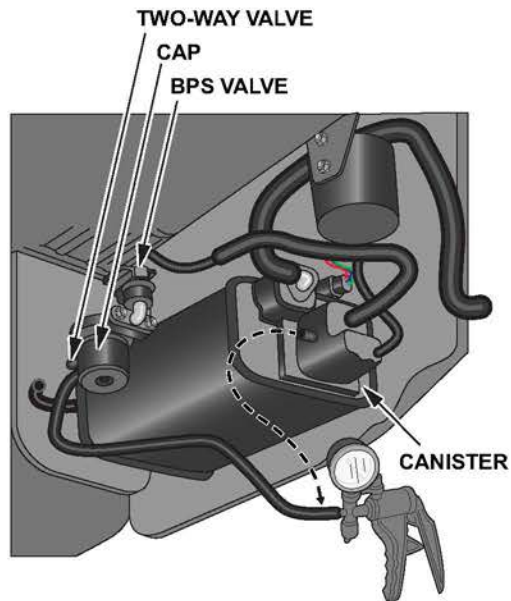
- Disconnect the hose on the two-way valve that goes to the fuel tank and cap the hose fitting on the two-way valve.
- Disconnect the hose from the canister that connects to the two-way valve.
- Connect a vacuum pump to the canister side two-way valve hose.

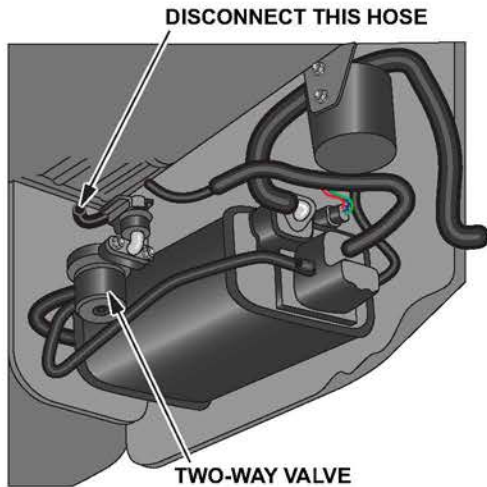
- Disconnect the FTP sensor hose from the two-way valve.

Yes – The FTP sensor or hose is leaking. Replace the FTP sensor and hose. Go to step 9.

No – The two-way valve and BPS valve assembly are leaking. Replace the two-way valve and BPS valve assembly. Go to step 9.

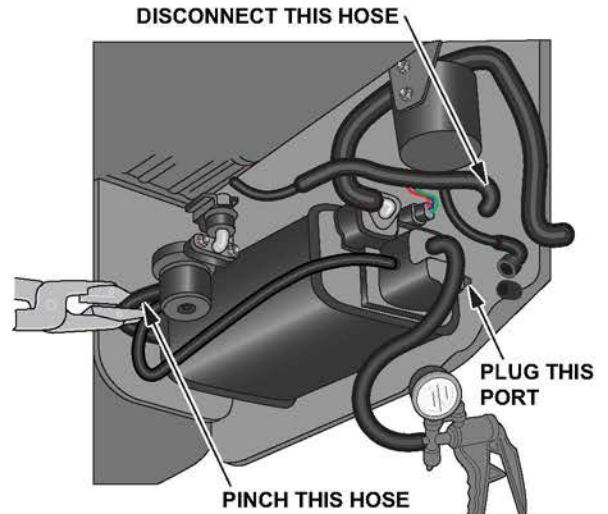
- Reconnect any disconnected hoses.
- Disconnect the fuel tank vapor control hose from the canister, and plug the fitting on the canister.
- Pinch the hose between the two-way valve and the fuel tank.
- Disconnect the purge hose from the canister, and connect a vacuum pump to the canister fitting.

Yes – The EVAP canister is leaking. Replace the EVAP canister. Go to step 9.

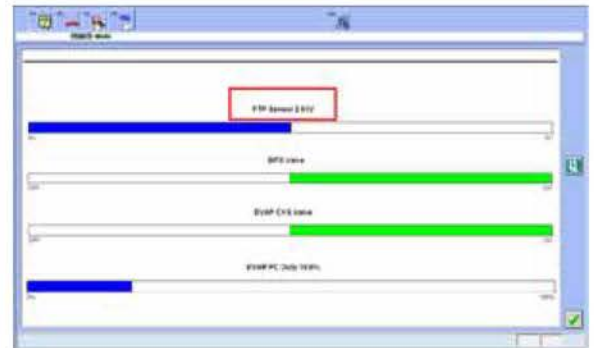
- Enter the HDS PGM-FI menu, and select INSPECTION> EVAP TEST> MULTI SOLENOIDS> PCS ON> CVS ON> BPS ON.

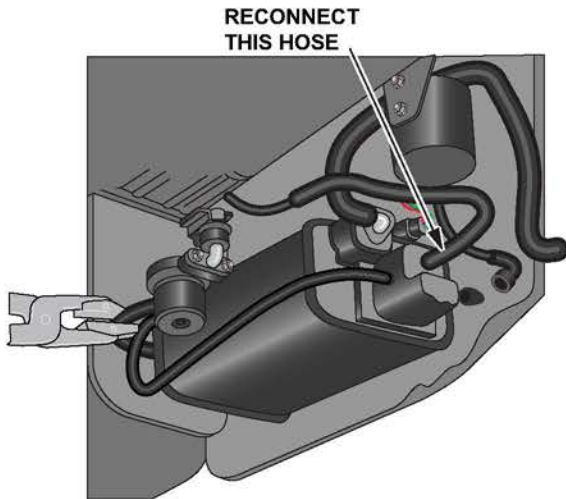
- Leave the fuel tank vapor control hose disconnected from the canister but make sure it is still plugged.
- Leave the hose between the two-way valve and the fuel tank pinched.
- Reconnect the purge hose to the canister.

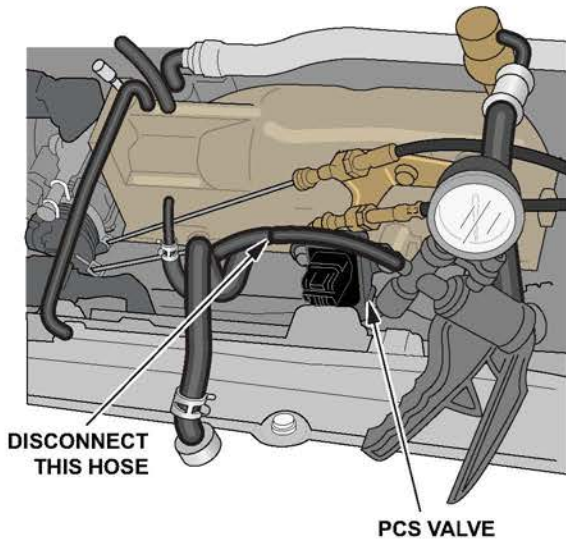
- Disconnect the purge hose from the PCS valve that leads to the canister, and connect the vacuum pump.

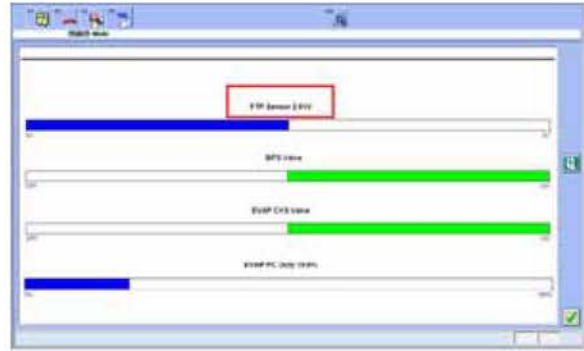
- Enter the HDS PGM-FI menu, and select INSPECTION>EVAP TEST>MULTI SOLENOIDS. PCS ON>CVS ON>BPS ON.

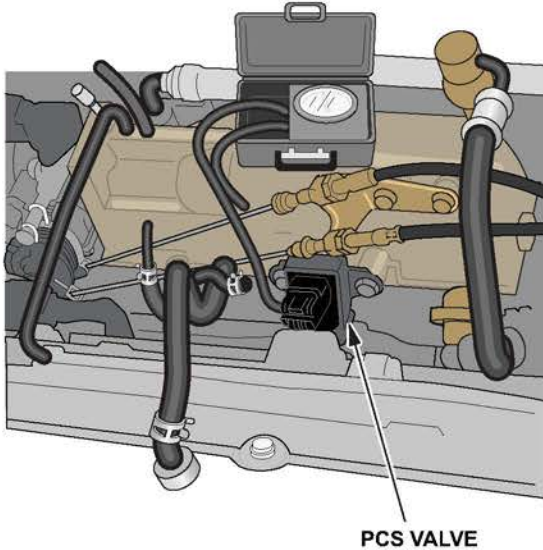
- Start the engine.

Yes – The PCS valve is leaking. Replace the PCS valve. Go to step 10.

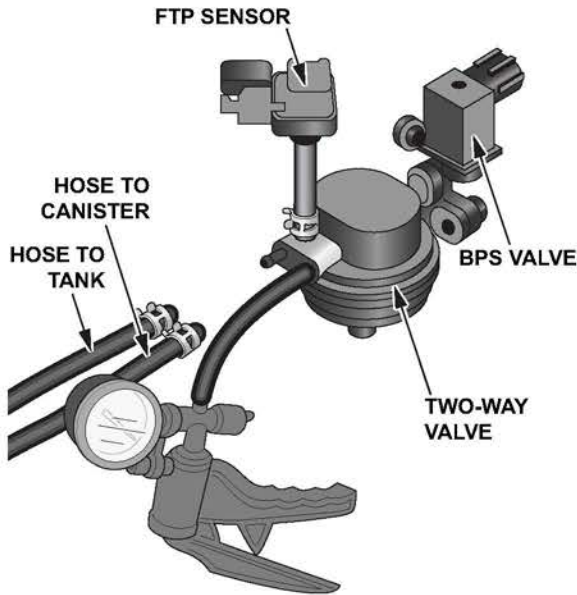
- Connect a vacuum pump to the canister side two-way valve hose.

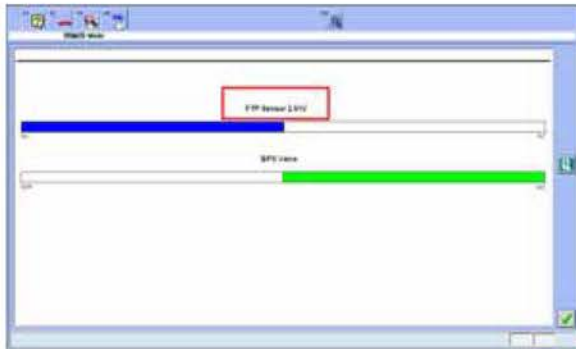
- Apply about **5 in.Hg** of vacuum to the system.
- Enter HDS PGM-FI menu, and select INSPECTION> EVAP TEST> SINGLE SOLENOID> BYPASS SOLENOID. Click the green check box to turn ON the BPS valve.

Did the vacuum bleed off when the BPS valve was turned on?

Yes – The BPS valve is operating correctly. Go to step 5.

No – The BPS valve is not operating correctly. Make sure there is not an open, short, or high resistance in the BPS valve. If the circuit tests OK, replace the BPS valve. Go to step 10.

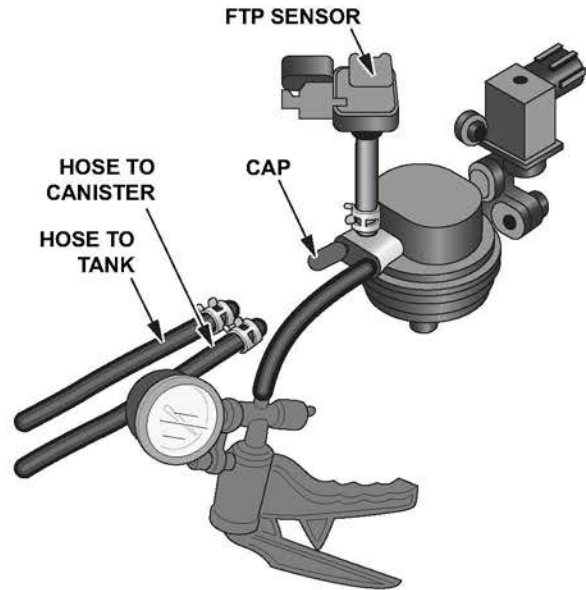
- Make sure the BPS valve is still commanded ON with the HDS.
- Cap the open hose fitting on the two-way valve.

Yes – The two-way valve and BPS valve assembly are leaking. Replace the two-way valve and BPS valve assembly. Go to step 10.

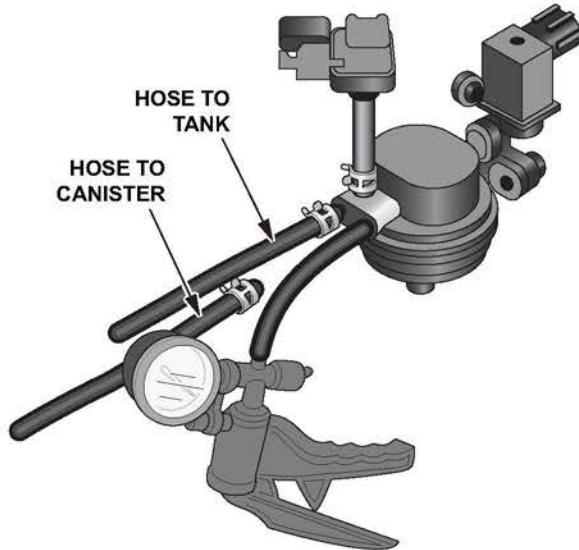
- Make sure the BPS valve is still commanded ON with the HDS.
- Reconnect the BPS valve connector.
- Reconnect the two-way valve hose coming from the fuel tank.
- Reconnect the vacuum pump.

- Watch the FTP sensor value on the HDS, apply vacuum until the value reads approximately **2.10V**.

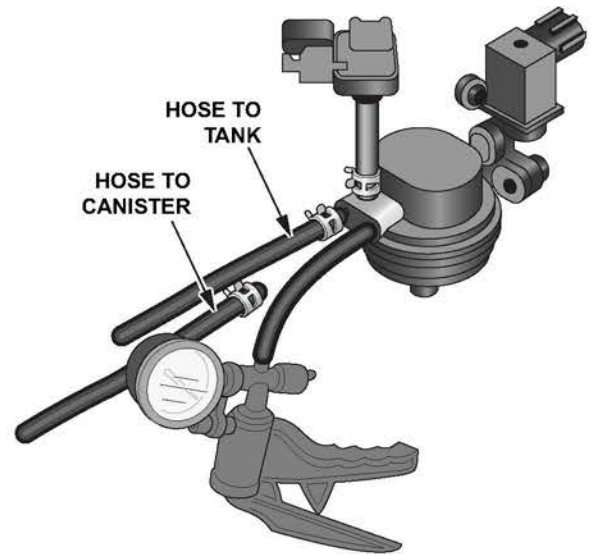
- Make sure the BPS valve is still commanded ON with the HDS.
- Disconnect the fuel tank vapor control valve hose from the canister, and plug the opening.

No – The fuel tank vapor control valve is leaking. Replace the fuel tank vapor control valve. Go to step 10.

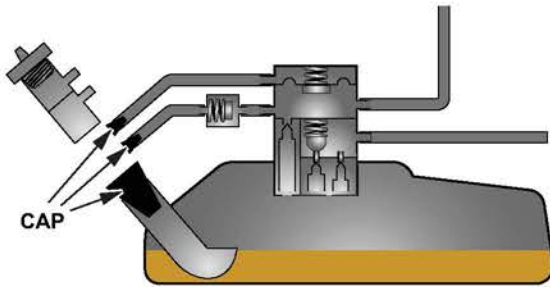
8. Isolate the fuel fill neck and fuel cap.
- Make sure the BPS valve is still commanded ON with the HDS.
 - Disconnect the three hoses connected to the fuel fill neck and cap the openings. Rubber cones used to plug exhaust systems for leak testing are ideal to plug the large fuel fill neck hose.

No – The fuel fill neck or fuel cap is leaking. Replace the fuel fill neck and the fuel cap. Go to step 10.

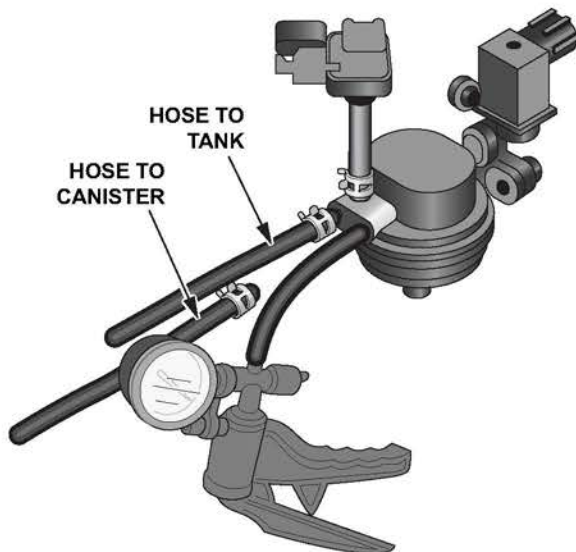
- Watch the FTP sensor value on the HDS, apply vacuum until the value reads approximately 2.10 V.

Did the value increase more than 0.05 V in 20 seconds?

Yes – The fuel fill neck and fuel cap are not leaking. Go to step 9.

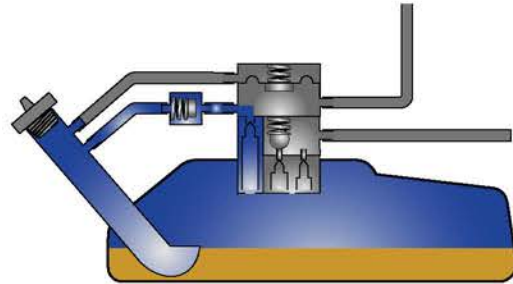
- Reconnect all of the hoses that are disconnected.

- The leak has been isolated to the tank area. Closely inspect all hoses and connections shown in the picture for signs of any cracks, holes, or other signs of leaks. Use a mirror and shop light to inspect as the fuel tank for any damage, cracks or signs of leaks.
- If you are unable to locate a leak with a visual inspection, you will need to remove the fuel tank from the vehicle to continue with the diagnosis. Follow the electronic service manual procedures for your vehicle to remove the fuel tank.
- Once the fuel tank is removed, test the hoses connected to the fuel tank for leaks by disconnecting the hoses, plugging one end of the hose and then applying vacuum to the other end. If the hose does not hold steady vacuum for 20 seconds, replace the hose.

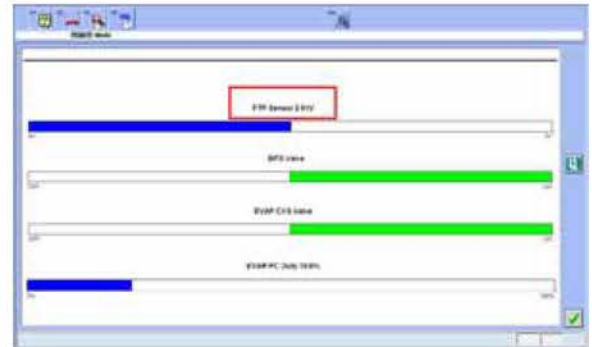
2. Test for canister side leaks.
 - Leave the fuel cap off.
 - Pinch the hose between the two-way valve and the fuel tank.
 - Enter HDS PGM-FI menu, and select INSPECTION> EVAP TEST> MULTI SOLENOIDS> PCS ON> CVS ON> BPS ON.

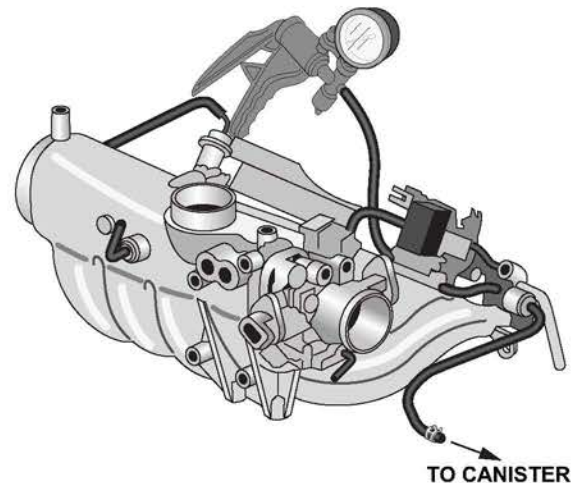
- Make sure that you can hear and feel all of the solenoids operate.
- Attach a vacuum pump to the engine side of the PCS (purge control solenoid) valve.
- Apply vacuum to the system while monitoring the FTP sensor on the HDS. Stop when the value reads approximately 1.50 V.

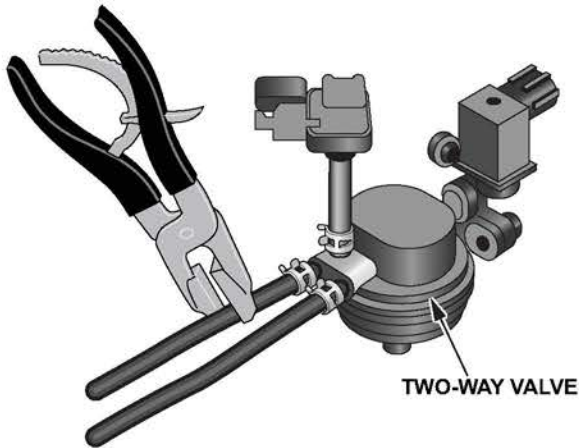
Rear of vehicle.

- Pinch the hose between the two-way valve and the fuel tank.

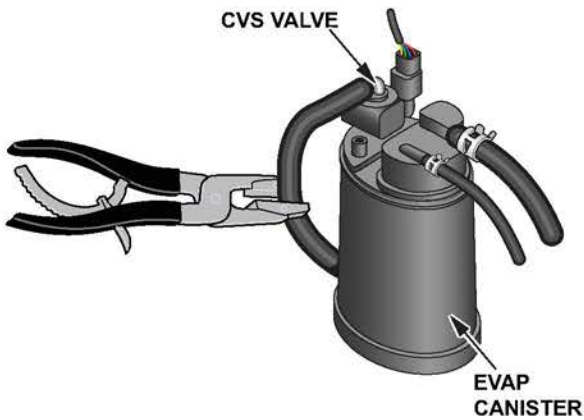
Front of vehicle.

- Pinch the hose between the CVS valve and EVAP filter.

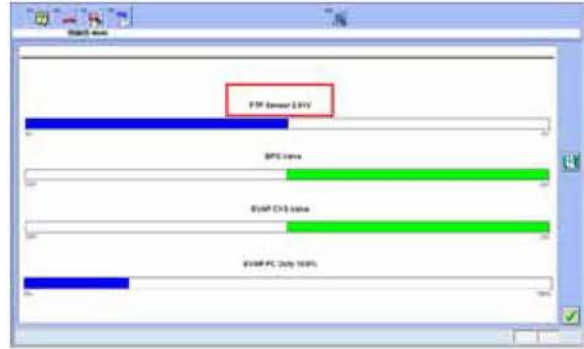
- Enter the HDS PGM-FI menu, and select INSPECTION>EVAP TEST>MULTI SOLENOIDS>PCS ON>CVS ON>BPS ON.

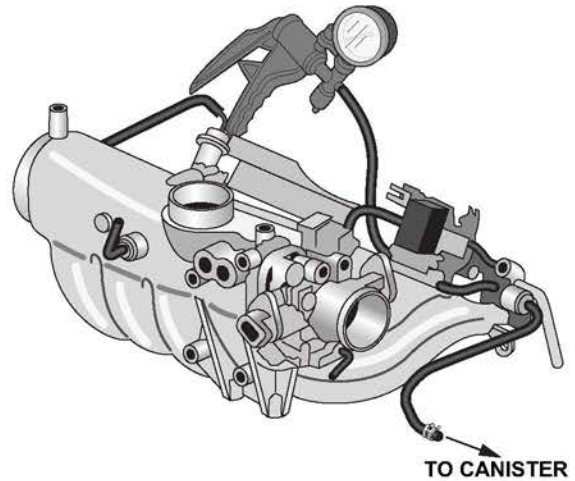
- Apply vacuum to the system while monitoring the FTP sensor value on the HDS. Stop when the value reads approximately 1.50 V.

- Watch the value on the HDS for 20 seconds.

Did the value increase more than 0.05 V in 20 seconds?

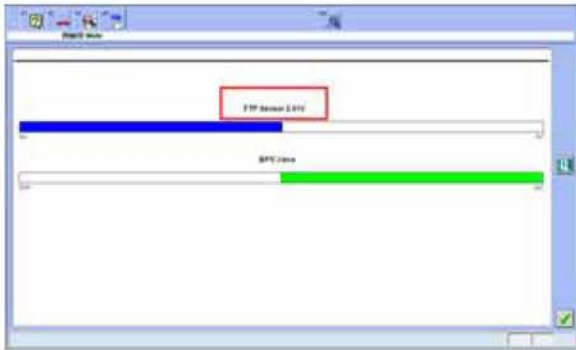
- Remove the vacuum pump, reconnect the hoses, and remove the clamping pliers.
- Enter the HDS PGM-FI menu, and select INSPECTION> EVAP TEST> SINGLE SOLENOID> BYPASS SOLENOID. Click the green check box to turn ON the BPS valve.

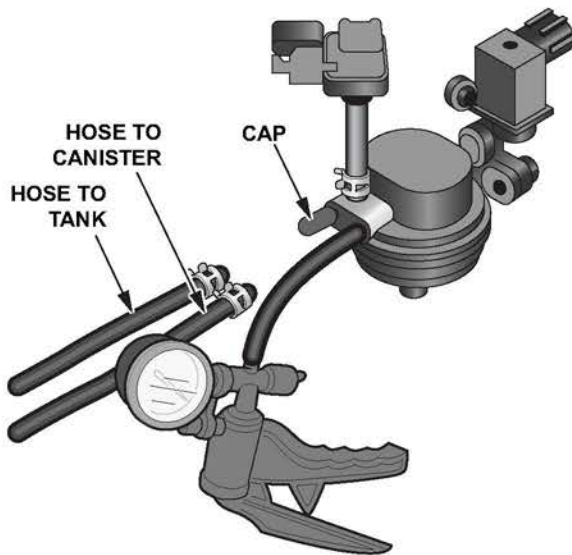
- Disconnect the hose on the two-way valve that goes to the fuel tank, and cap the hose fitting on the two-way valve.
- Disconnect the hose from the canister that connects to the two way valve.
- Connect a vacuum pump to the canister side two-way valve hose.

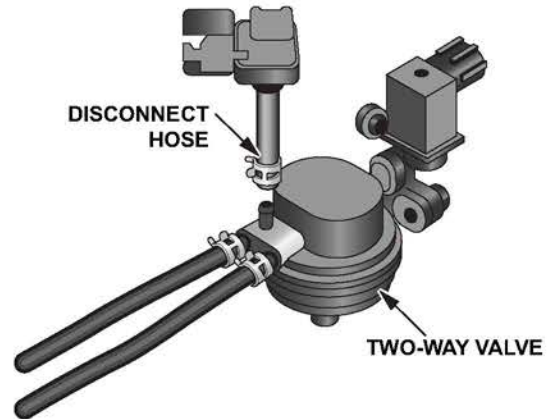
- Disconnect the FTP sensor hose from the two-way valve.

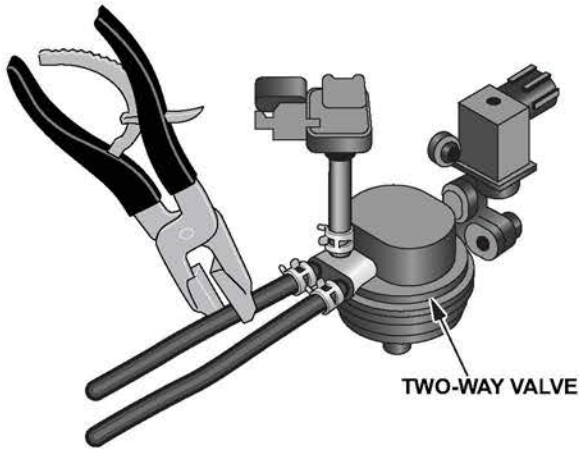
Rear of vehicle.

- Reconnect any disconnected hoses.
- Pinch the hose between the two-way valve and the fuel tank.

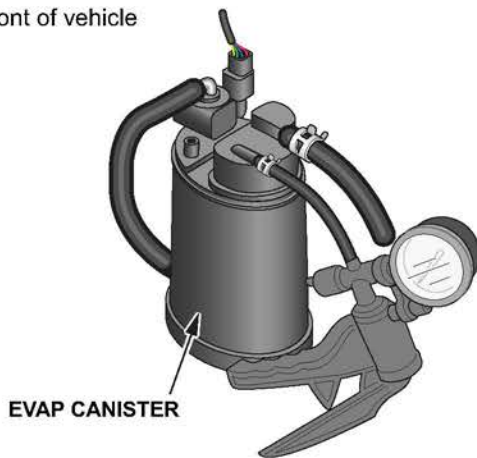
Front of vehicle

- Disconnect the purge hose from the canister and connect a vacuum pump to the canister fitting.

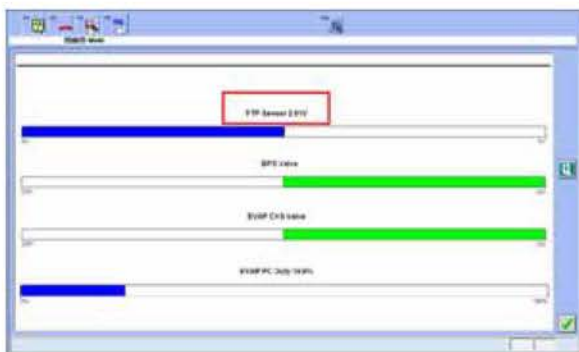
- Enter the HDS PGM-FI menu, and select INSPECTION> EVAP TEST> MULTI SOLENOIDS> PCS ON> CVS ON> BPS ON.

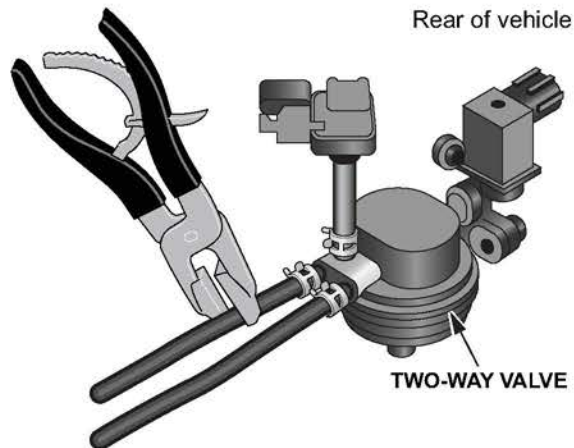
Rear of vehicle

- Leave the hose between the two-way valve and the fuel tank pinched.

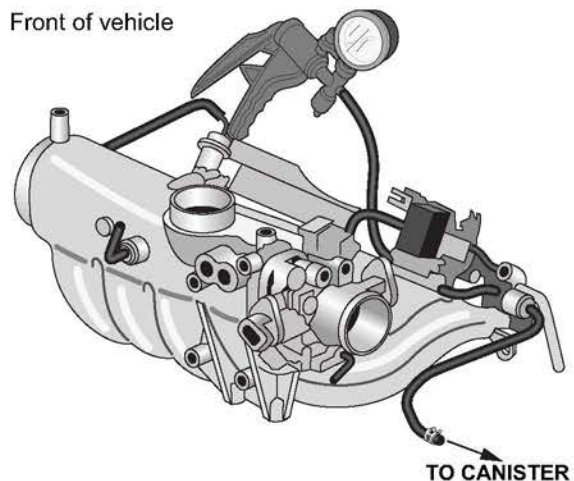
Front of vehicle

- Reconnect the purge hose to the canister.
- Disconnect the purge hose from the PCS valve that leads to the canister, and connect the vacuum pump.

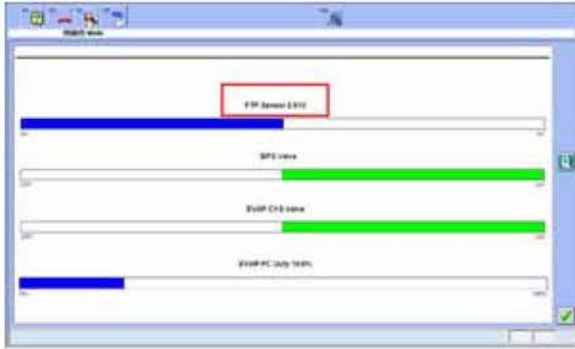
- Enter the HDS PGM-FI menu, and select INSPECTION> EVAP TEST> MULTI SOLENOIDS, PCS ON> CVS ON> BPS ON.

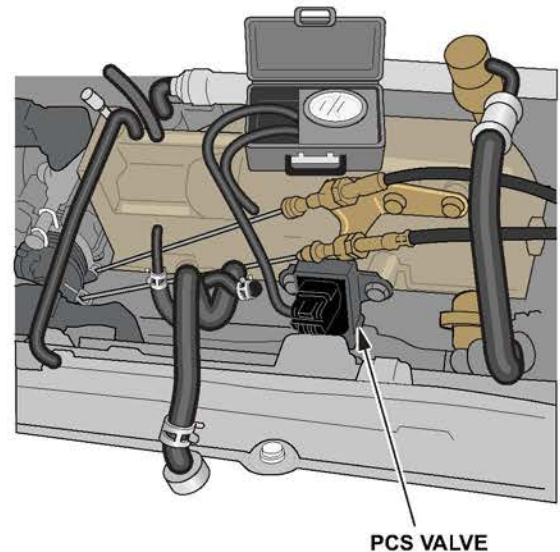
8. Test the PCS valve.
 - Reconnect all of the hoses disconnected.
 - Disconnect the hose leading to the PCS valve from the canister.
 - Connect a Mini Helic vacuum gauge to the PCS valve hose.

- Start the engine.
Does the vacuum gauge show vacuum?
Yes – The PCS valve is leaking. Replace the PCS valve. Go to step 9.
No – No leak has been found in the system. Go to step 9.
