SWS Contract Report 401

SEDIMENTATION SURVEY OF LAKE PITTSFIELD, PIKE COUNTY, ILLINOIS

Prepared for the City of Pittsfield

Champaign, Illinois
September 1986

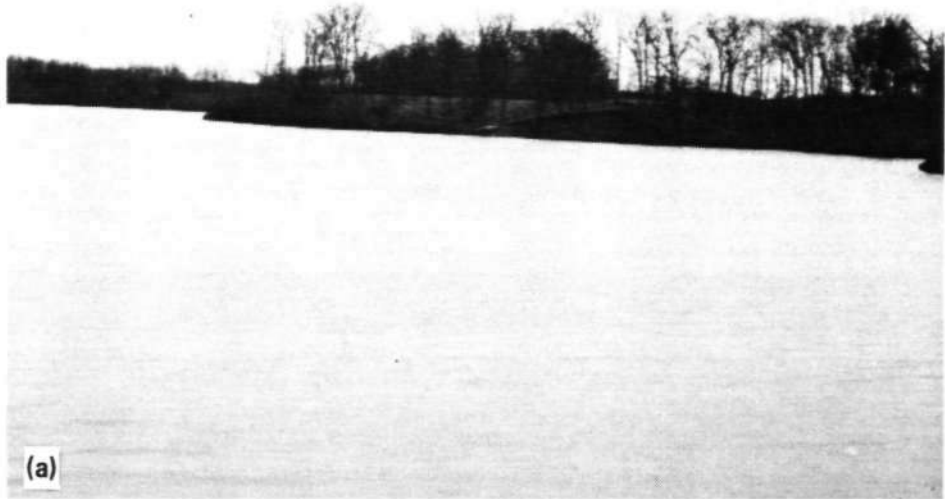
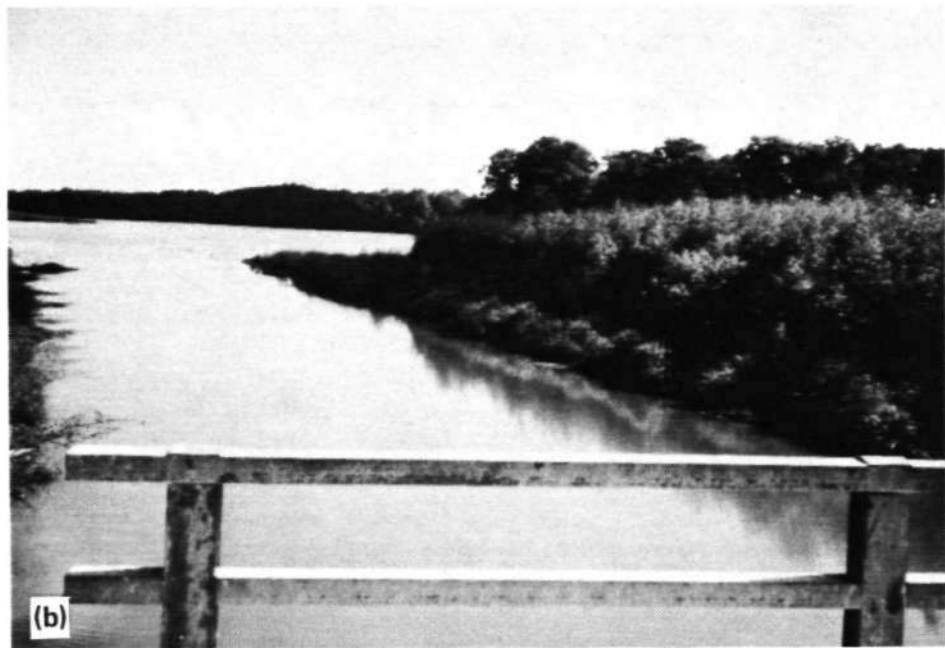
Figure 5. Downstream view from the bridge in lake segment 11
in a) 1979 and b) 1985

On the basis of observations made at the time of the 1979 and 1985 surveys, a part of the apparent sedimentation rate reduction may result from the emphasis of all the surveys on the lake capacity loss. This analysis excludes deposits above water level, which have had significant impact in segments 10, 11, 12, 15, and 18. Figure 5 shows photographs of the downstream view from the bridge in segment 11 in 1979 and 1985. These views show the growth of the delta downstream of the bridge. Upstream of the bridge, a 30-acre ponded area has been reduced to a stream channel with a width of 100 to 125 feet.
