Land Rover Range Rover L322 2006 +, Range Rover Sport, Discovery 3 EAS Air Compressor Filter Drier Unit Repair Kit Instructions

by x8rltd on March 14, 2014

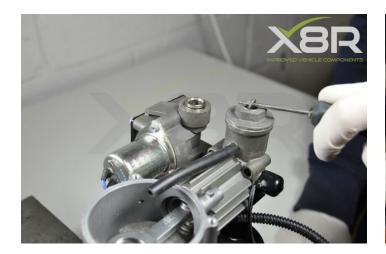
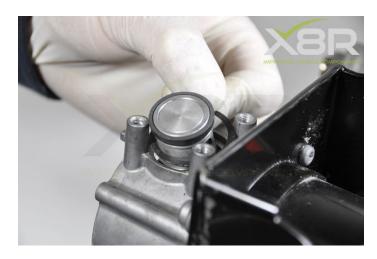
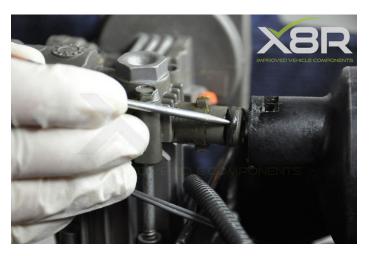
Step 1: Placement of Additional O-Rings in Kit
Please refer to the images in this step for the placement of the
additional O-rings we have started to supply in our kits from 2015 on wards.

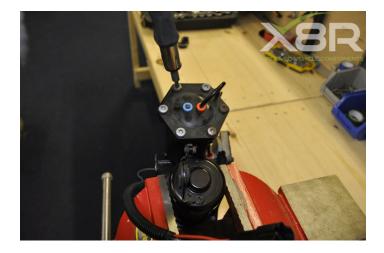
Step 2: Remove filter cover
Take a T27 Torx and unscrew the 6 bolts on the filter unit cover, the filter cover is spring loaded, take care when removing cover, remember which bolt fits which hole for re installation. Remove the cover gently remembering the orientation of the spring.

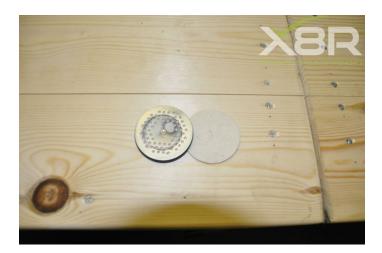
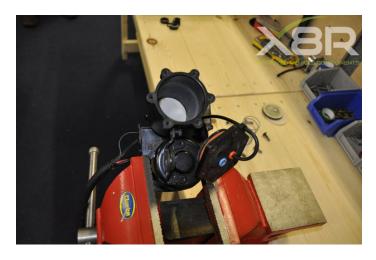
Step 3: Remove old filters
Using a small flat head screw driver lever the first filter out of the unit. Remove the second felt filter and discard.

Take a bag and remove the drying beads from the filter unit by tilting the filter unit in to the bag, these can then be disposed of.

Take flat headed screw driver and remove final filter at the base of the filter unit.

It is a good idea at this point to tilt the filter unit on its end to remove any wayward drying beads.

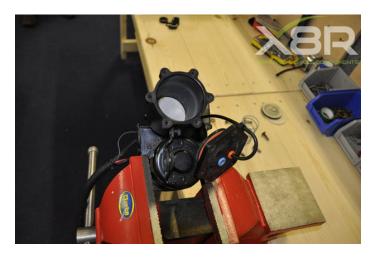
Step 4: Insert new filter and media

Install our replacement felt filter at the base of the unit; use the reverse of a screw driver to tap the filter snugly in to the base of the filter unit.

Pour new drying beads in to filter unit, level off the beads and fit the new felt filter on top.

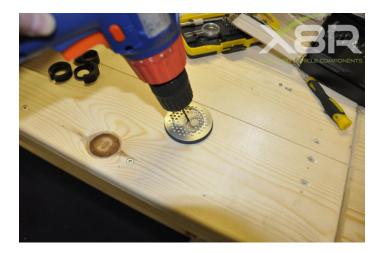
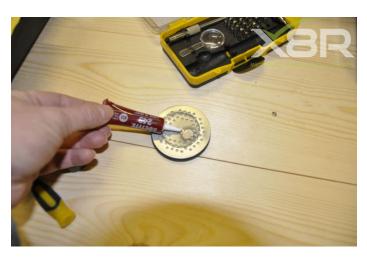
Step 5: Adapt original metal filter

Take the original metal filter and drill out the rivet. Remove the rivet both sides and separate the filter. Retain the two metal face plates and O-ring from around felt filter and dispose of old felt filter. Take the new filter with plastic surround from our kit and fit 0-ring in to the outer plastic part. Refit face plates and either rivet back together or punch hole through felt and refit using small nut and bolt included (using lock tight on bolt thread). Ensure face plates are central to felt filter and that you can see 0-ring around the circumference of the filter, this mates to the filter wall, this is important to prevent air circumventing the filter.

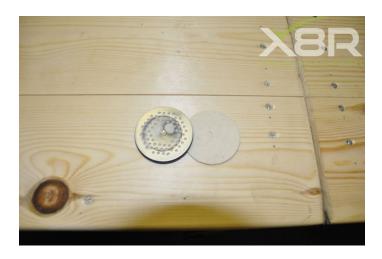
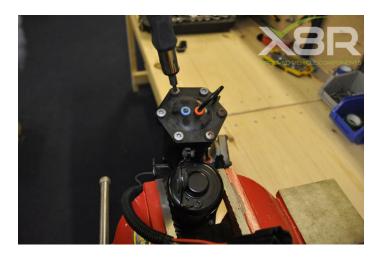
Step 6: Insert revised metal filter and replace cover

Insert metal filter back in to filter unit, if metal filter was refitted with nut and bolt rather than rivet ensure the bolt side is pointing outwards rather than damaging the felt filter below.

Take spring and refit filter cover. The filter replacement is now complete, we would recommend testing the compressor at this point on the bench to check successful install of new filters.

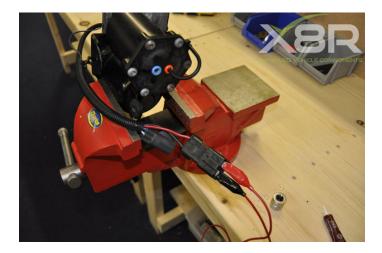
Step 7: Test compressor
Connect a 12v positive feed from a car battery to the Red wire to the compressor and a feed from the negative terminal of the battery to the Black wire to the compressor. The compressor will now run, check that output is good, you shouldn't be able to stop air being pushed out of the unit when putting thumb over output pipe, if you can stop flow there is a problem with install, if not output is good and you can proceed to reinstall.
