A summary of a NIOSH fire fighter fatality investigation

November 12, 2014

9 Volunteer Fire Fighters and 1 Off-Duty Career Fire Captain Killed by an Ammonium Nitrate Explosion at a Fertilizer Plant Fire – Texas

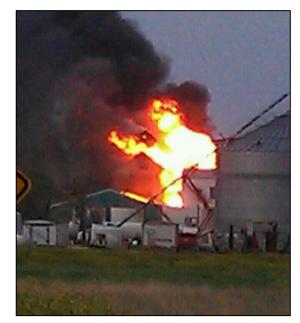
Burning fertilizer plant prior to the explosion, as seen from the South looking North. (Cell phone photo courtesy of ATF)

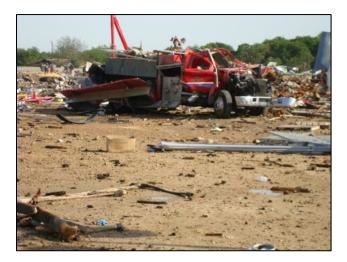
Engine 2 post explosion. Note that it is believed the force of the explosion moved the engine from its original location and orientation at the time of the blast. (NIOSH Photo)

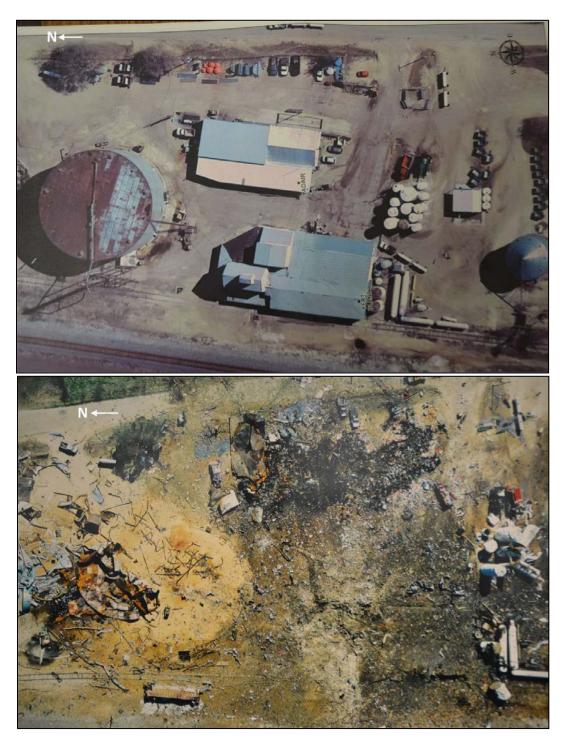
Photo 1 and Photo 2. Overhead views pre-blast (top) and post-blast (bottom). (Source - ATF)

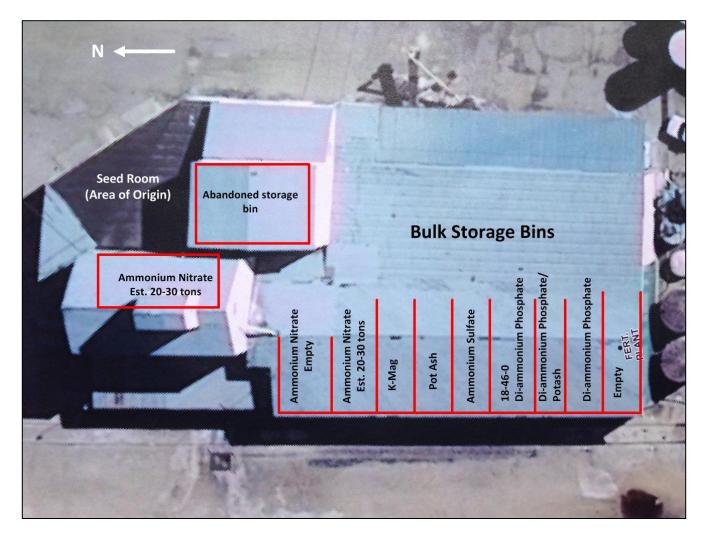
Photo 3. Overhead view of fire building showing the approximate locations of the storage bins that contained the bulk dry fertilizer materials. The seed room is believed to be the room of origin. (Adapted from ATF Diagram)

The structure was built of wood-frame construction on a concrete slab with several additions and modifications. The structure was mostly one-story in height with the exception of vertical storage bins fed by an overhead conveyor system. This area was estimated to be approximately 75 feet in height. One of these vertical storage bins was designated for ammonium nitrate but was empty at the time of the fire. The roof was a mixture of asphalt rolled roofing materials, asphalt shingle and corrugated metal. The structure did not contain a sprinkler system or other means of automatic fire suppression.

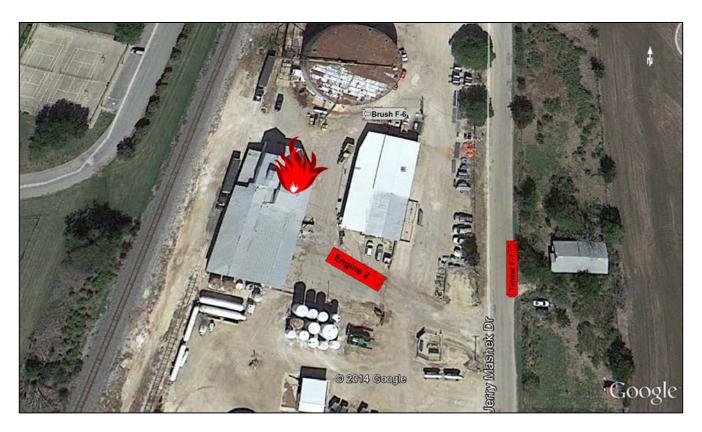
Figure 1. Apparatus position of first three fire department apparatus on scene. Positions and orientation are approximate estimates. (Figure adapted from Google Earth satellite image. Imagery date 10/2012.)

Engine 1 arrived on scene and staged east of the burning fertilizer plant. The brush truck staged east and north of the structure (north of Engine 1). Two $1\frac{1}{2}$ - inch pre-connected hand lines were pulled

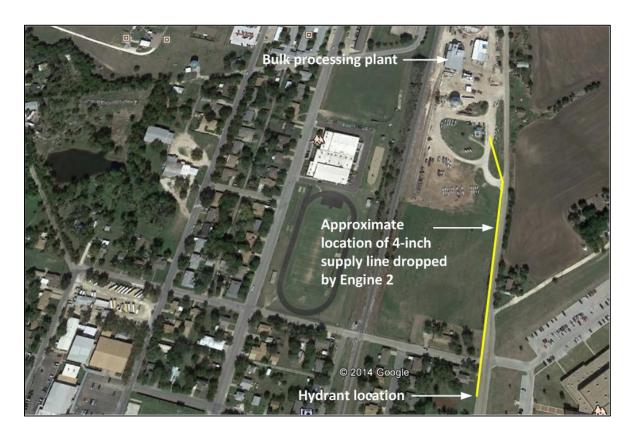
Figure 2. Approximate location of 4-inch supply line dropped by Engine 2. (*Figure adapted from Google Earth satellite image. Imagery date 10/2012.*)

Engine 2 drove north toward the fertilizer plant and immediately saw smoke after leaving the station. E-2 stopped at the hydrant located south of the complex. The captain and fire fighter pulled a 4-inch supply line from the rear of E-2 to the hydrant. Engine 2 then drove toward the fertilizer plant, laying out the 4-inch supply line until all the supply line was unloaded on the ground. The end of the supply line was still hundreds of feet from where Engine 1 was located (see Figure 2, Photo 3, Photo 4, and Photo 5). The fire fighter stayed at the end of the supply line while the captain continued north toward the fertilizer plant, driving E-2 to where E-1 was located on the east side of the fertilizer plant. The captain observed that two 1¹/₂ - inch hand lines were pulled from E-1 and two fire fighters were on each hand line. The captain recalled that two fire fighters were on each hand line but their backs were toward the captain so he could not positively identify any of the fire fighters. The two hand lines pulled from E-1 were the 1 ¹/₂-inch bumper line pulled from the front bumper, and a 1 ¹/₂-inch preconnected cross-lay. The captain observed fire coming out an open sliding door at the north end of the east side of the plant. The two hand lines were in operation and tank water was being directed toward the open door. The fire was rapidly growing in size. The captain yelled to the four fire fighters working the hose lines that they were too close to the structure and needed to back up. As they backed away from the burning structure, the captain told them that they needed to break down their hose lines because he wanted to switch the two engines. The captain intended to lay out the supply line on Engine 1 back to the end of the supply line previously dropped from Engine 2, then position Engine 1 at the hydrant to boost pressure in the supply line back to Engine 2.

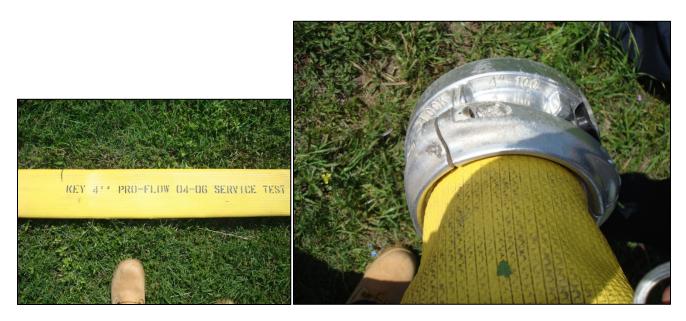
Photo 5 and Photo 6. Close-up views of 4-inch supply line (on left) and coupler (on right). (Photos taken by NIOSH investigators.)

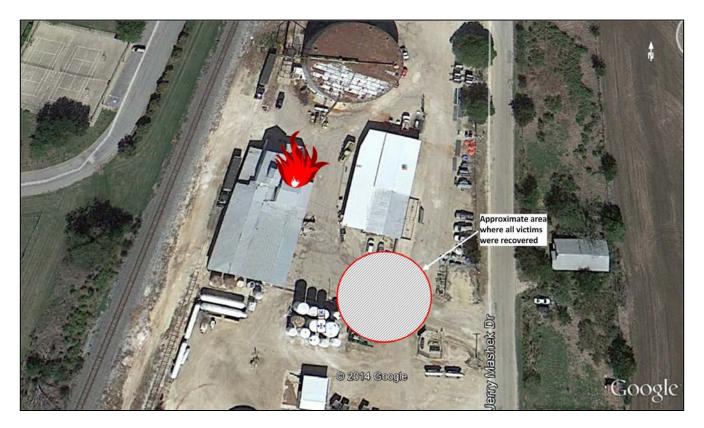
Figure 3. Approximate area where the deceased fire fighters were recovered. (*Figure adapted from Google Earth satellite image. Imagery date 10/2012.*)

as a small-scale earthquake. In addition to the 10 fire fighters who were killed and 5 who were seriously injured, two civilians who were supporting the fire department in non-suppression activities were killed. One of the civilians worked for a local company who built fire apparatus and routinely responded to fires to provide support and advice to the apparatus operators. The 5 injured fire fighters suffered a variety of explosion-related trauma injuries including bruises, broken bones, lacerations and other injuries. Figure 3 indicates the approximate area where the victims were recovered.

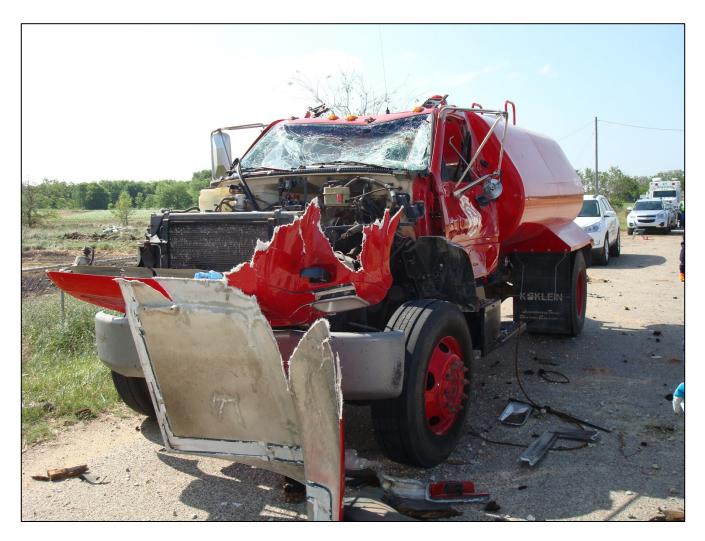
Photo 7. Damage to Tanker F-7. Tanker is shown in the same location on county road east of fertilizer plant as it was at the time of the explosion several hundred feet from the center of the explosion. (Photo NIOSH.)

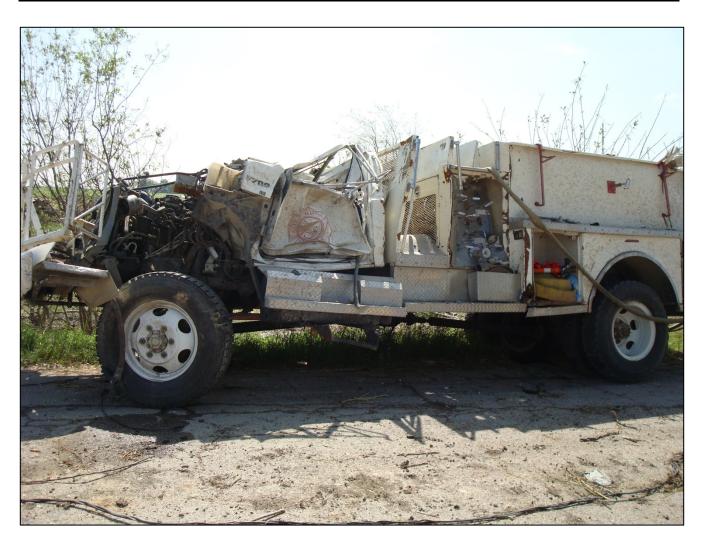
Photo 8. Side view of Brush Truck F-6. Truck has been moved from its location at the time of the explosion. (NIOSH Photo.)

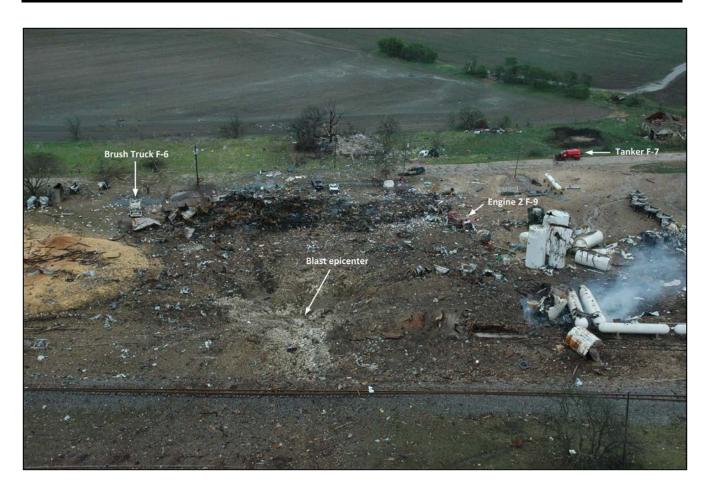
Photo 9. Photo shows fire apparatus locations post-explosion. Orientation is looking east. (*Photo source – ATF.*)

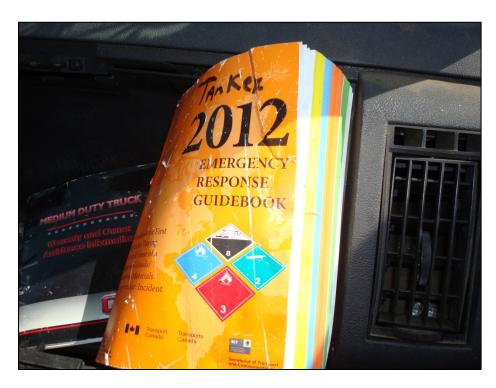
Photo 10. Emergency Response Guidebook found in cab of tanker F-7. (Photo NIOSH.)

The US Department of Transportation's Emergency Response Guidebook $\frac{29}{2}$ is a guidebook for first responders during the initial phase of a dangerous goods/hazardous materials transportation incident. Although the guide is for initial phase involving transportation incidents, it is a valuable resource at structure fires and other incidents when no other information is available. The Emergency Response Guidebook was developed jointly by the US Department of Transportation, Transport Canada, and the Secretariat of Communications and Transportation of Mexico (SCT) for use by firefighters, police, and other emergency services personnel who may be the first to arrive at the scene of a transportation incident involving a hazardous material. It is primarily a guide to aid first responders in (1) quickly identifying the specific or generic classification of the material(s) involved in the incident, and (2) protecting themselves and the general public during this initial response phase of the incident. The ERG is updated every three to four years to accommodate new products and technology. Emergency Response Guidebooks (2012 version) were found in the glove boxes of some of the fire department's responding apparatus (see Photo 9). A quick look in the guidebook under ammonium nitrate fertilizer would have shown "May explode from heat or contamination" and a recommendation for large fires that says "for massive fires, use unmanned hose holders or monitor nozzles; if this is impossible, withdraw from area and let fire burn." Under the evacuation section the initial evacuation distance recommended for rail or tank trucks is "1/2 mile in all directions."

This fire involving ammonium nitrate was considerably larger than one tank or rail car, and the recommendation from the *Emergency Response Guidebook* to withdraw from the area would have been a well suited strategy considering the amount of fire, the known presence of ammonium nitrate at the facility, the amount of available resources and the lack of available water supply.
