**DOT/FAA/AR-03/74**  
Office of Aviation Research  
Washington, D.C. 20591

# **Bonded Repair of Aircraft Composite Sandwich Structures**

February 2004

Final Report

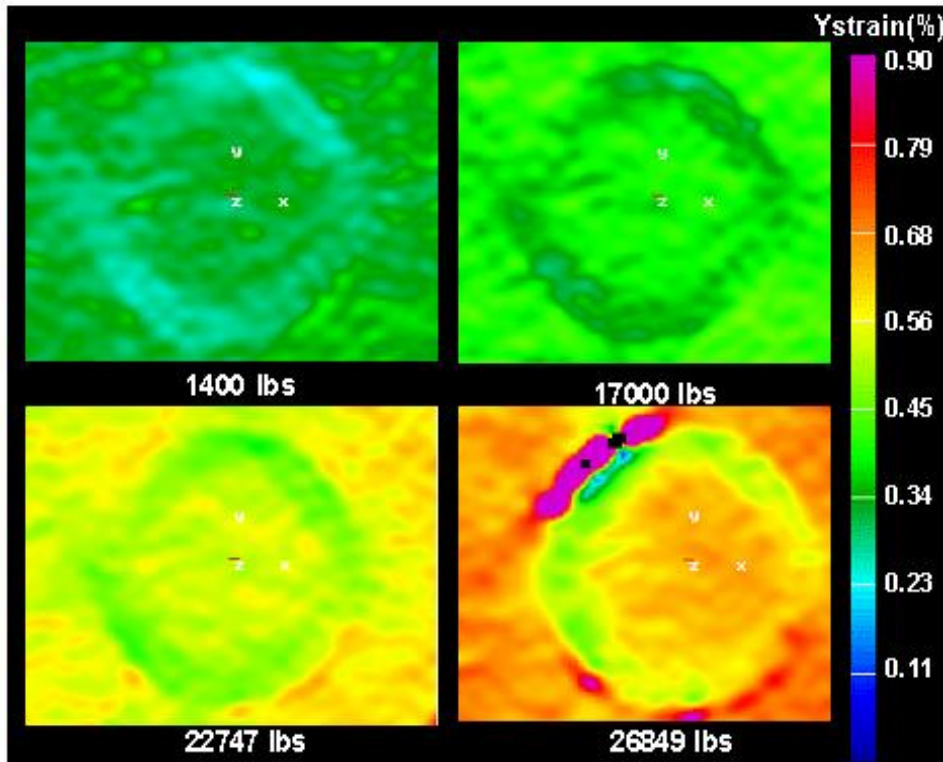
FIGURE 22. Y STRAIN DISTRIBUTION AT DIFFERENT LOAD LEVELS FOR A PICTURE FRAME SHEAR ELEMENT REPAIRED WITH THE OEM METHOD

Figure 22 shows the y strain distribution, or strain in the direction of the load, in a repaired picture frame shear coupon at different load levels. It also shows high-stress concentrations at the taper repair area where the failure was initiated.

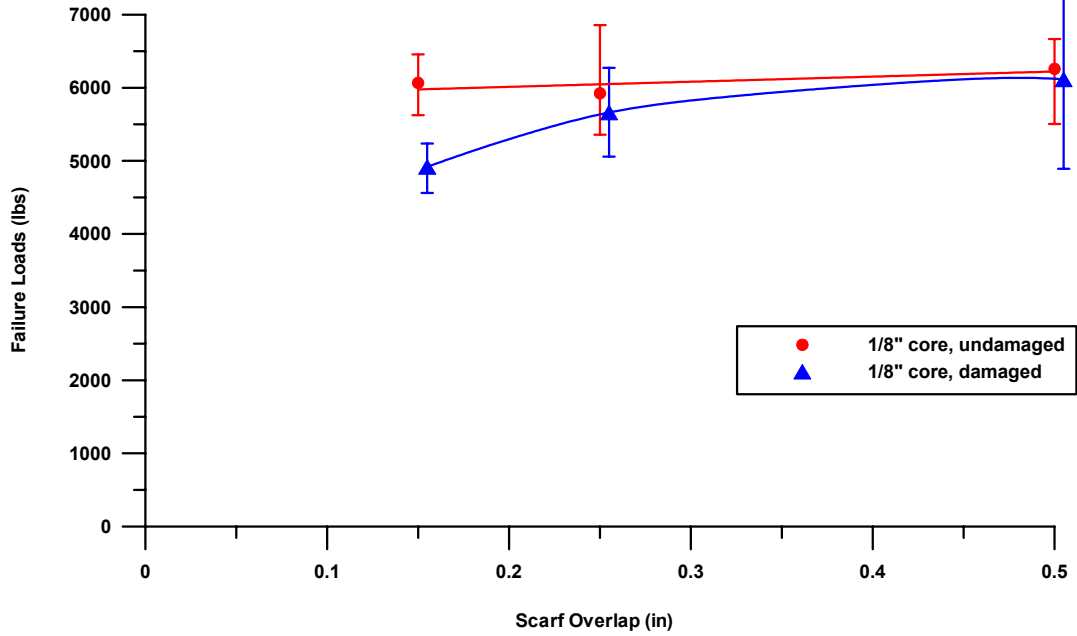
FIGURE 32. EFFECTS OF DAMAGE ON THE FAILURE LOADS OF 1/8-INCH CORE LARGE FOUR-POINT BENDING BEAMS

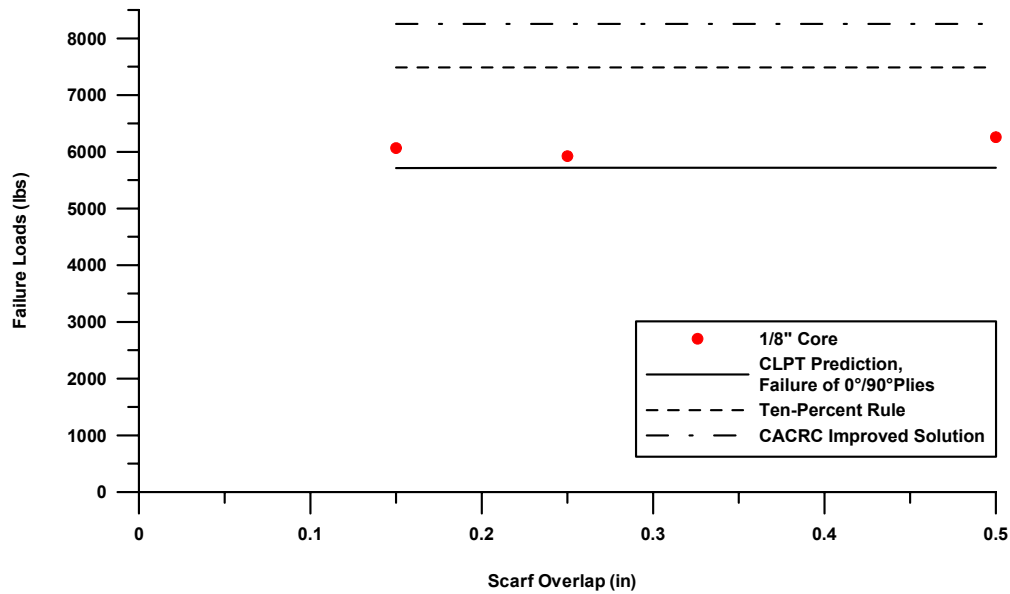
FIGURE 74. LAMINATE MODELS FAILURE LOAD PREDICTIONS COMPARED WITH EXPERIMENTAL DATA FOR THE 1/8-INCH CORE LARGE FOUR-POINT BENDING BEAMS

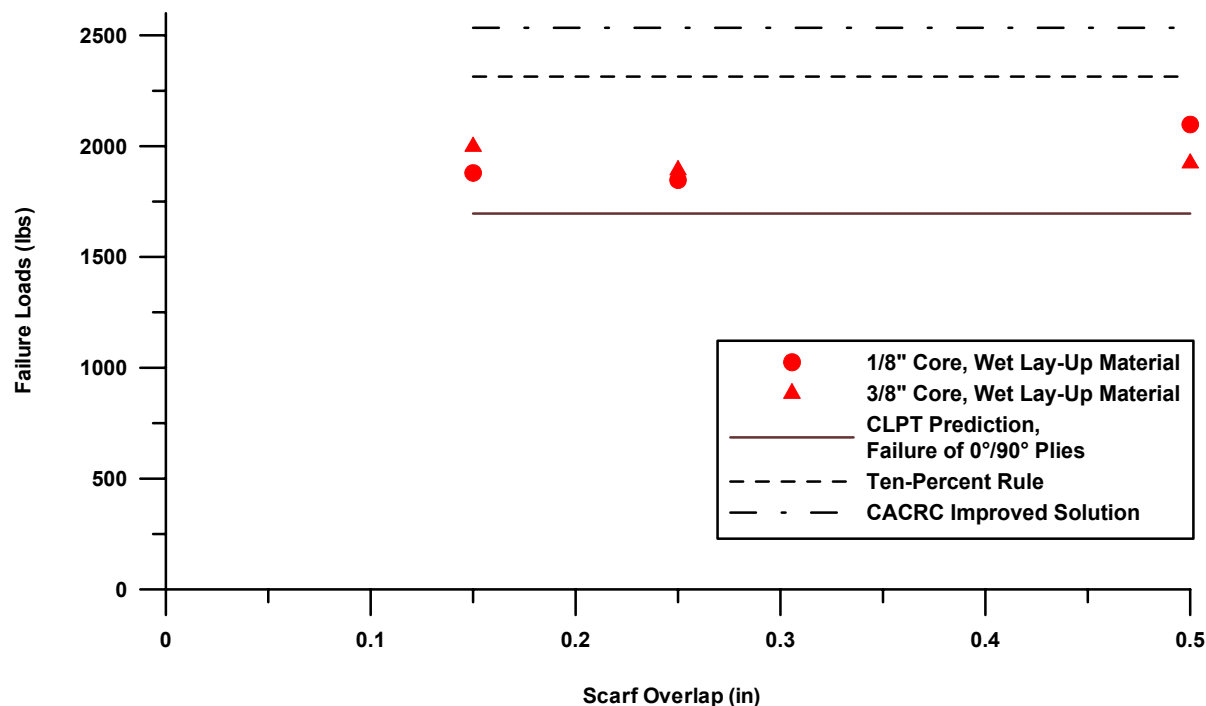
FIGURE 77. LAMINATE MODELS FAILURE LOAD PREDICTIONS COMPARED WITH EXPERIMENTAL DATA FOR THE SMALL FOUR-POINT BENDING COUPONS REPAIRED WITH THE WET LAY-UP MATERIAL SYSTEM
