INTEGRATED
CONTROL MODULES

FUEL INJECTION
THROTTLE BODIES

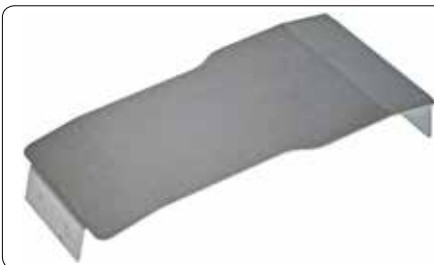
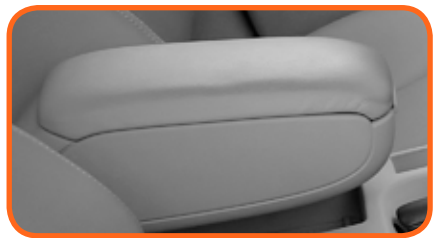
Console Armrest Repair Kit

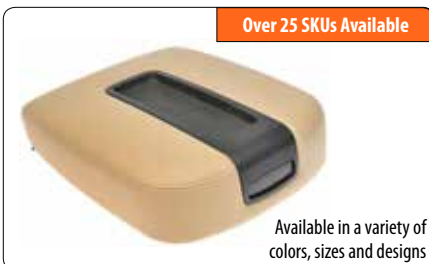
Over 25 SKUs Available

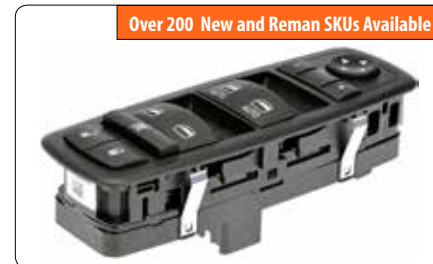
Over 200 New and Reman SKUs Available

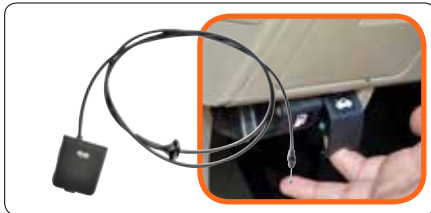
- Failure results in car horn not functioning properly
- Electrical contacts corrode and crack from general wear and tear

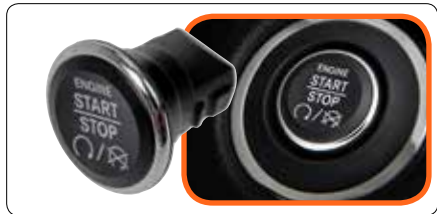
Ignition Switch Actuator

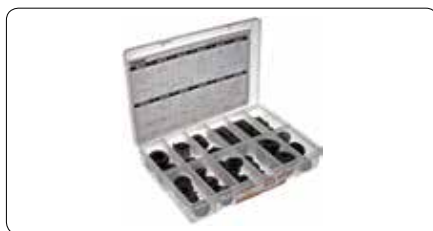
Radiator Mount Bushing Tech Tray

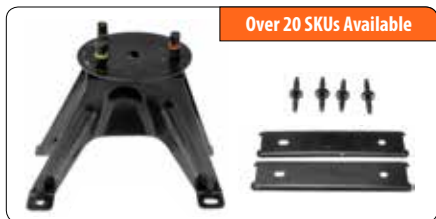
Over 20 SKUs Available

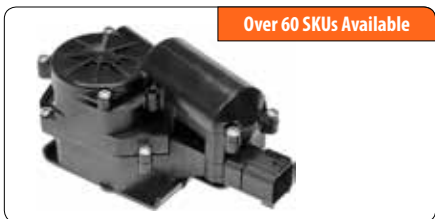
Over 60 SKUs Available

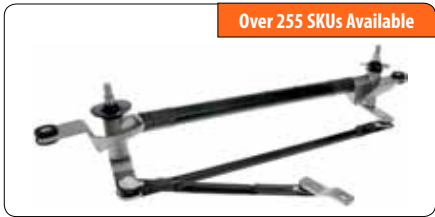
Over 255 SKUs Available

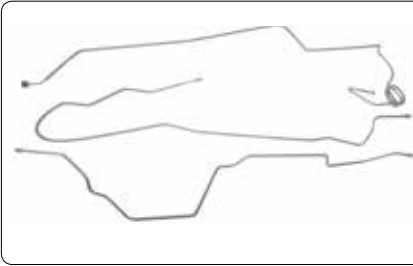
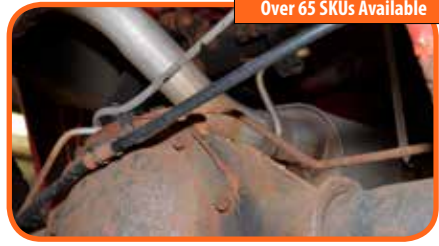
Over 65 SKUs Available

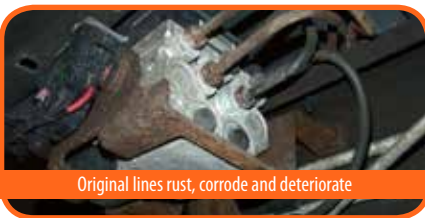
Original lines rust, corrode and deteriorate

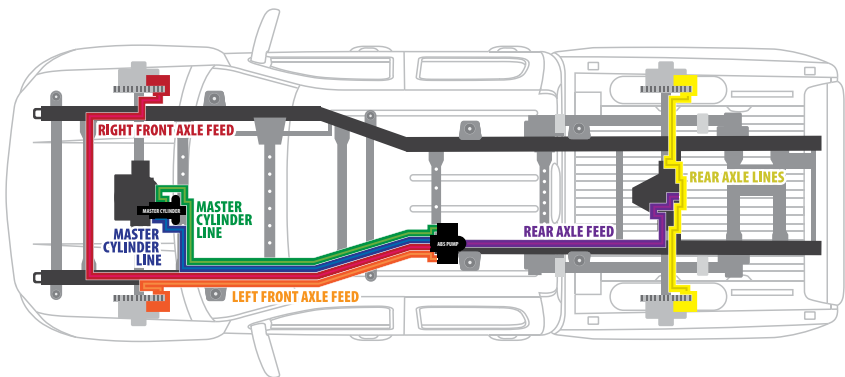
FOR ALL STAINLESS STEEL BRAKE LINE DETAILS PLEASE VISIT US AT:
WWW.DORMANPRODUCTS.COM/STEEL-LINES

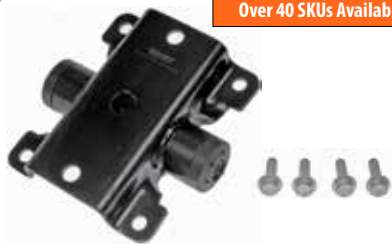
Over 10 SKUs Available

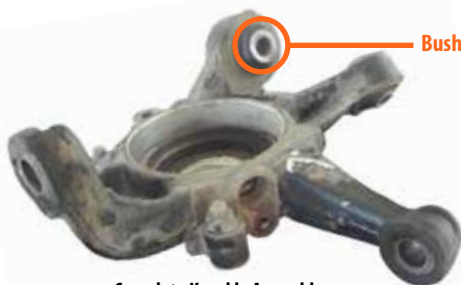
Over 15 SKUs Available

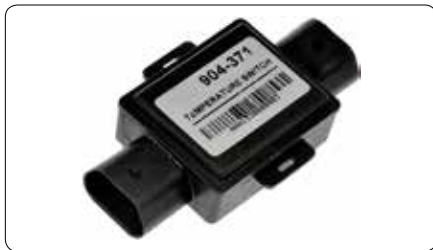
Diesel Emissions Fluid Temperature Sensor

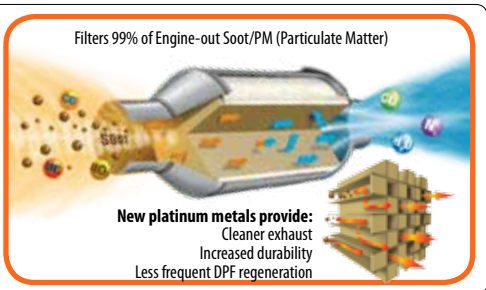
- 100% new units eliminate the core hassle and reduced lifespan of remanufactured alternatives
- New Aftermarket coverage for light and medium duty applications
- Dorman's direct replacement DPFs include gaskets and mounting hardware needed for a complete repair

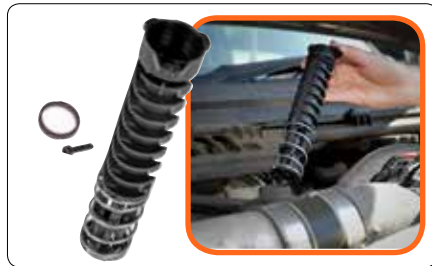
**Engine Oil Filter Housing Return Tube**

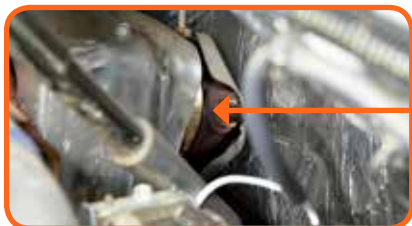
Over 10 SKUs Available

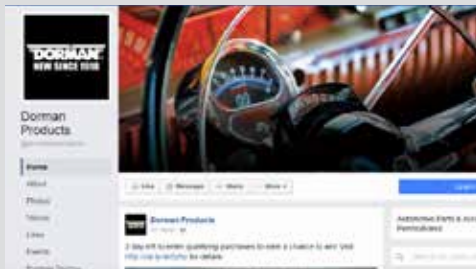
- Maintenance / Safety Tips
- Product Alerts
- Quizzes / Games
- Special Announcements

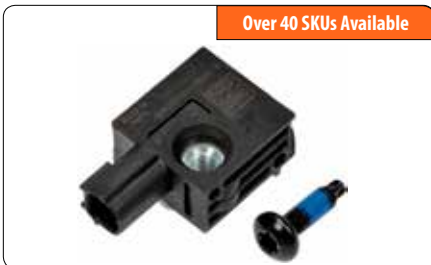
Air Bag Impact Sensors

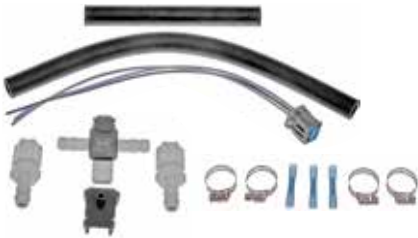
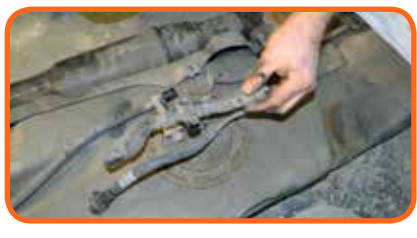
Fuel Tank Pressure Sensors

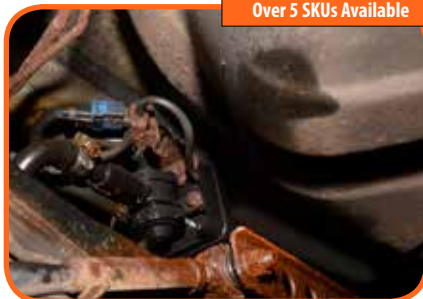
Vapor Canister Vent Valves

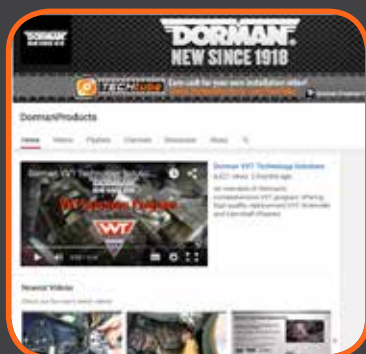
VISIT US ON **YouTube** !

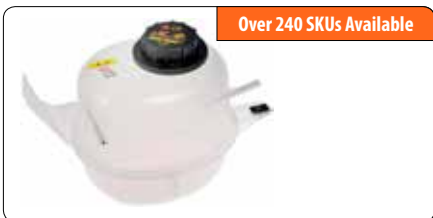
Over 240 SKUs Available

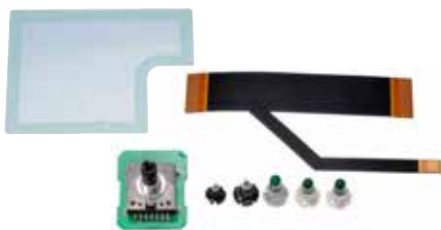
- Redesigned with a more durable plastic construction to withstand the effects of stress generated by the engine compartment
- Includes cap, drain tube and sensor (where applicable)

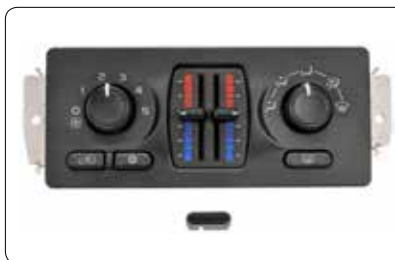
Over 65 SKUs Available

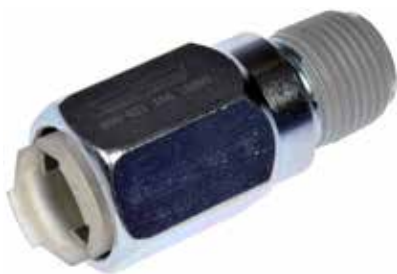
Over 20 SKUs Available

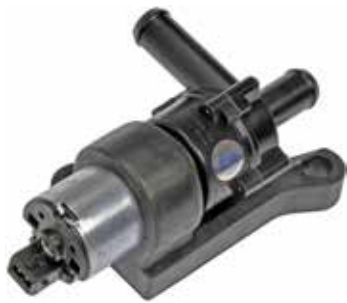
- Original O-Ring leaks due to age or damaged during servicing
- Leaking/loss of pressure

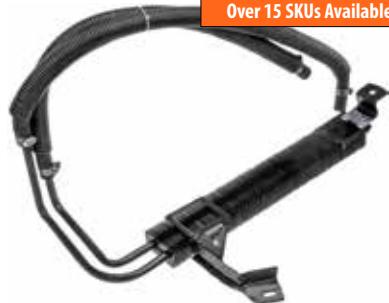
Over 15 SKUs Available

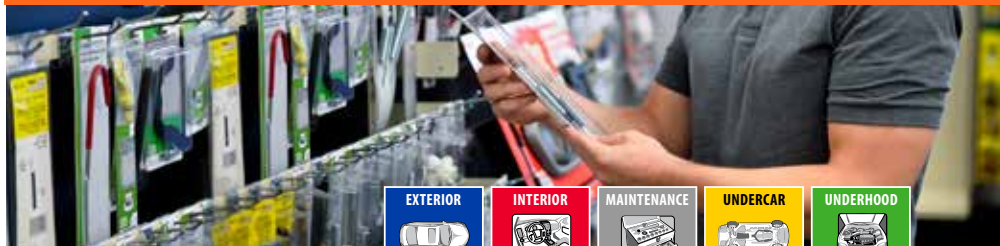
HUNDREDS OF HARD TO FIND SKUs AVAILABLE • WWW.FINDDORMANHELP.COM
