## Peening for Mitigation of PWSCC in Alloy 600

**Paul Crooker** – MRP, EPRI

**NRC/Industry Tech Meeting**

June 9, 2011

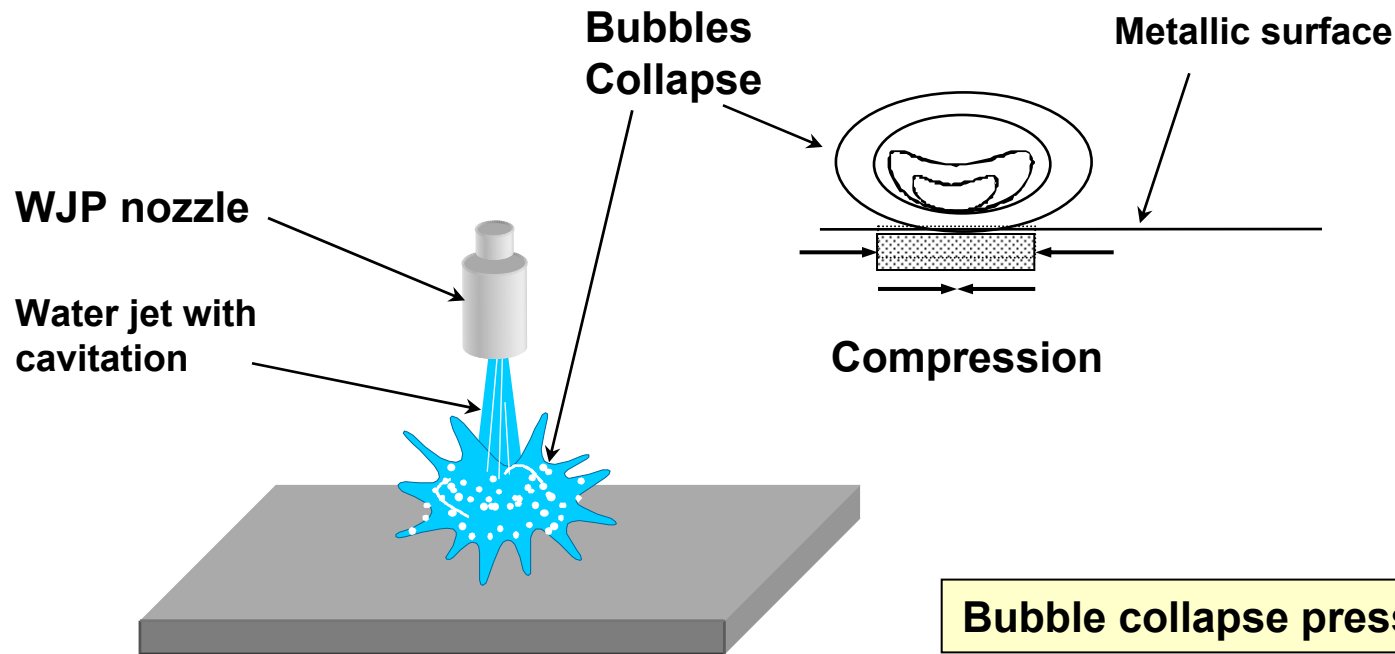
**Schematic**

- *High velocity jet results in pressure below vapor pressure in water*
- *Vapor bubbles form in water*
- *Bubbles collapse at surface generating high pressures*
- *Compressive stresses in the surface layer of material result*

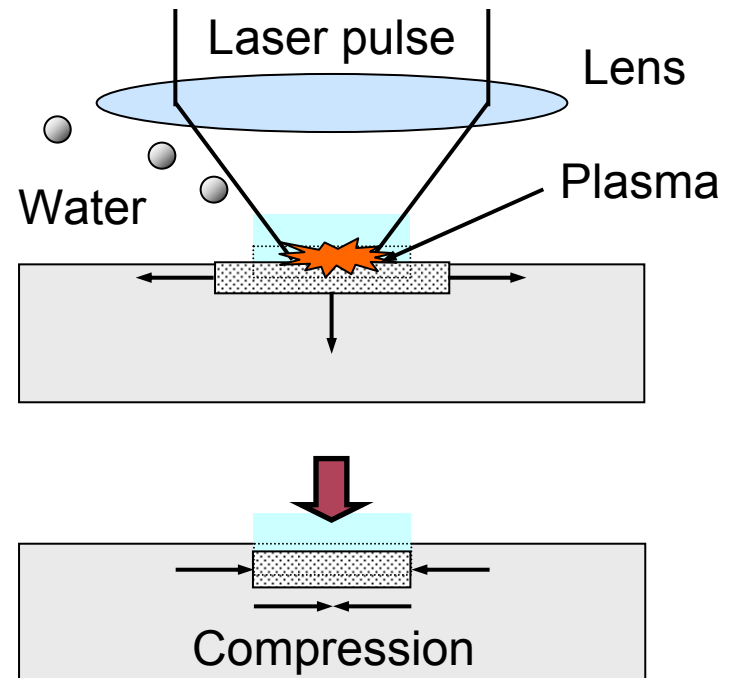
## Schematic

- ***Focused high-energy laser pulse irradiates metal surface in water***
- ***High-pressure plasma forms on the metal surface***
- ***Shock wave forms, impinges on metal surface, and creates permanent local strains***
- ***Compressive residual stress is produced by constraint of surrounding material***

- Plasma pressure ~ 725 ksi  
- Alloy 600 Yield Strength ~ 35-42 ksi

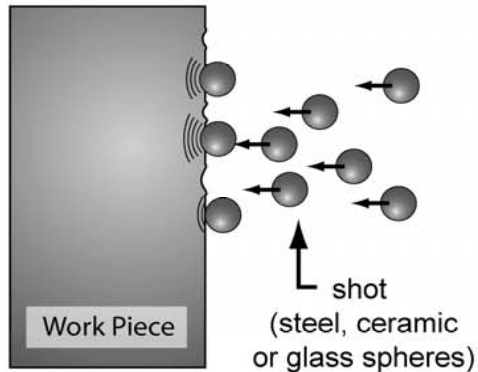
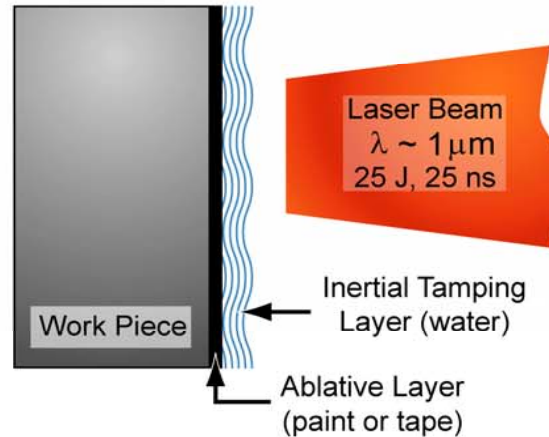
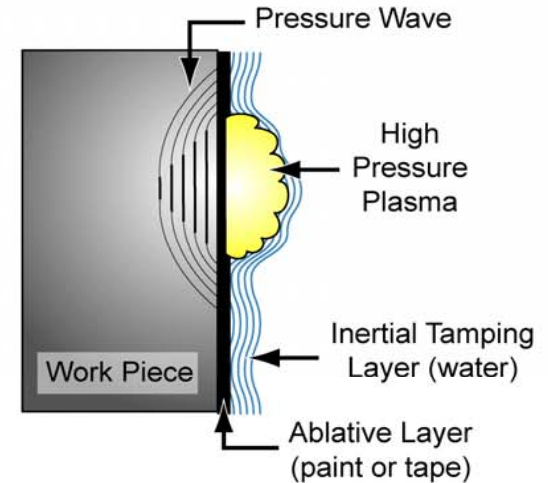
# Laser Shock Peening (air)

- An extension of conventional peening
- Laser peening provides
  - Highly compressive surface residual stress
  - Deep layer of compressive residual stress
  - Smooth surface
  - Excellent process control

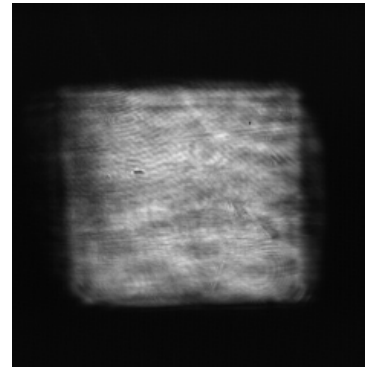
Laser near field image

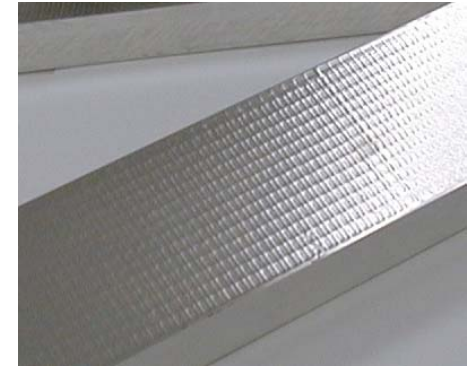
Laser peened aluminum

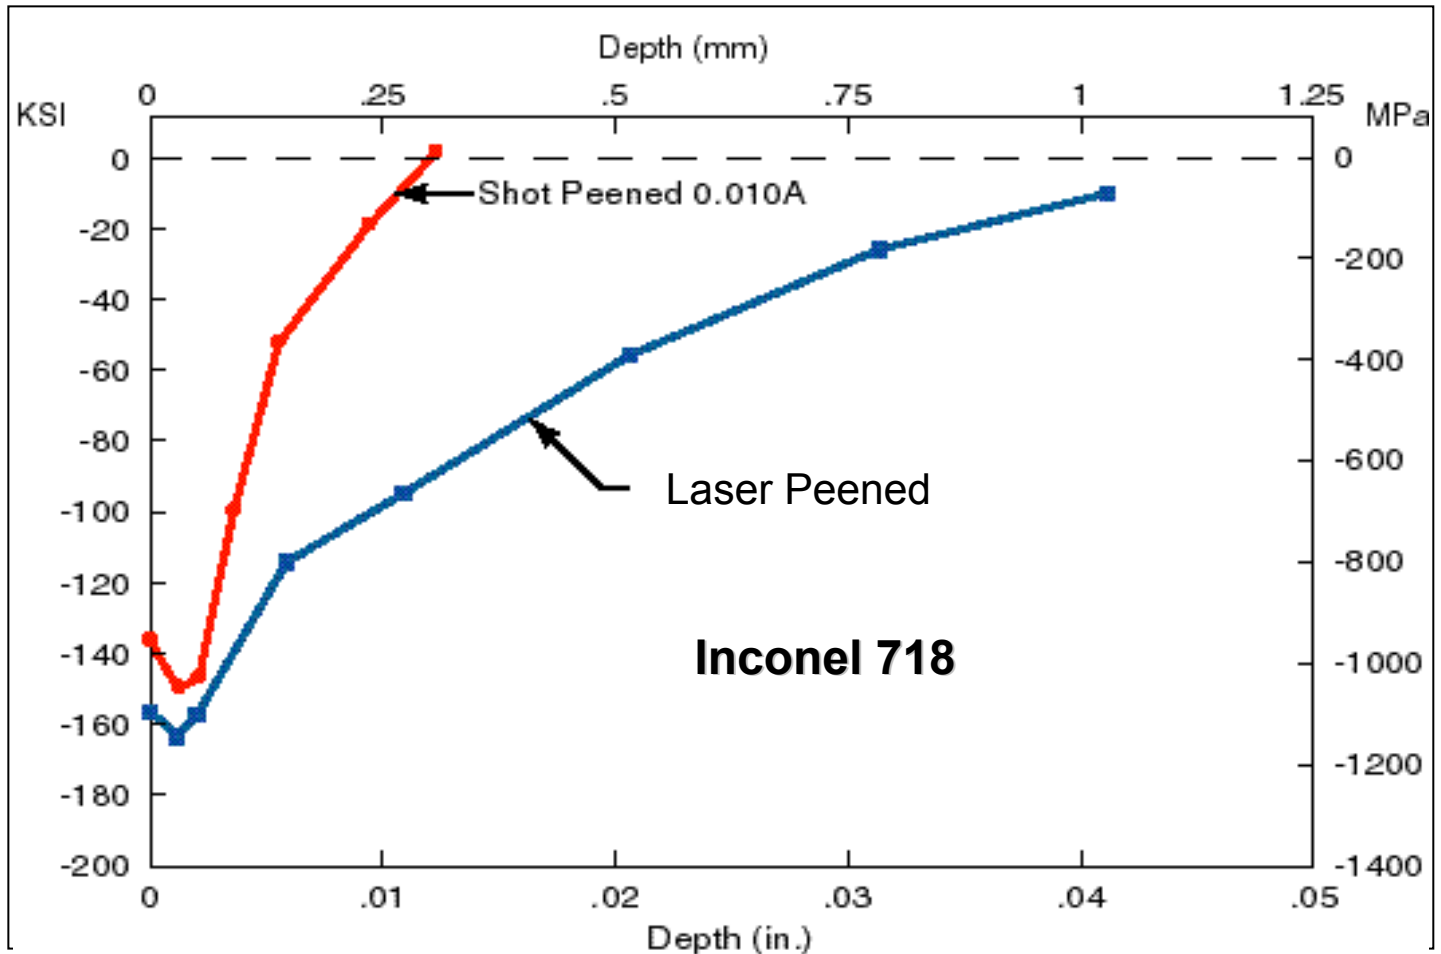
# Advanced Peening Techniques Provide Deeper Residual Compressive Stress

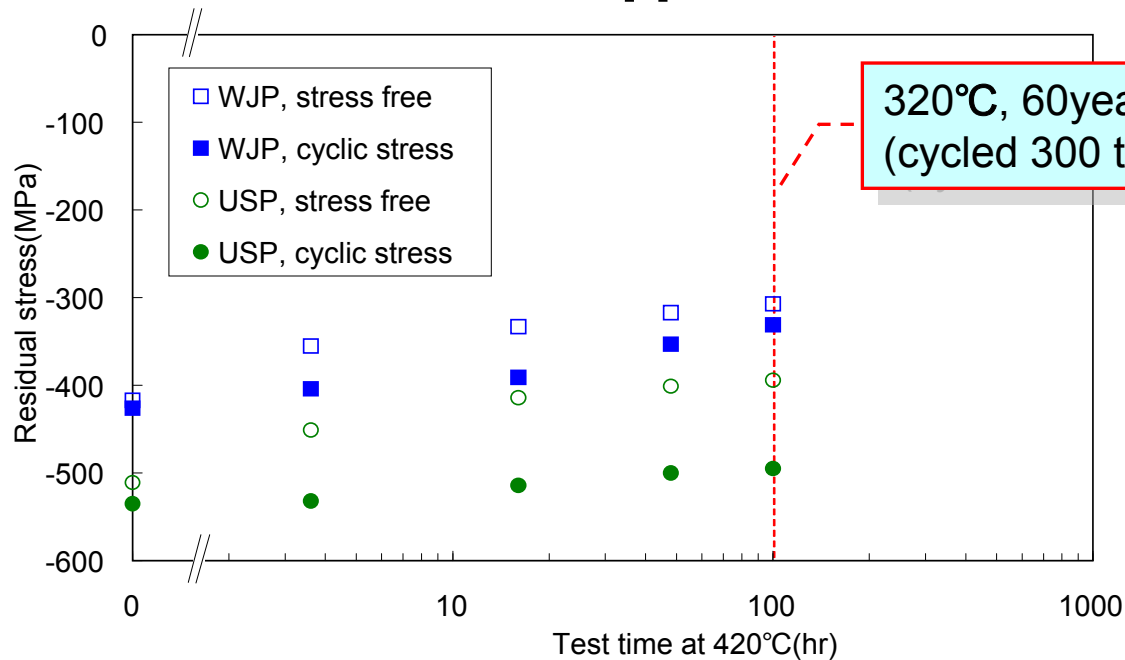
## Stress Relaxation – Affect of temperature and cyclic stress

**MRP testing shows that most relaxation occurs during early cycles**

“60 years” is the evaluation time in 593K(320°C) which calculated the result of examination temperature 693K(420°C) in Larson-Miller parameter  
[ $T \times (\text{Log } t + 20) = \text{const.}$      $T$  : temp ( K )     $t$  : time]
