AFRL-RX-TY-TR-2010-0094

## **RAPID SET MATERIALS FOR ADVANCED SPALL REPAIR**

August 2010

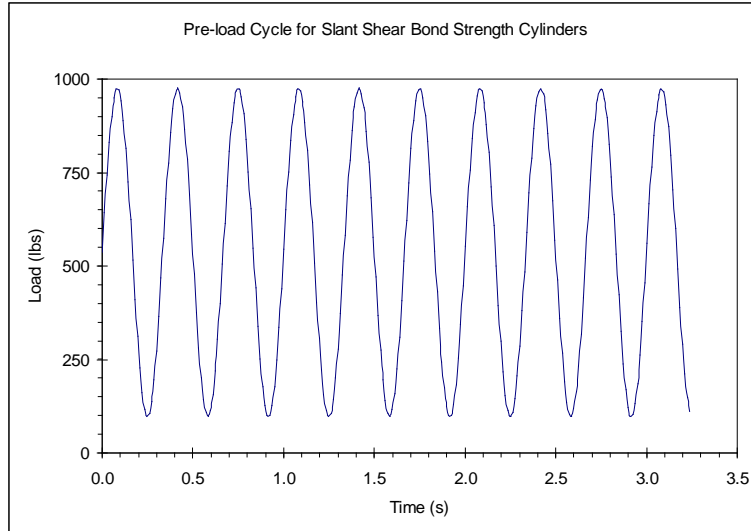
**Figure 3. Pre-Load Cycles for Fatigue Tests**

2. The cylinders prepared in step 1 were pre-loaded at time intervals shown in Table 5. The time intervals were measured from the start of mixing and not from final set. A cyclic compressive pre-load with a maximum compressive stress equivalent to the tire pressure of a C-17 (138 psi, or 975 lbs for a 3-in-diameter cylinder) were applied ten times at the appropriate time interval as shown in Figure 3. After the pre-load was applied, the samples were stored at room temperature and tested after at least 28 days measured from mixing time of the spall repair material to determine early loading affect on fatigue life.

3. During fatigue testing, the maximum load was defined by the stress ratio given in Table 5. The minimum load was a stress ratio of approximately 0.05.

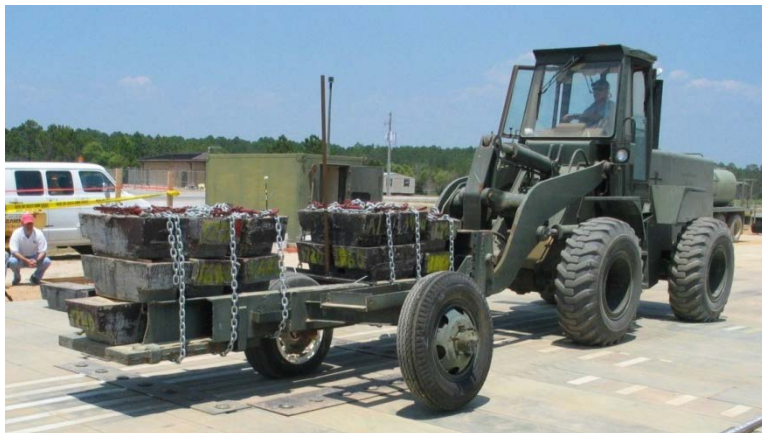
**Figure 4. F-15 Load Cart**

An F-15 load cart with wheel load of 32,500 lbs (315 psi tire pressure) was used to traffic edge and corner spall repairs for a total of 1,500 passes. A photograph of AFRL’s F-15 load cart is shown in Figure 4.

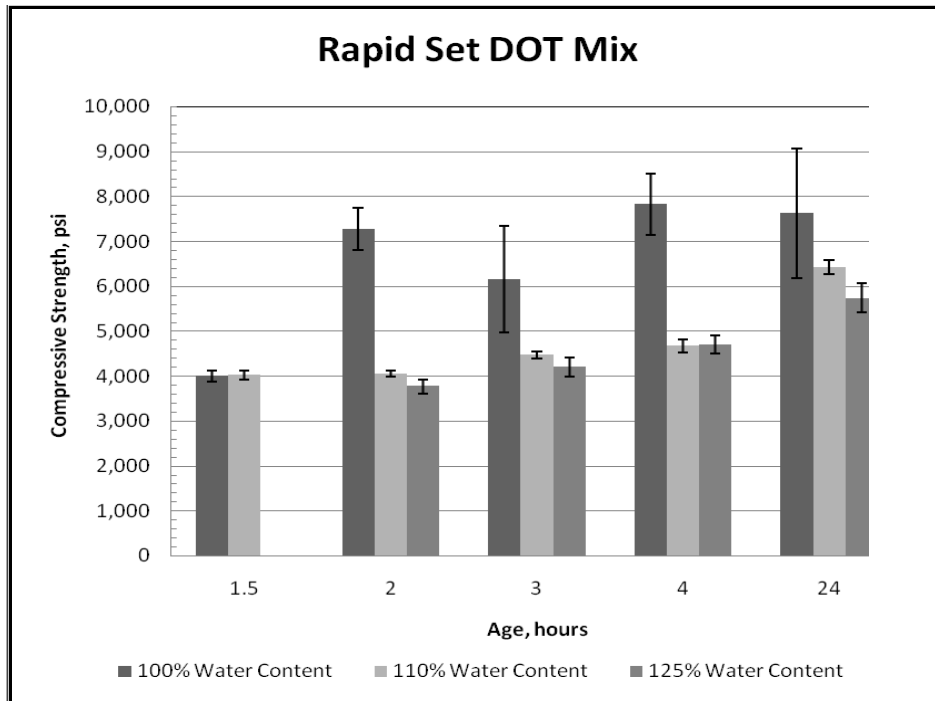
**Figure 16. Rapid Set DOT Mix Compressive Strength with Variable Water**

The four materials selected from Table 6 were prepared with water contents that equaled 110 percent and 125 percent of the manufacturer’s recommendations. Each material sample was prepared and stored at room temperature until the appropriate test time interval. The results of compressive strength tests conducted in accordance with ASTM C39 are presented in Figures 16 through 19 for the four products. In these figures, the bar charts represent the average compressive strength values, while the error bars represent 95 percent confidence intervals on the mean.

These data indicate that all four materials are sensitive to increases in mix water content, and that strength is significantly reduced, particularly at early ages, by increasing the mix water above that recommended by the manufacturer. These findings were expected, because these trends are true for most cementitious materials, i.e., increasing the water-cementitious ratio has a detrimental effect on strength. Of the four materials tested, Rapid Set DOT Mix (Fig. 16) was the least sensitive to an increase in mix water, and Futura 15 (Fig. 17) was the most sensitive.

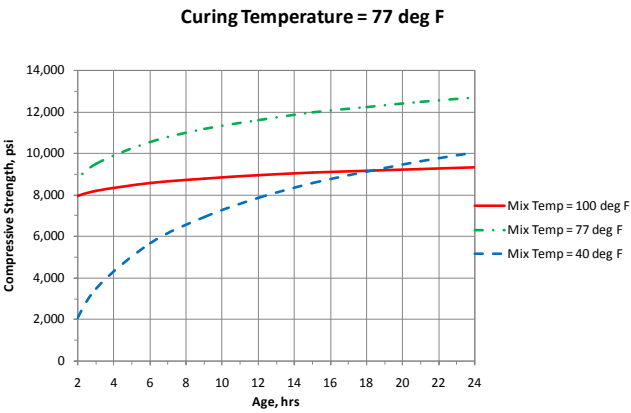
**Figure 20. Predicted Compressive Strength Gain Curves, DOT Repair Mix**

Figure 20 through Figure 23 present plots of the compressive strength versus age from the regression models for the four materials given various scenarios of mixing and curing temperatures. The first graph in each figure presents the scenario of equal mixing and curing temperatures of 40, 77, and 100 °F. The three lower graphs show the model predictions for curing temperatures of 40, 77, and 100 °F with mixing temperatures of 40, 77, and 100 °F for each curing temperature. The premise behind these plots is that field users will have no control over curing temperature, but may control mixing temperature by storing materials in a temperature-controlled environment until just before mixing.

The most striking conclusion from these models, based on data from a designed experiment, is that the mixing and placing temperatures have a significant effect on the early-age compressive strength gain. Comparing the various materials shows that these effects vary from material to material, and a general trend is not readily evident across all the materials. It is expected that increased temperature would speed up the hydration reaction, and result in increased compressive strength at early age. This trend seems to be apparent for 10-61 and Futura 15, while DOT Repair Mix and Pavemend 15 are negatively impacted by high temperatures. More information on the constituent materials and additional research would need to be conducted to determine the causes of these effects.
